# Environmetnal Team Services for Contract No. SS H504 Design and Construction of Chai Wan Government Complex and Vehicle Depot

15<sup>th</sup> Monthly EM&A Report (January 2023)

Contract No. SS H504 Design and Construction of Chai Wan Government Complex and Vehicle Depot

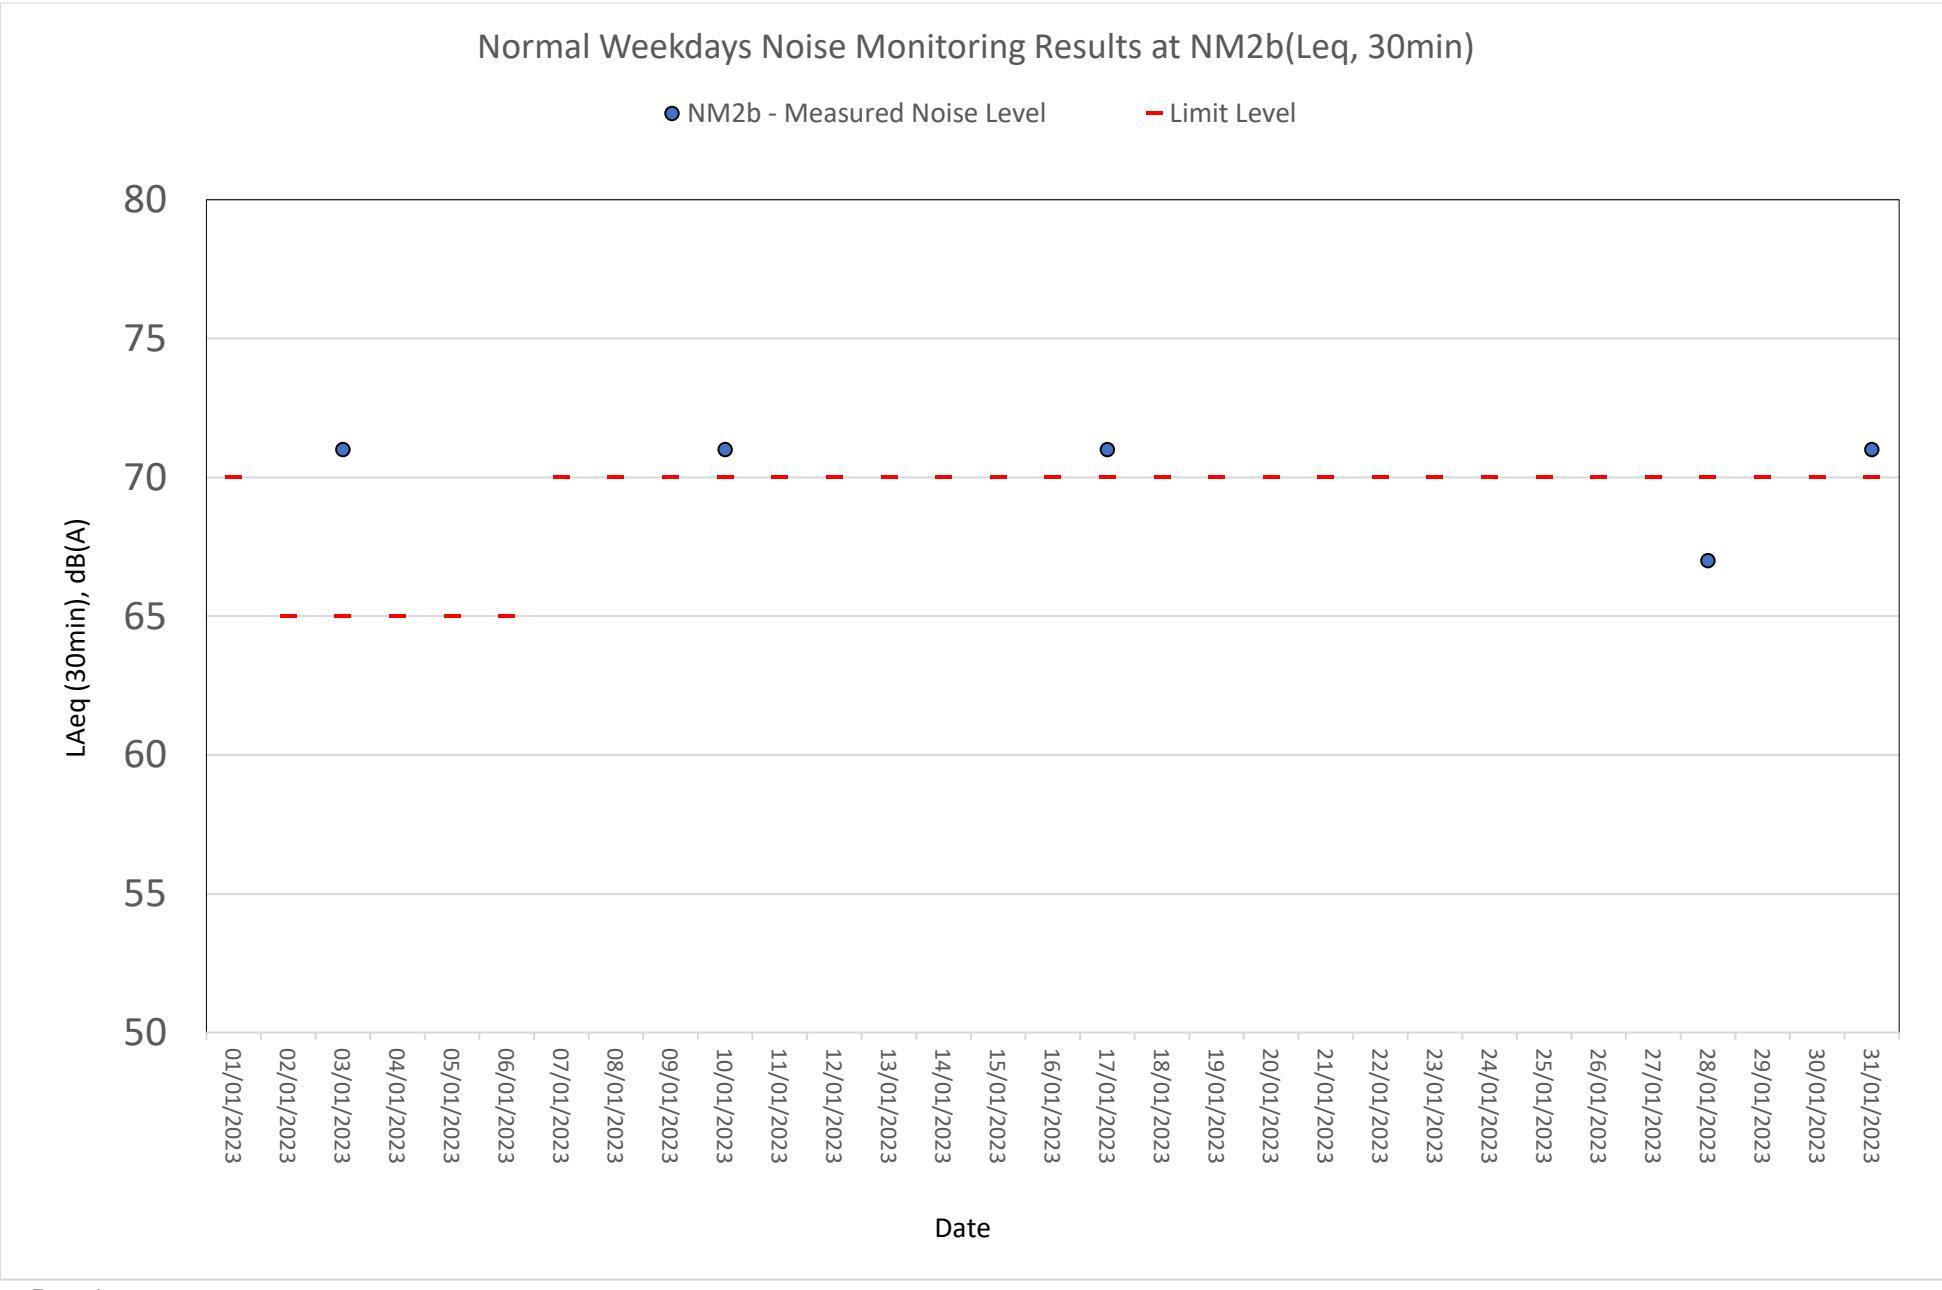
On 3 Jan 2023 the measured nose level of NM2b exceeded the action level of 65dB(A) as it was examination period. However, it was lower than the baseline level of 73.4dB(A). Therefore, it is not considered as an Limit Level exceedance.

On 10, 17 and 31 Jan 2023 the measured nose level of NM2b exceeded the action level of 70dB(A). However, they were lower than the baseline level of 73.4dB(A). Therefore, they are not considered as an Limit Level exceedance.

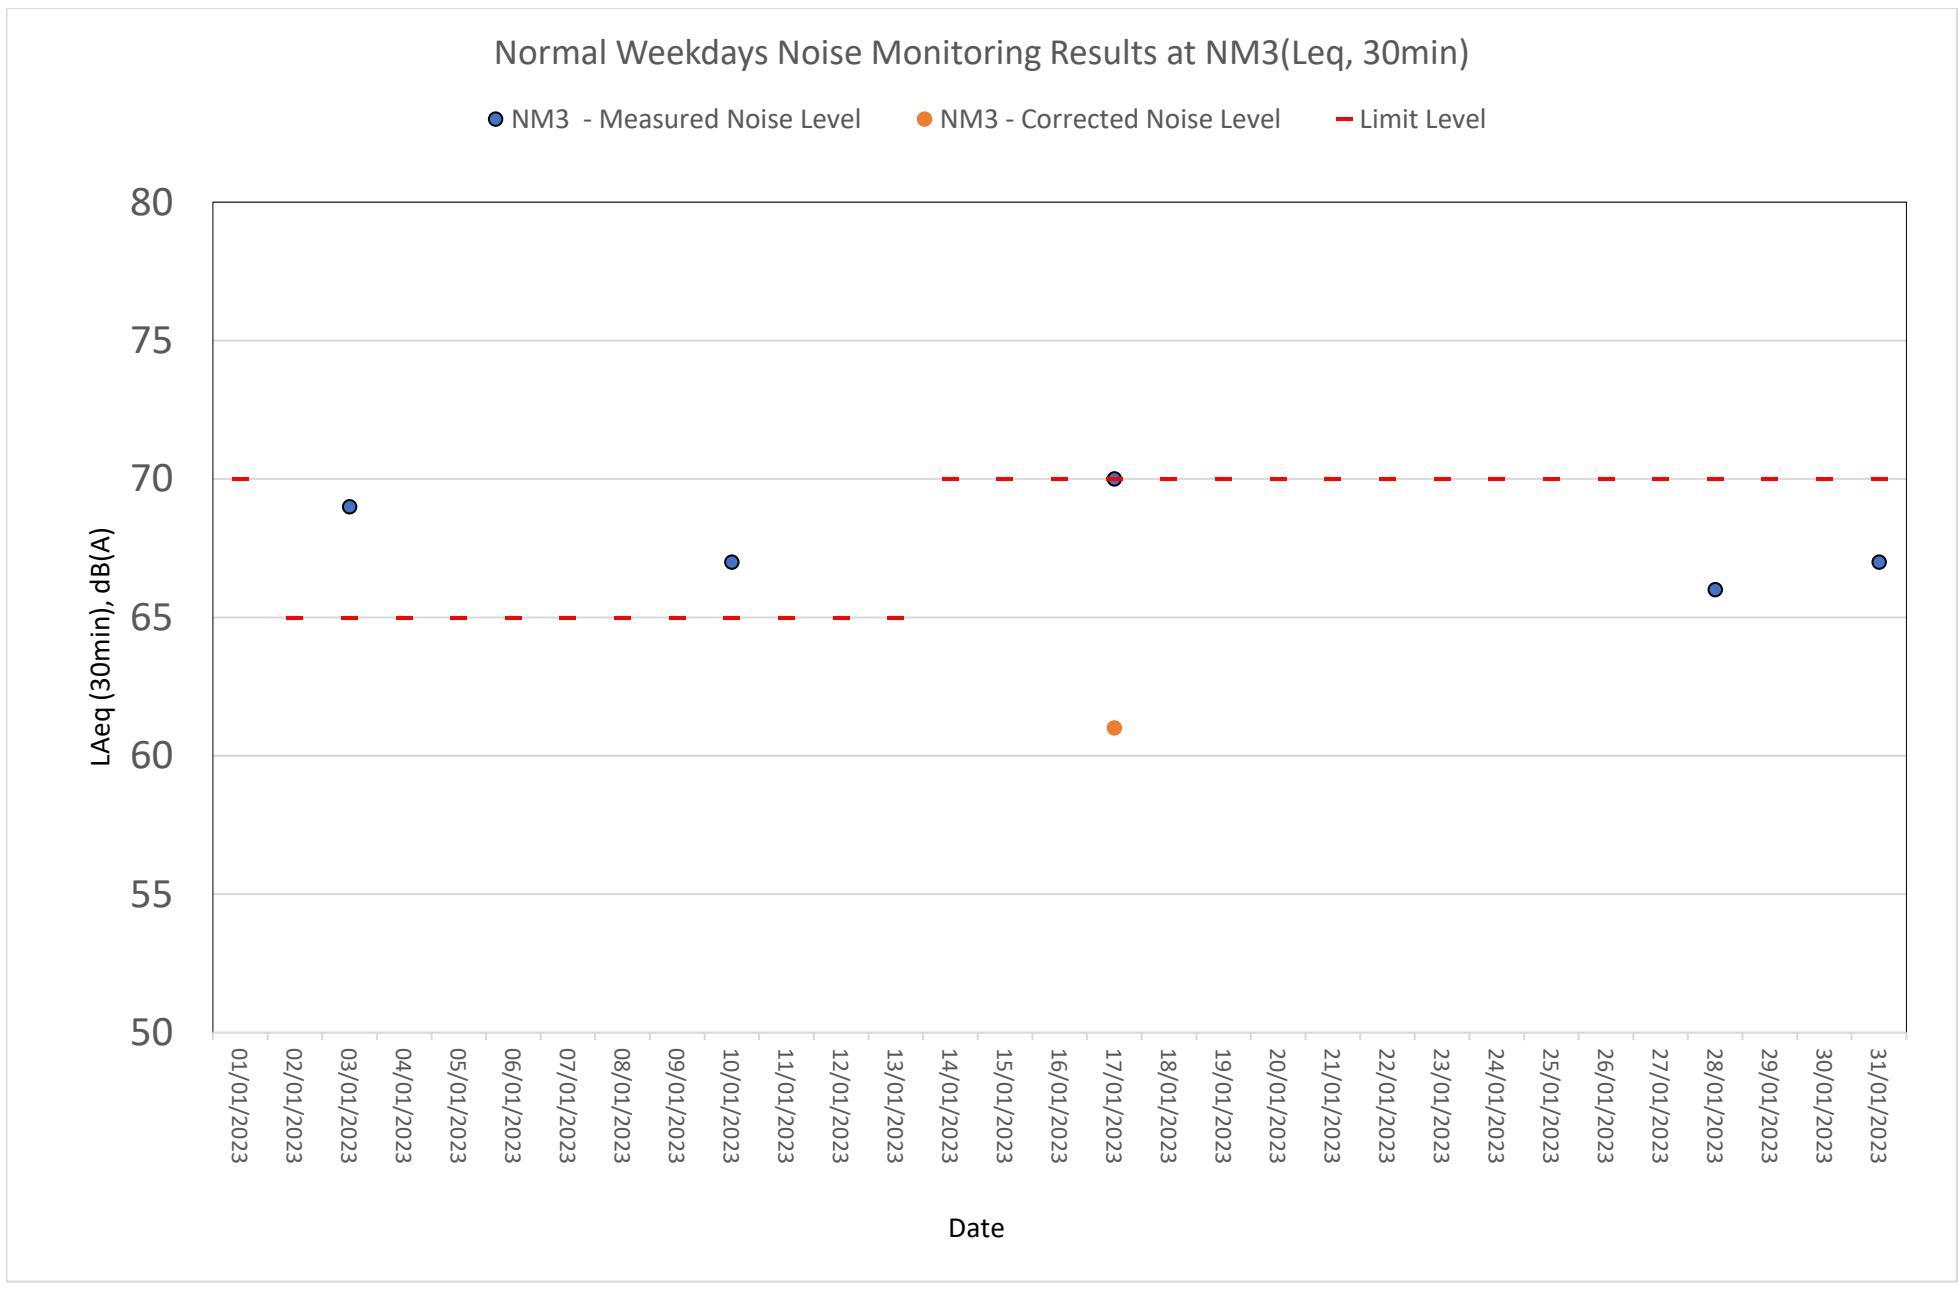
# The measured noise level exceeded the noise level of 70dB(A) and it was higher than the baseline level of 69.8 dB(A). Therefore, baseline correction was carried out and the corrected noise level which solely represent the noise level of Construction works are lower than the noise criteria. As such the EAP was not triggered.

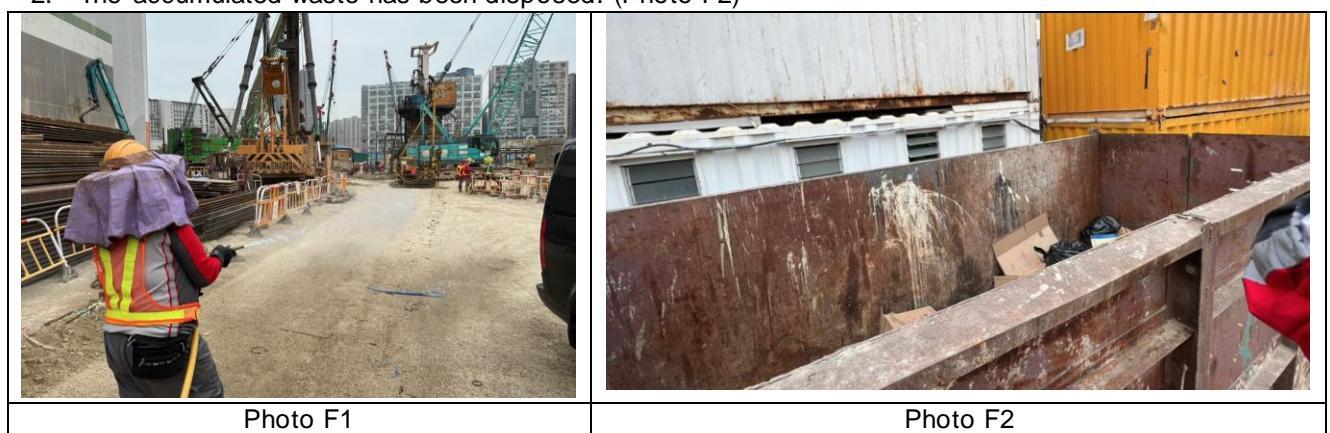
The area was backfilled and the Contractor has arranged watering for the work area. (Photo F1)
The accumulated waste has been disposed. (Photo F2)

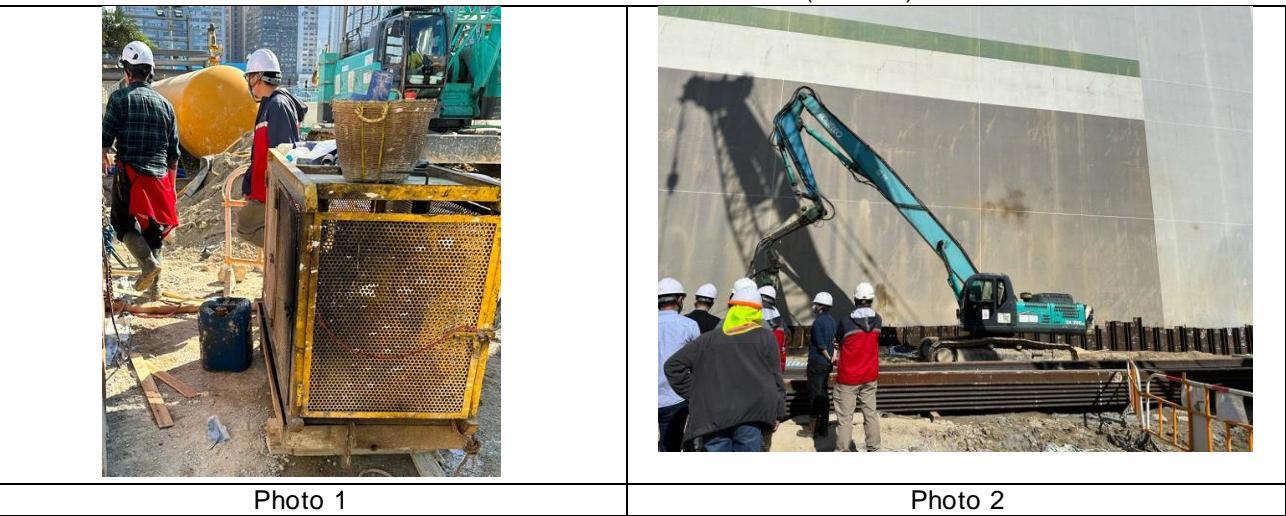
- Chemical container was observed without drip tray. The Contractor has been reminded to provide drip trays for all chemical containers.
- Vibration hammer was observed without movable noise barriers. The Contractor has been reminded to provide movable noise barriers for vibration shammers to fulfil the CNMP requirement.

1. Chemical container is observed without drip tray. (Photo 1)

1. Vibration hammer is observed without moveable noise barriers. (Photo 2)

- 1. The Contractor has been reminded to provide drip trays for all chemical containers.
- 2. The Contractor has been reminded to provide moveable noise barriers for vibration hammers to fulfil the CNMP requirement.

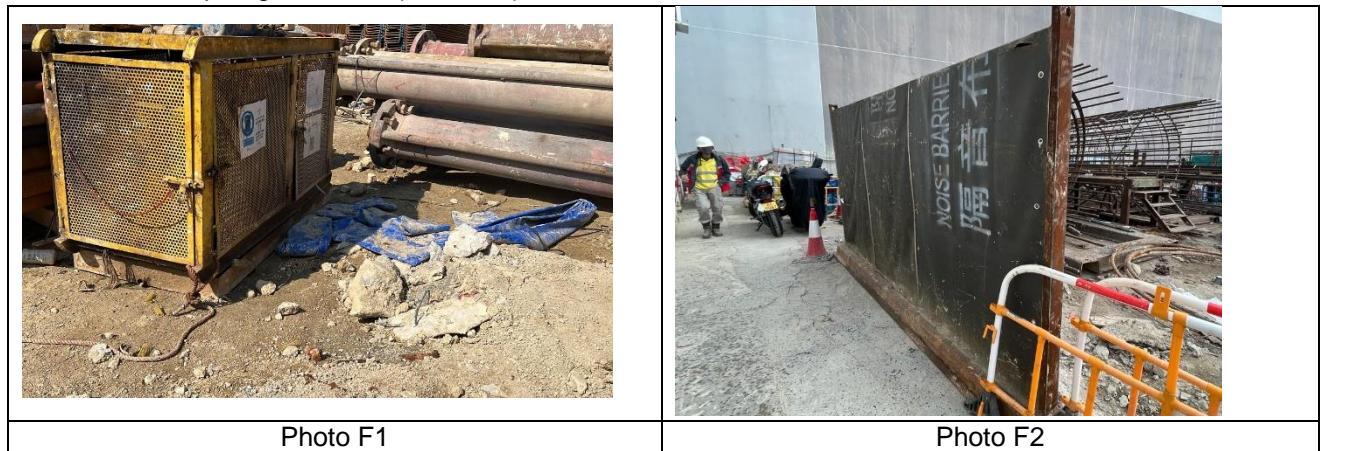
- 1. The chemical container was removed. (Photo F1)
- 2. The Contractor has prepared the movable noise barrier and they have been reminded to provide the noise barrier for pilling machine. (Photo F2)

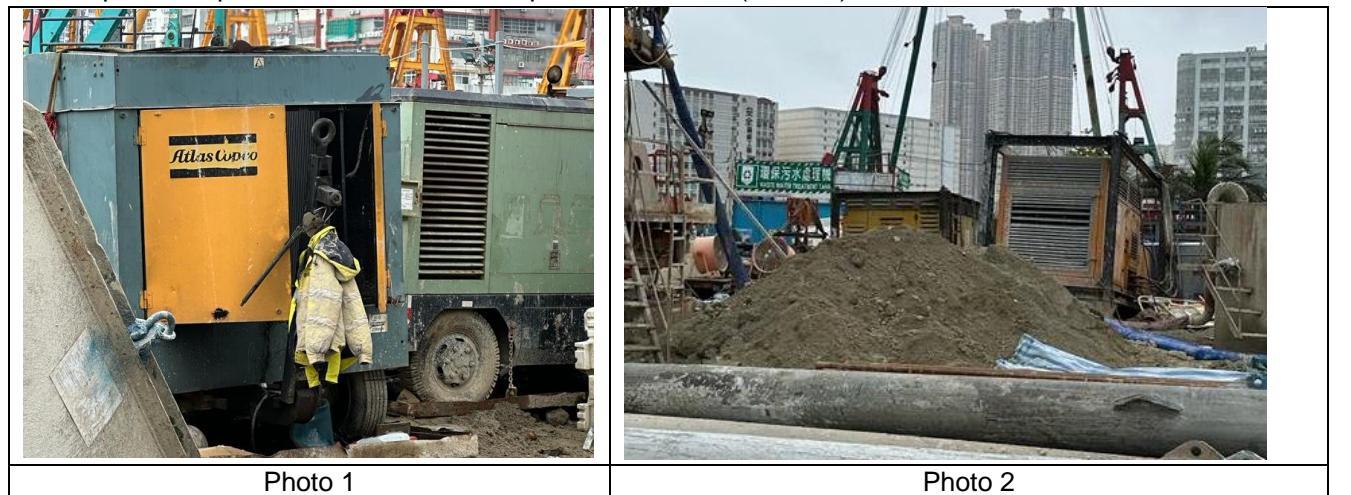
- An air compressor was operated with door opened. The Contractor has been reminded to close the door when operating air compressors.
- Open stockpile was observed without impervious sheets. The Contractor has been reminded to cover the stockpile with impervious sheets before the rainfall.

1. An air compressor is operated with door opened. (Photo 1)

1. Open stockpile is observed without impervious sheets. (Photo 2)

- 1. The Contractor has been reminded to close the door when operating air compressors.
- 2. The Contractor has been reminded to cover the stockpile with impervious sheets before the rainfall.

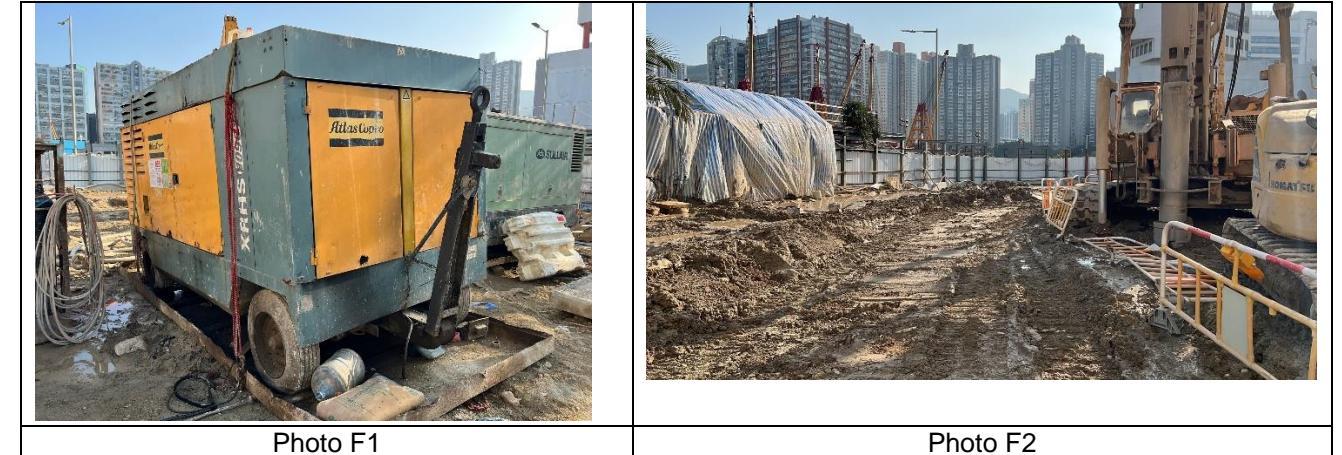
- 1. The air compressor was operated with door closed. (Photo F1)
- 2. The open stockpile was removed. (Photo F2)

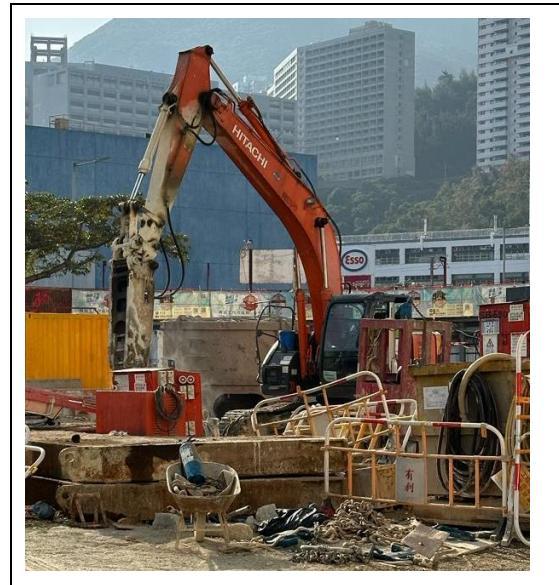
- Dust was generated from the breaking work. The Contractor has been reminded to spray water on surface continuously during breaking work.
- Oil stain was observed under the mobile crane. The Contractor has been reminded to clear the oil stain and dispose of as chemical waste.
- The channel at the vehicle washing was accumulated with sand and silt. The Contractor has been reminded to remove the sand and silt in the channel.

- 1. Dust is generated from the breaking work. (Photo 1)
- 2. Oil stain is observed under the mobile crane. (Photo 2)

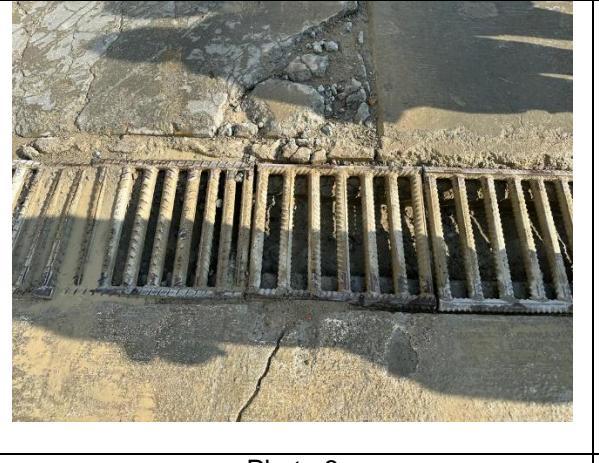
Photo 3

1. The channel at the vehicle washing is accumulated with sand and silt. (Photo 3)

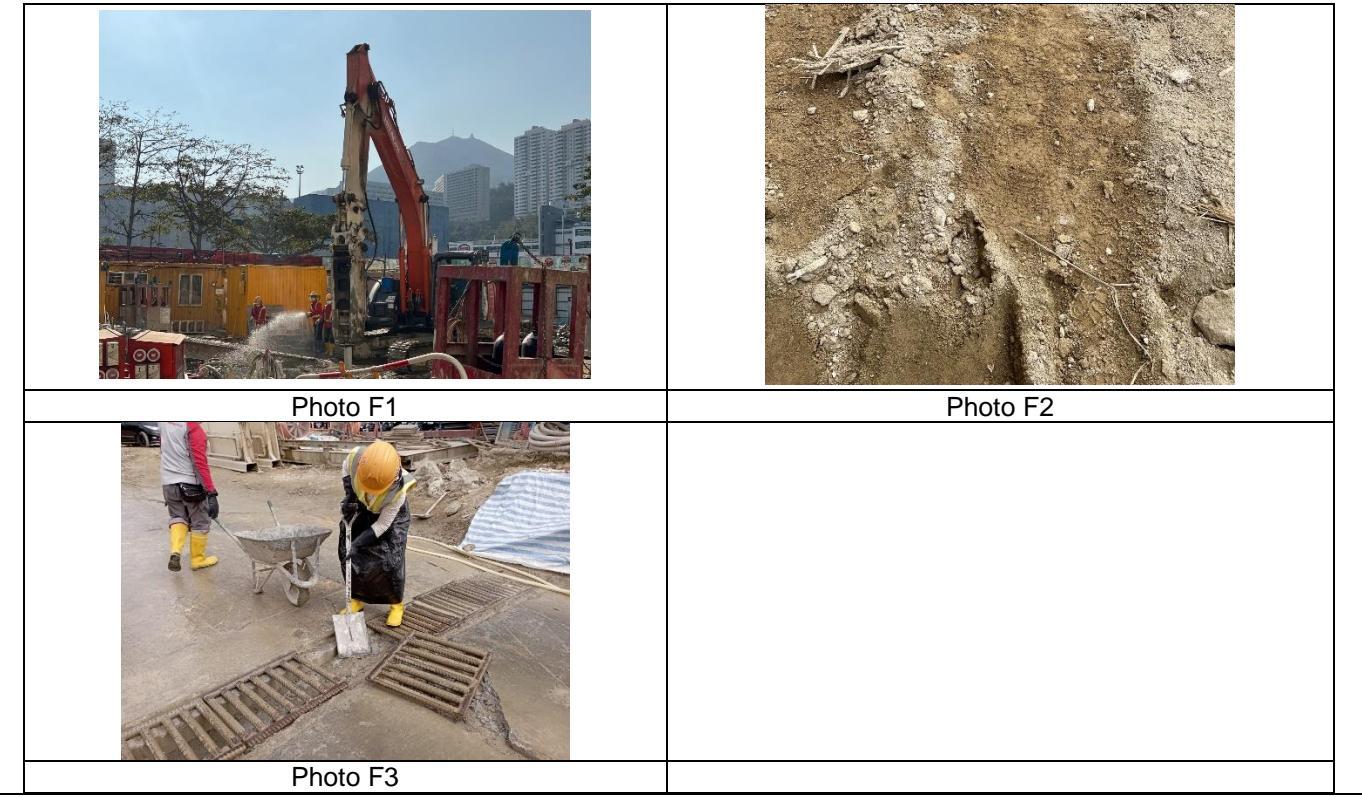
- 1. The Contractor sprayed water on surface continuously during breaking work. (Photo F1)
- 2. The oil stain was cleared and disposed of as chemical waste. (Photo F2)
- 3. Sand and Silt were removed from the channel. (Photo F3)

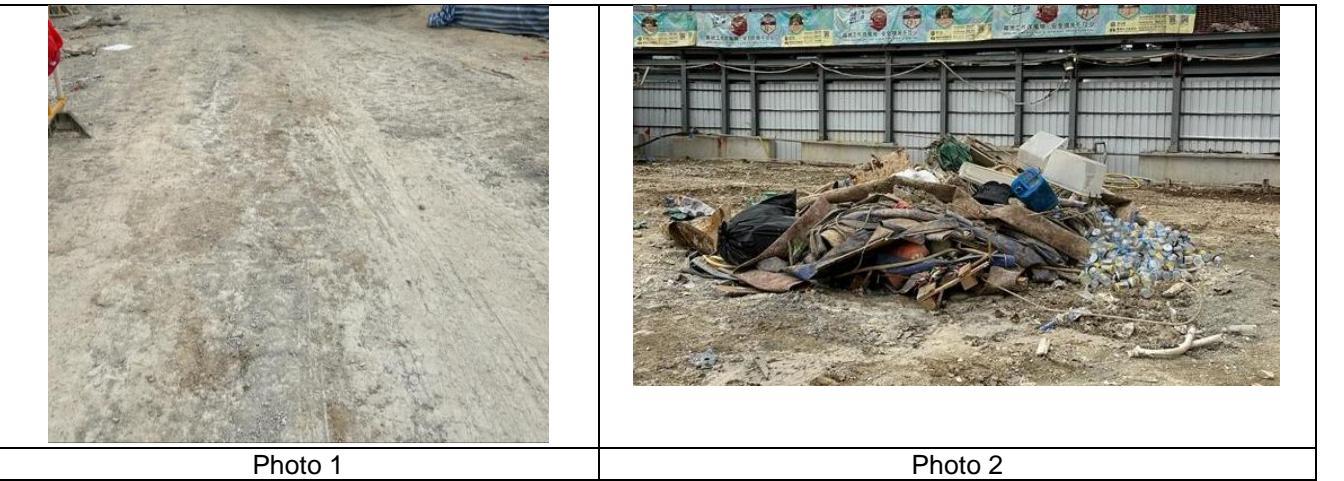
- The work area was dry and fugitive dust was observed. The Contractor has been reminded to schedule watering for the work area.
- Open stockpile of waste was observed and oil container was stored with other waste. General waste shall be stored in enclosed bins or compaction units separately from the construction and chemical waste.

- Reminder(s):
  - 1. The work area is dry and fugitive dust is observed. (Photo 1)
  - 2. Open stockpile of waste is observed and oil container is stored with other waste. (Photo 2)

- 1. The Contractor has been reminded to schedule watering for the work area.
- 2. General waste shall be stored in enclosed bins or compaction units separately from the construction and chemical wastes.
