CONTRACT NO: CV/2012/07
**DEVELOPMENT AT ANDERSON ROAD -
FOOTBRIDGE D AND ASSOCIATED WORKS AREA**
**QUARTERLY ENVIRONMENTAL MONITORING & AUDIT
REPORT**
-OCTOBER 2014 TO DECEMBER 2014 -

**Re: Contract No. CV/2012/07
Development at Anderson Road
Footbridge D and Associated Works Area
Quarterly EM&A Report for October 2014 to December 2014**

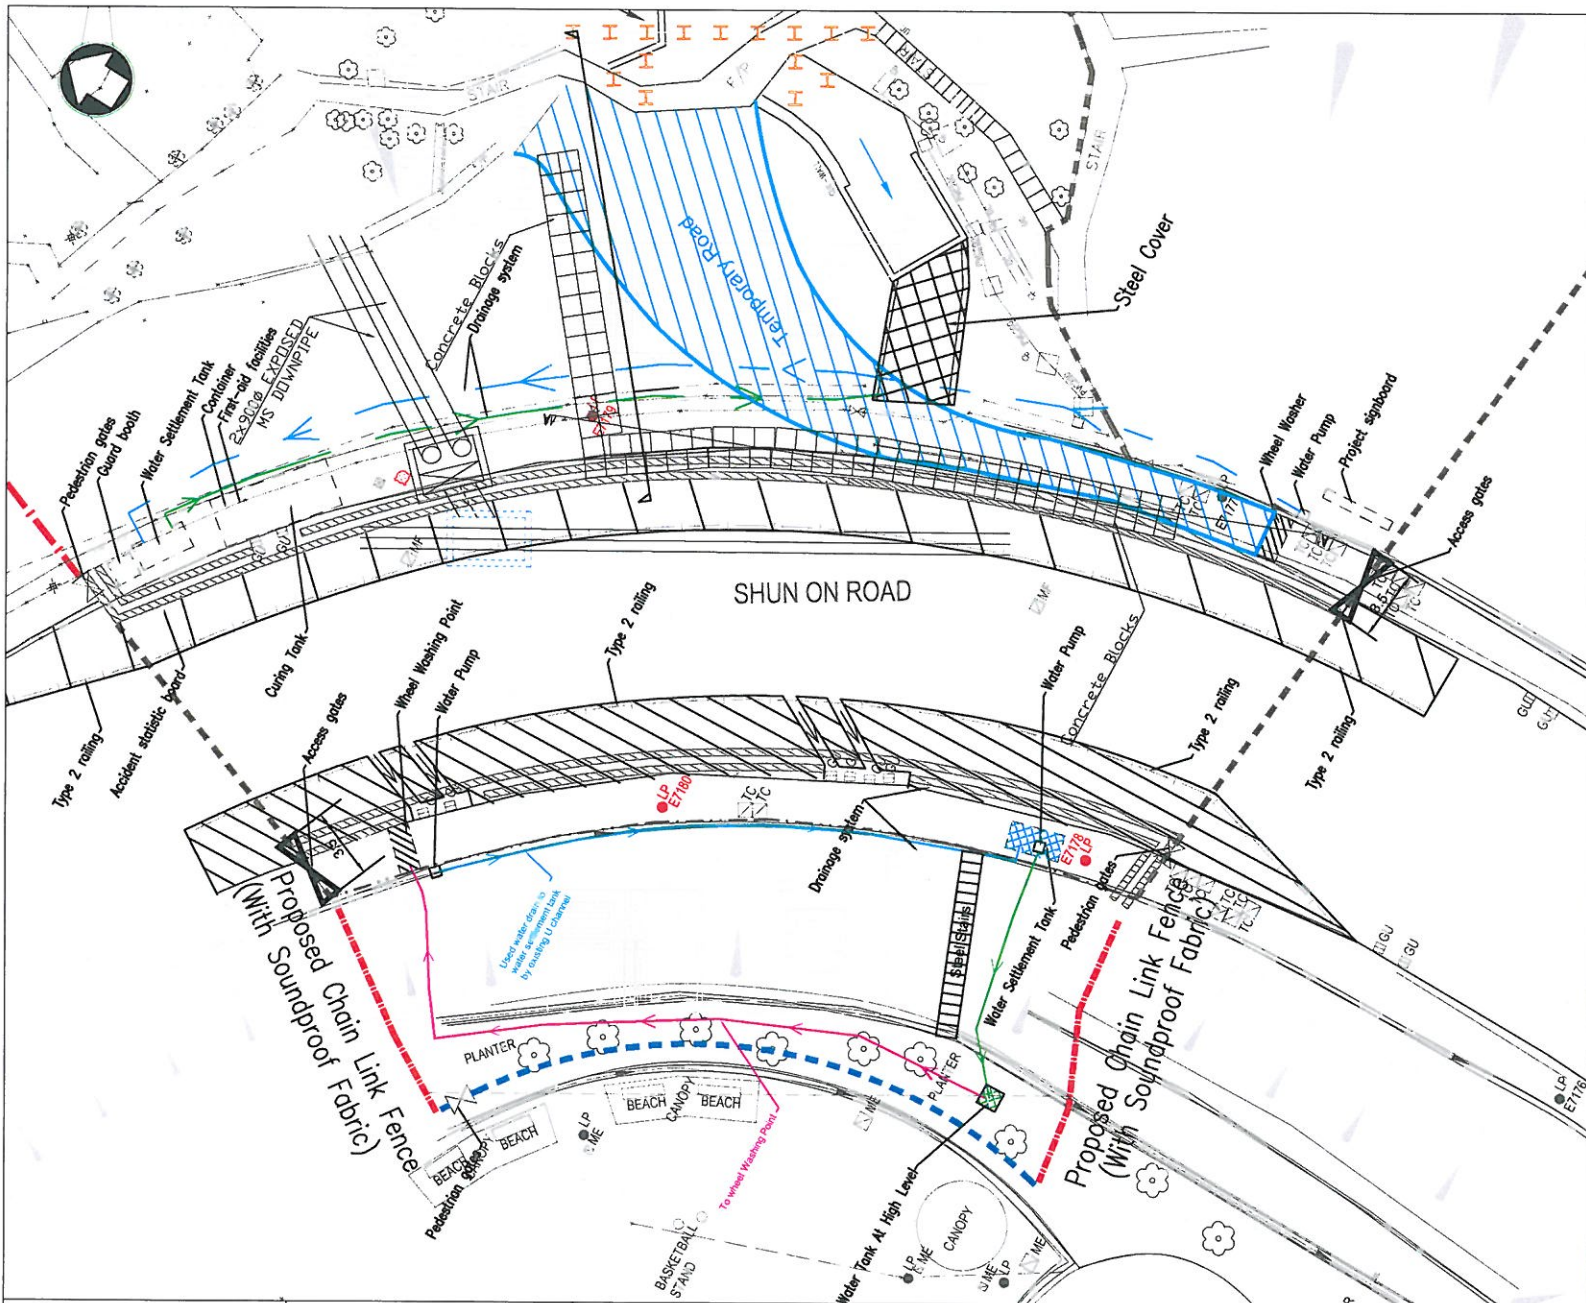
Figure 2.1

- 2.2.1. The Project is located mainly near Shun Tin Estate and Ning Po No.2 College, as shown in **Figure 2.1**.
- 2.2.2. The scope of the Project comprises:
- Construction of footbridge and associated lift towers between Shun On Road and future platform at +152mPD and across Shun On Road. In Conjunction with these footbridge works are the associated furniture, drainage system, irrigation system and traffic signs.
 - Construction of drainage system for diversion of an existing stream on the slope adjoining Footbridge D.
 - Site formation and associated slopeworks for Footbridge D adjacent to Shun On Road.

Project Layout
