Expansion of Shek Wu Hui Sewage Treatment Works

Monthly EM&A Report No. 4
for March 2006

Report no: 01284R0122

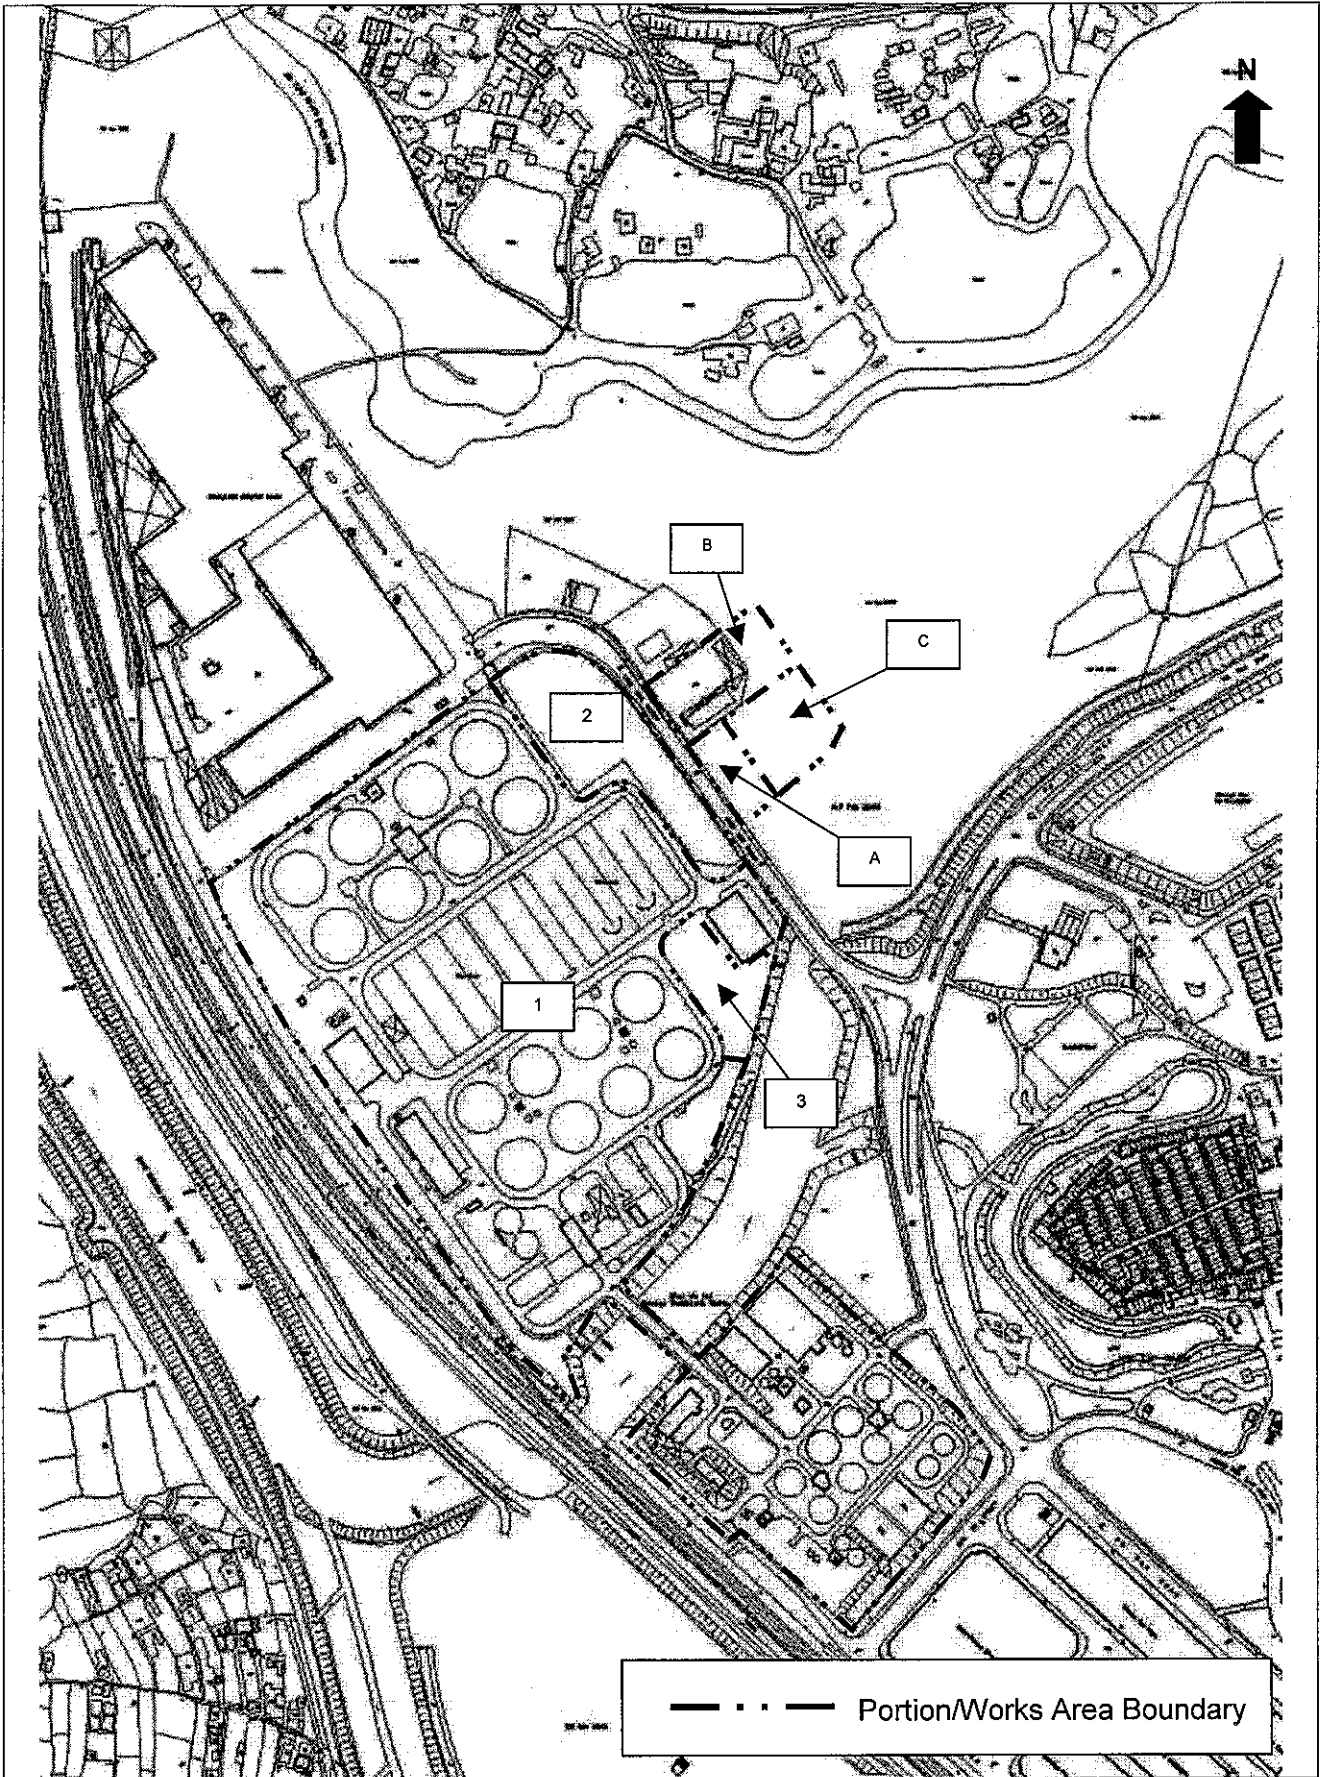
Title
Expansion of Shek Wu Hui Sewage Treatment Works – Location of Portion/Works Area

The site has been subdivided into different Works Areas/Portions as illustrated in Appendix 3. The construction of permanent piles was carried out at Portions 2 and 3. The setup of loading tests for the piles was carried out at Portion 1. Cable / utilities division was carried out at Portion 2 and the excavation was conducted at Portions 1, 2 and 3.

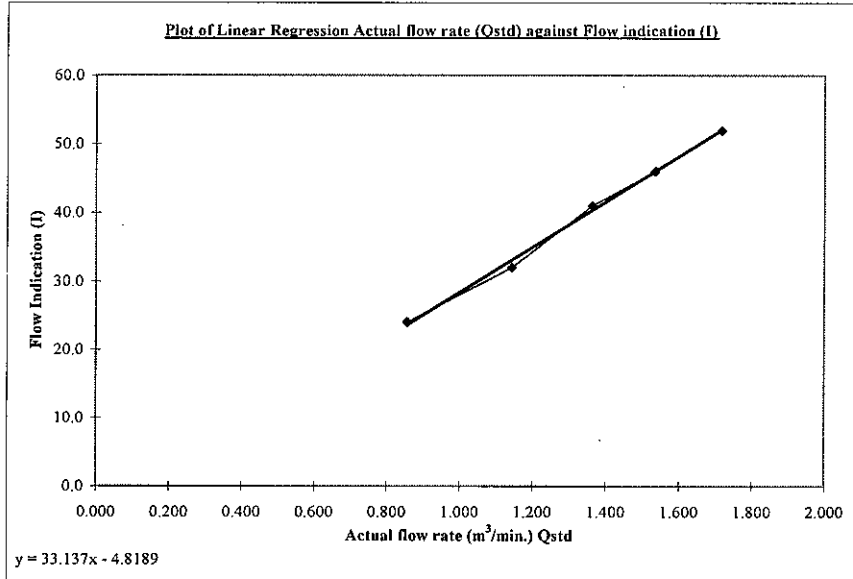
Sample no.	Pressure Drop (H), inch	Flow (corrected), m ³ /min	Actual flow rate (Qstd), m ³ /min	Flow indication (I), arbitrary
1	11.8	3.458	1.716	52.0
2	9.4	3.086	1.533	46.0
3	7.4	2.738	1.362	41.0
4	5.2	2.295	1.143	32.0
5	2.9	1.714	0.857	24.0

Correlation Coefficient : 0.9982

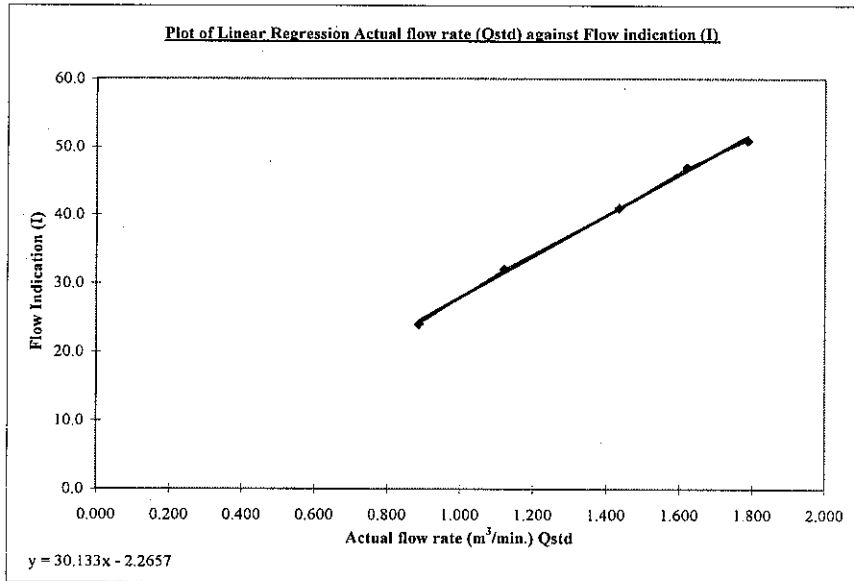
Sample no.	Pressure Drop (H), inch	Flow (corrected), m ³ /min	Actual flow rate (Qstd), m ³ /min	Flow indication (I), arbitrary
1	12.3	3.599	1.786	51.0
2	10.1	3.261	1.620	47.0
3	7.9	2.884	1.434	41.0
4	4.8	2.248	1.120	32.0
5	3.0	1.777	0.888	24.0

Correlation Coefficient : 0.9989

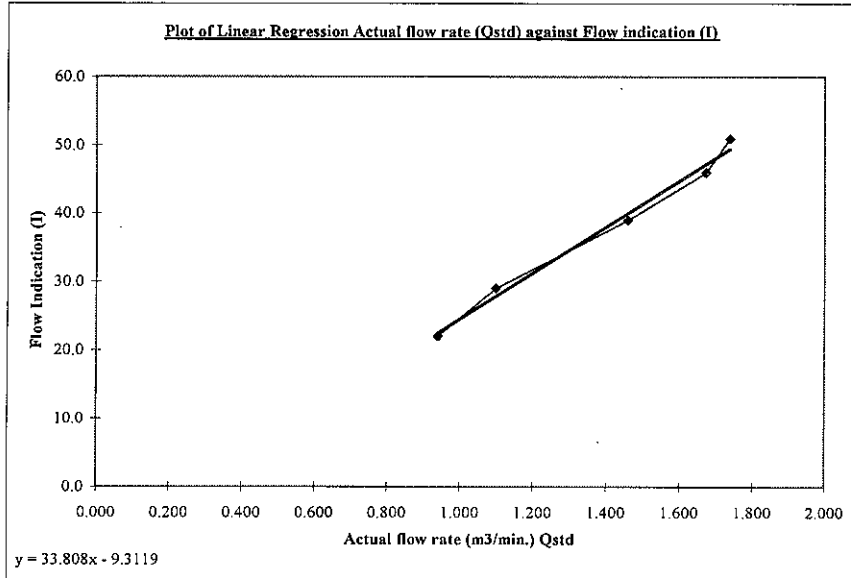
Sample no.	Pressure Drop (H), inch	Flow (corrected), m ³ /min	Actual flow rate (Qstd), m ³ /min	Flow indication (I), arbitrary
1	12.1	3.502	1.738	51.0
2	11.2	3.369	1.673	46.0
3	8.5	2.935	1.459	39.0
4	4.8	2.205	1.099	29.0
5	3.5	1.883	0.940	22.0

Correlation Coefficient : 0.9943

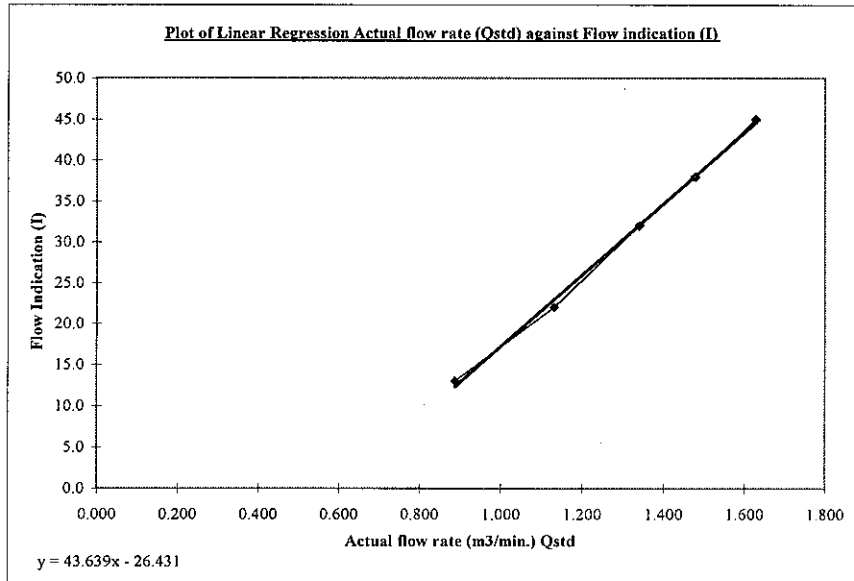
Sample no.	Pressure Drop (H), inch	Flow (corrected), m ³ /min	Actual flow rate (Qstd), m ³ /min	Flow indication (I), arbitrary
1	10.2	3.277	1.627	45.0
2	8.4	2.974	1.478	38.0
3	6.9	2.696	1.341	32.0
4	4.9	2.272	1.132	22.0
5	3.0	1.777	0.888	13.0

Correlation Coefficient : 0.9988

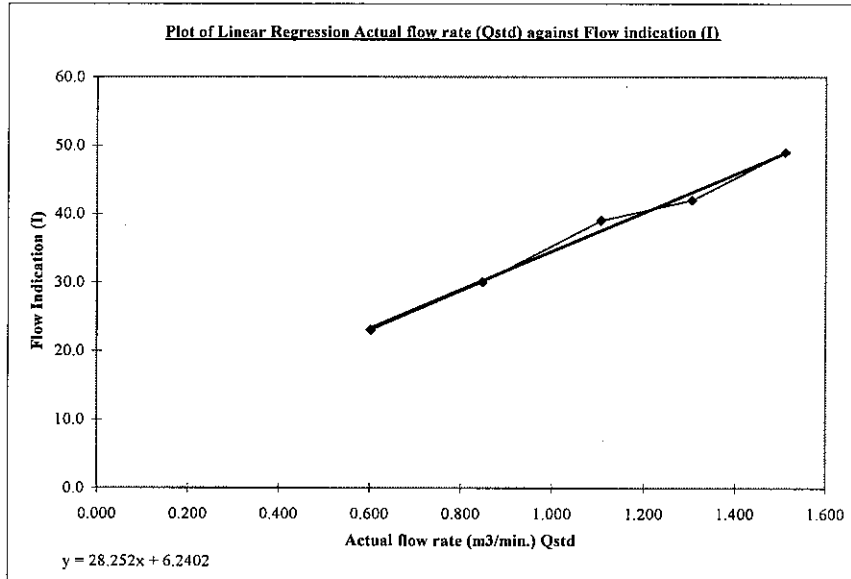
Sample no.	Pressure Drop (H), inch	Flow (corrected), m ³ /min	Actual flow rate (Qstd), m ³ /min	Flow indication (I), arbitrary
1	9.0	3.040	1.511	49.0
2	6.7	2.623	1.305	42.0
3	4.8	2.220	1.106	39.0
4	2.8	1.696	0.848	30.0
5	1.4	1.199	0.603	23.0

Correlation Coefficient : 0.9957

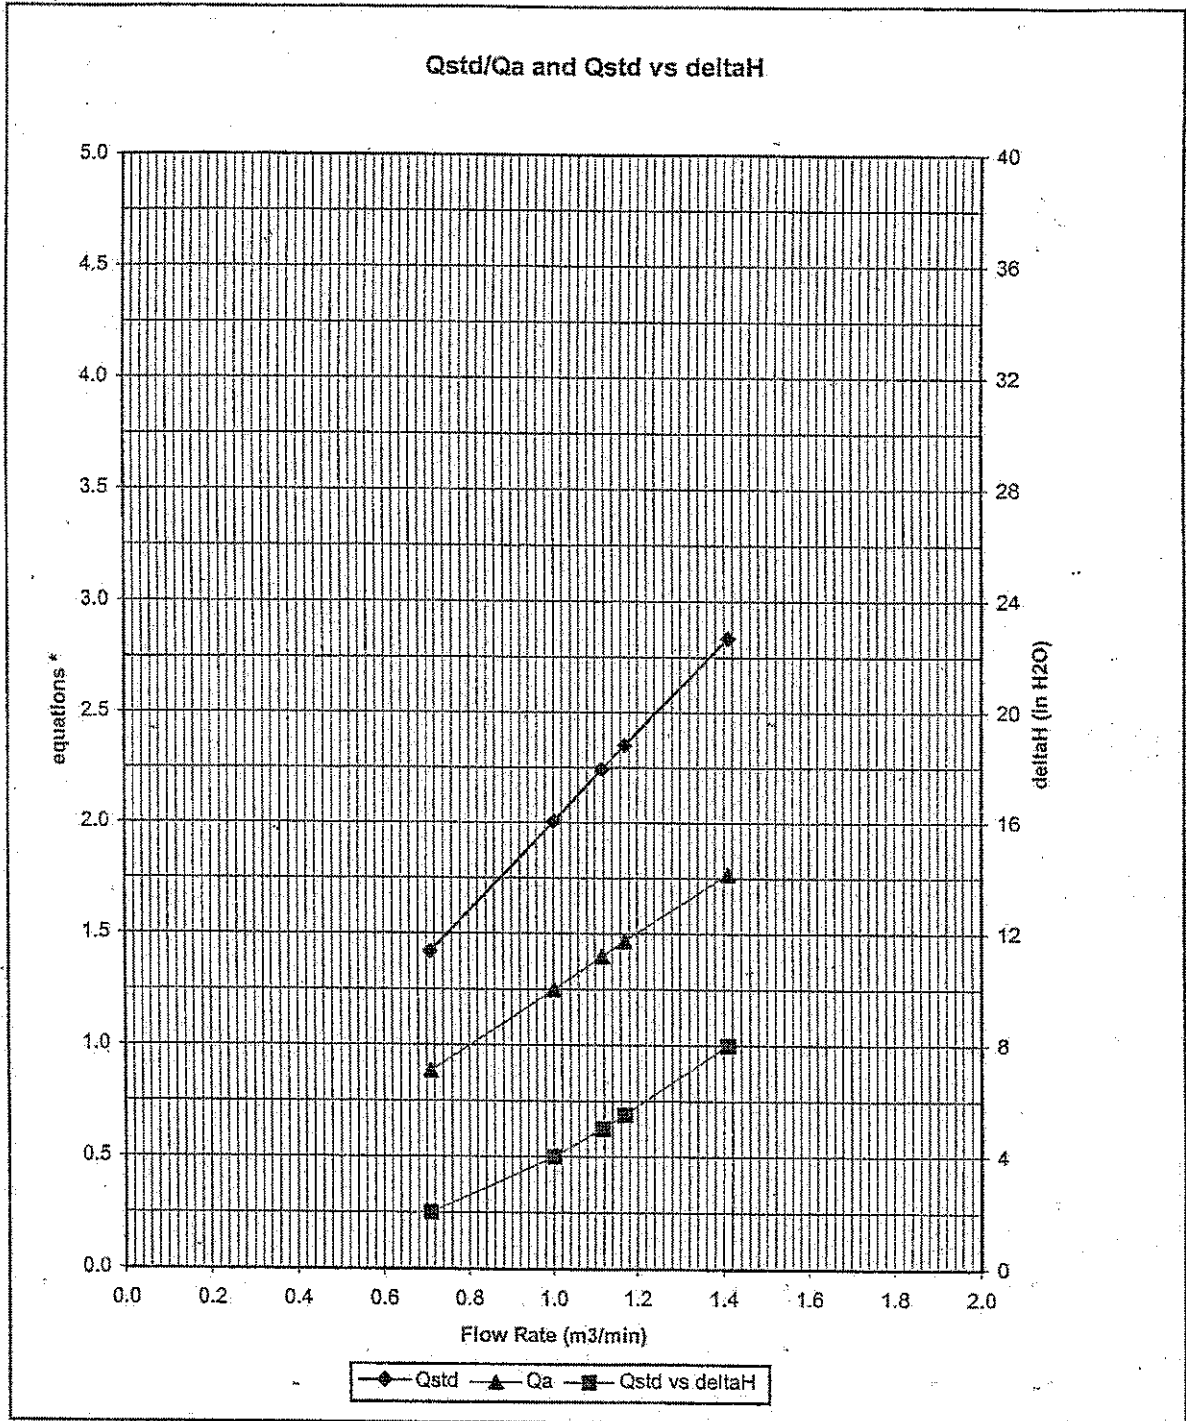
* y-axis equations:

Qstd series:
$$\sqrt{\Delta H \left(\frac{P_a}{P_{std}} \right) \left(\frac{T_{std}}{T_a} \right)}$$

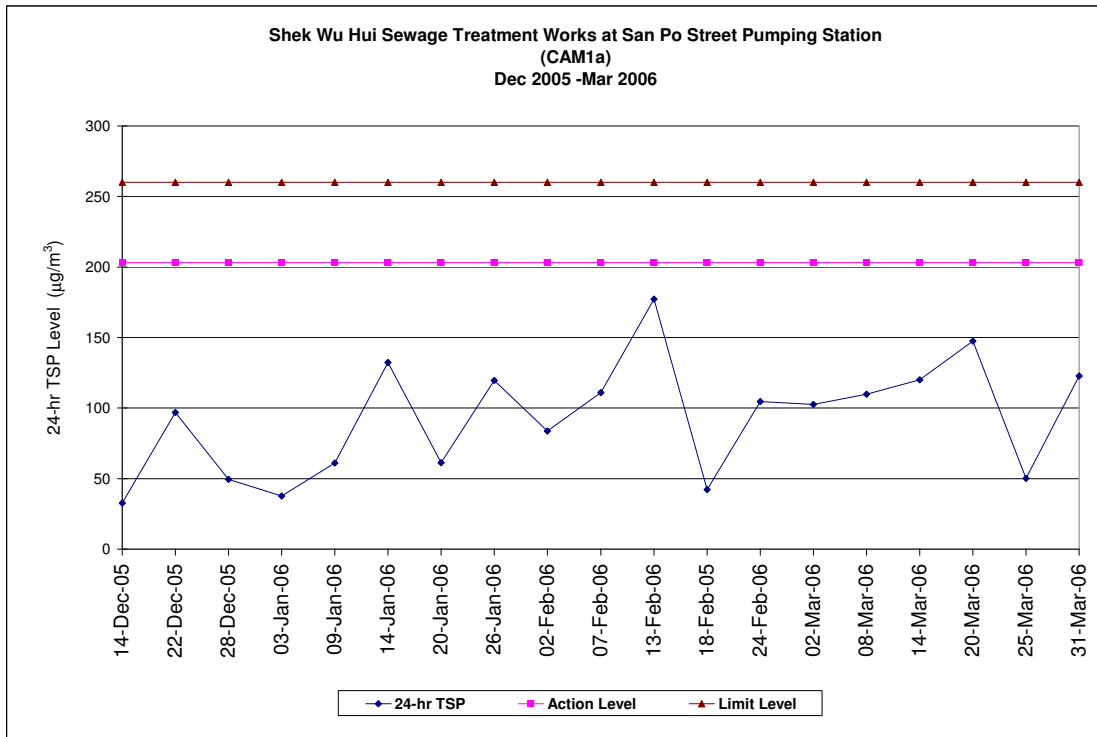
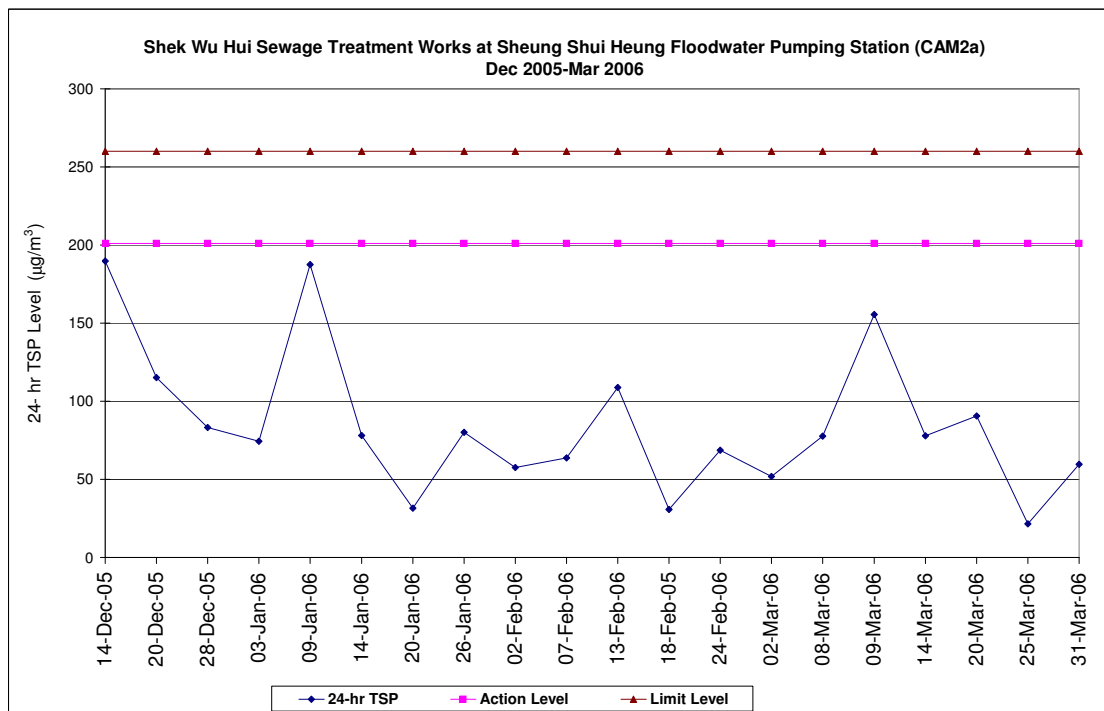
"Shading" indicates an exceedance of Action Level. "Bold and shading" indicates an exceedance of Limit Level.

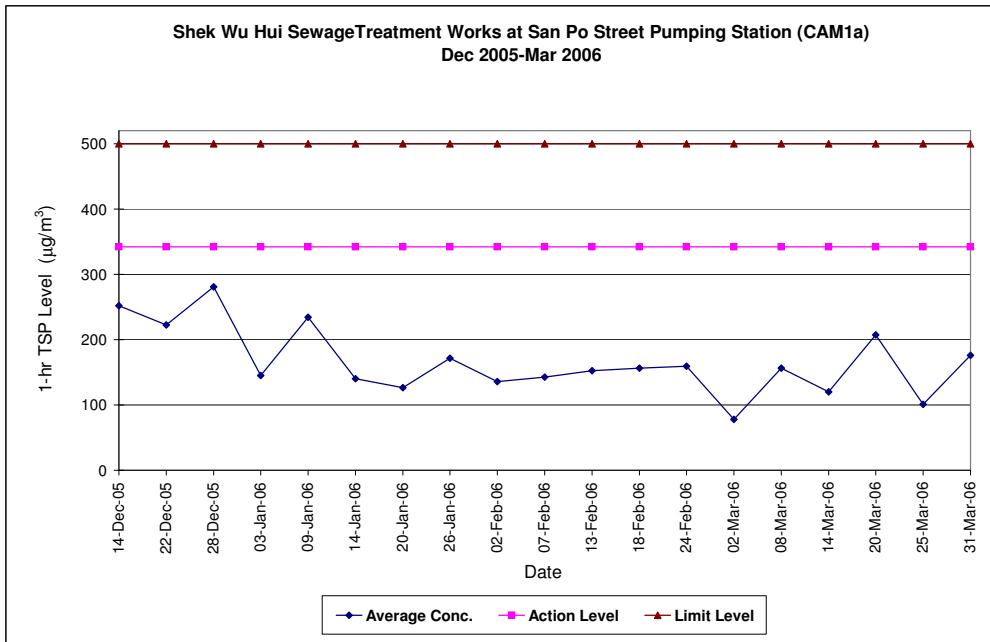
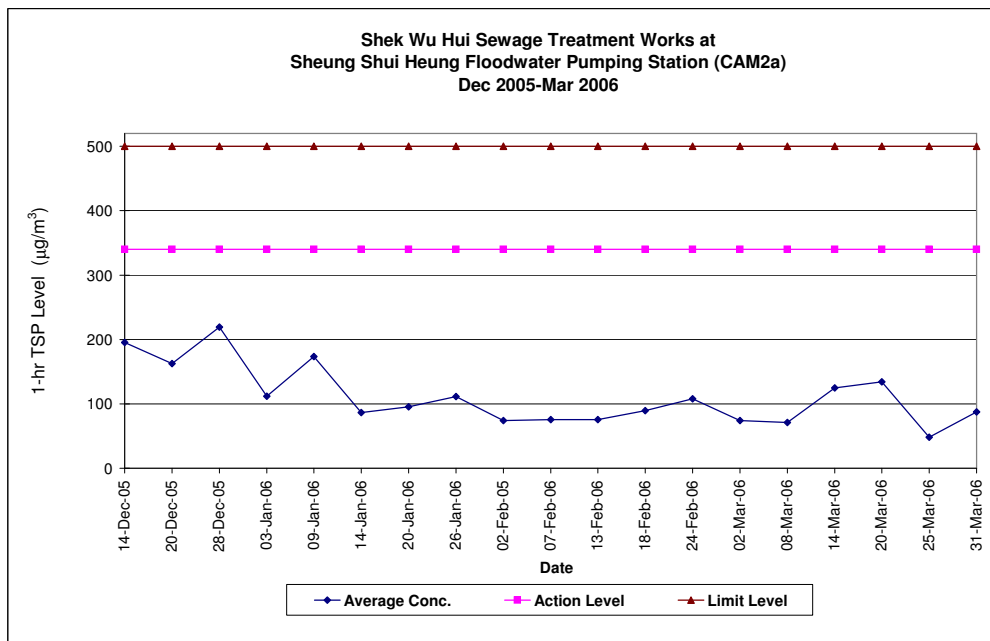
Air Quality Impact Monitoring Results (1-Hour TSP)

Shading indicates an exceedance of Action Level. *Bold and shading* indicates an exceedance of Limit Level.

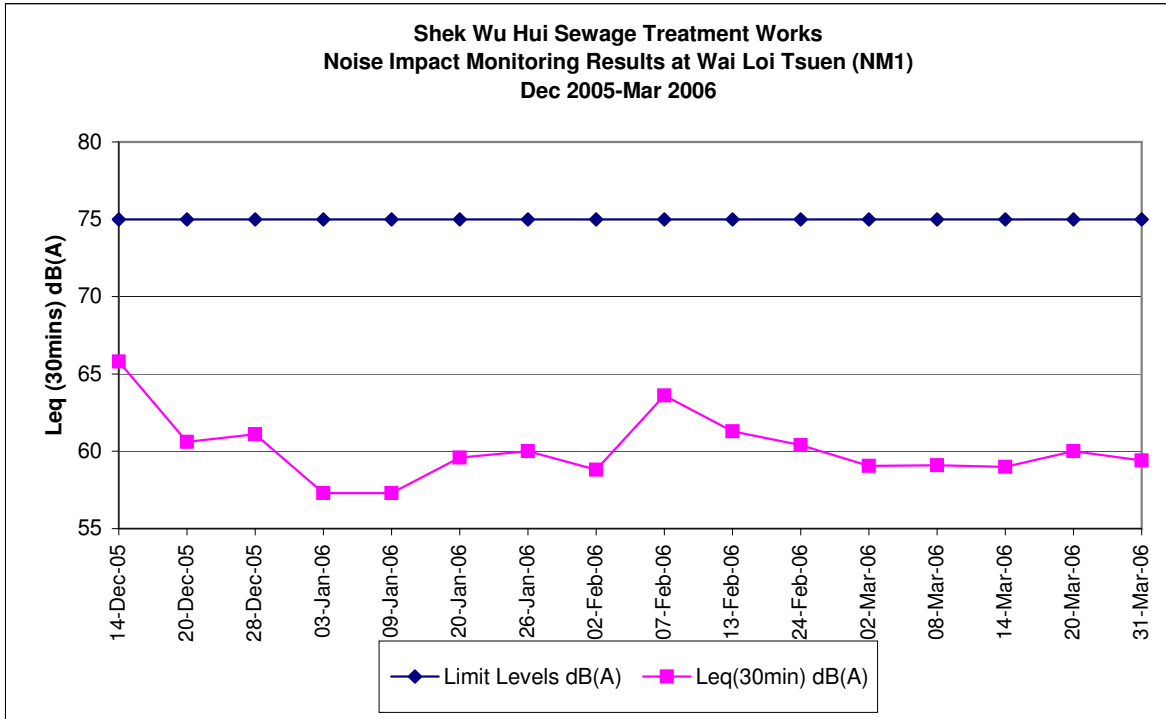
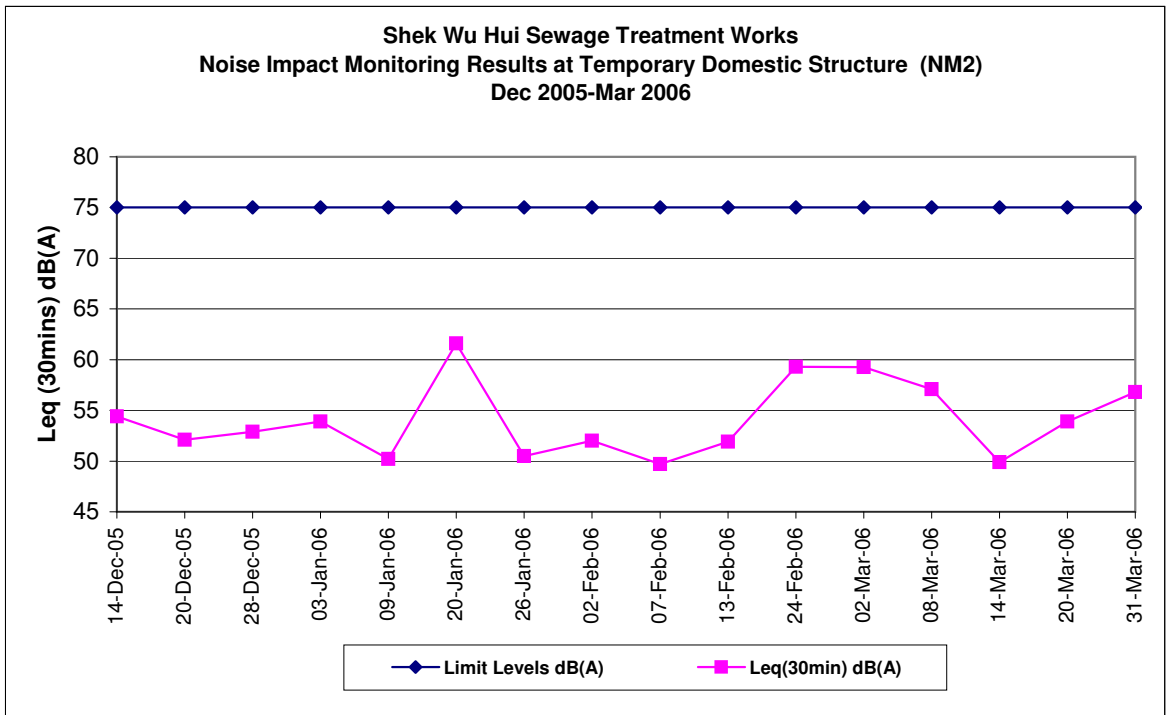
Noise Impact Monitoring Results

Noise monitoring results are summarised in Table 6-11 and detailed in Appendix 8. Graphical plots of the monitoring results are also provided in Appendix 8. As all monitoring was conducted at free field condition, a facade correction of 3dB(A) was applied to each of the noise measurements.

A façade correction of 3 dB(A) was applied to each measurement result. "Shading" indicates an Limit Level exceedance.
