Contract No. DC/2009/09  
Construction of Tai Po Sewage Treatment  
Works – Stage V Phase II B

**Monthly Environmental Monitoring  
and Audit Report for  
November 2011**

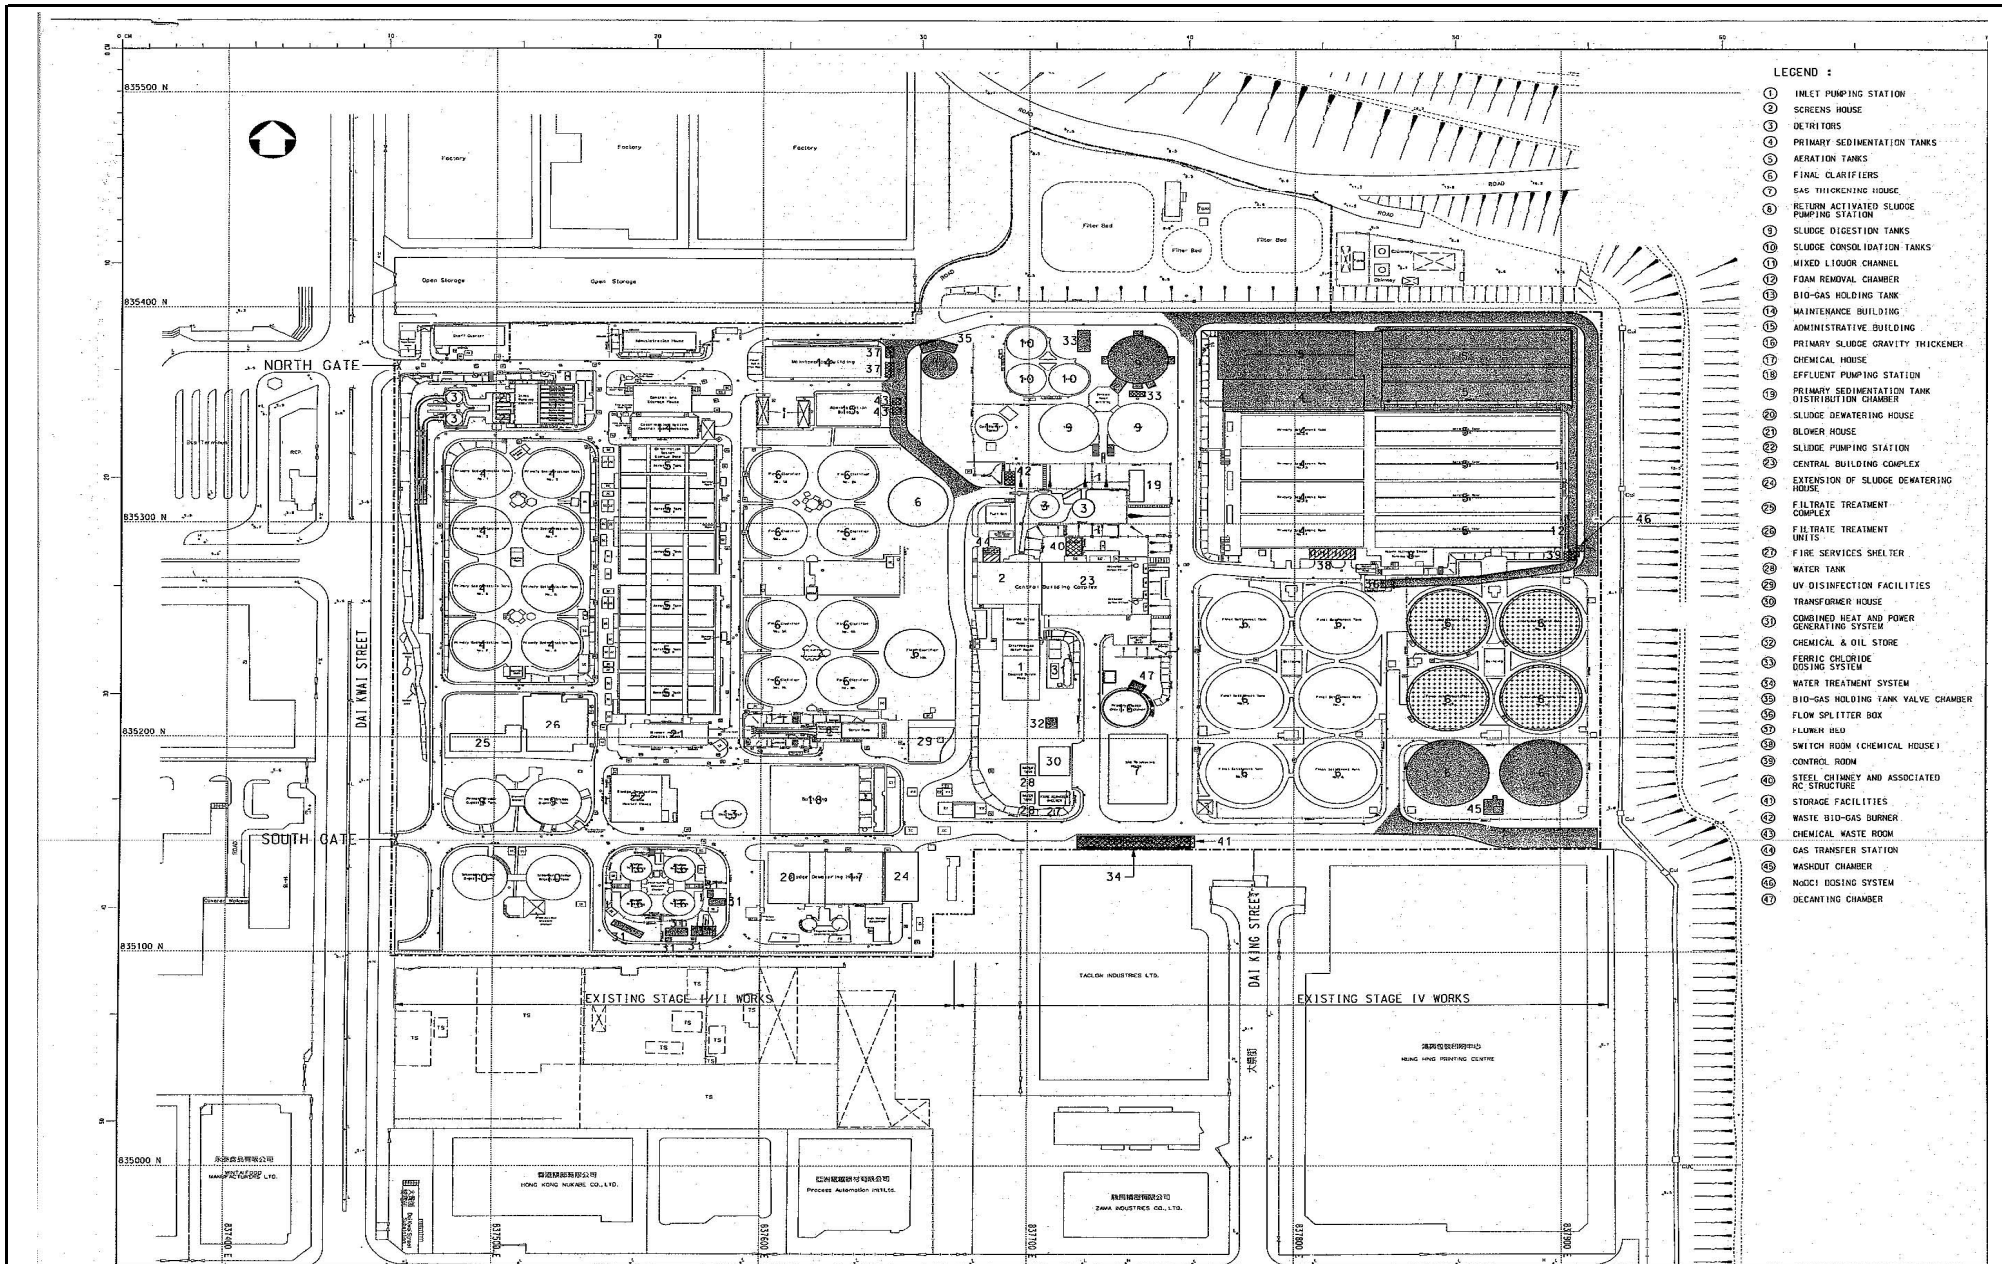
Scale	N.T.S	Project No.	MA0010	<b>CINOTECH</b>
Date	Jul-10	Figure	1.1

PROJECT SITE LAYOUT PLAN (TPSTW)

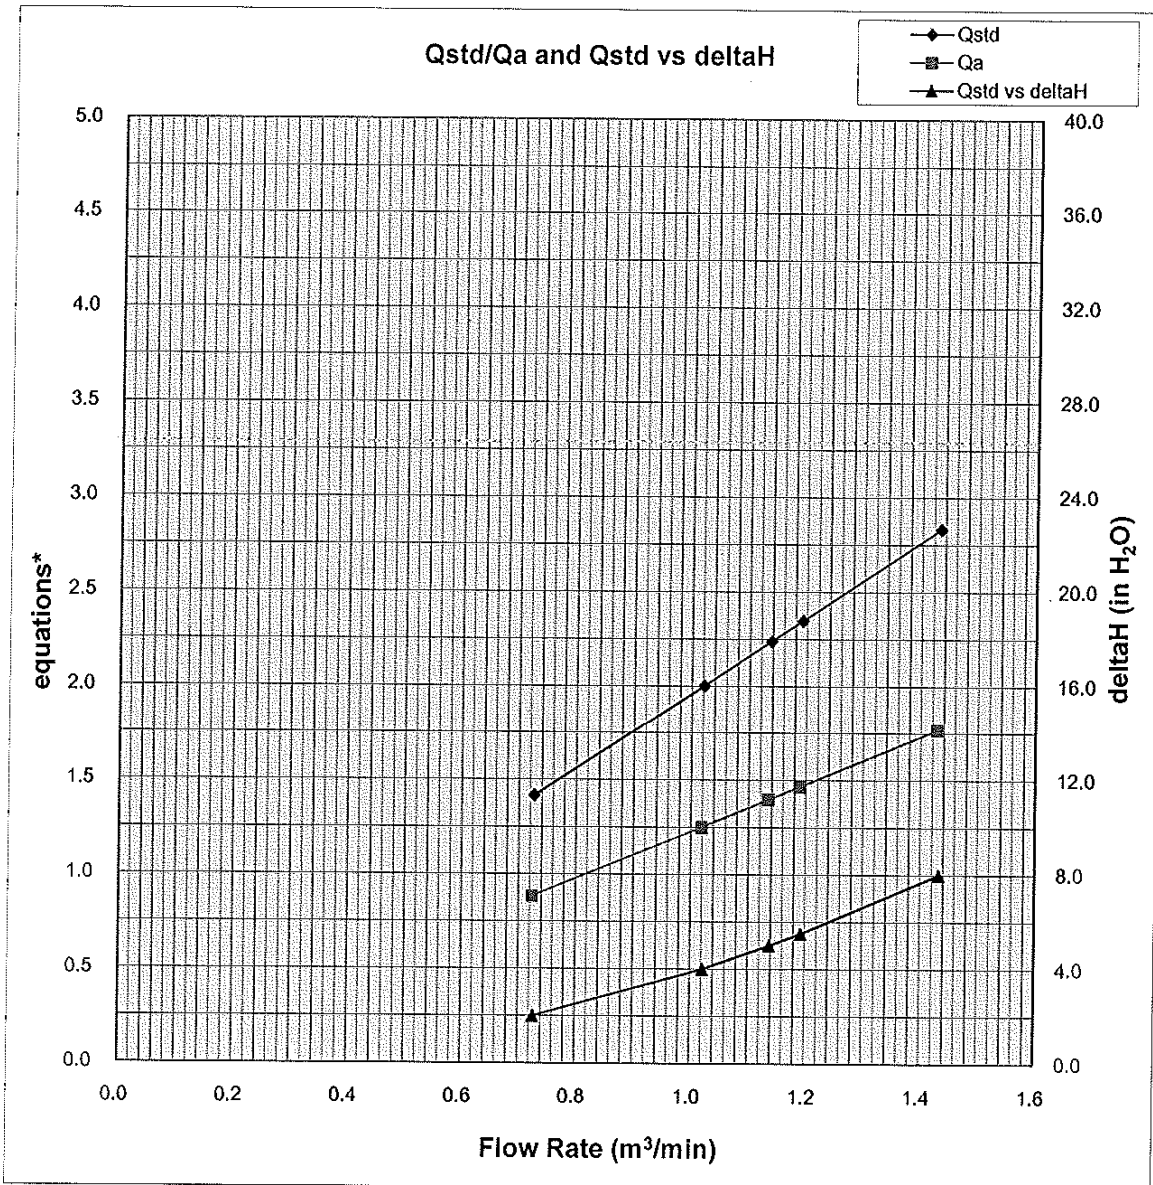
Y-axis equations:

Qstd series:  $\text{SQRT}[\Delta H(\text{Pa}/\text{Pstd})(\text{Tstd}/\text{Ta})]$

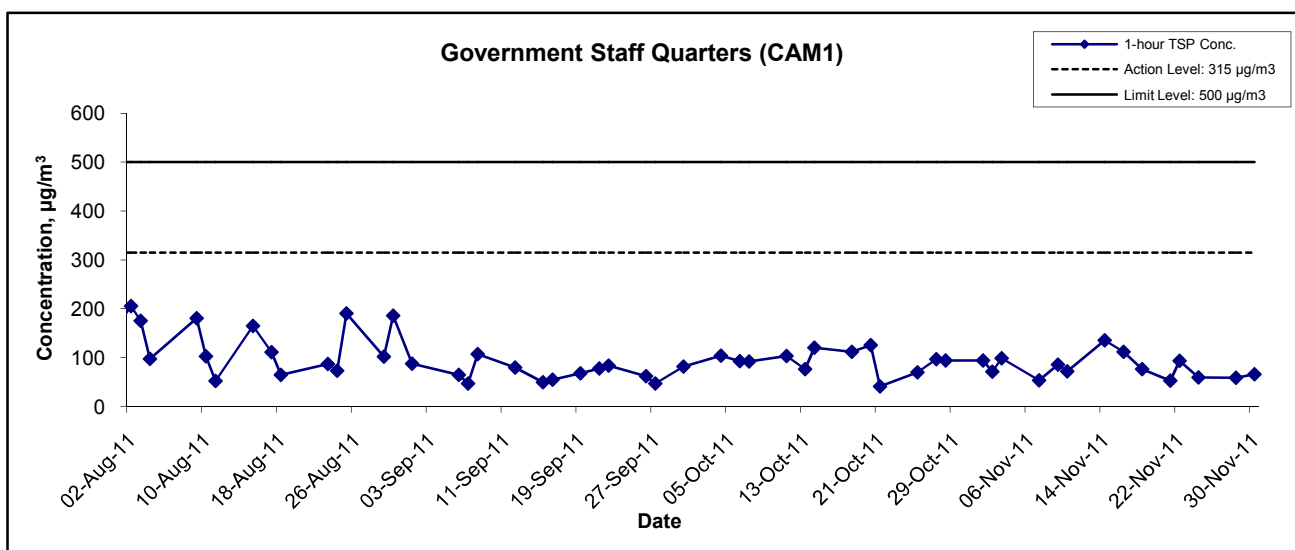
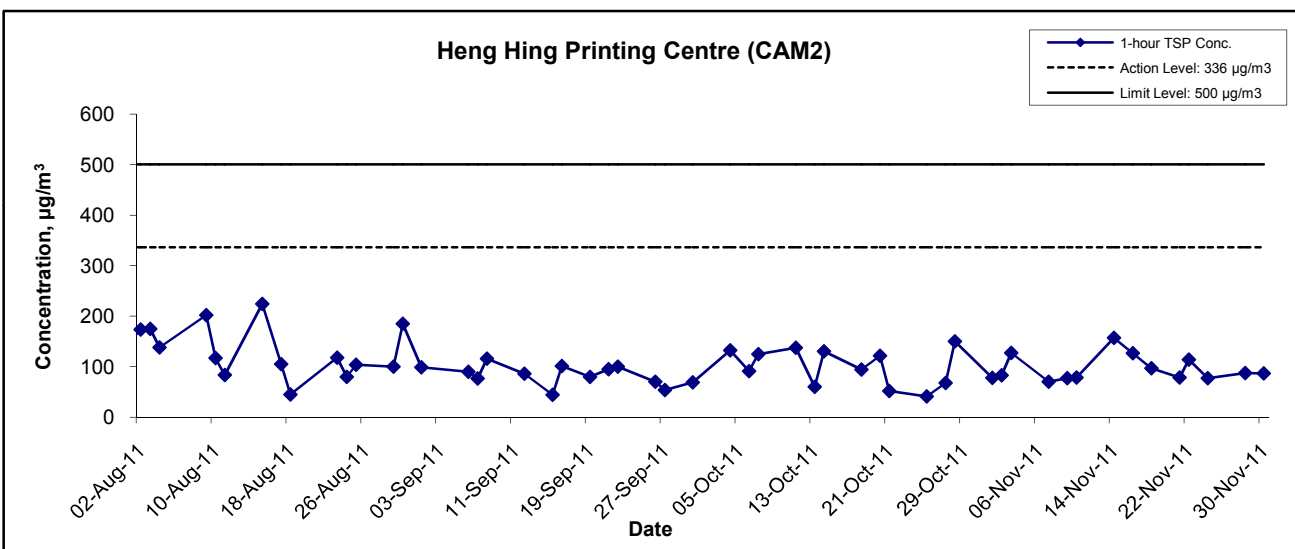
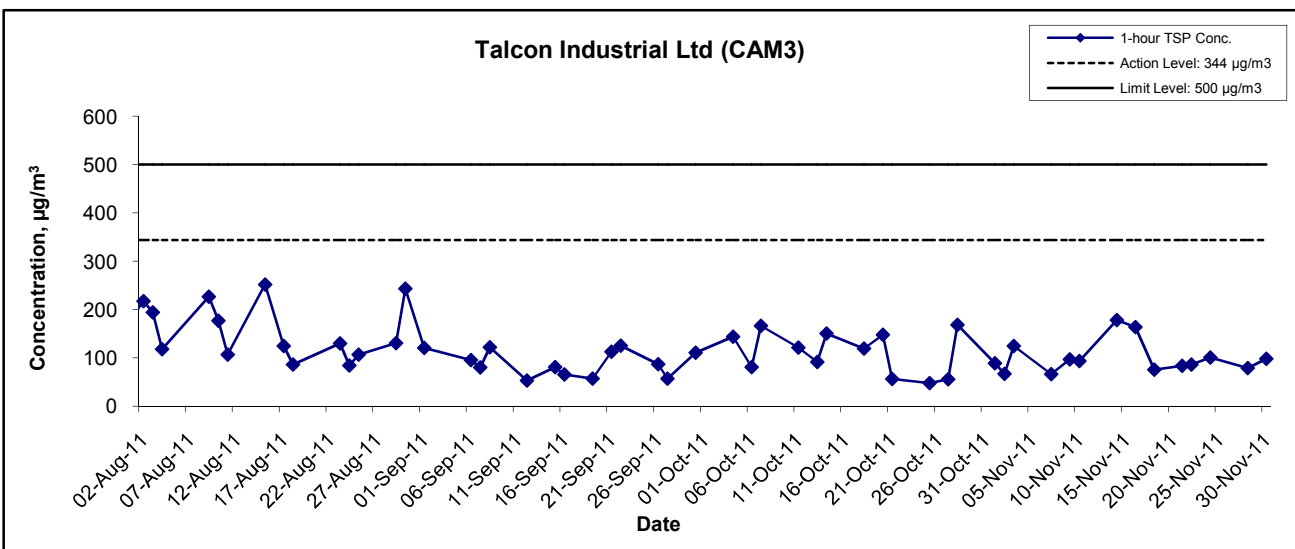
Title Contract No. DC/2009/09 Construction of Tai Po Sewage Treatment Works - Stage V Phase II B Graphical Presentation of 1-hour TSP Impact Monitoring Results	Scale N.T.S	Project No. MA0010	
	Date Nov 11	Appendix D

16-Nov-11	9:00	Sunny	296.7	765.7	3.3932	3.4052	0.0120	19116.9	19117.9	1.0	1.22	1.22	1.22	73.2	164
18-Nov-11	9:30	Cloudy	296.4	760.1	3.3537	3.3592	0.0055	19141.9	19142.9	1.0	1.22	1.22	1.22	73.0	75
21-Nov-11	9:00	Sunny	294.1	770.1	3.3612	3.3674	0.0062	19142.9	19143.9	1.0	1.24	1.24	1.24	74.2	84
22-Nov-11	9:00	Sunny	293.6	770.0	3.4017	3.4081	0.0064	19143.9	19144.9	1.0	1.24	1.24	1.24	74.2	86
24-Nov-11	9:00	Sunny	293.7	770.5	3.3402	3.3477	0.0075	19168.9	19169.9	1.0	1.24	1.24	1.24	74.2	101
28-Nov-11	9:00	Sunny	296.5	760.1	3.3905	3.3963	0.0058	19169.9	19170.9	1.0	1.22	1.22	1.22	73.5	79
30-Nov-11	14:00	Sunny	298.9	761.8	3.1267	3.1339	0.0072	19194.9	19195.9	1.0	1.22	1.22	1.22	73.3	98
														Min	66
														Max	178
														Average	100

### 1-hr TSP Concentration Levels

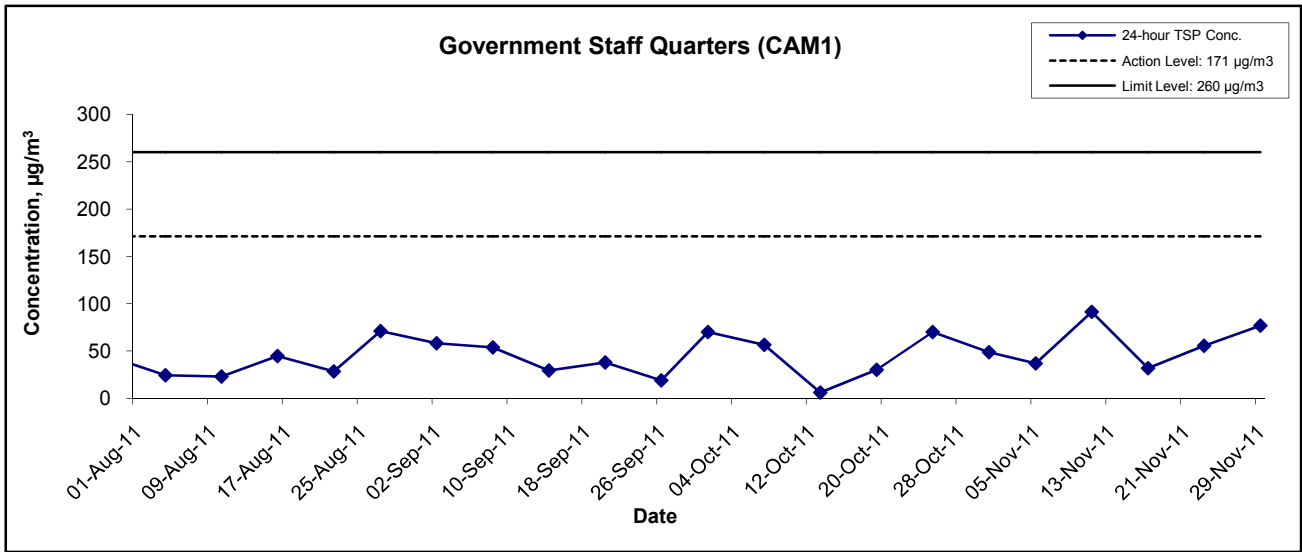
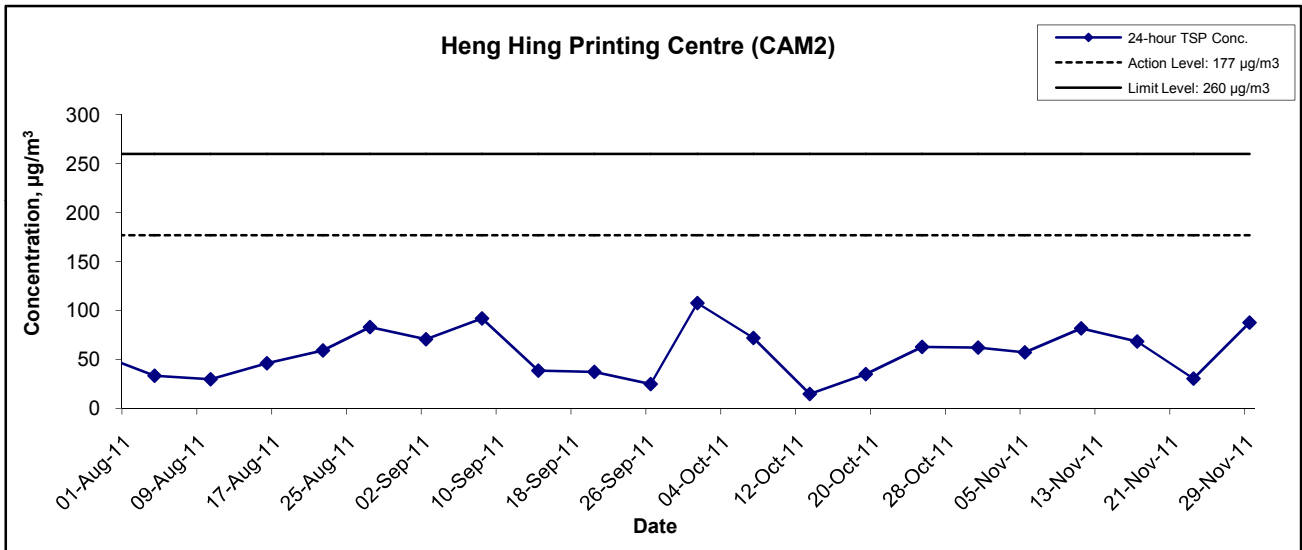
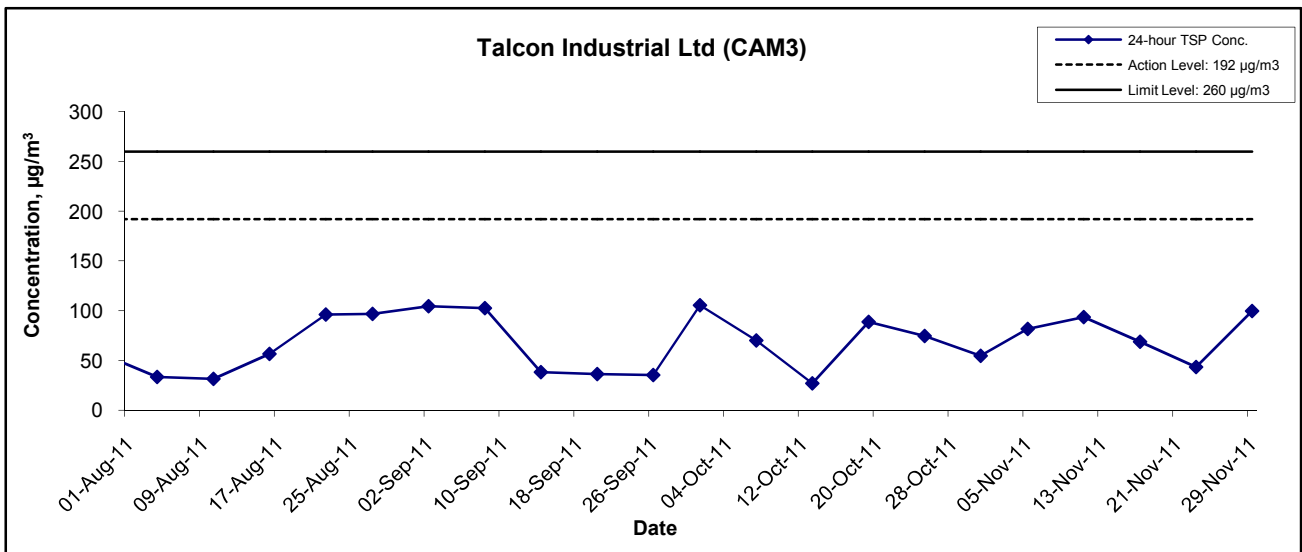
Title	Contract No. DC/2009/09	Scale	Project No.	CINOTECH
	Construction of Tai Po Sewage Treatment Works - Stage V Phase II B	N.T.S	MA0010	
	Graphical Presentation of 24-hour TSP Impact Monitoring Results	Date	Appendix	
		Nov 11	E

Start Date	Weather Condition	Air Temp. (K)	Atmospheric Pressure (Pa)	Filter Weight (g)		Particulate weight (g)	Elapse Time		Sampling Time(hrs.)	Flow Rate (m <sup>3</sup> /min.)		Av. flow (m <sup>3</sup> /min)	Total vol. (m <sup>3</sup> )	Conc. (µg/m <sup>3</sup> )
				Initial	Final		Initial	Final		Initial	Final			
5-Nov-11	Cloudy	300.2	764.3	3.3944	3.5368	0.1424	19064.9	19088.9	24.0	1.21	1.21	1.21	1745.2	82
11-Nov-11	Sunny	298.2	766.1	3.3888	3.5530	0.1642	19091.9	19115.9	24.0	1.22	1.22	1.22	1752.2	94
17-Nov-11	Cloudy	296.7	763.6	3.4003	3.5213	0.1210	19117.9	19141.9	24.0	1.22	1.22	1.22	1753.6	69
23-Nov-11	Cloudy	293.5	769.1	3.3704	3.4479	0.0775	19144.9	19168.9	24.0	1.24	1.24	1.24	1780.5	44
29-Nov-11	Sunny	296.6	765.1	3.1184	3.2947	0.1763	19170.9	19194.9	24.0	1.23	1.23	1.23	1767.7	100
													Min	44
													Max	100
													Average	78

### 24-hr TSP Concentration Levels

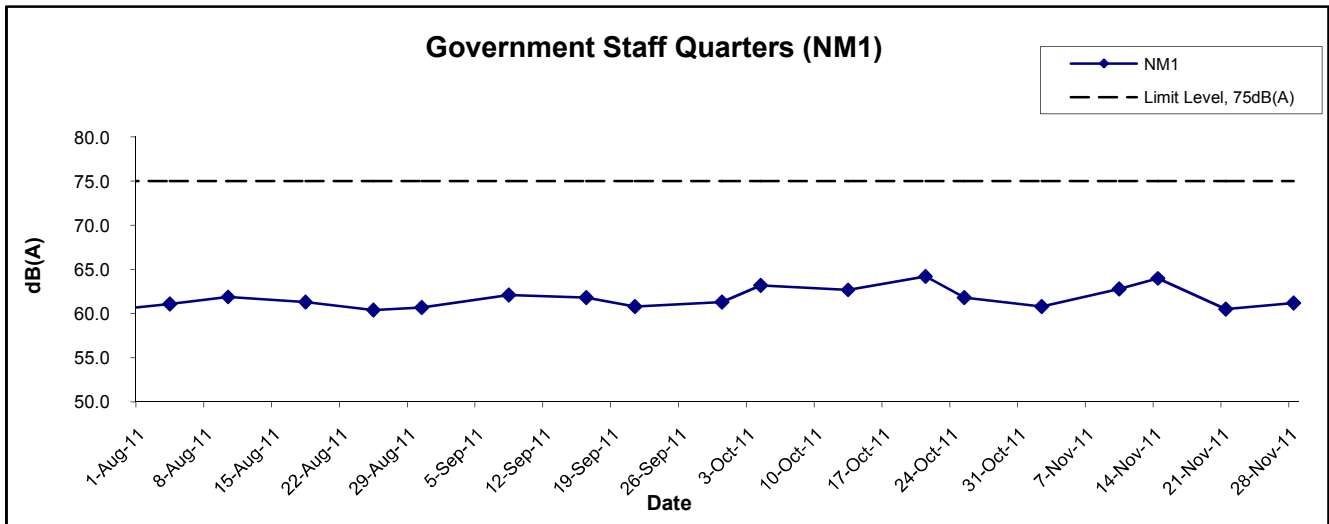
Location NM1 - Government Staff Quarters					
Date	Time	Weather	dB (A) (30-min)		
			L <sub>eq</sub>	L <sub>10</sub>	L <sub>90</sub>
2-Nov-11	9:00	Sunny	60.8	62.4	59.1
10-Nov-11	10:10	Sunny	62.8	65.7	60.3
14-Nov-11	14:05	Cloudy	64.0	66.2	62.7
21-Nov-11	13:04	Sunny	60.5	63.2	59.2
28-Nov-11	13:00	Sunny	61.2	63.7	60.5
		Average	62.1	64.2	60.4
		Minimum	60.5	62.4	59.1
		Maximum	64.0	66.2	62.7

## Noise Levels

**Title**  
 Contract No. DC/2009/09  
 Construction of Tai Po Sewage Treatment Works - Stage V Phase II B  
 Graphical Presentation of Construction Noise Monitoring Results

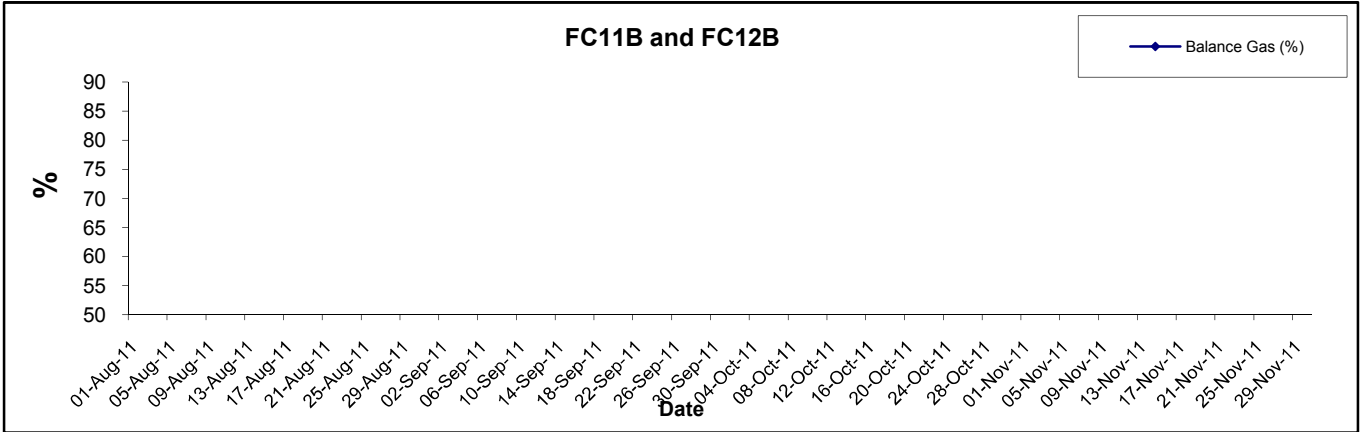
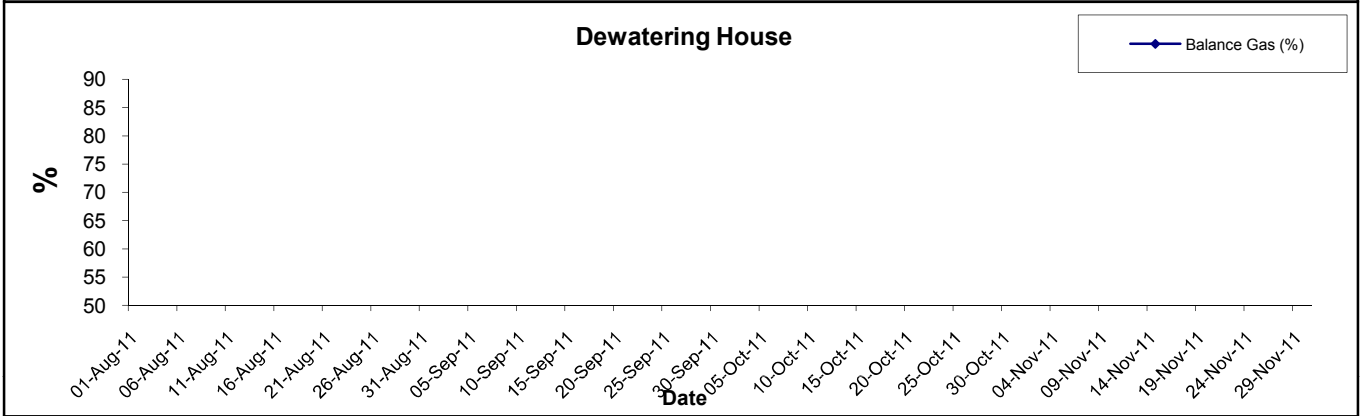
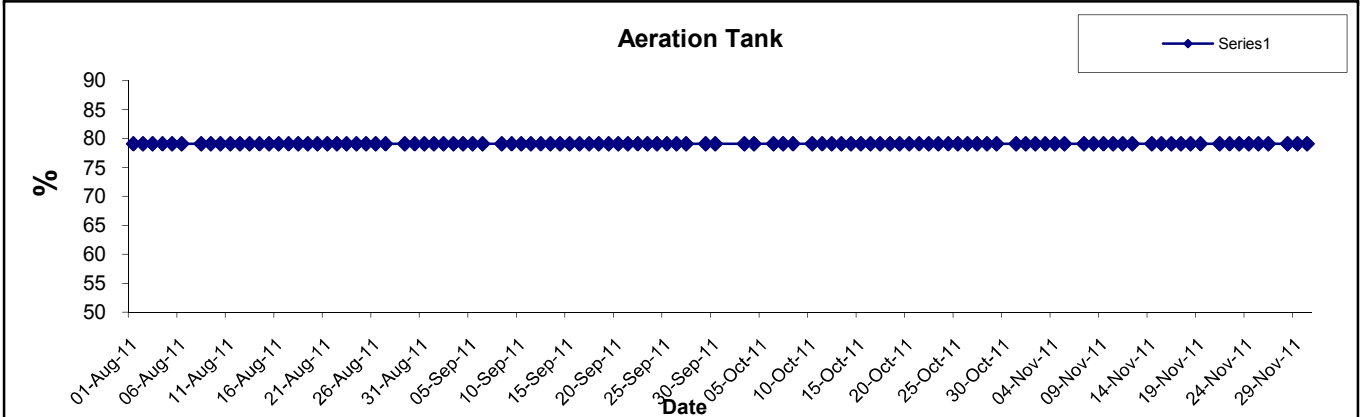
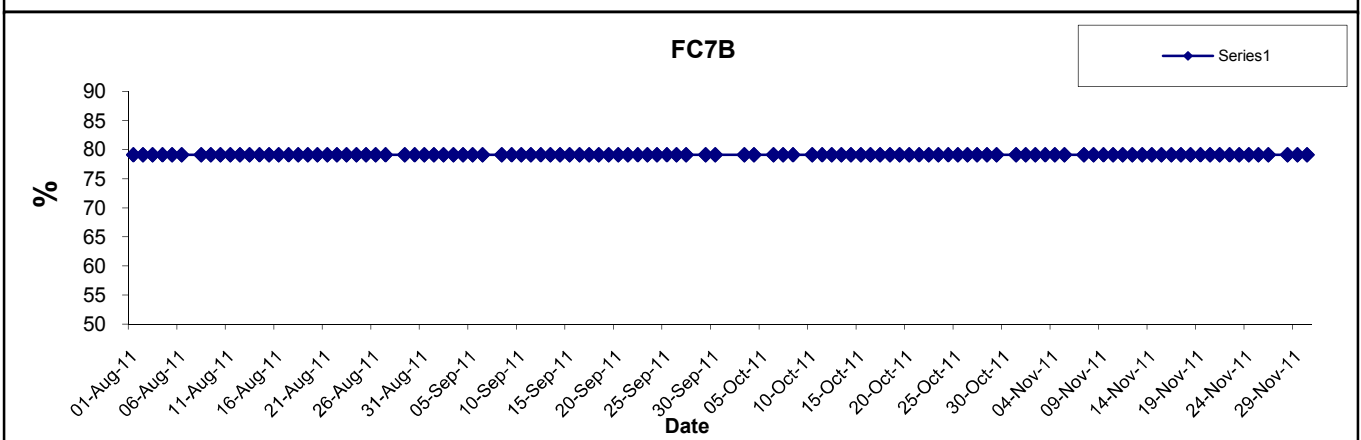
### Balance Gas

**Title**  
 Contract No. DC/2009/09  
 Construction of Tai Po Sewage Treatment Works - Stage V Phase II B  
 Graphical Presentation of Landfill Gas Measurement

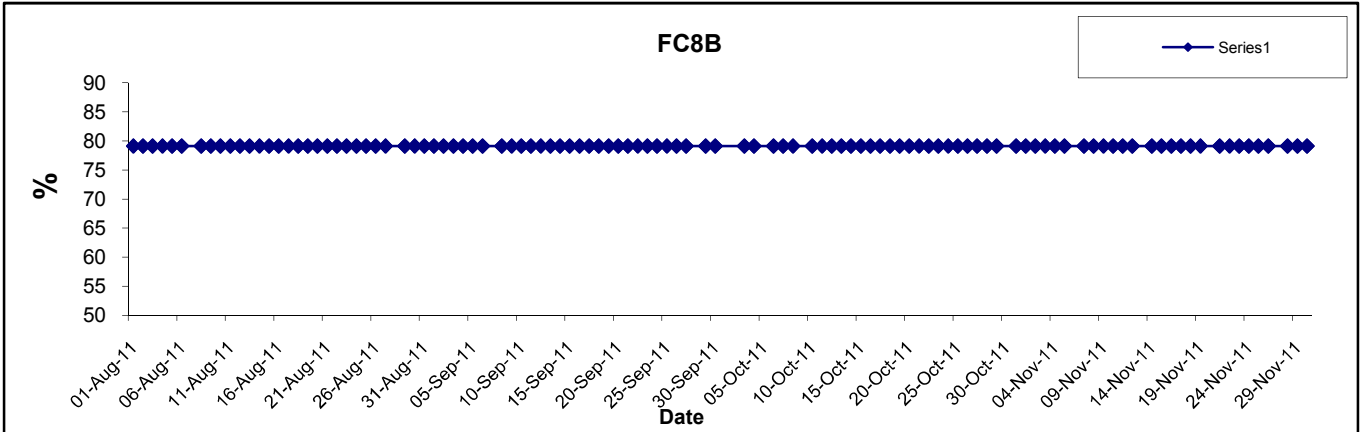
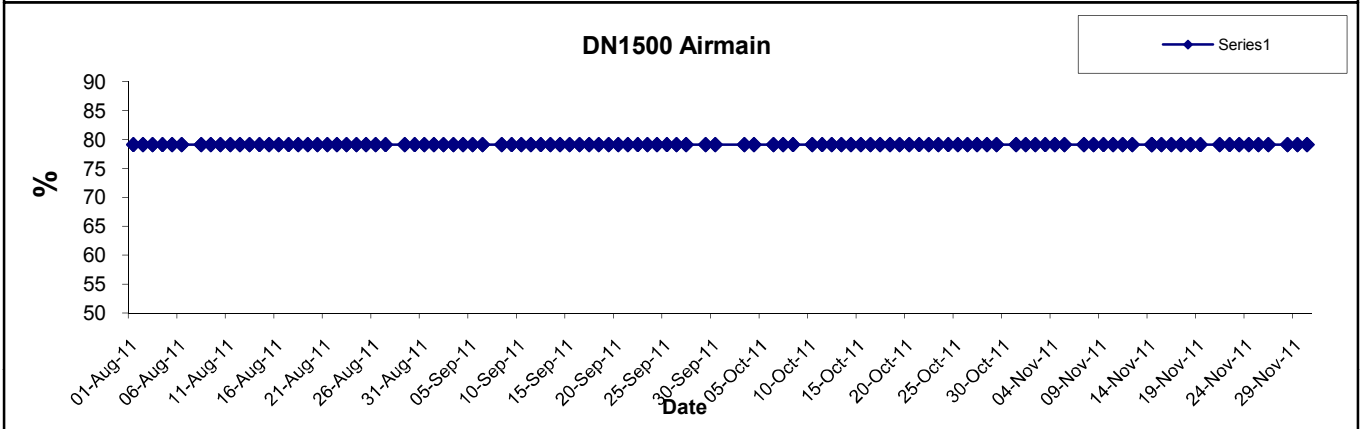
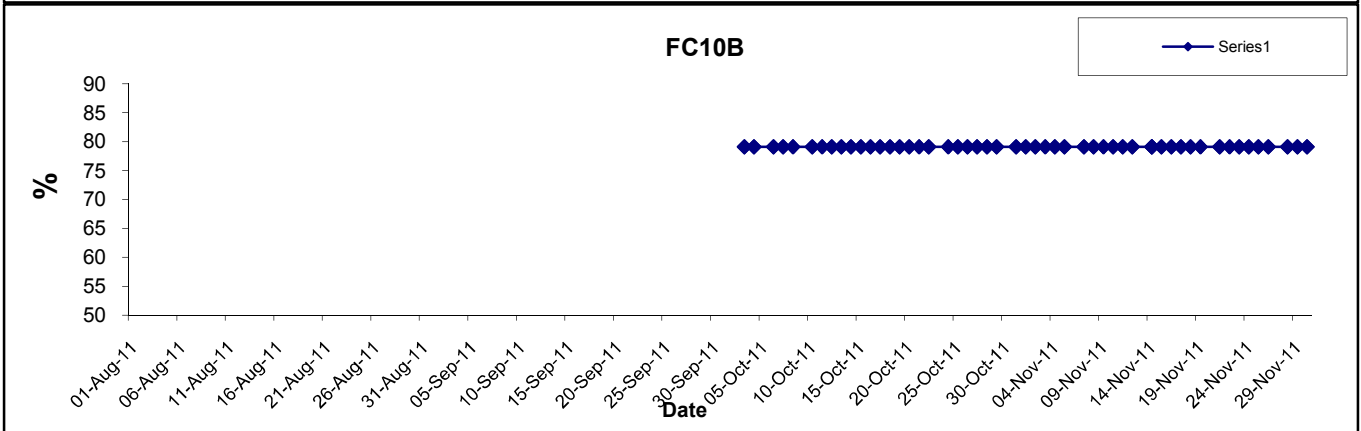
### Balance Gas

Title Contract No. DC/2009/09 Construction of Tai Po Sewage Treatment Works - Stage V Phase II B  Graphical Presentation of Landfill Gas Measurement	Scale	N.T.S	Project No.	MA0010	CINOTECH
	Date	Nov 11	Appendix	G

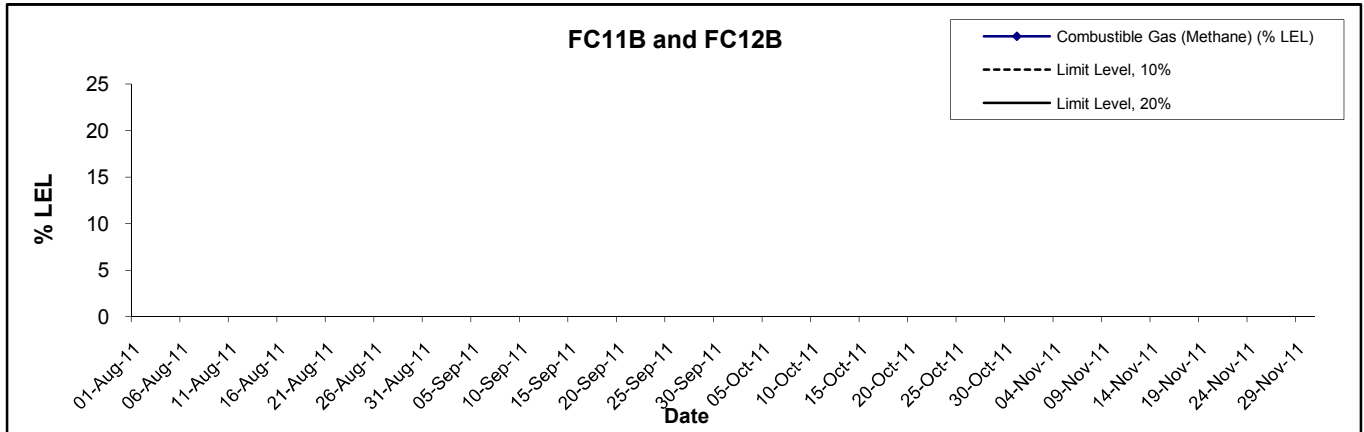
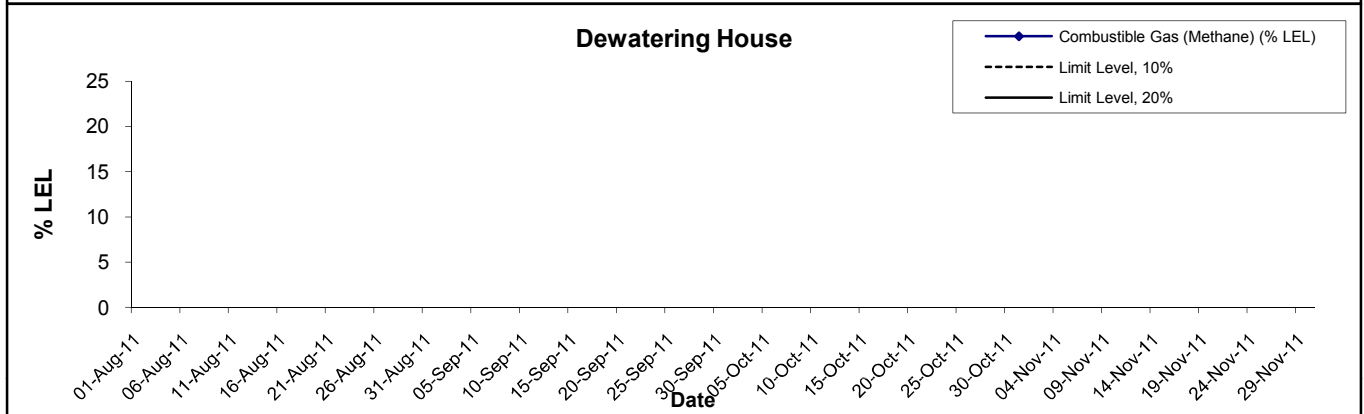
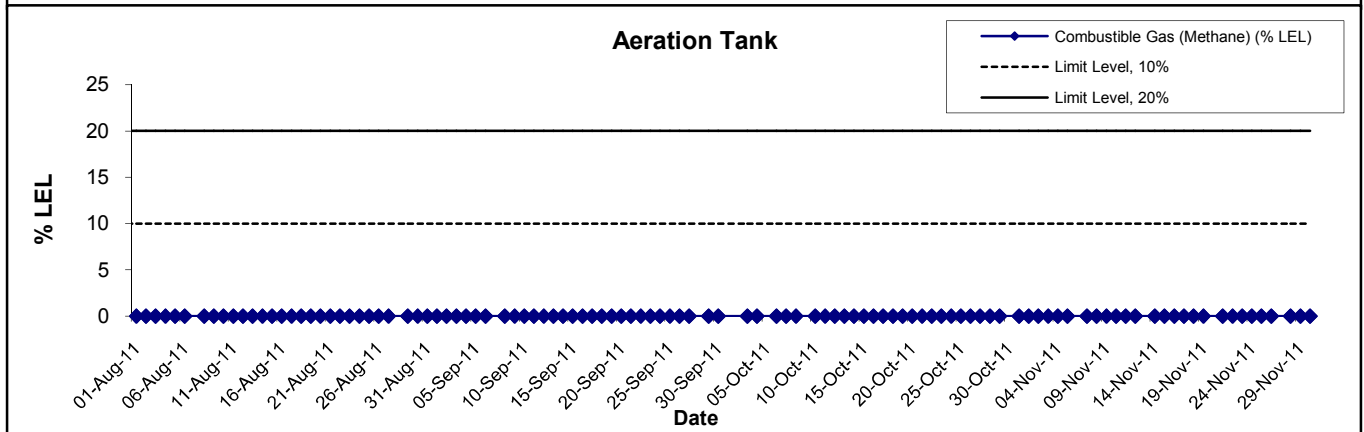
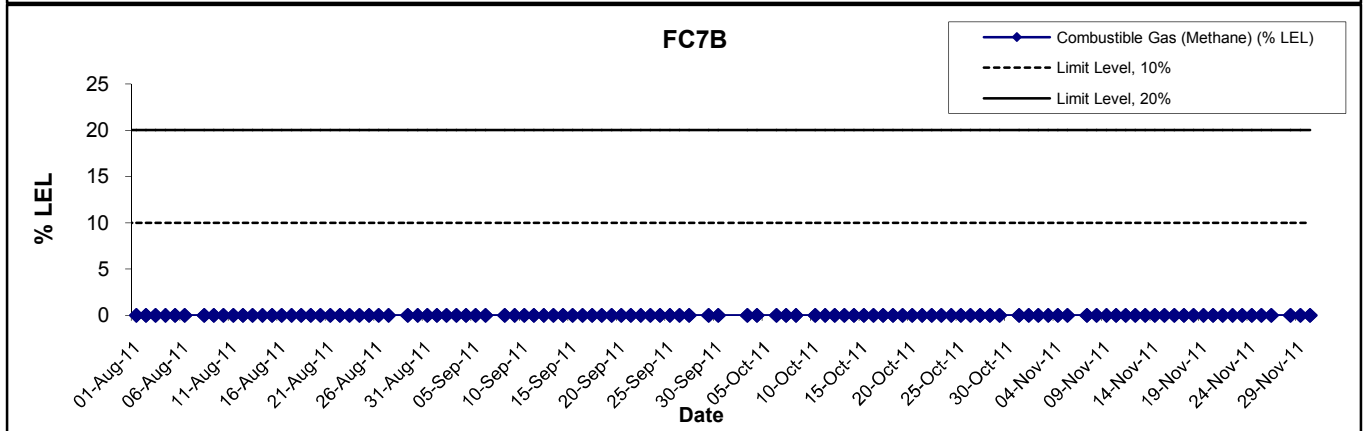
### Combustible Gas (Methane)

**Title**  
 Contract No. DC/2009/09  
 Construction of Tai Po Sewage Treatment Works - Stage V Phase II B  
 Graphical Presentation of Landfill Gas Measurement

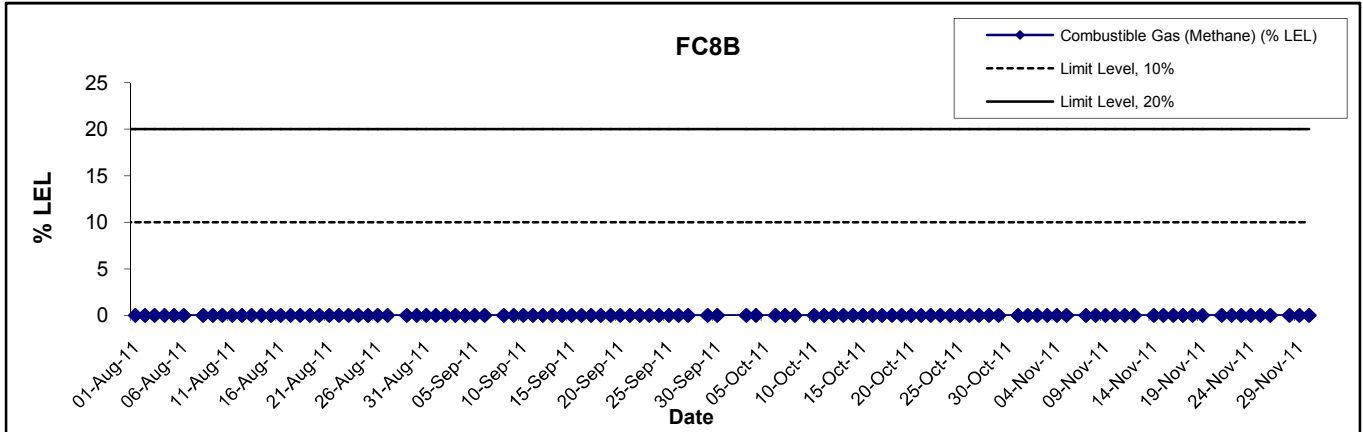
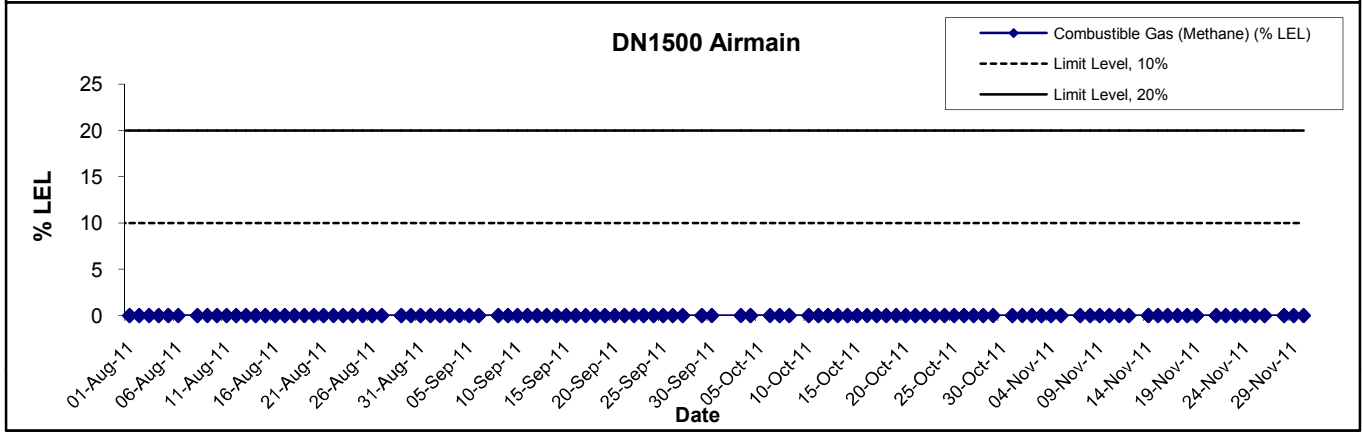
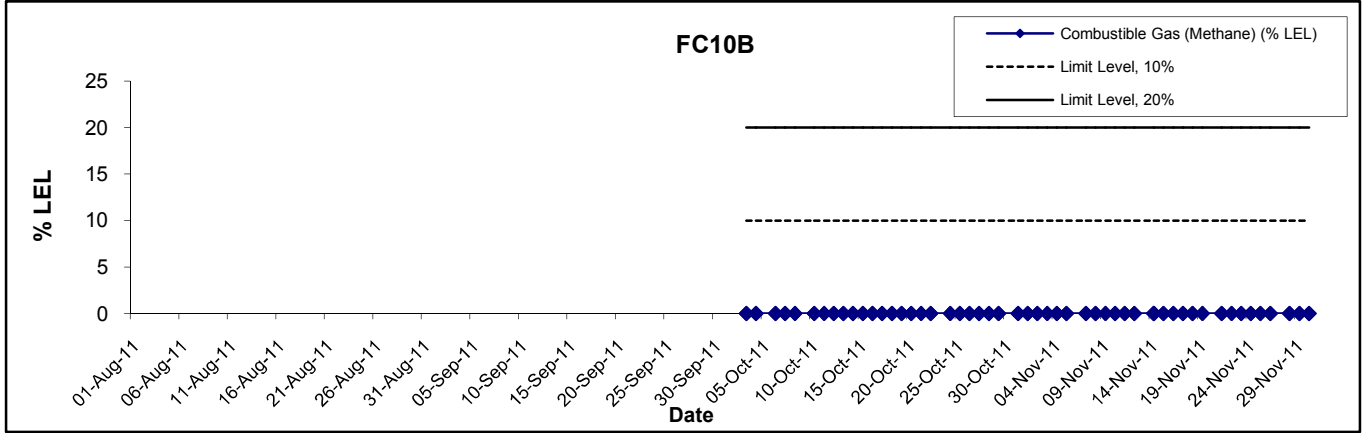
### Combustible Gas (Methane)

Title Contract No. DC/2009/09 Construction of Tai Po Sewage Treatment Works - Stage V Phase II B  Graphical Presentation of Landfill Gas Measurement	Scale	N.T.S	Project No.	MA0010	CINOTECH
	Date	Nov 11	Appendix	G

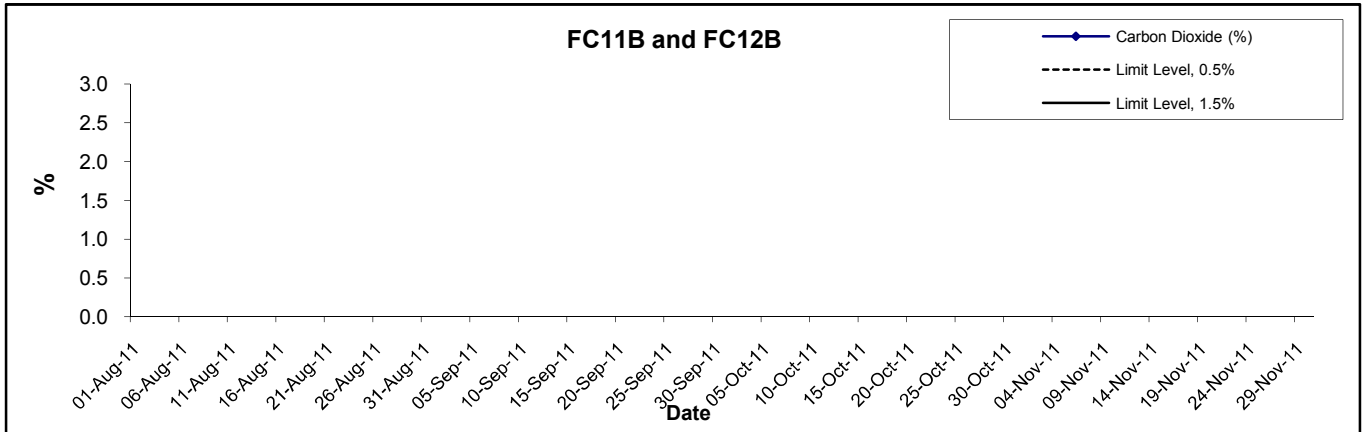
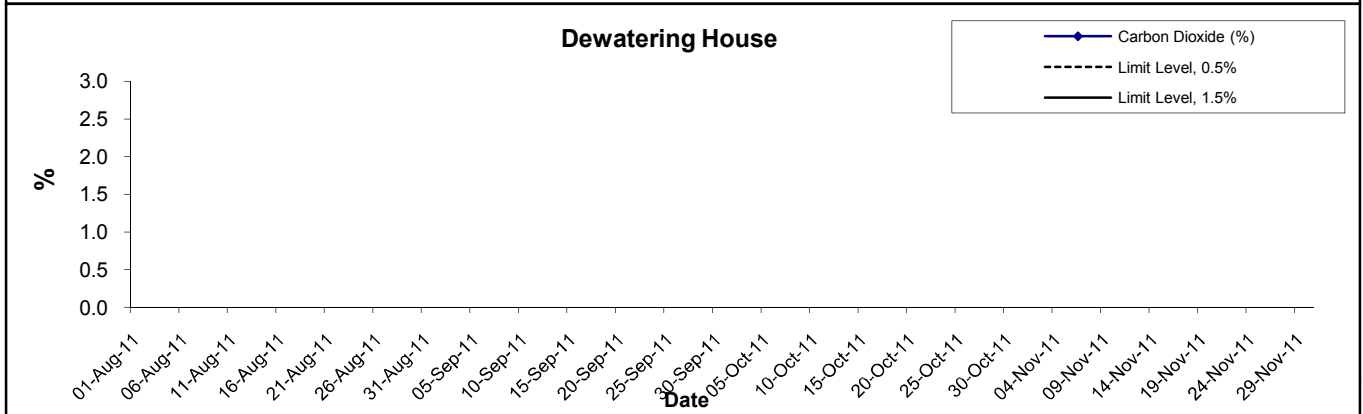
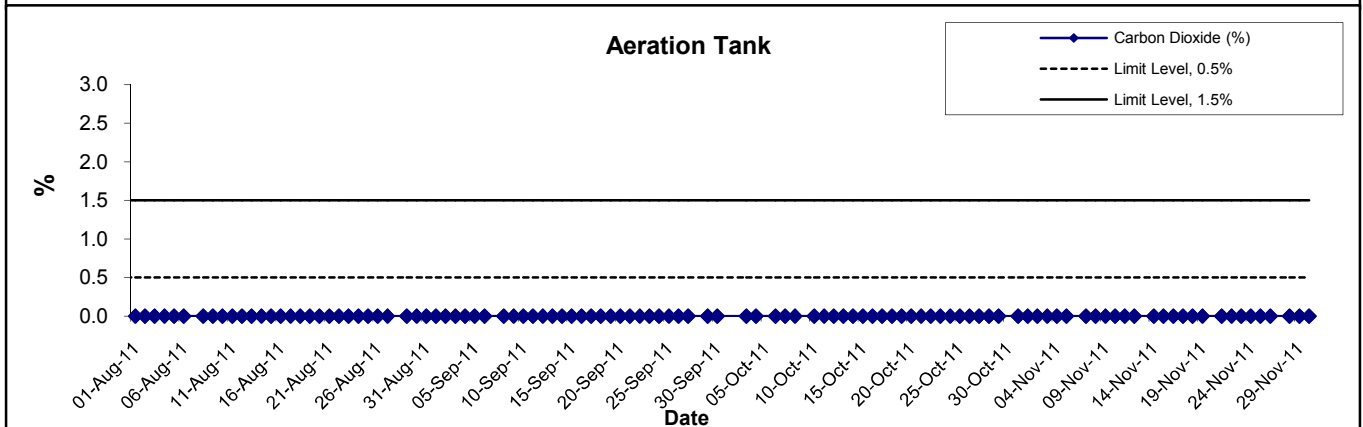
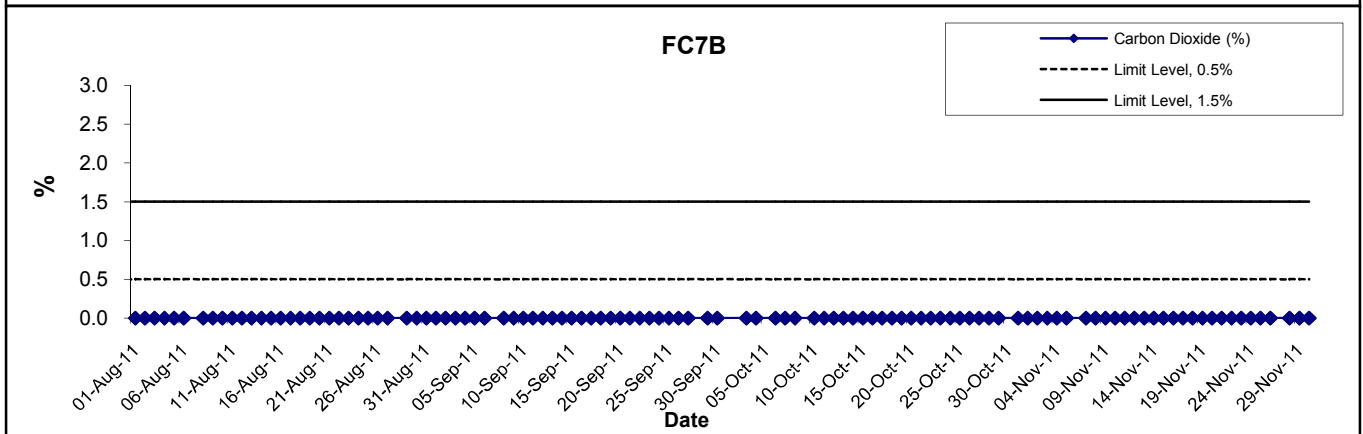
### Carbon Dioxide

**Title**  
 Contract No. DC/2009/09  
 Construction of Tai Po Sewage Treatment Works - Stage V Phase II B  
 Graphical Presentation of Landfill Gas Measurement

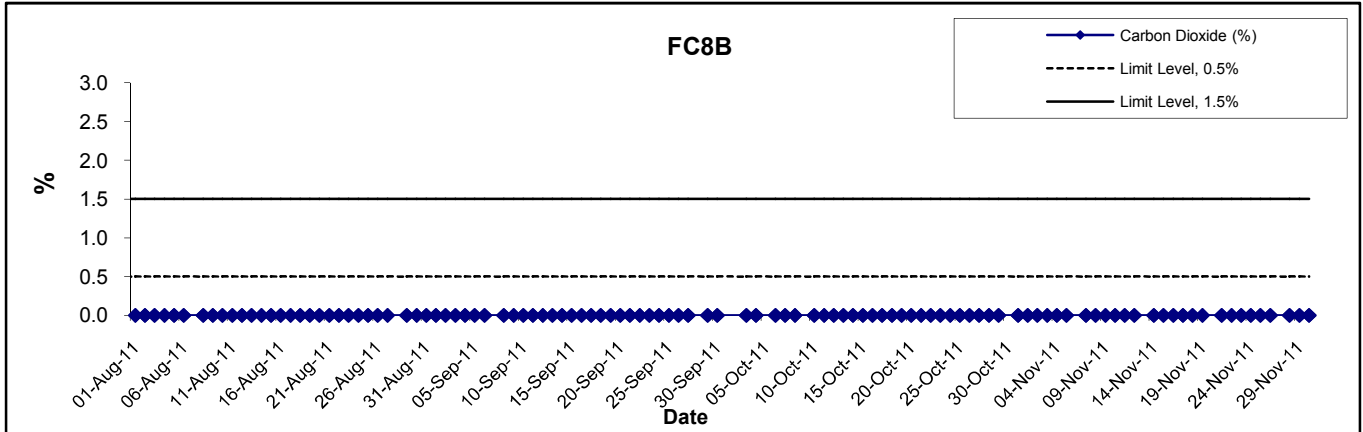
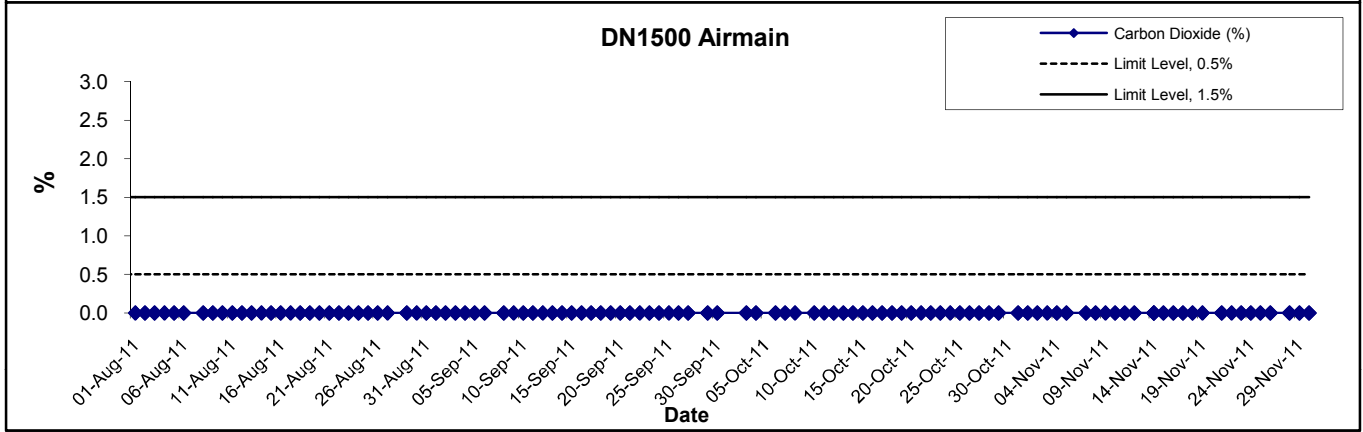
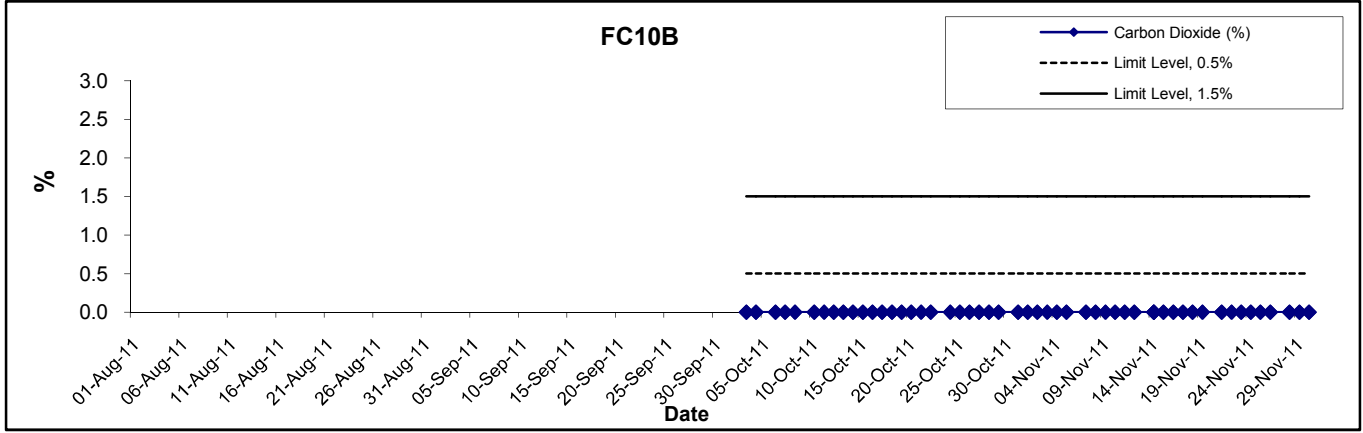
### Carbon Dioxide

Title Contract No. DC/2009/09 Construction of Tai Po Sewage Treatment Works - Stage V Phase II B  Graphical Presentation of Landfill Gas Measurement	Scale	N.T.S	Project No.	MA0010	CINOTECH
	Date	Nov 11	Appendix	G
