Contract No. DC/2009/09  
Construction of Tai Po Sewage Treatment  
Works – Stage V Phase II B

**Monthly Environmental Monitoring  
and Audit Report for  
November 2011**

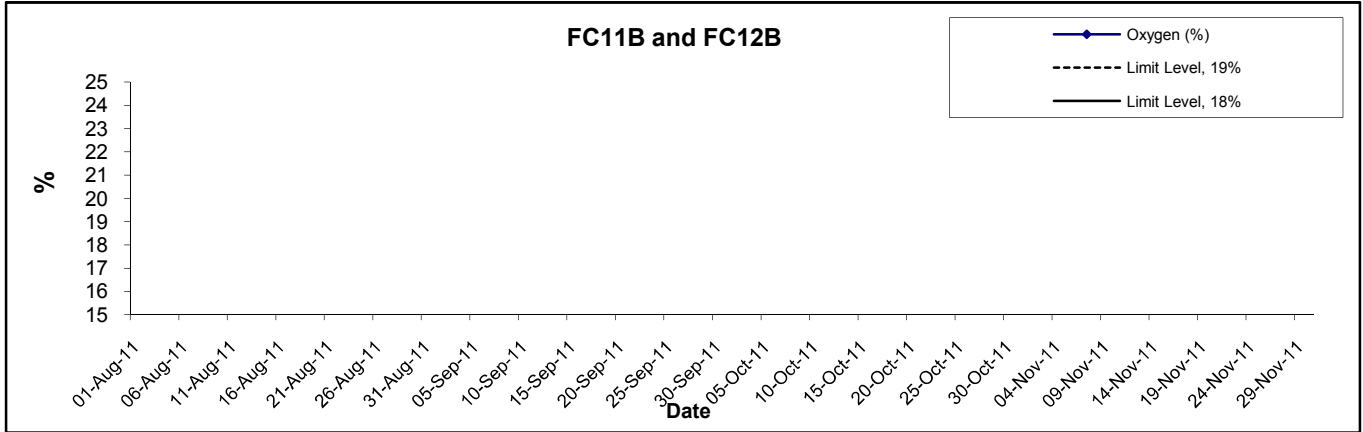
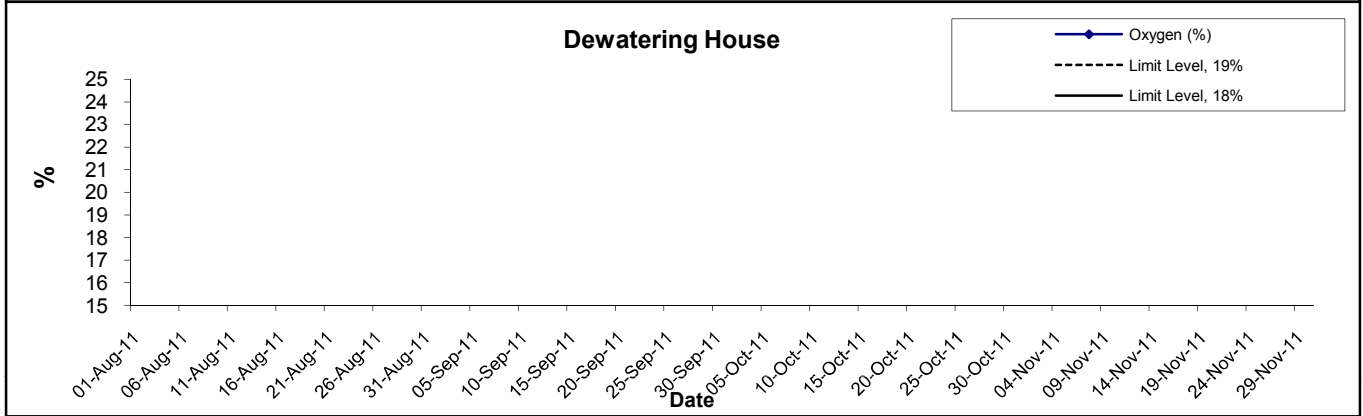
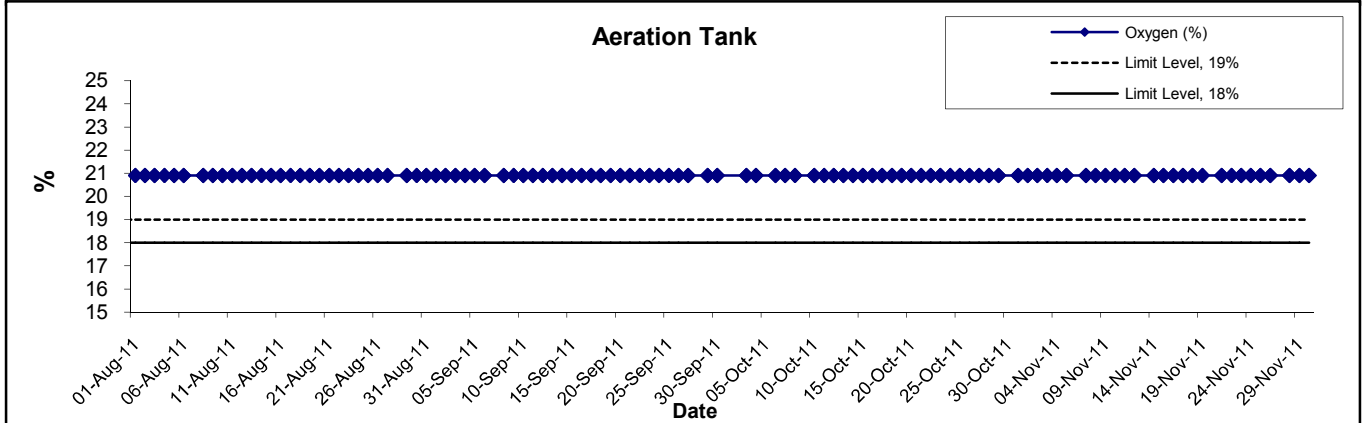
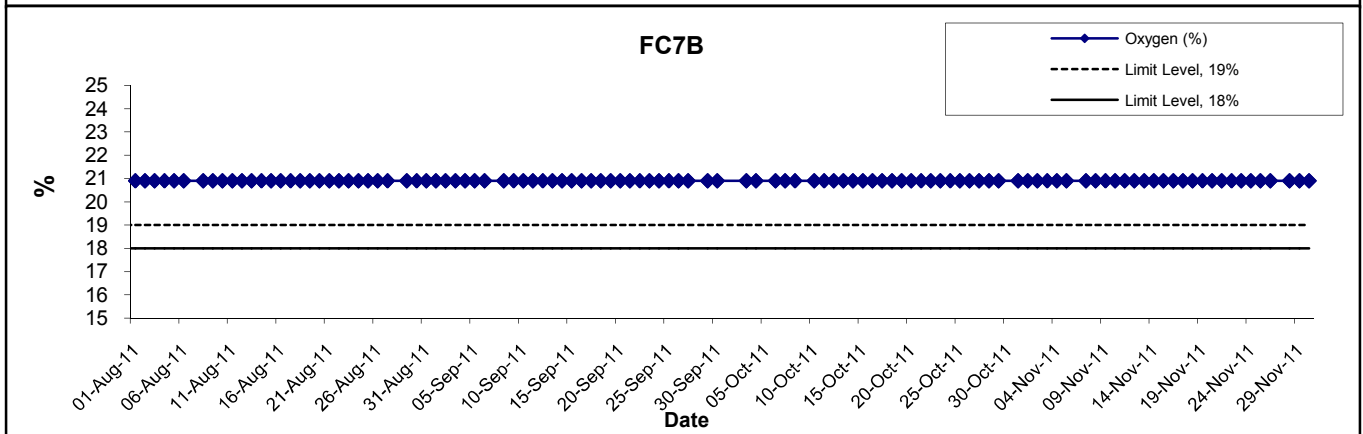
## Oxygen

**Title**  
 Contract No. DC/2009/09  
 Construction of Tai Po Sewage Treatment Works - Stage V Phase II B  
 Graphical Presentation of Landfill Gas Measurement
