Contract No. DE/2009/09  
Supply and Installation of Electrical and  
Mechanical Equipment for Tai Po Sewage  
Treatment Works Stage 5 Phase 2B

## Monthly Environmental Monitoring and Audit Report for May 2012

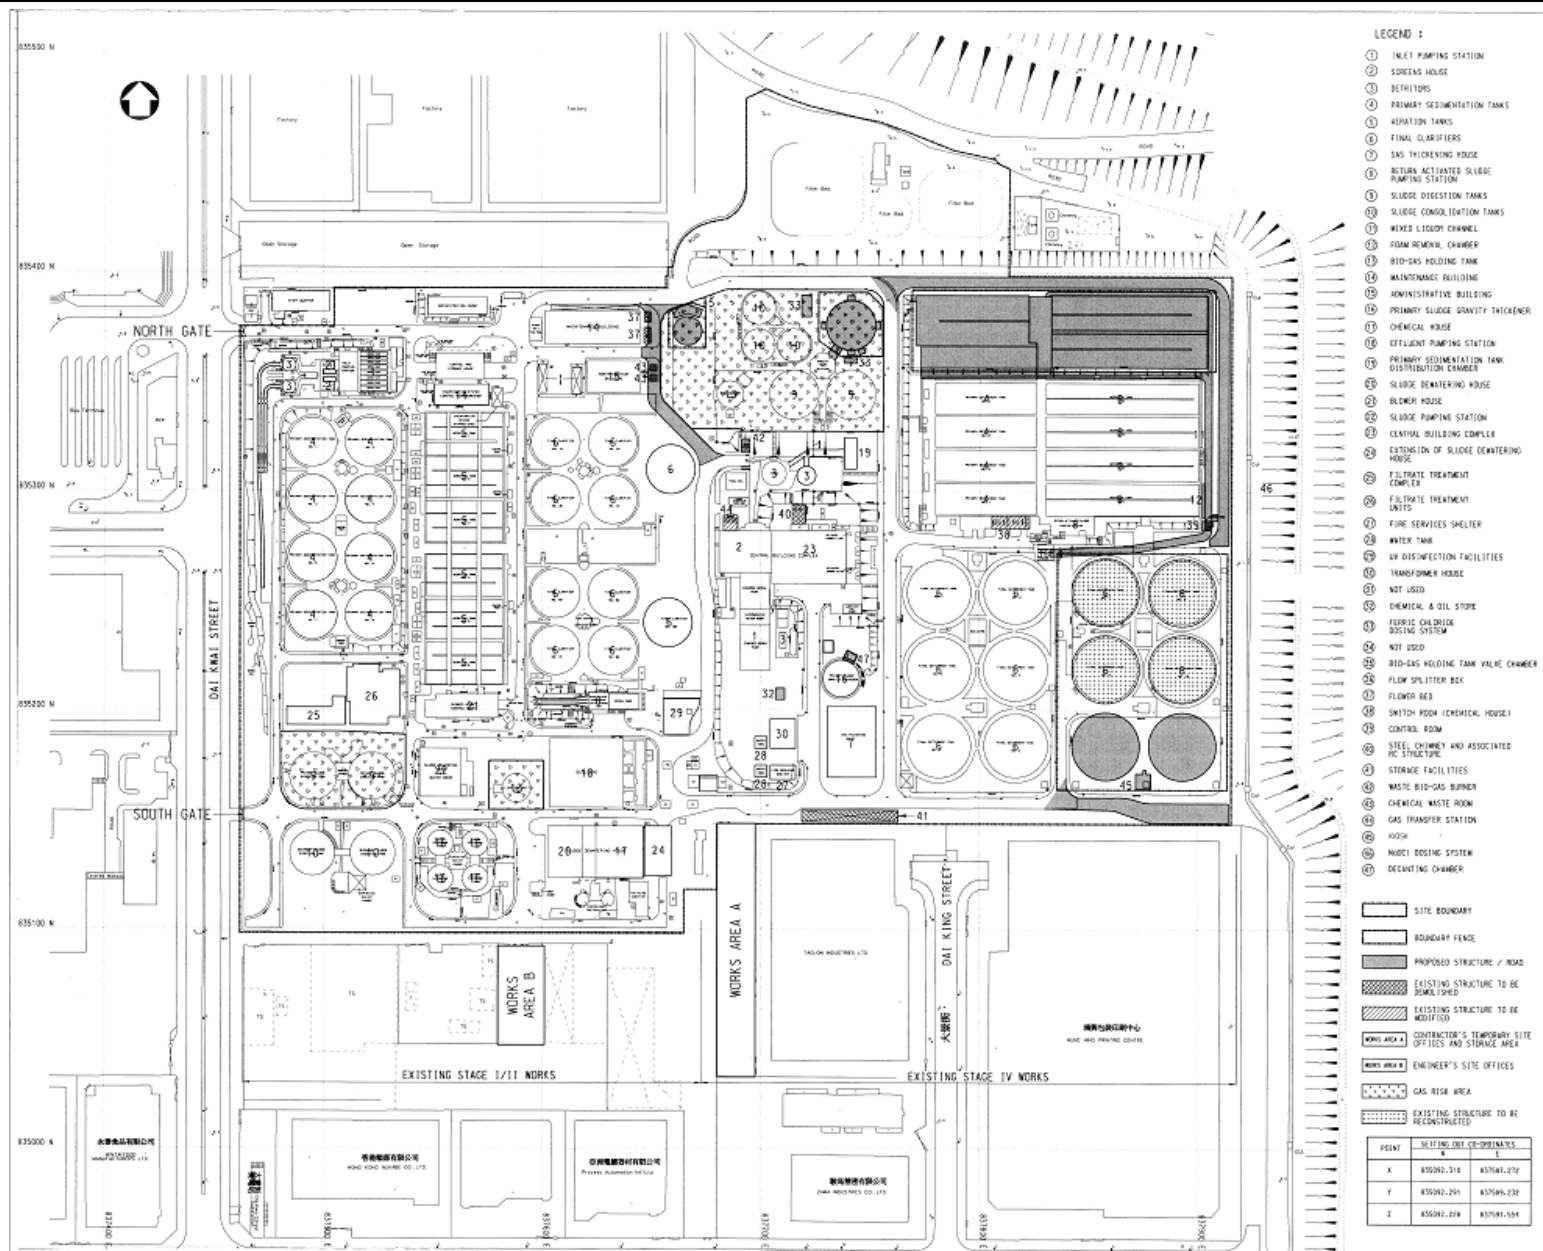
1.1

- LEGEND :**
- ① INLET PUMPING STATION
  - ② SCREENS HOUSE
  - ③ DETRITORS
  - ④ PRIMARY SEDIMENTATION TANKS
  - ⑤ AERATION TANKS
  - ⑥ FINAL CLARIFIERS
  - ⑦ GAS THICKENING HOUSE

- ⑧ RETURN ACTIVATED SLUDGE PUMPING STATION
  - ⑨ SLUDGE DISSOLUTION TANKS
  - ⑩ SLUDGE CONSOLIDATION TANKS
  - ⑪ MIXED LIQUOR CHANNEL
  - ⑫ FOAM REMOVAL CHANNEL

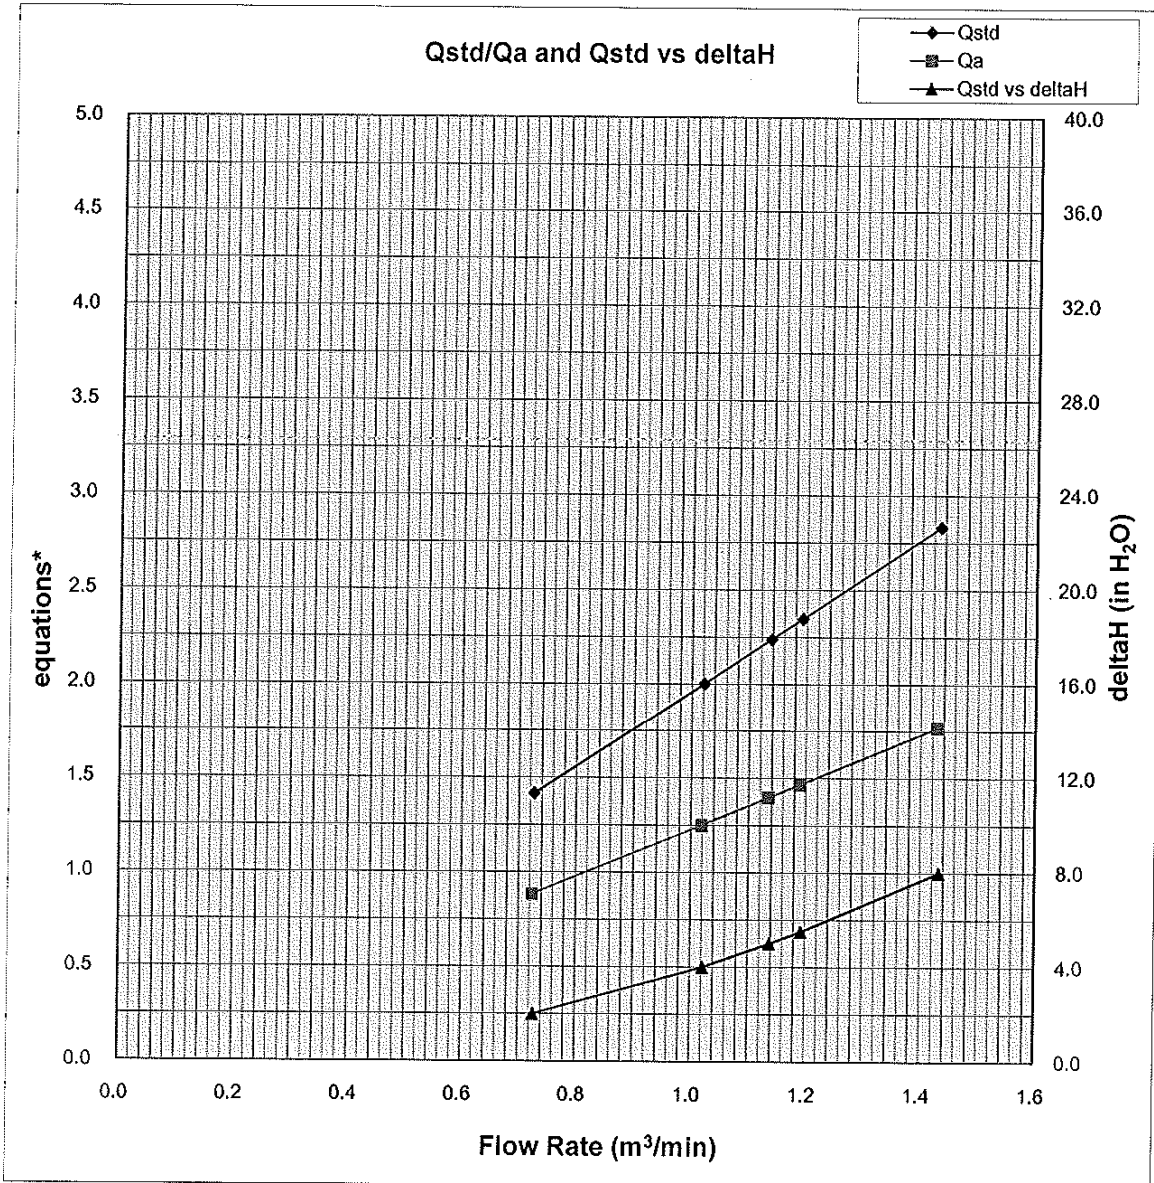
Y-axis equations:

Qstd series:  $\text{SQRT}[\Delta H(\text{Pa}/\text{Pstd})(\text{Tstd}/\text{Ta})]$

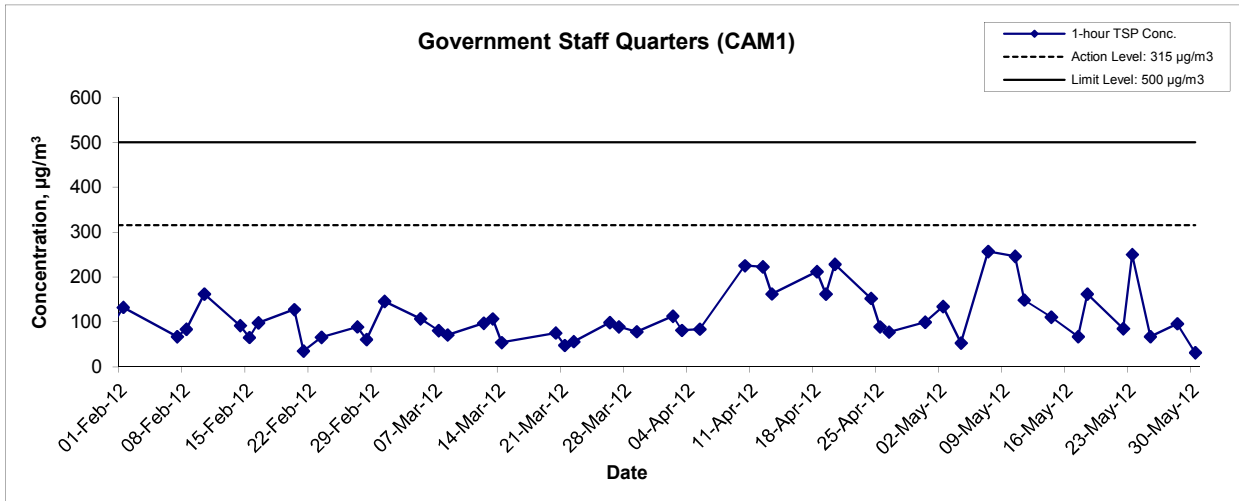
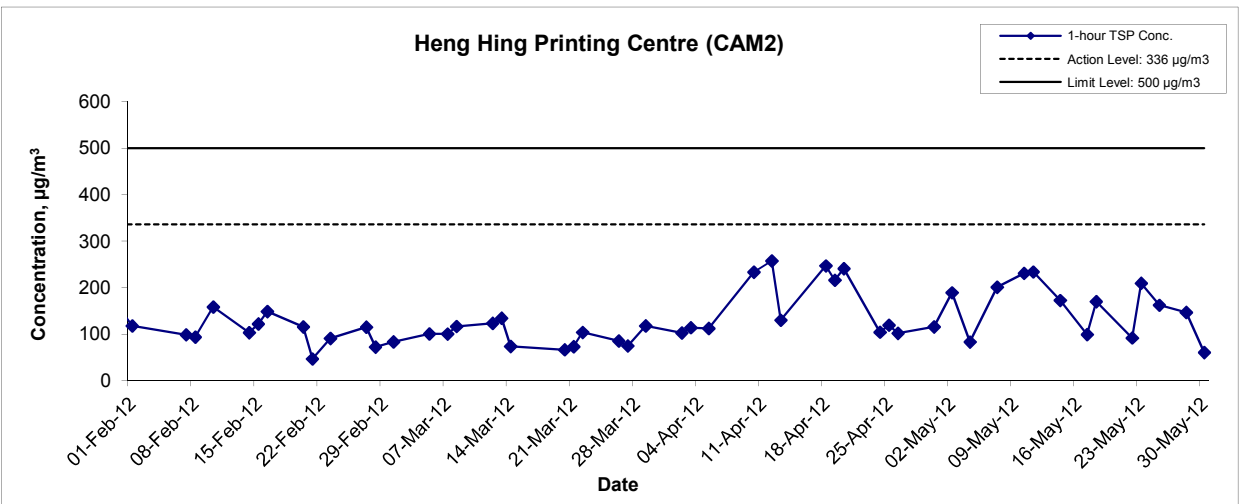
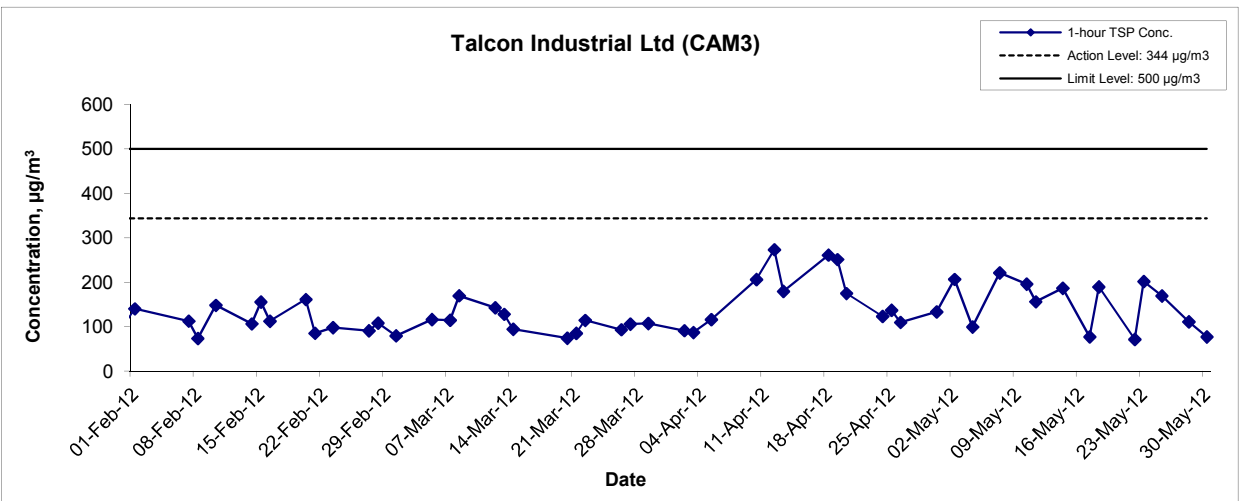
### 1-hr TSP Concentration Levels

Title Contract No. DE/2009/09 Supply and Installation of Electrical and Mechanical Equipment for Tai Po Sewage Treatment Works Stage 5 Phase 2B Graphical Presentation of 1-hour TSP Impact Monitoring Results	Scale N.T.S	Project No. MA10069	
	Date May 12	Appendix D

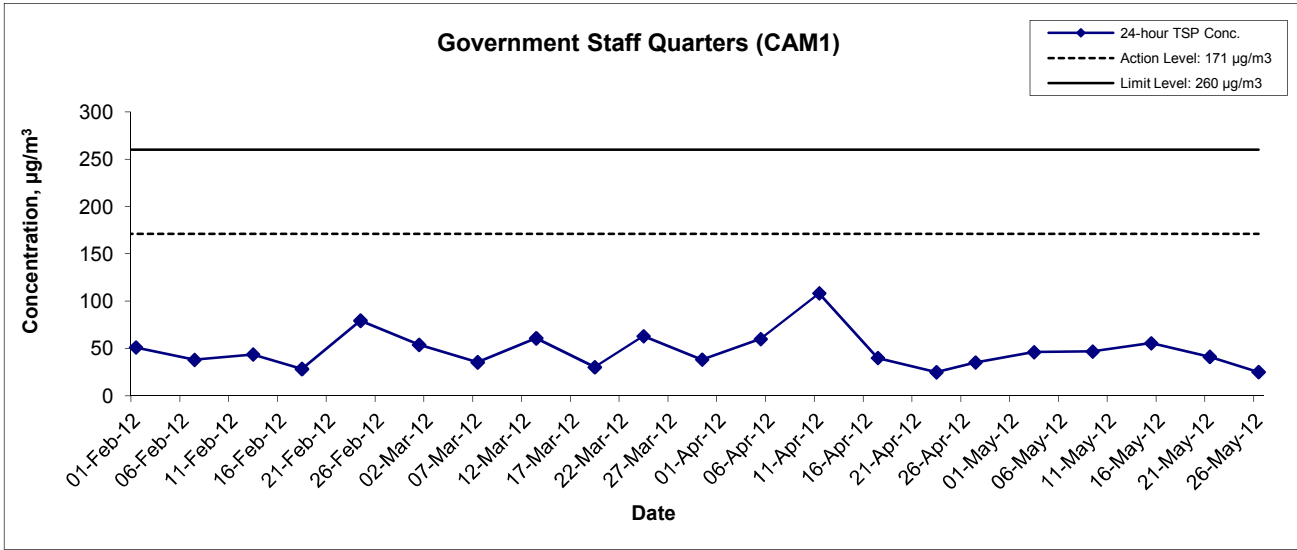
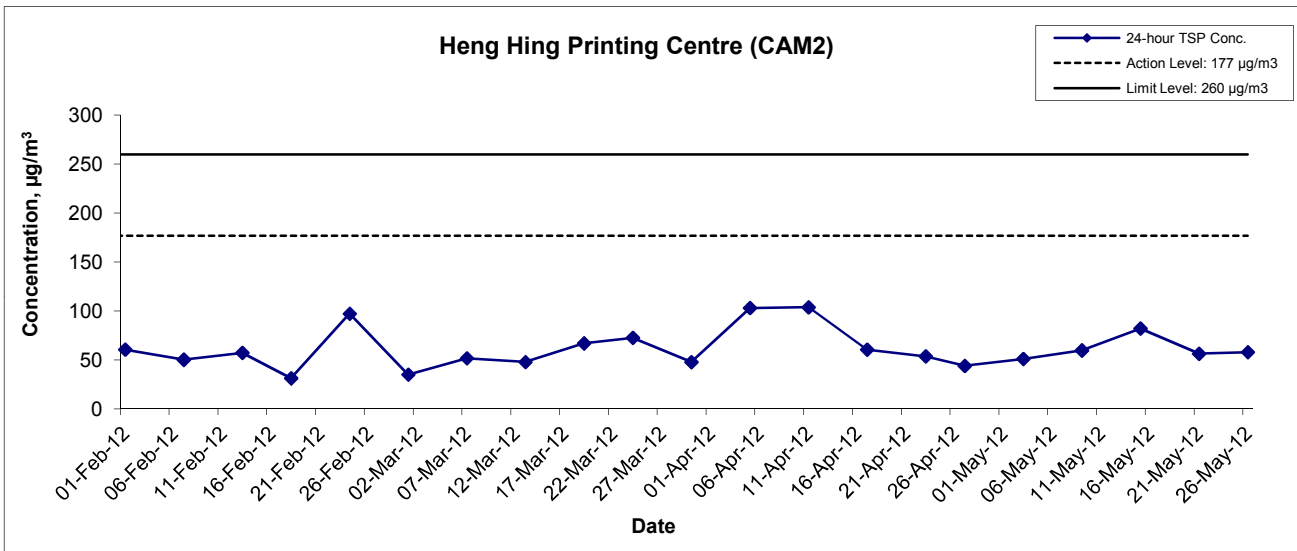
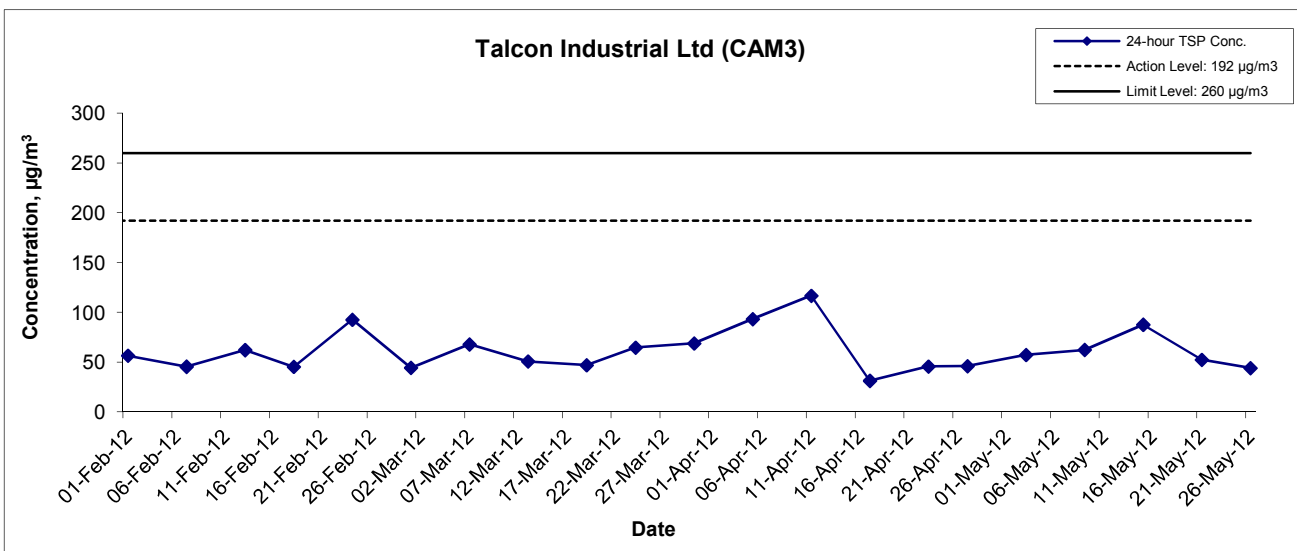
### 24-hr TSP Concentration Levels

Title Contract No. DE/2009/09 Supply and Installation of Electrical and Mechanical Equipment for Tai Po Sewage Treatment Works Stage 5 Phase 2B  Graphical Presentation of 24-hour TSP Impact Monitoring Results	Scale N.T.S  Date May 12
--	--------------------------------------

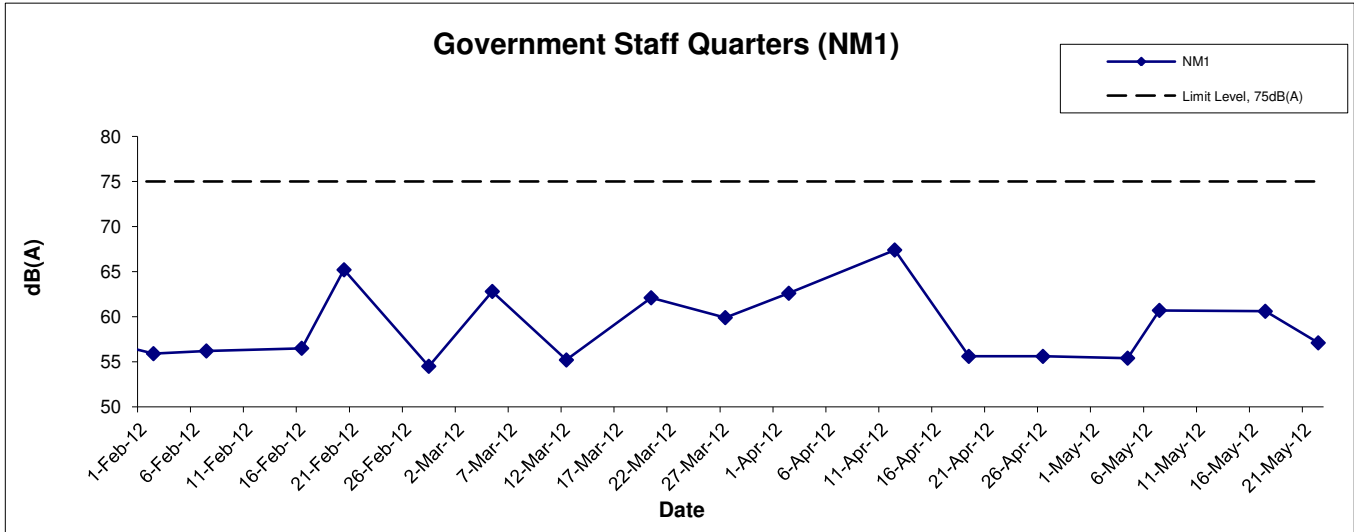
## Noise Levels

Title Contract No. DE/2009/09 Supply and Installation of Electrical and Mechanical Equipment for Tai Po Sewage Treatment Works Stage 5 Phase 2B Graphical Presentation of Construction Noise Monitoring Results	Scale	N.T.S	Project No.	MA10069	CINOTECH
	Date	May 12	Appendix	F
