China Harbour Engineering Company Limited

Contract No. DC/2009/09
Construction of Tai Po Sewage Treatment
Works – Stage V Phase II B

**Monthly Environmental Monitoring
and Audit Report for
February 2013**

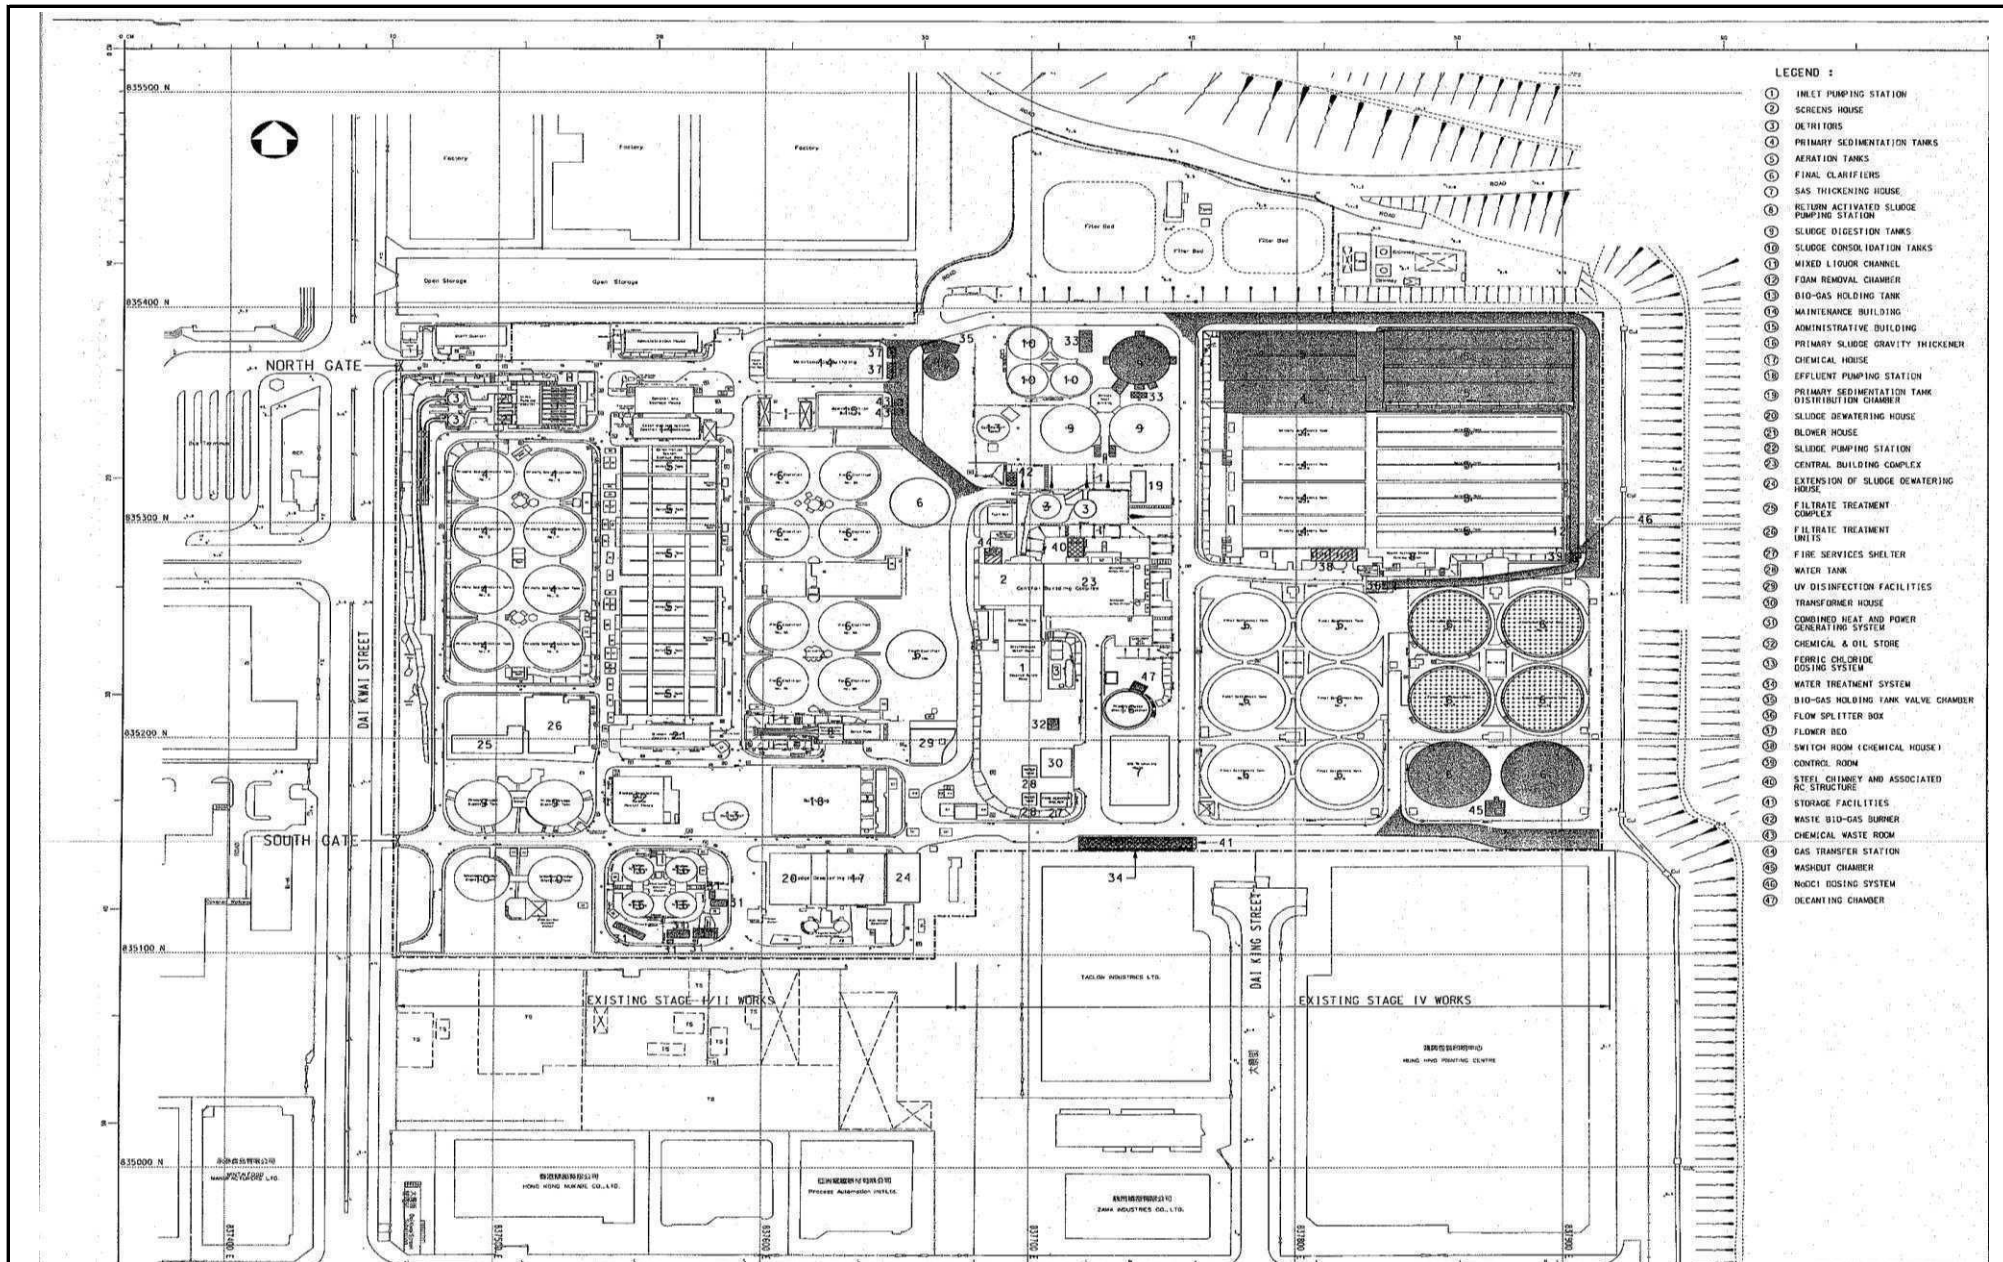
1.1

- LEGEND :**
- ① TRLET PUMPING STATION
 - ② SCREENS HOUSE
 - ③ ULTRAFILTS
 - ④ PRIMARY SEDIMENTATION TANKS
 - ⑤ AERATION TANKS
 - ⑥ FINAL CLARIFIERS
 - ⑦ SAS THICKENING HOUSE

- ⑧ RETURN ACTIVATED SLUDGE PUMPING STATION
 - ⑨ SLUDGE DIGESTION TANKS
 - ⑩ SLUDGE CONSOLIDATION TANKS
 - ⑪ MIXED LIQUOR CHANNEL
 - ⑫ FOAM REMOVAL CHAMBER

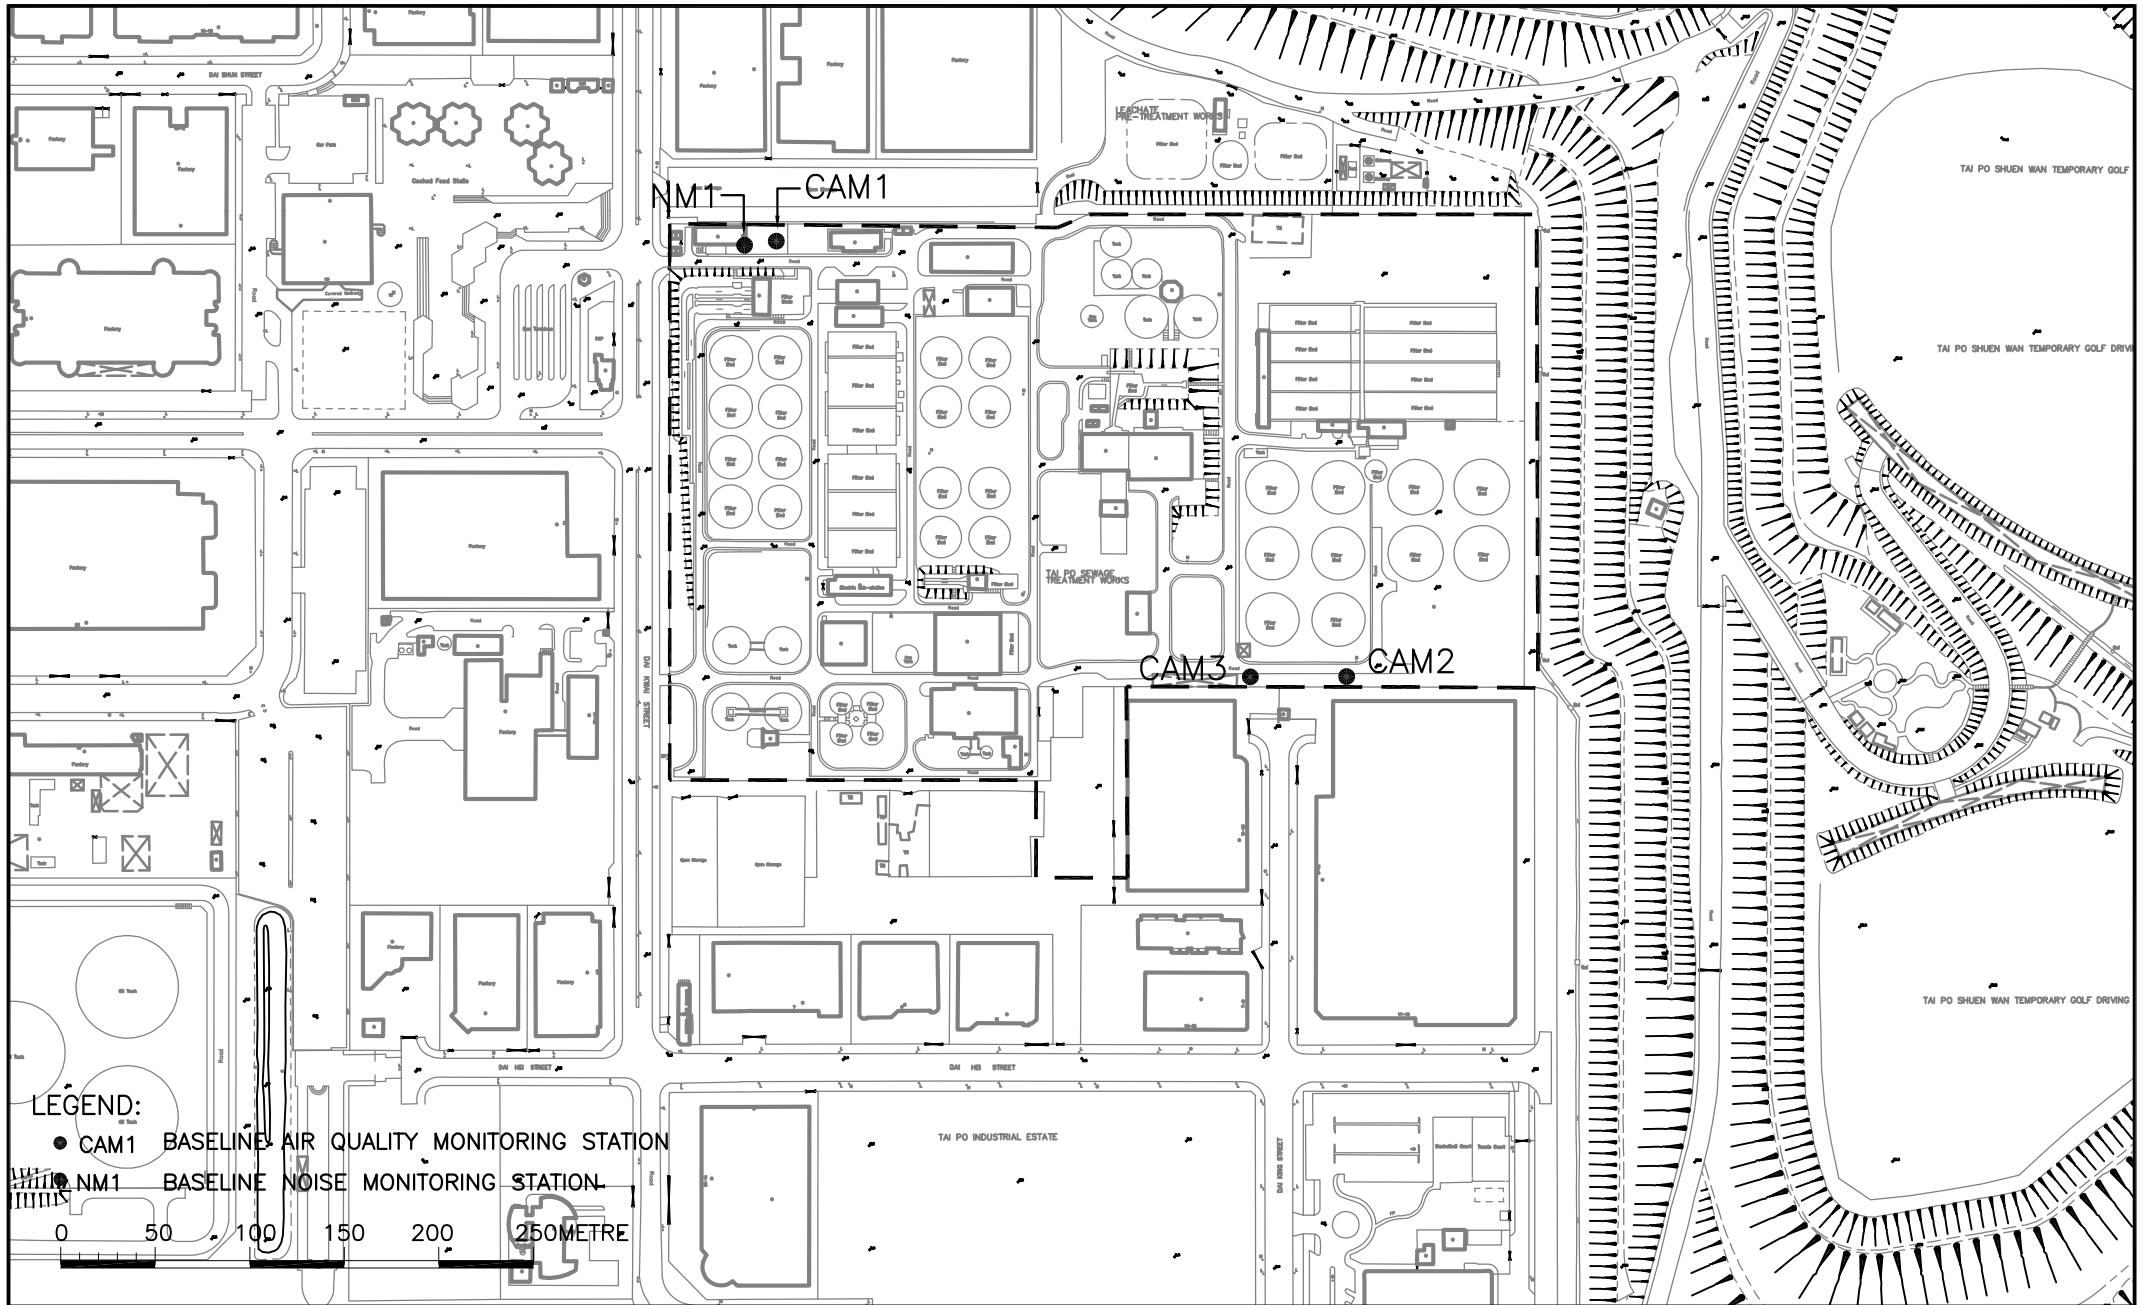
SCALE	A4 1:4000	DATE	2010	
CHECK	IT	DRAWN	SL	
JOB No.	MA0010	DRAWING No.	1.2	REV —

- CAM1 BASELINE AIR QUALITY MONITORING STATION
- NM1 BASELINE NOISE MONITORING STATION

LOCATIONS OF AIR QUALITY AND NOISE MONITORING STATIONS

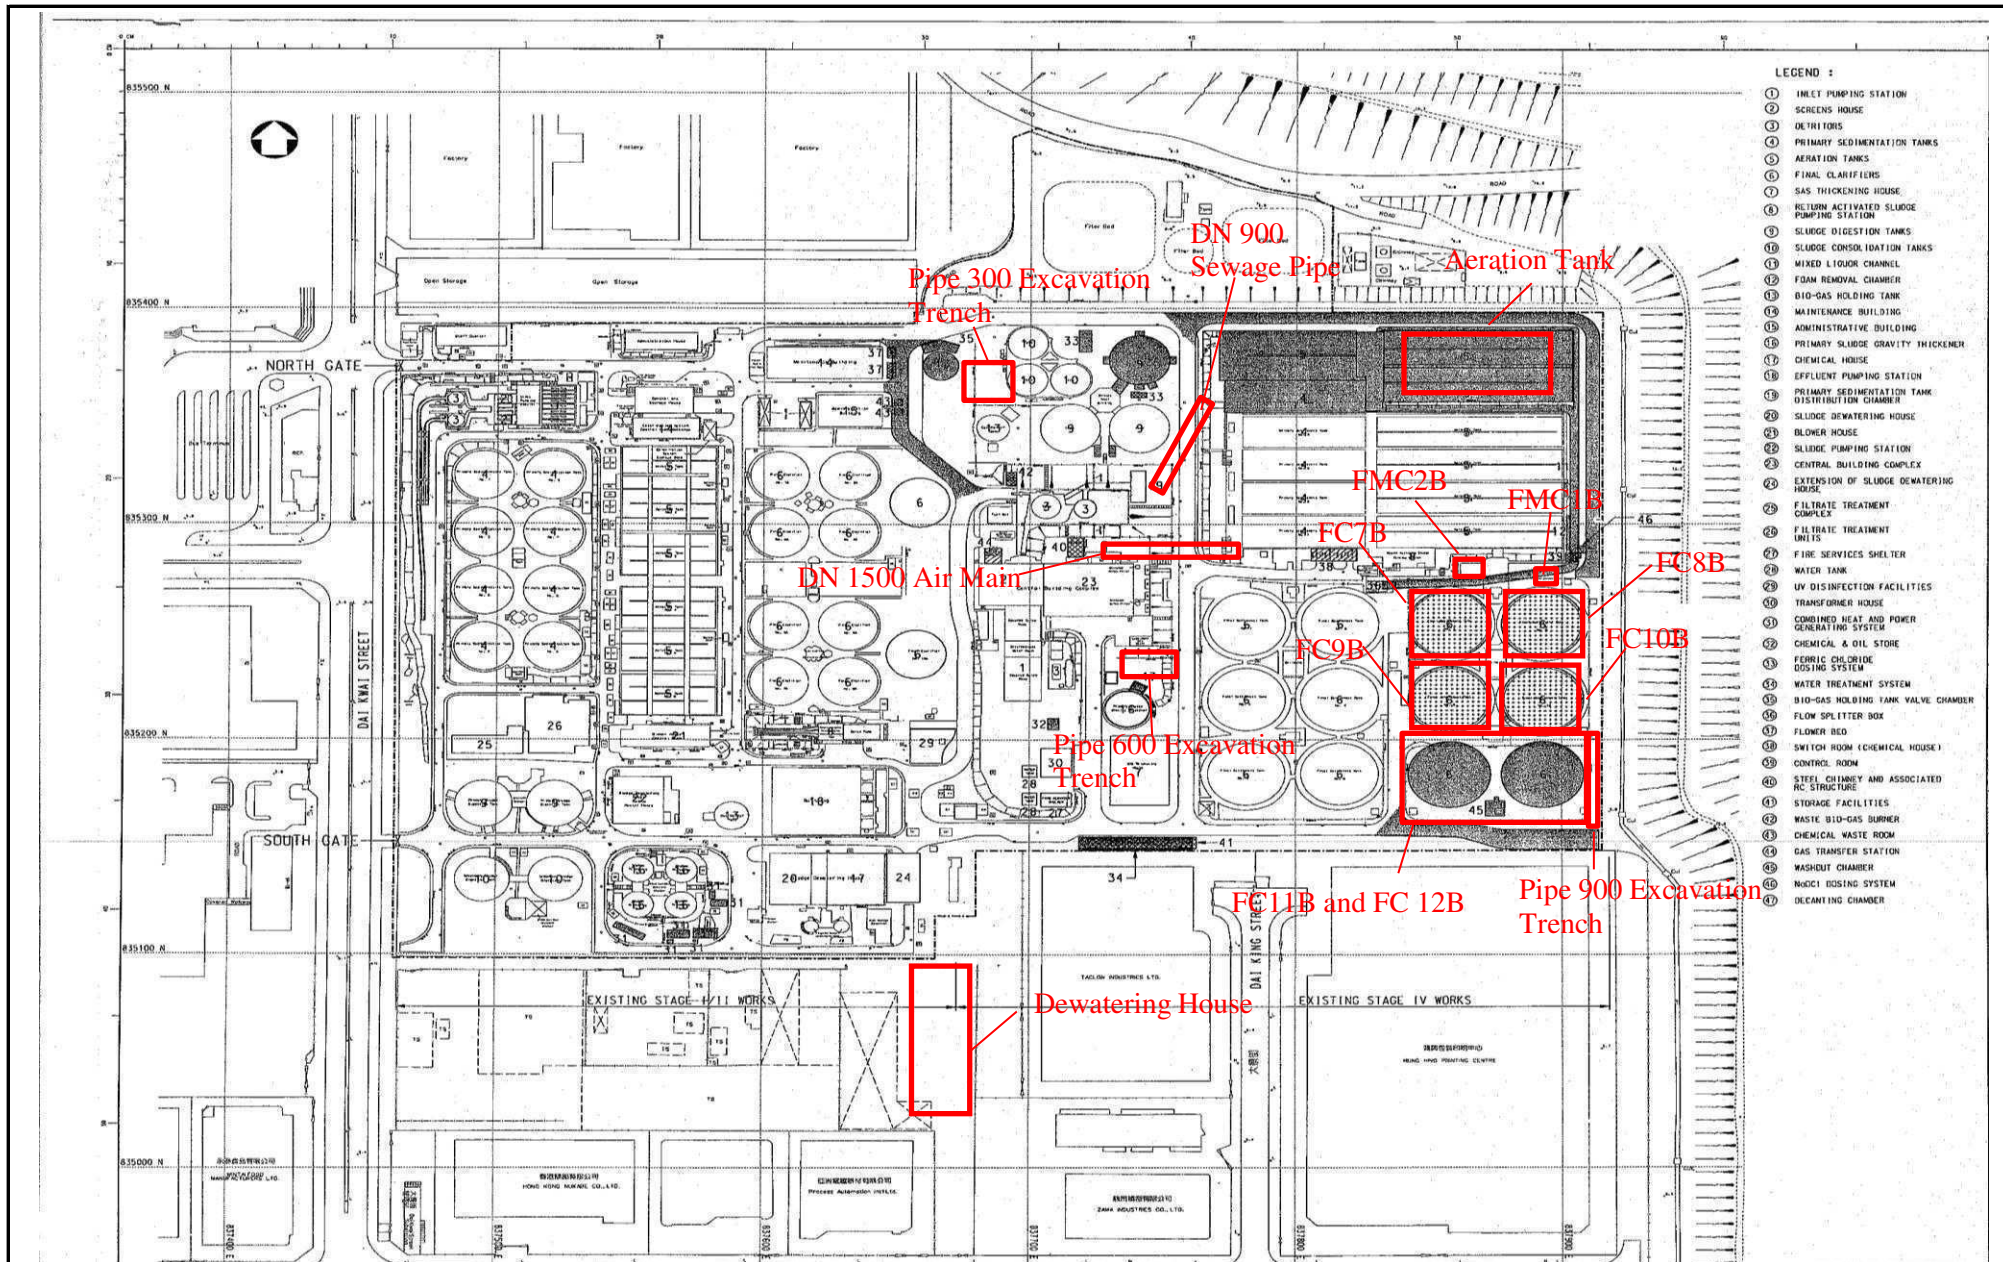
Landfill Gas Monitoring Area(TPSTW)

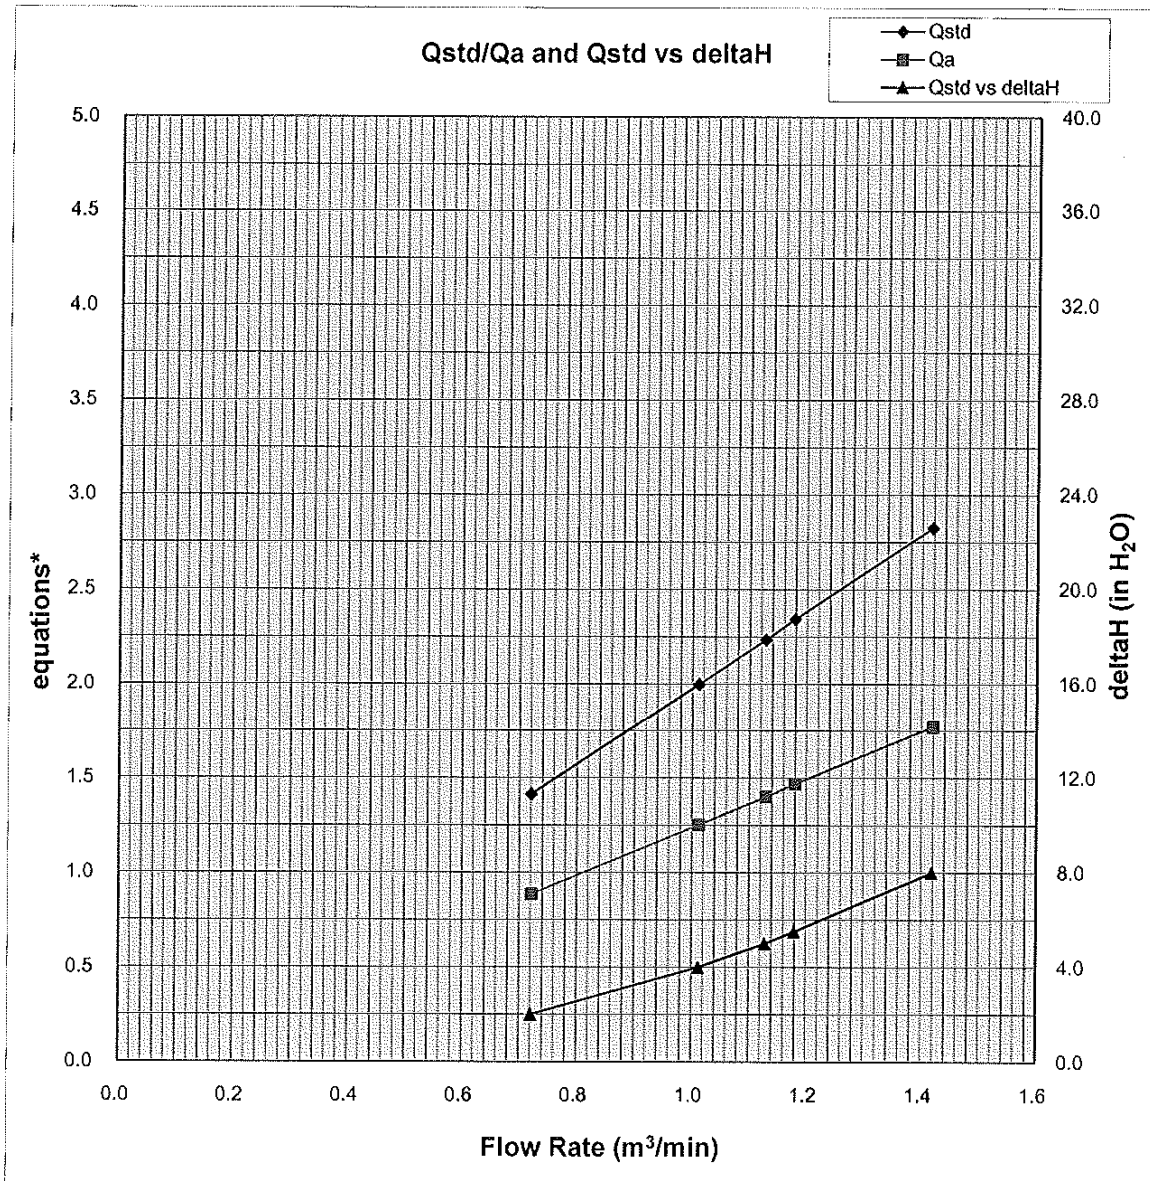
TEST REPORT

Y-axis equations:

Qstd series: $\text{SQRT}[\Delta H(\text{Pa}/\text{Pstd})(\text{Tstd}/\text{Ta})]$

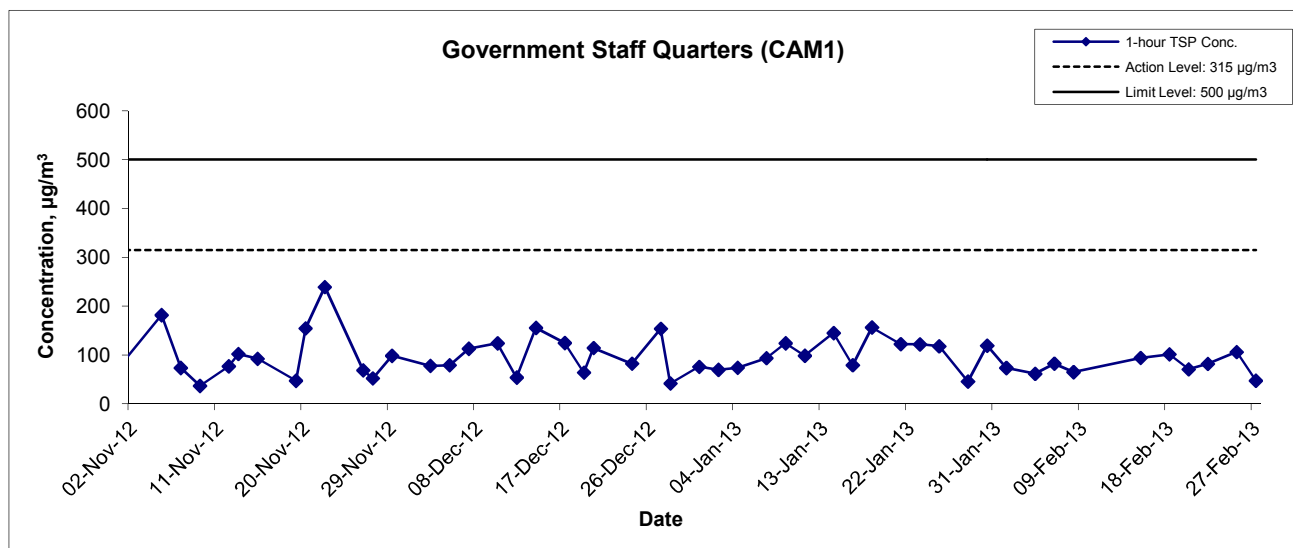
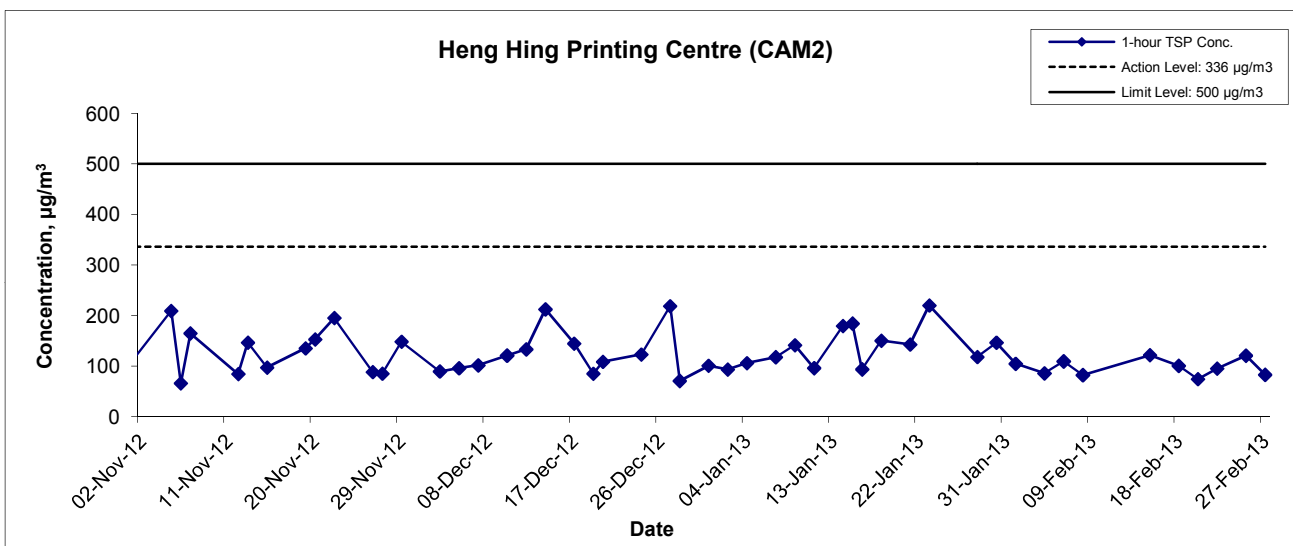
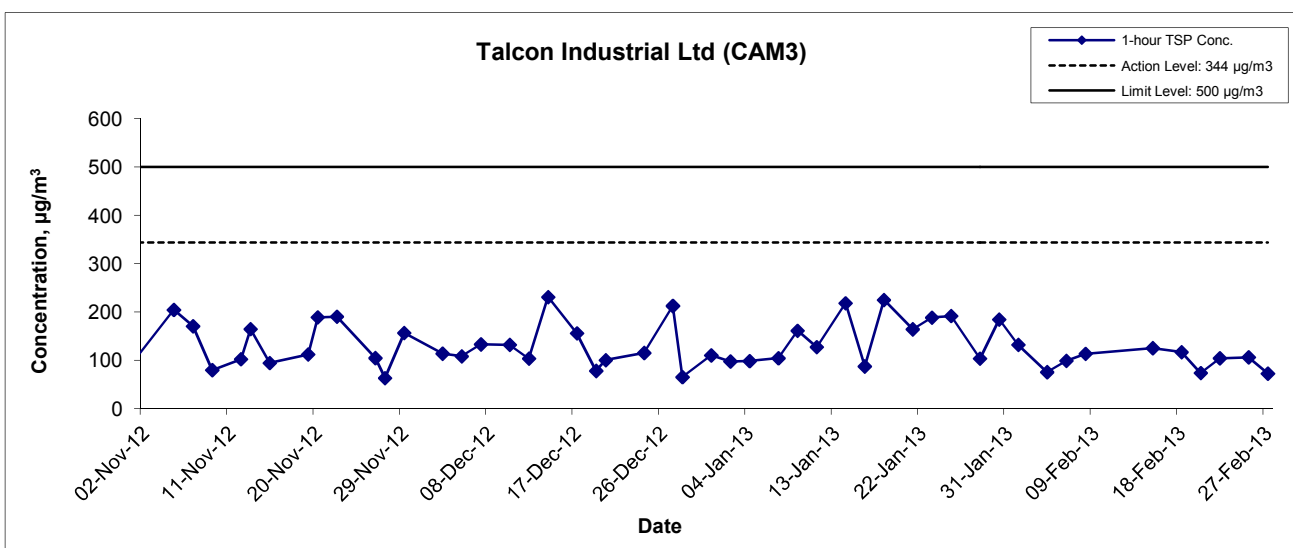
1-hr TSP Concentration Levels

Title	Contract No. DC/2009/09	Scale	Project No. MA0010	CINOTECH
	Construction of Tai Po Sewage Treatment Works - Stage V Phase II B	N.T.S		
Graphical Presentation of 1-hour TSP Impact Monitoring Results		Date	Appendix D	
		Feb 13

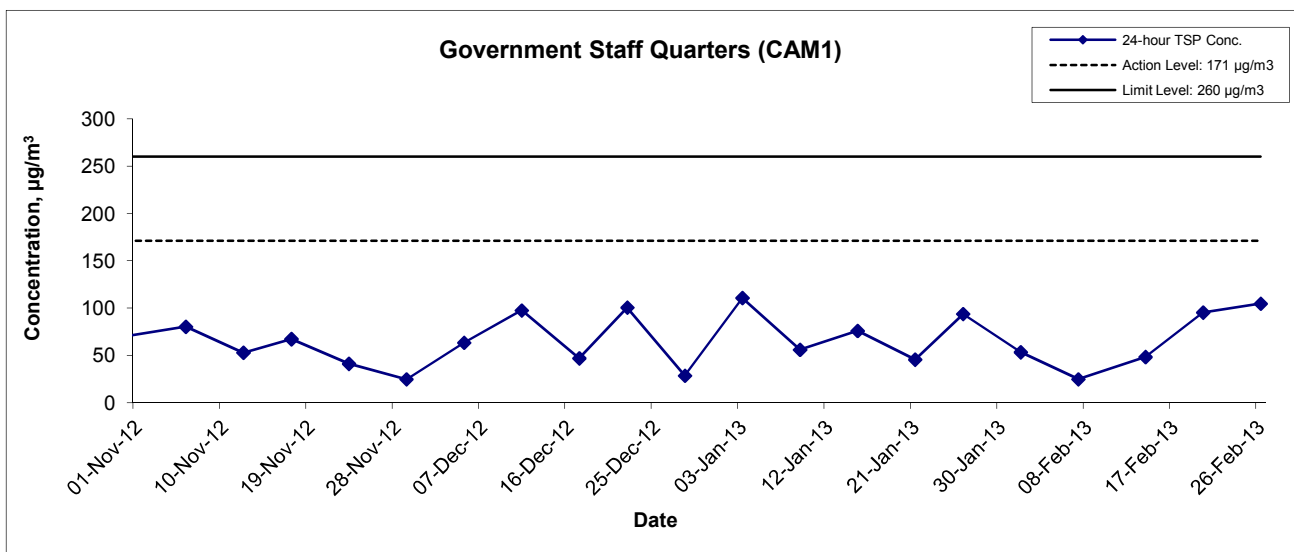
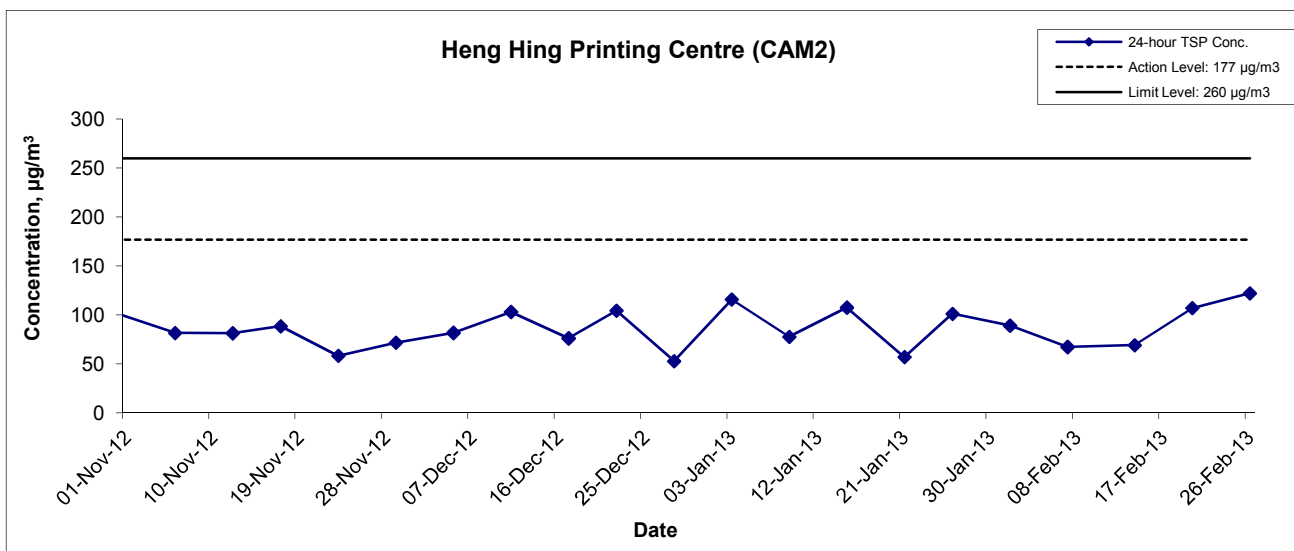
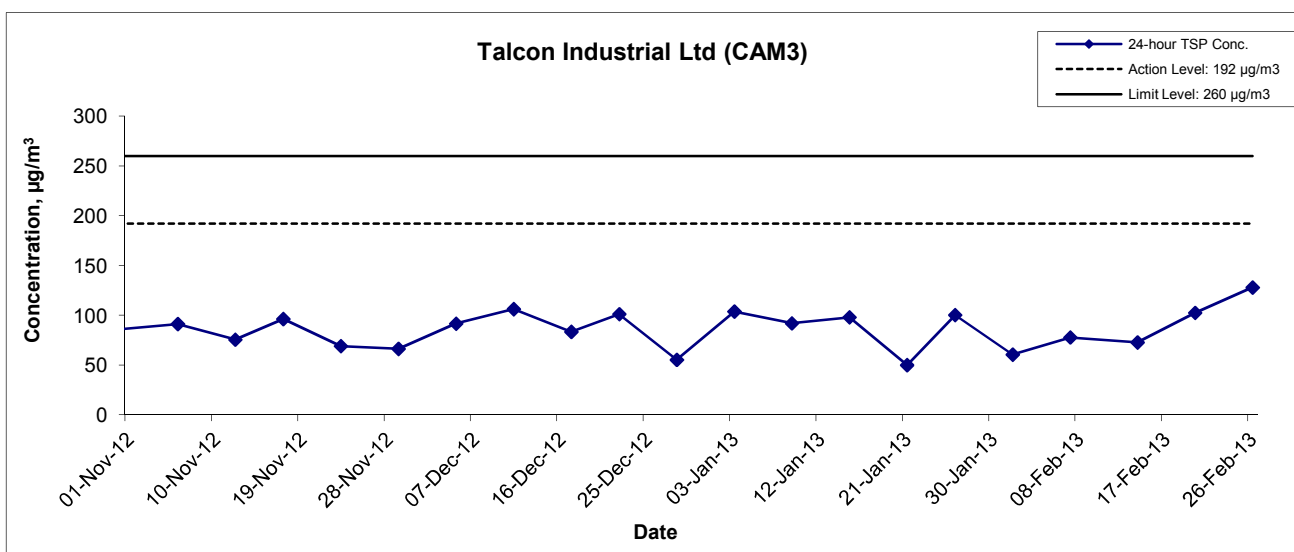
24-hr TSP Concentration Levels

Title Contract No. DC/2009/09 Construction of Tai Po Sewage Treatment Works - Stage V Phase II B Graphical Presentation of 24-hour TSP Impact Monitoring Results	Scale N.T.S	Project No. MA0010	
	Date Feb 13	Appendix E

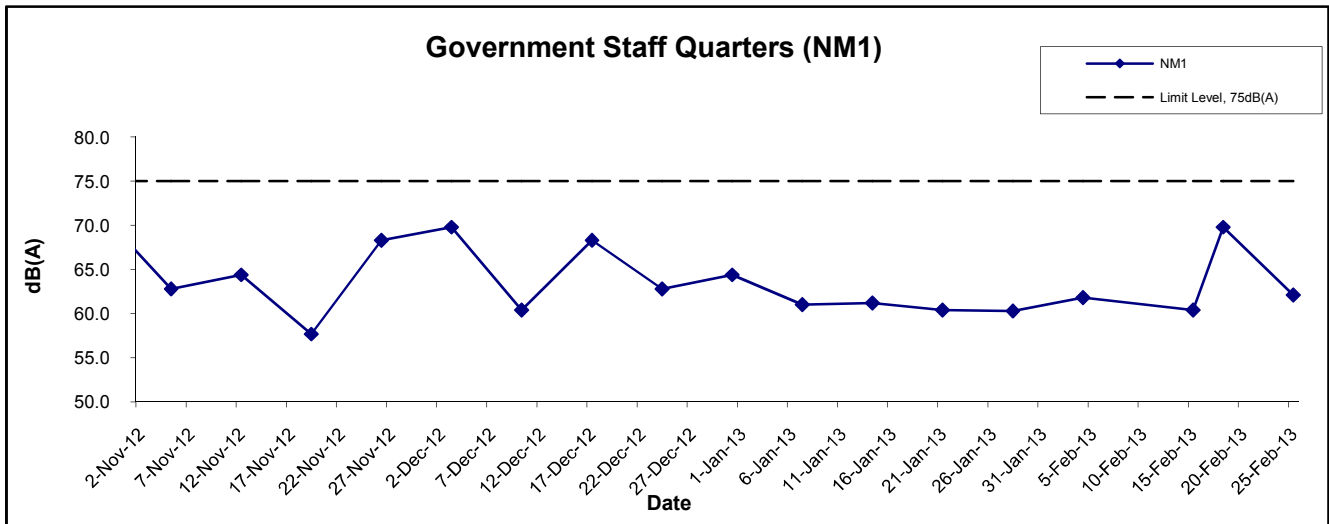
Noise Levels

Title Contract No. DC/2009/09 Construction of Tai Po Sewage Treatment Works - Stage V Phase II B Graphical Presentation of Construction Noise Monitoring Results	Scale N.T.S	Project No. MA0010	
	Date Feb 13	Appendix F

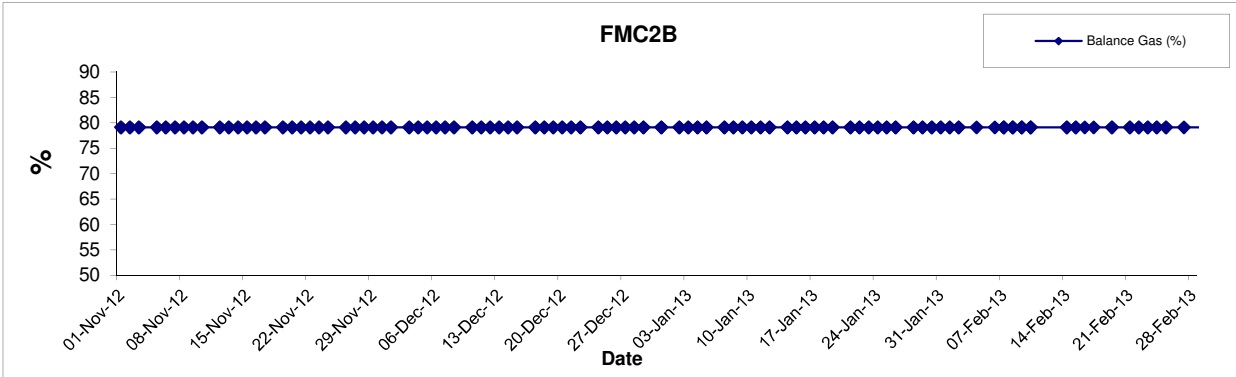
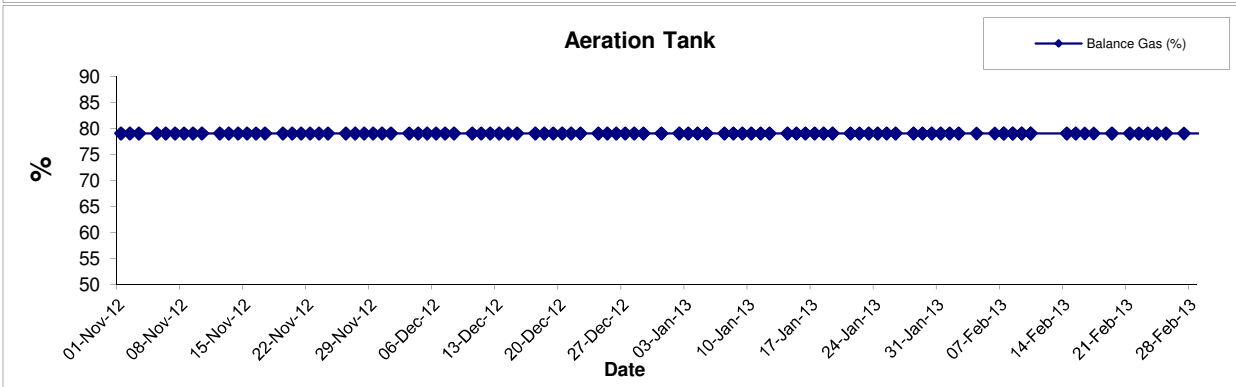
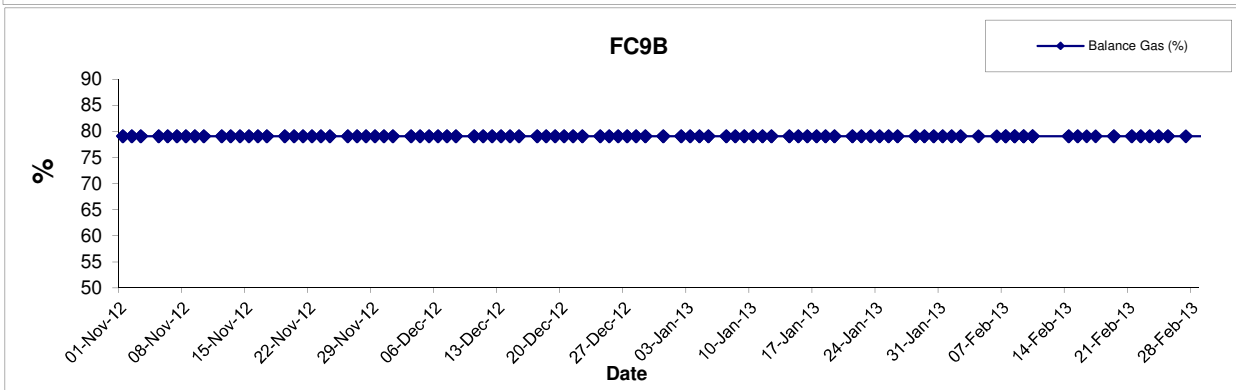
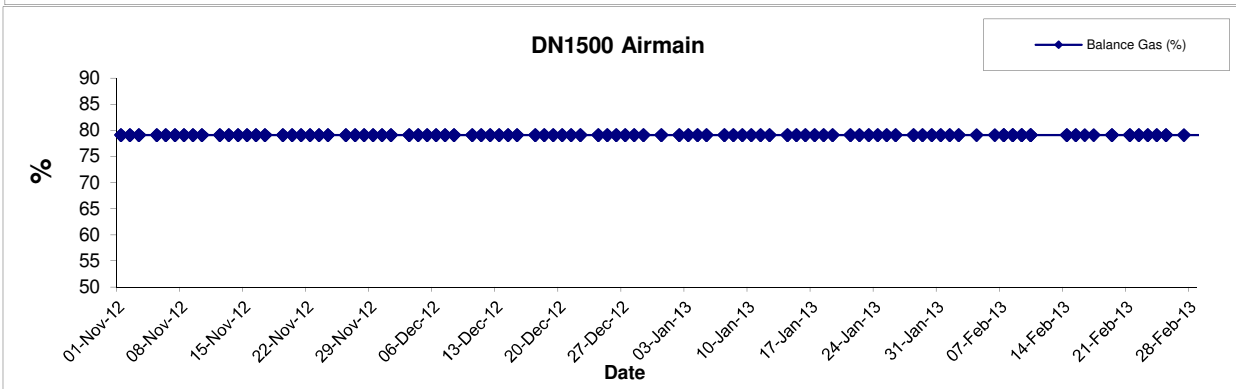
Balance Gas

Title
 Contract No. DC/2009/09
 Construction of Tai Po Sewage Treatment Works - Stage V Phase II B
 Graphical Presentation of Landfill Gas Measurement

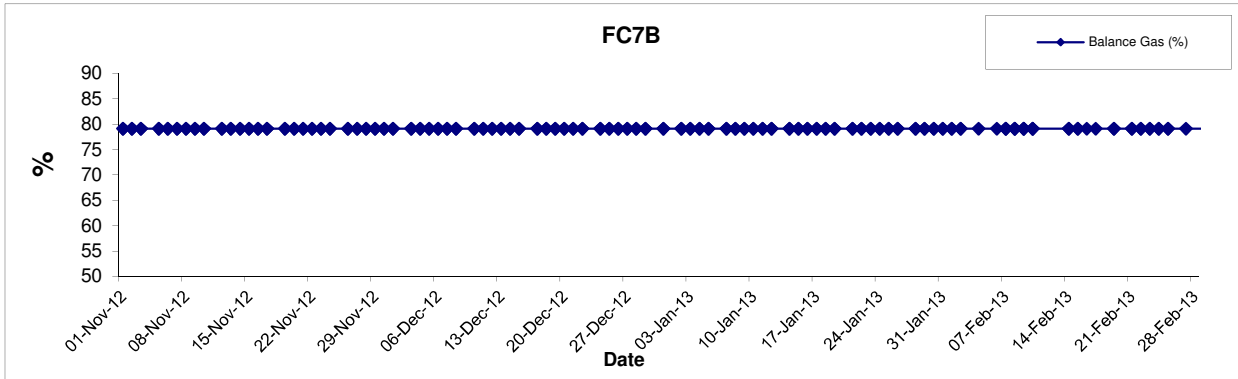
Balance Gas

Title Contract No. DC/2009/09 Construction of Tai Po Sewage Treatment Works - Stage V Phase II B Graphical Presentation of Landfill Gas Measurement	Scale N.T.S	Project No. MA0010	CINOTECH
	Date Mar 13	Appendix G

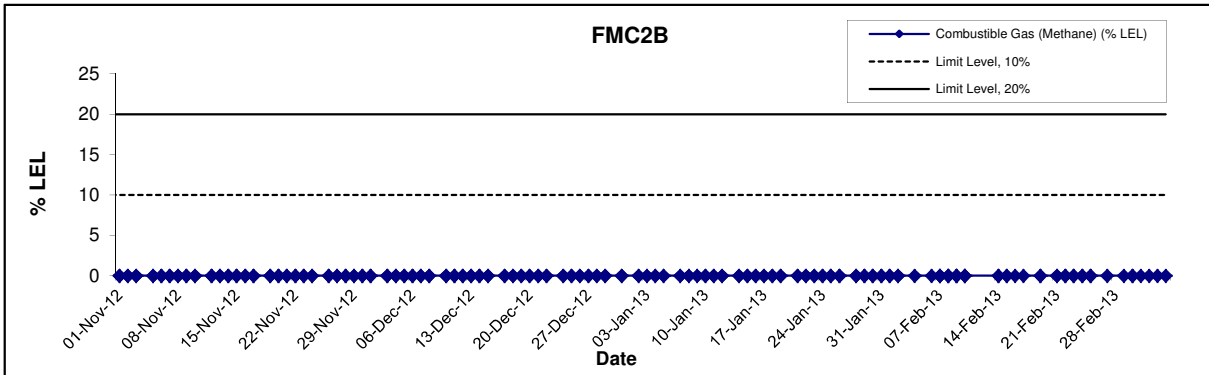
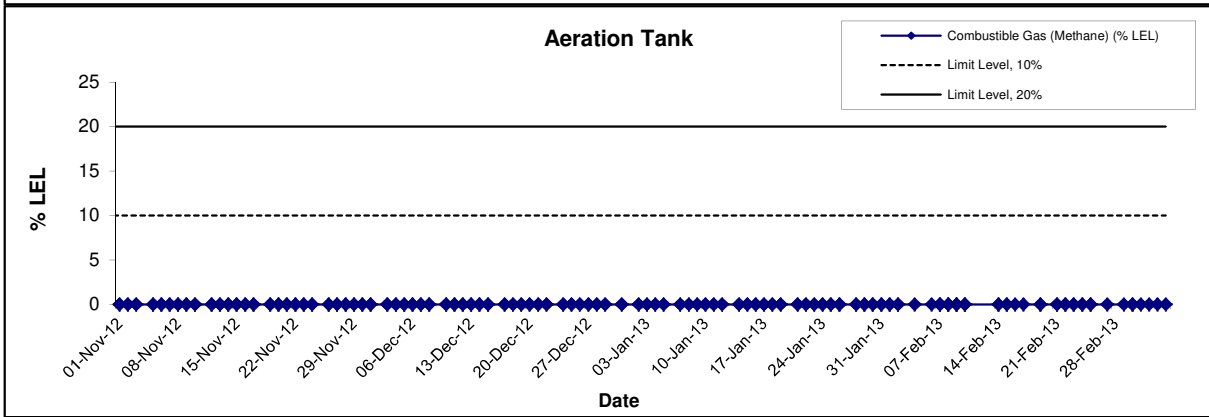
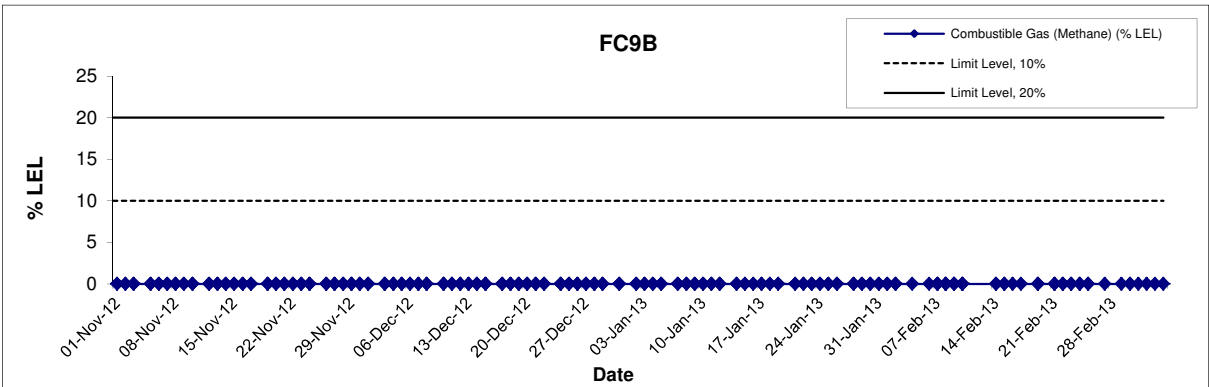
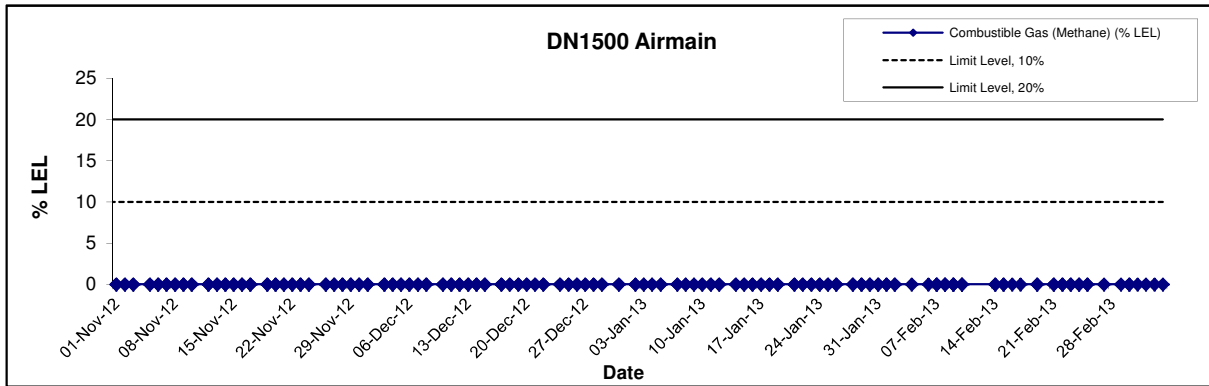
Combustible Gas (Methane)

Title Contract No. DC/2009/09
 Construction of Tai Po Sewage Treatment Works - Stage V Phase II B
 Graphical Presentation of Landfill Gas Measurement

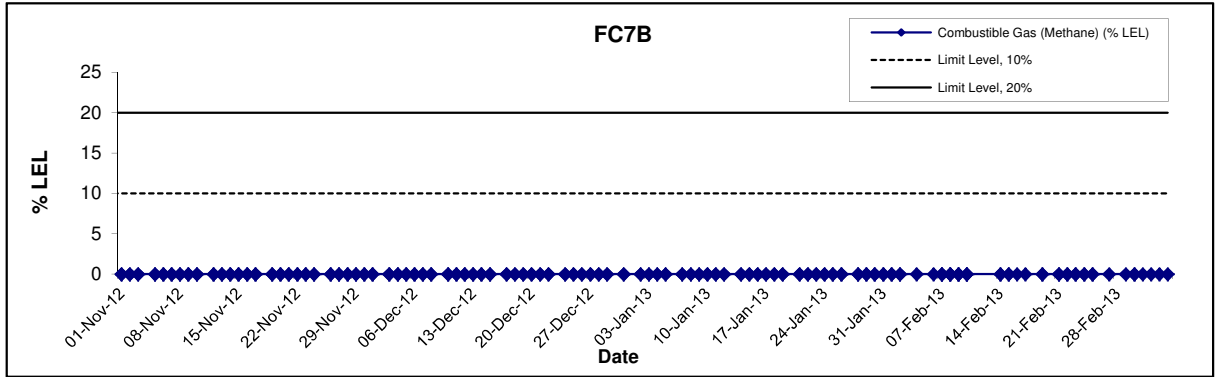
Combustible Gas (Methane)

Title Contract No. DC/2009/09 Construction of Tai Po Sewage Treatment Works - Stage V Phase II B Graphical Presentation of Landfill Gas Measurement	Scale N.T.S	Project No. MA0010	
	Date Mar 13	Appendix G

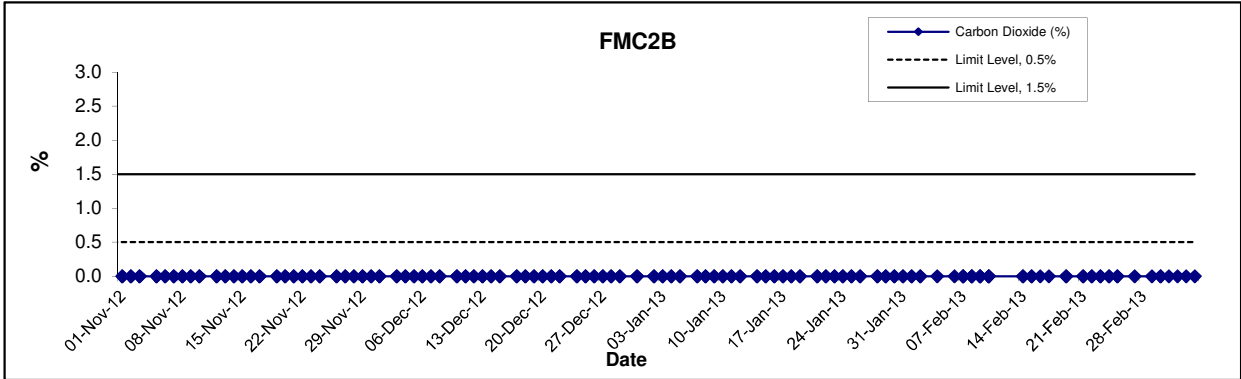
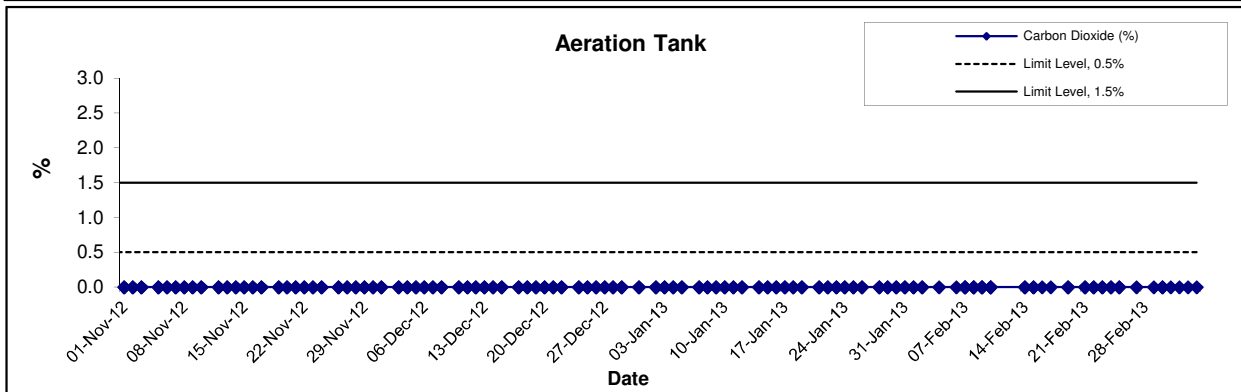
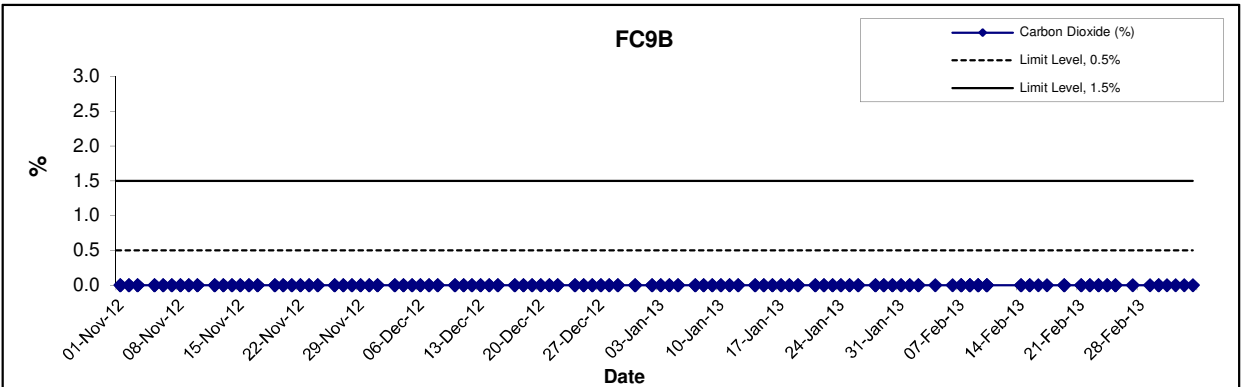
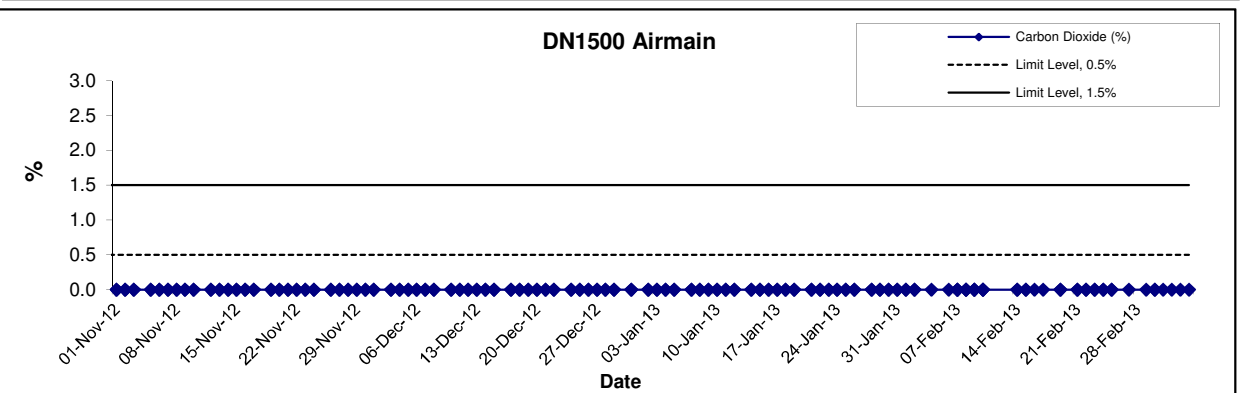
Carbon Dioxide

Title Contract No. DC/2009/09
 Construction of Tai Po Sewage Treatment Works - Stage V Phase II B
 Graphical Presentation of Landfill Gas Measurement

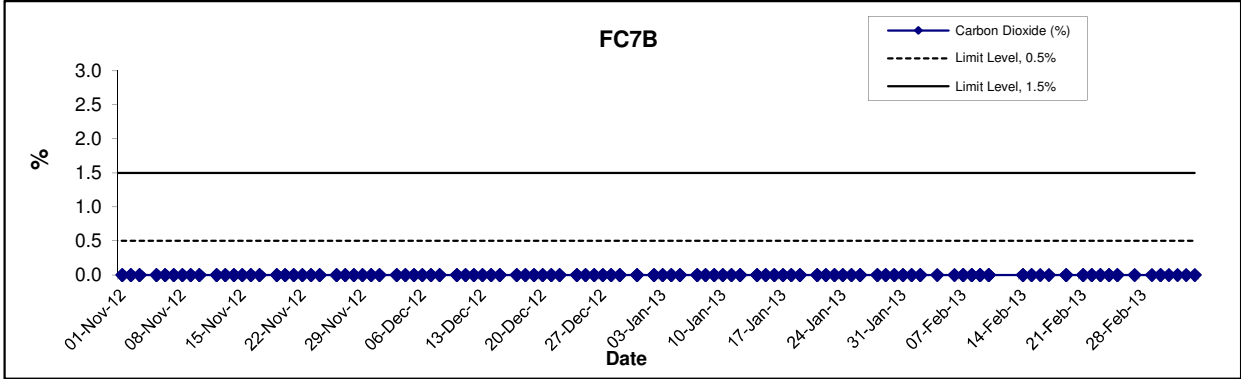
Carbon Dioxide

Title Contract No. DC/2009/09 Construction of Tai Po Sewage Treatment Works - Stage V Phase II B Graphical Presentation of Landfill Gas Measurement	Scale N.T.S	Project No. MA0010	
	Date Mar 13	Appendix G
