China Harbour Engineering Company Limited

Contract No. DC/2009/09
Construction of Tai Po Sewage Treatment
Works – Stage V Phase II B

**Monthly Environmental Monitoring
and Audit Report for
February 2013**

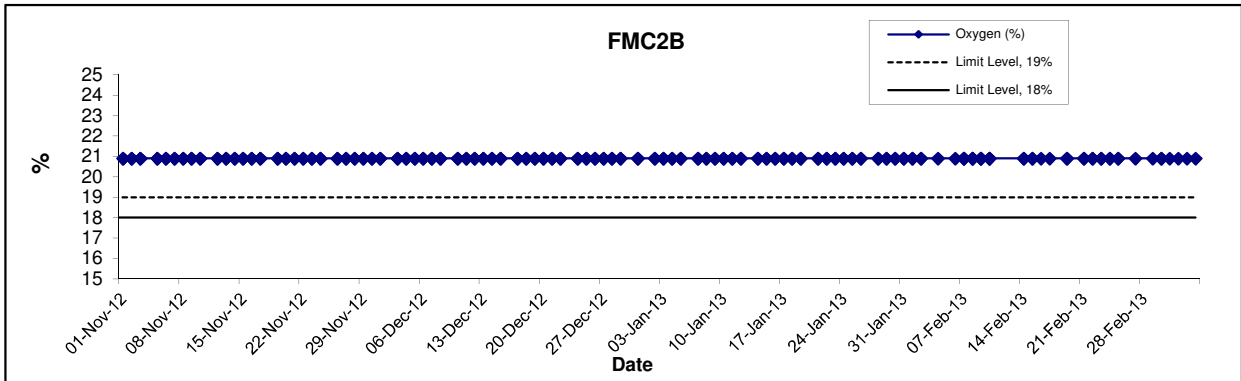
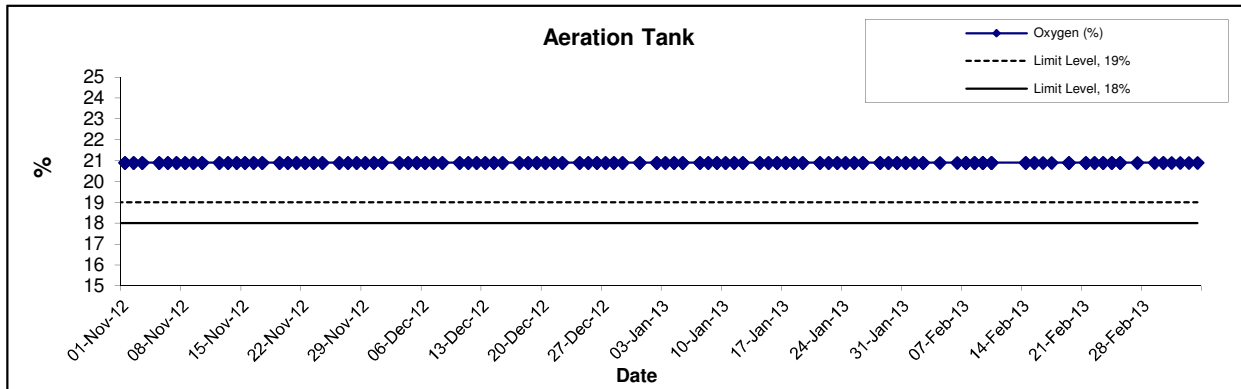
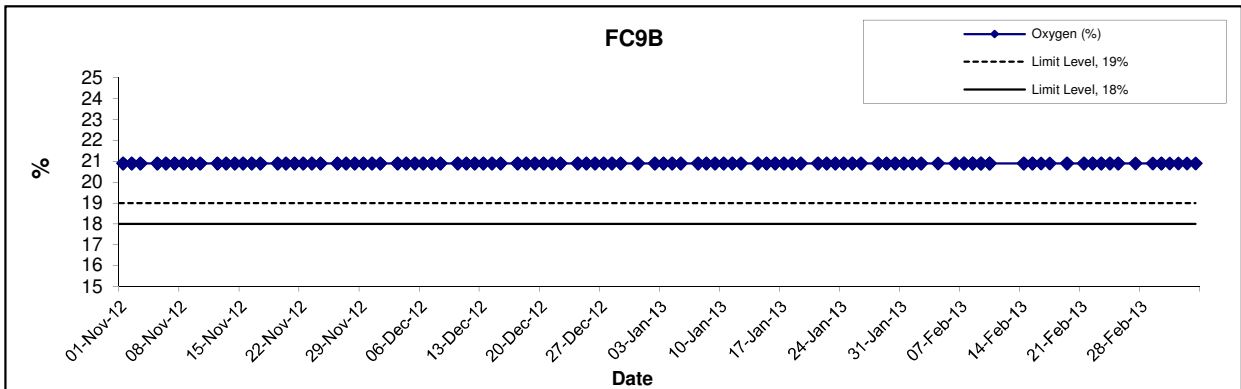
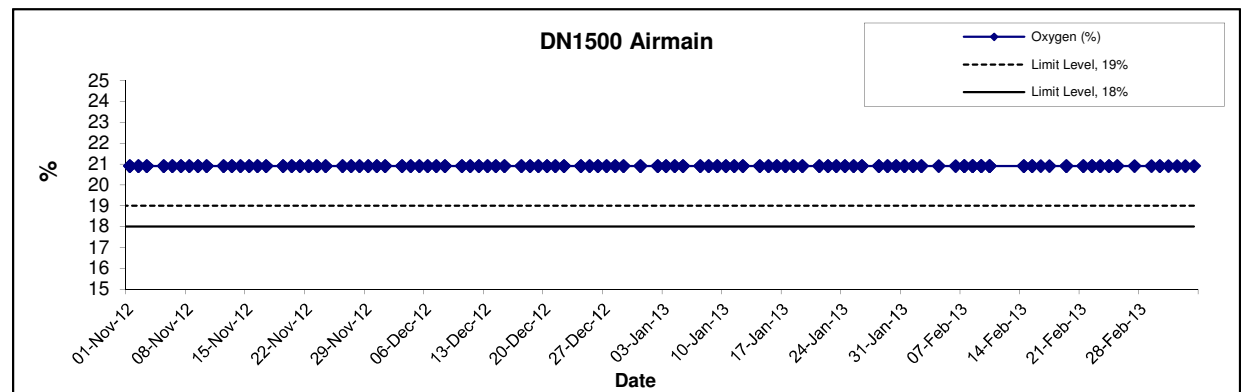
Oxygen

Title
 Contract No. DC/2009/09
 Construction of Tai Po Sewage Treatment Works - Stage V Phase II B
 Graphical Presentation of Landfill Gas Measurement

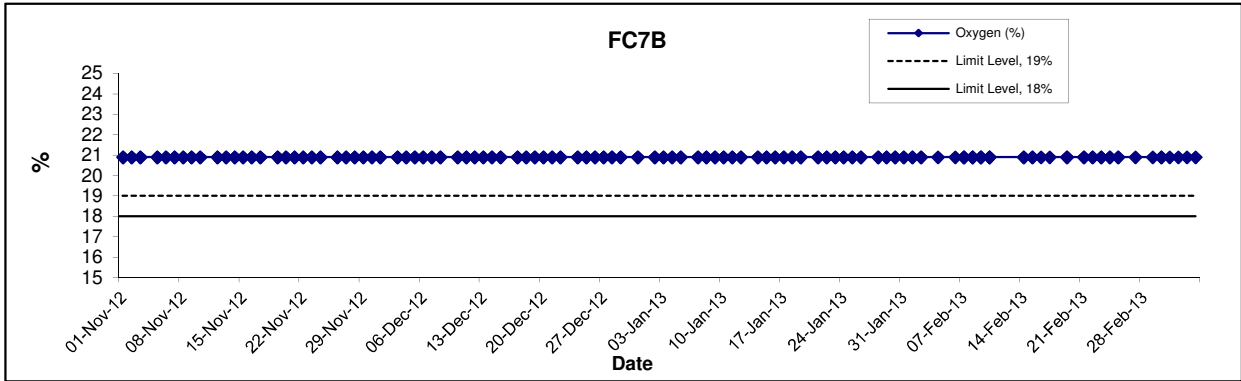
Oxygen

Title Contract No. DC/2009/09 Construction of Tai Po Sewage Treatment Works - Stage V Phase II B Graphical Presentation of Landfill Gas Measurement	Scale N.T.S	Project No. MA0010	
	Date Mar 13	Appendix G
