Contract No. DE/2009/09  
Supply and Installation of Electrical and  
Mechanical Equipment for Tai Po Sewage  
Treatment Works Stage 5 Phase 2B

**Monthly Environmental Monitoring  
and Audit Report for  
July 2013**

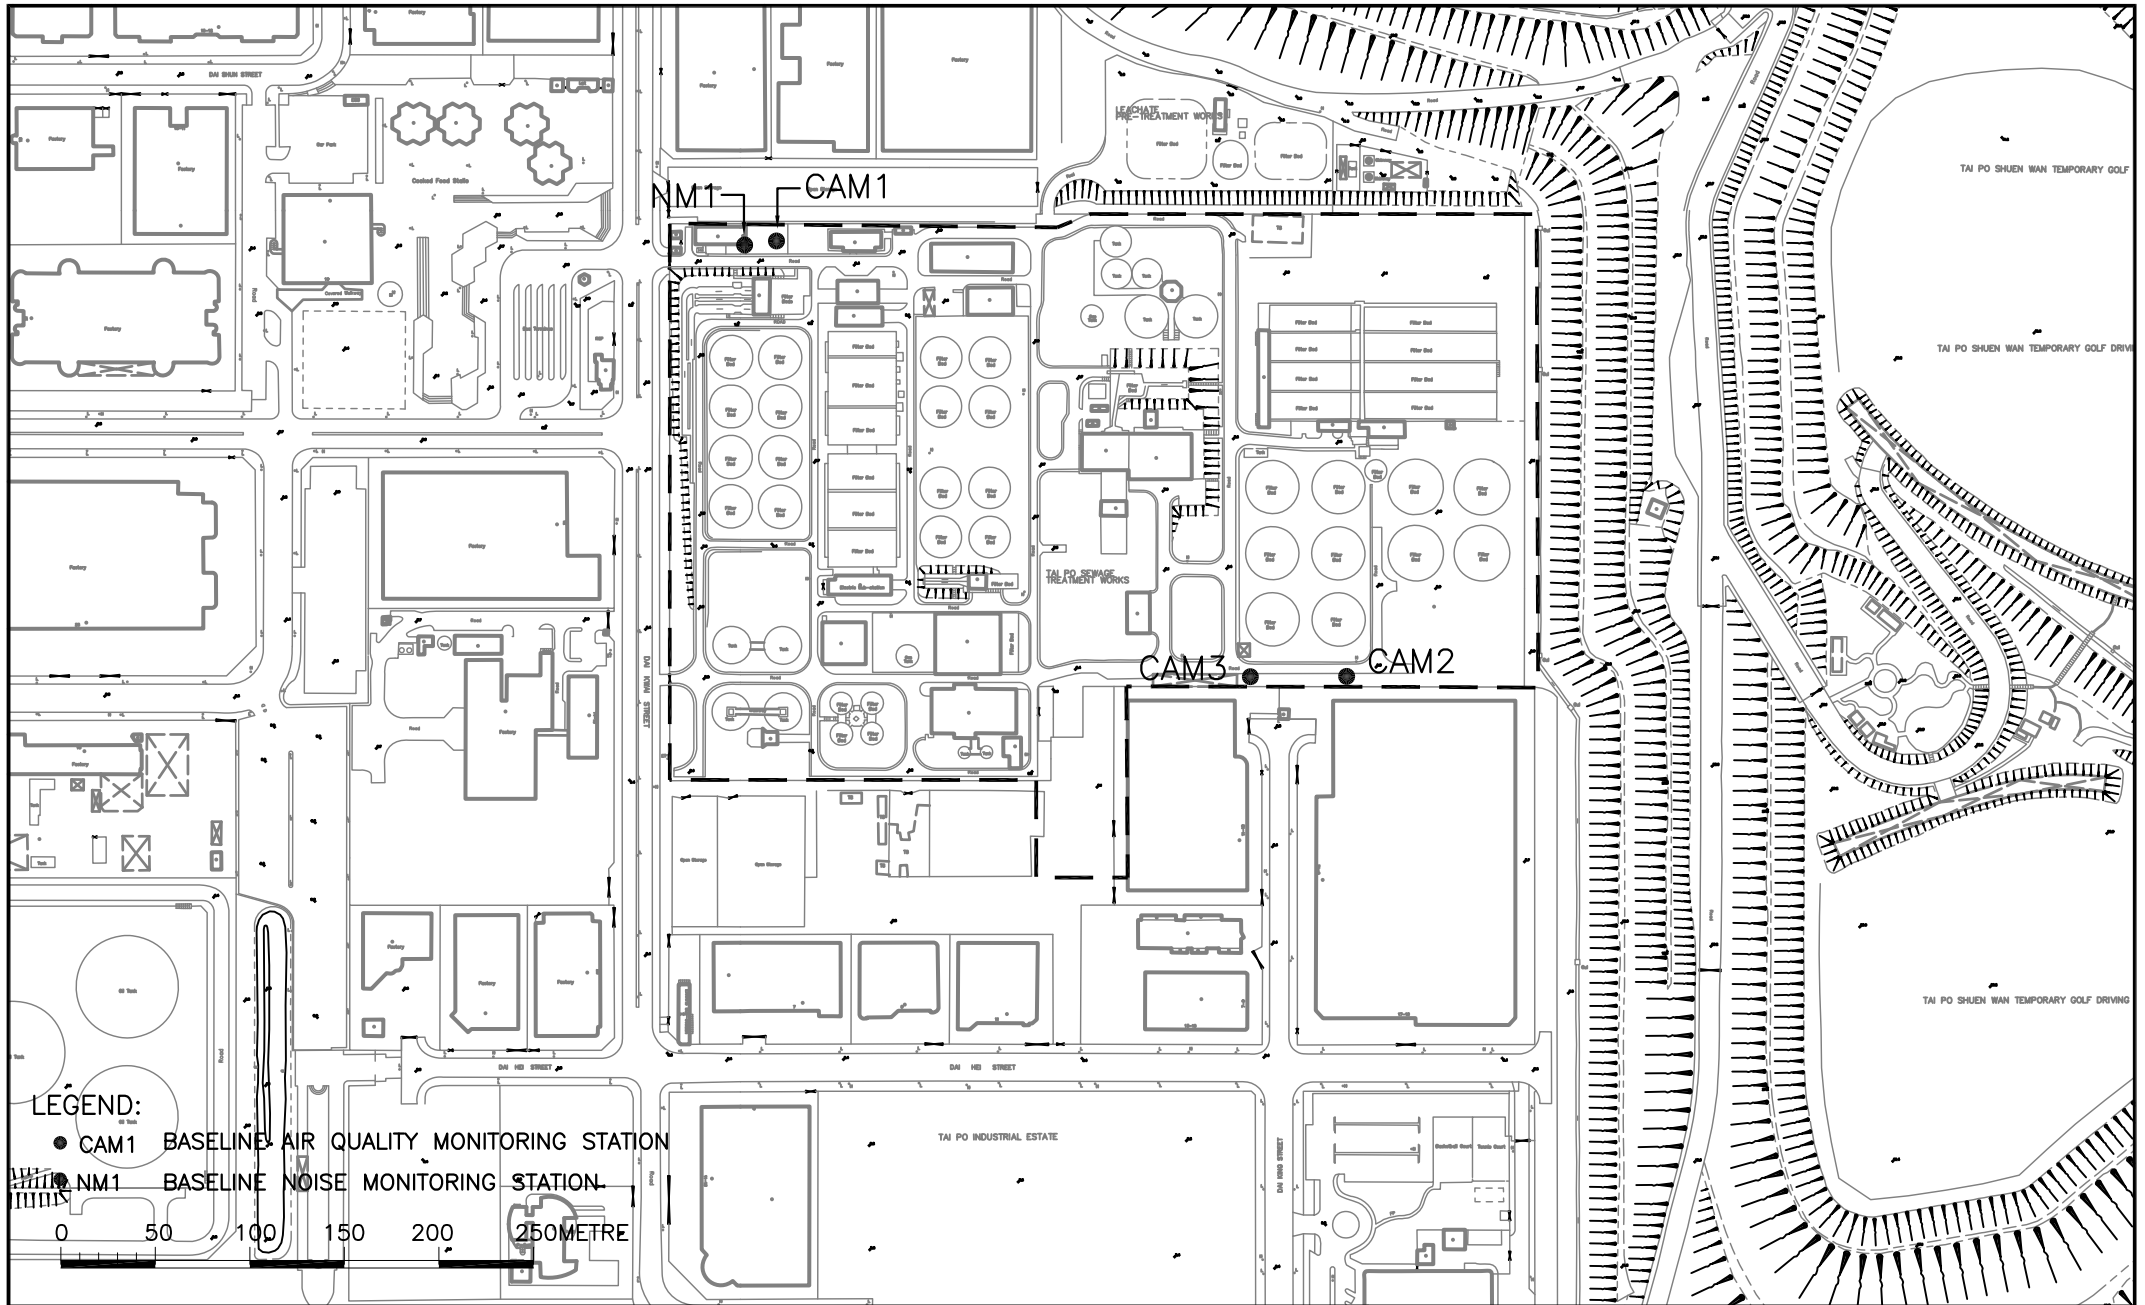
LOCATIONS OF AIR QUALITY AND NOISE MONITORING STATIONS
