Contract No. DC/2009/09
Construction of Tai Po Sewage Treatment
Works – Stage V Phase II B

Monthly Environmental Monitoring and Audit Report for April 2014

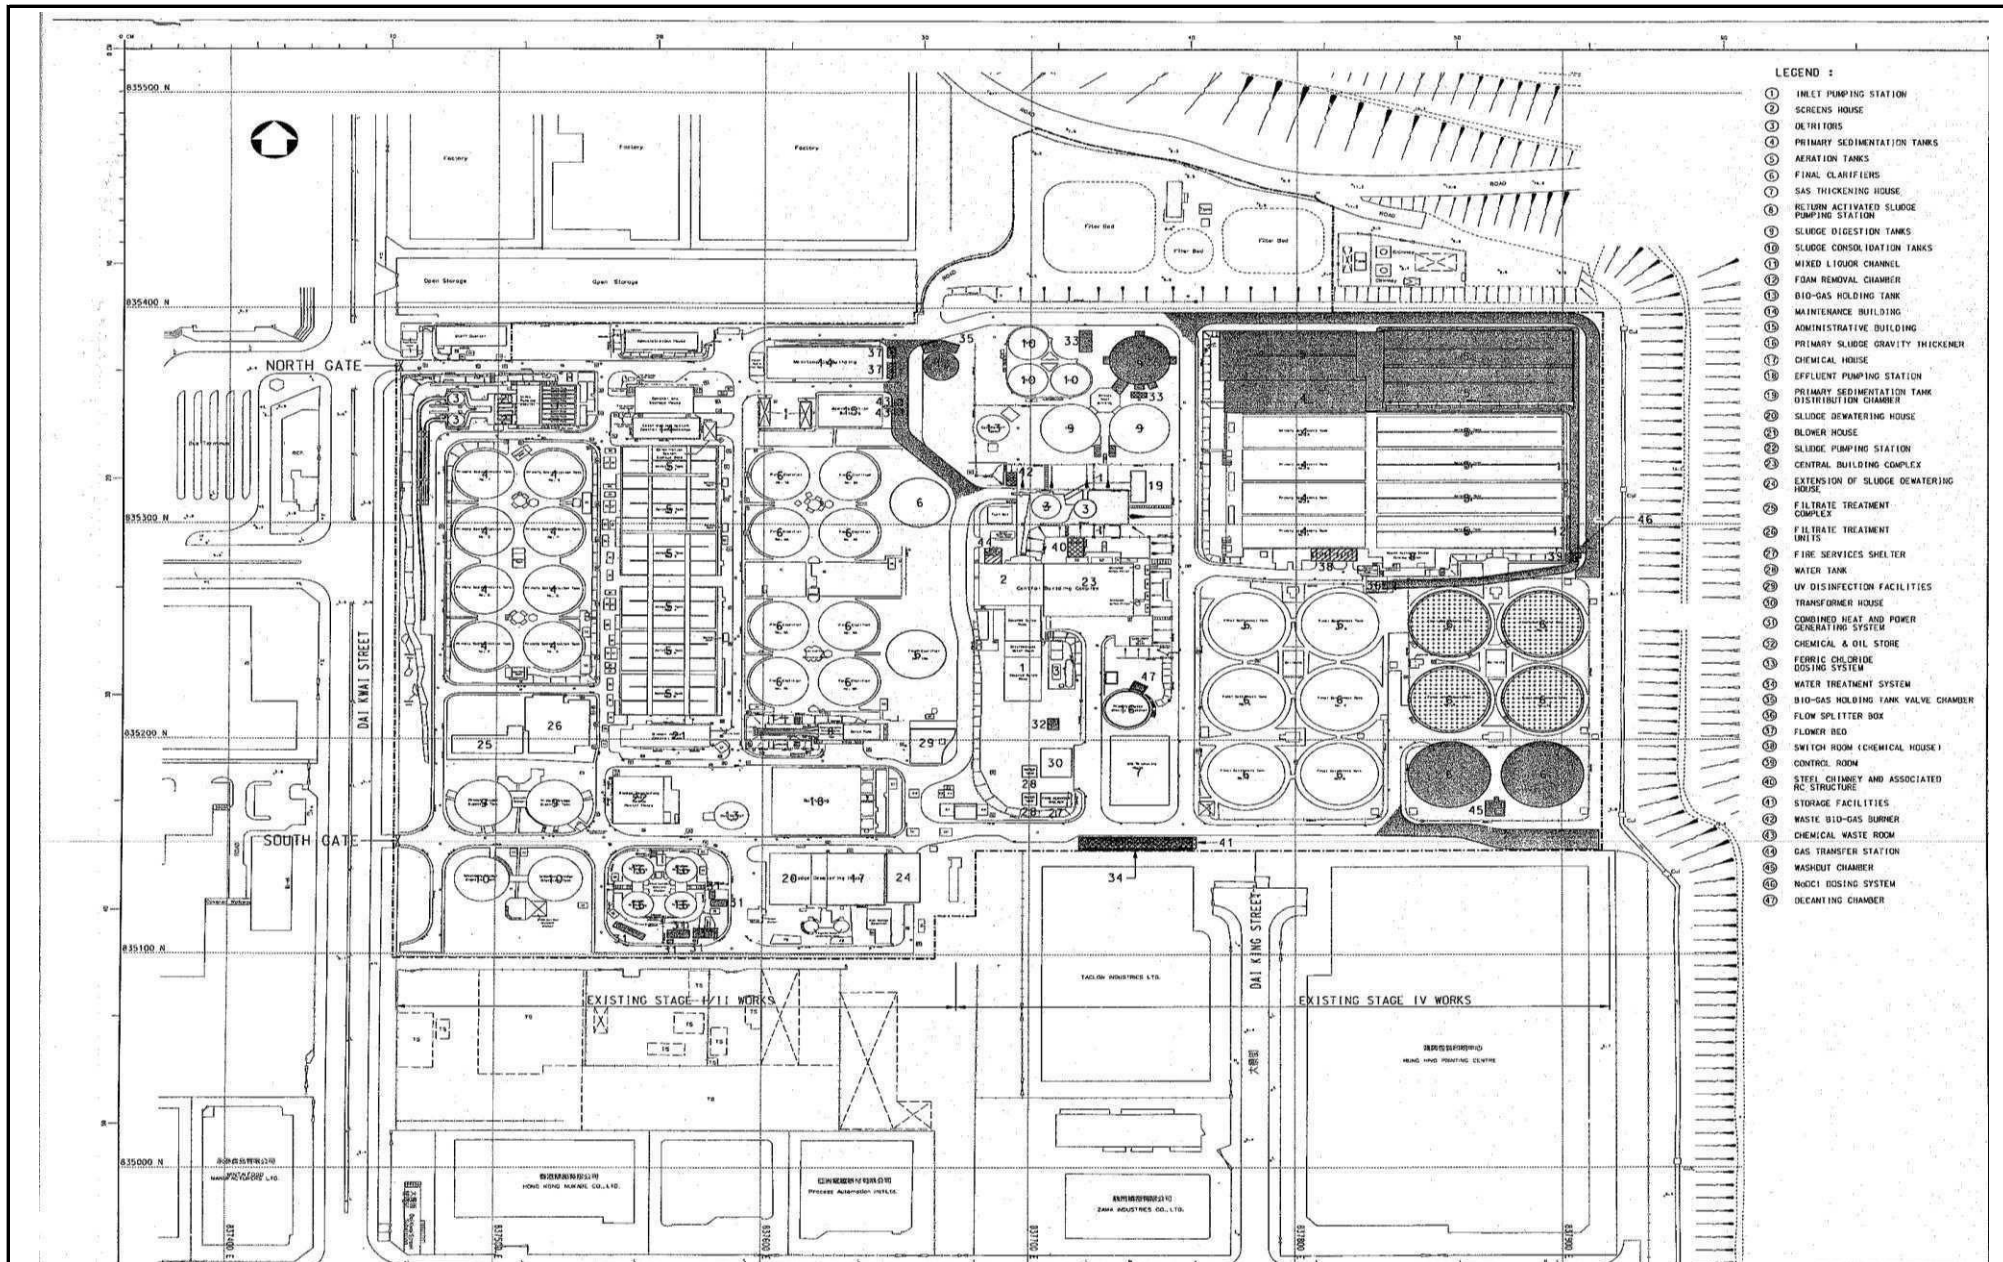
Scale	N.T.S	Project No.	MA0010	CINOTECH
Date	Jul-10	Figure	1.1

PROJECT SITE LAYOUT PLAN (TPSTW)

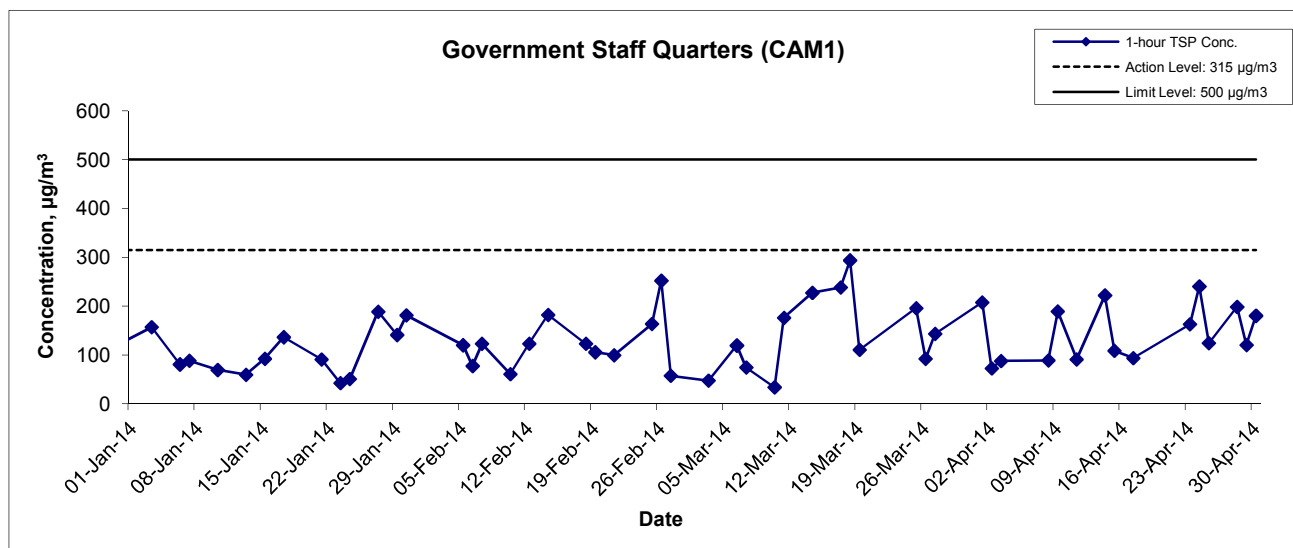
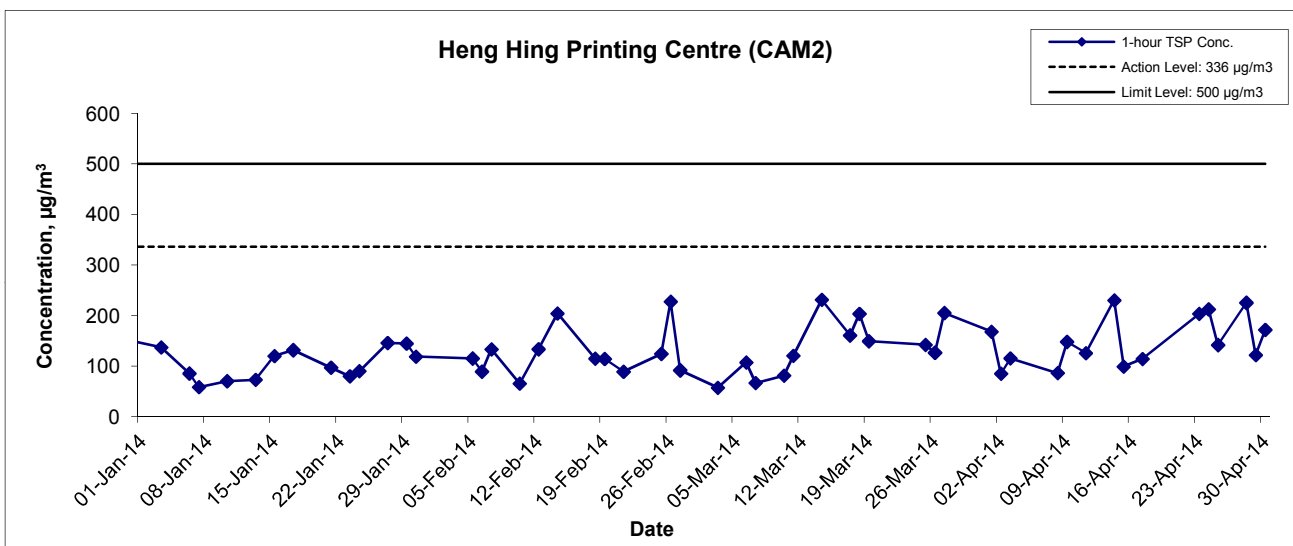
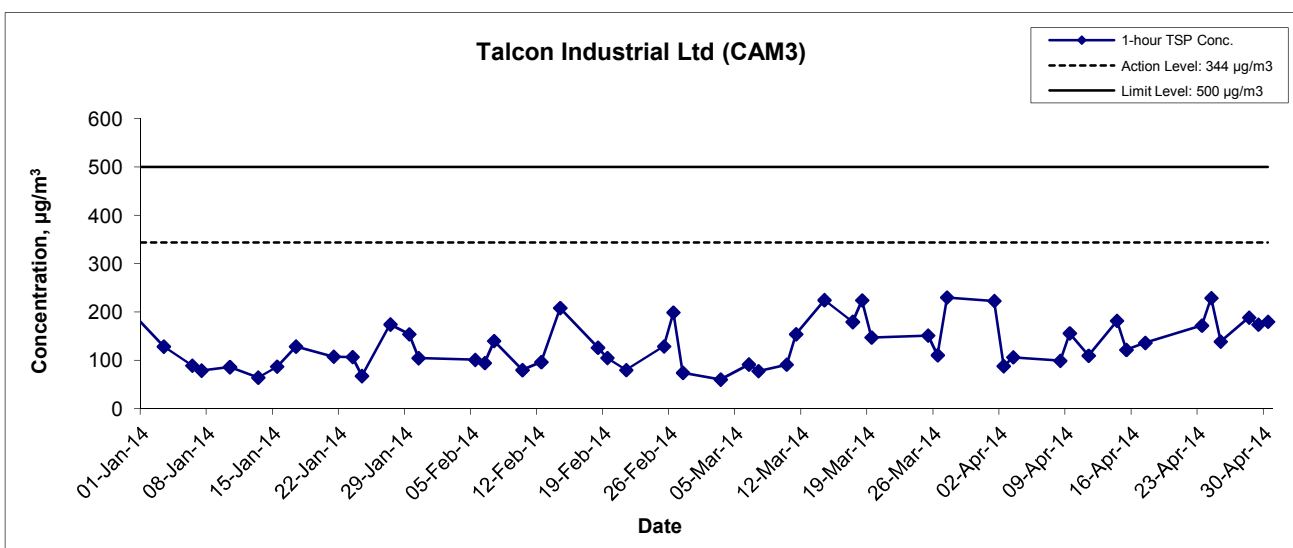
Title	Contract No. DC/2009/09	Scale	Project No. MA0010	CINOTECH
	Construction of Tai Po Sewage Treatment Works - Stage V Phase II B	N.T.S		
Graphical Presentation of 1-hour TSP Impact Monitoring Results	Date	Apr 14	Appendix D

1-hr TSP Concentration Levels

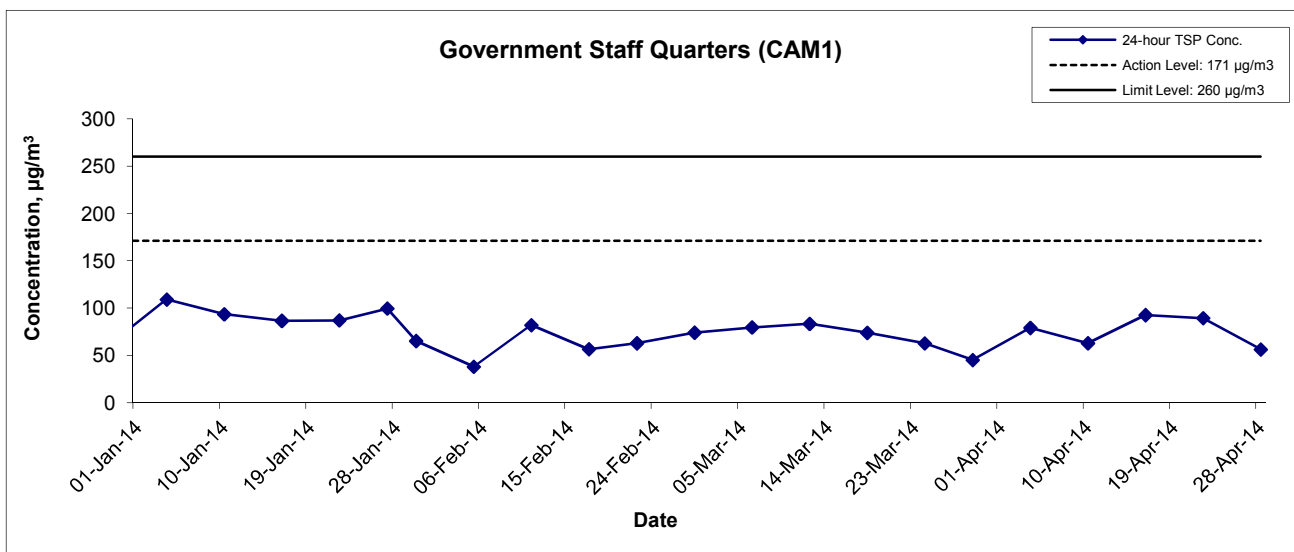
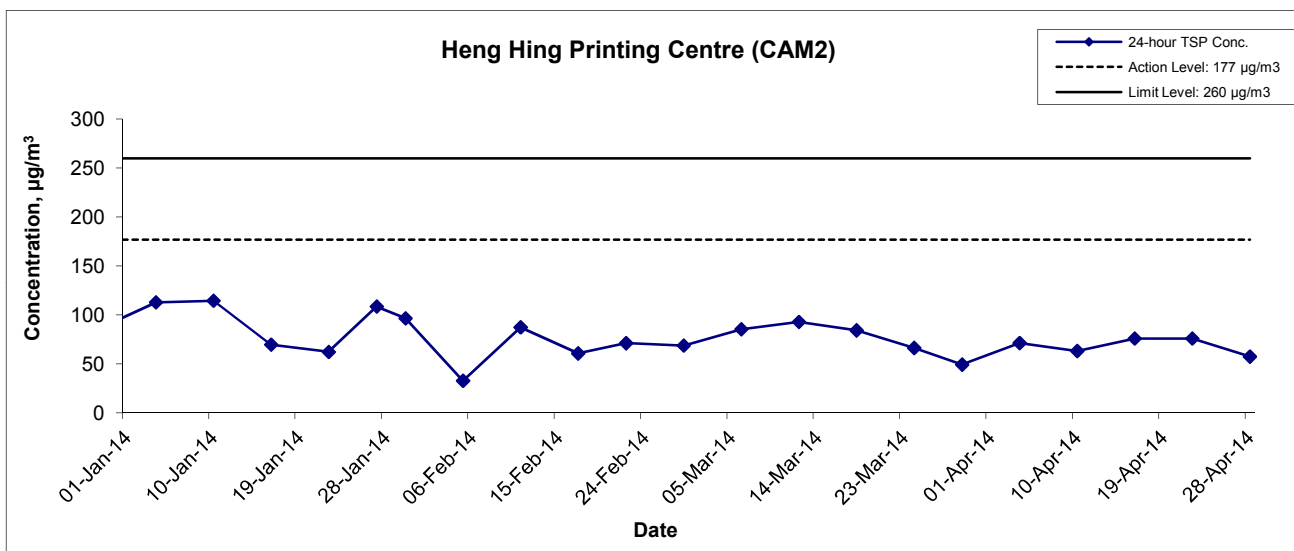
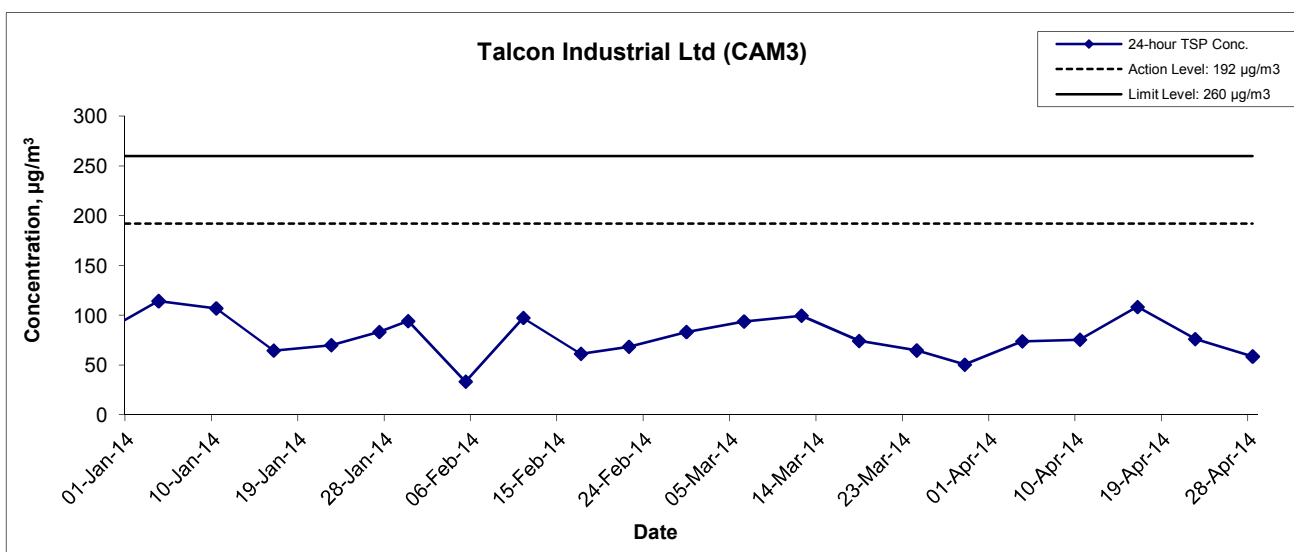
Title Contract No. DC/2009/09 Construction of Tai Po Sewage Treatment Works - Stage V Phase II B Graphical Presentation of 24-hour TSP Impact Monitoring Results	Scale N.T.S	Project No. MA0010	
	Date Apr 14	Appendix E

24-hr TSP Concentration Levels

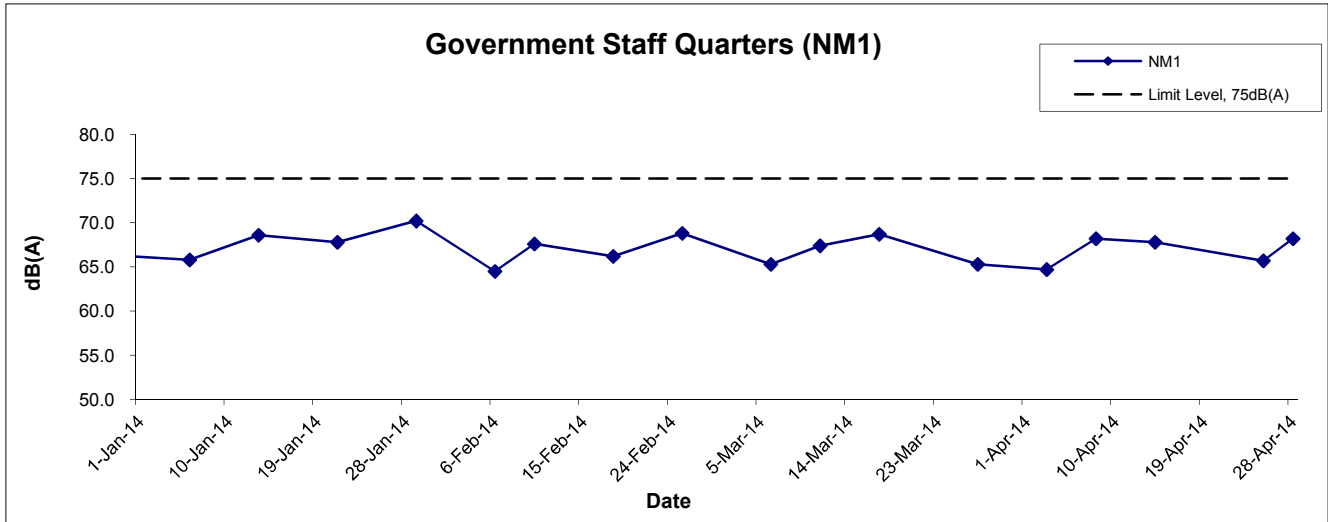
Title Contract No. DC/2009/09 Construction of Tai Po Sewage Treatment Works - Stage V Phase II B Graphical Presentation of Construction Noise Monitoring Results	Scale N.T.S	Project No. MA0010	
	Date Apr 14	Appendix F

Noise Levels
