Contract No. DC/2009/09
Construction of Tai Po Sewage Treatment
Works – Stage V Phase II B

Monthly Environmental Monitoring and Audit Report for May 2014

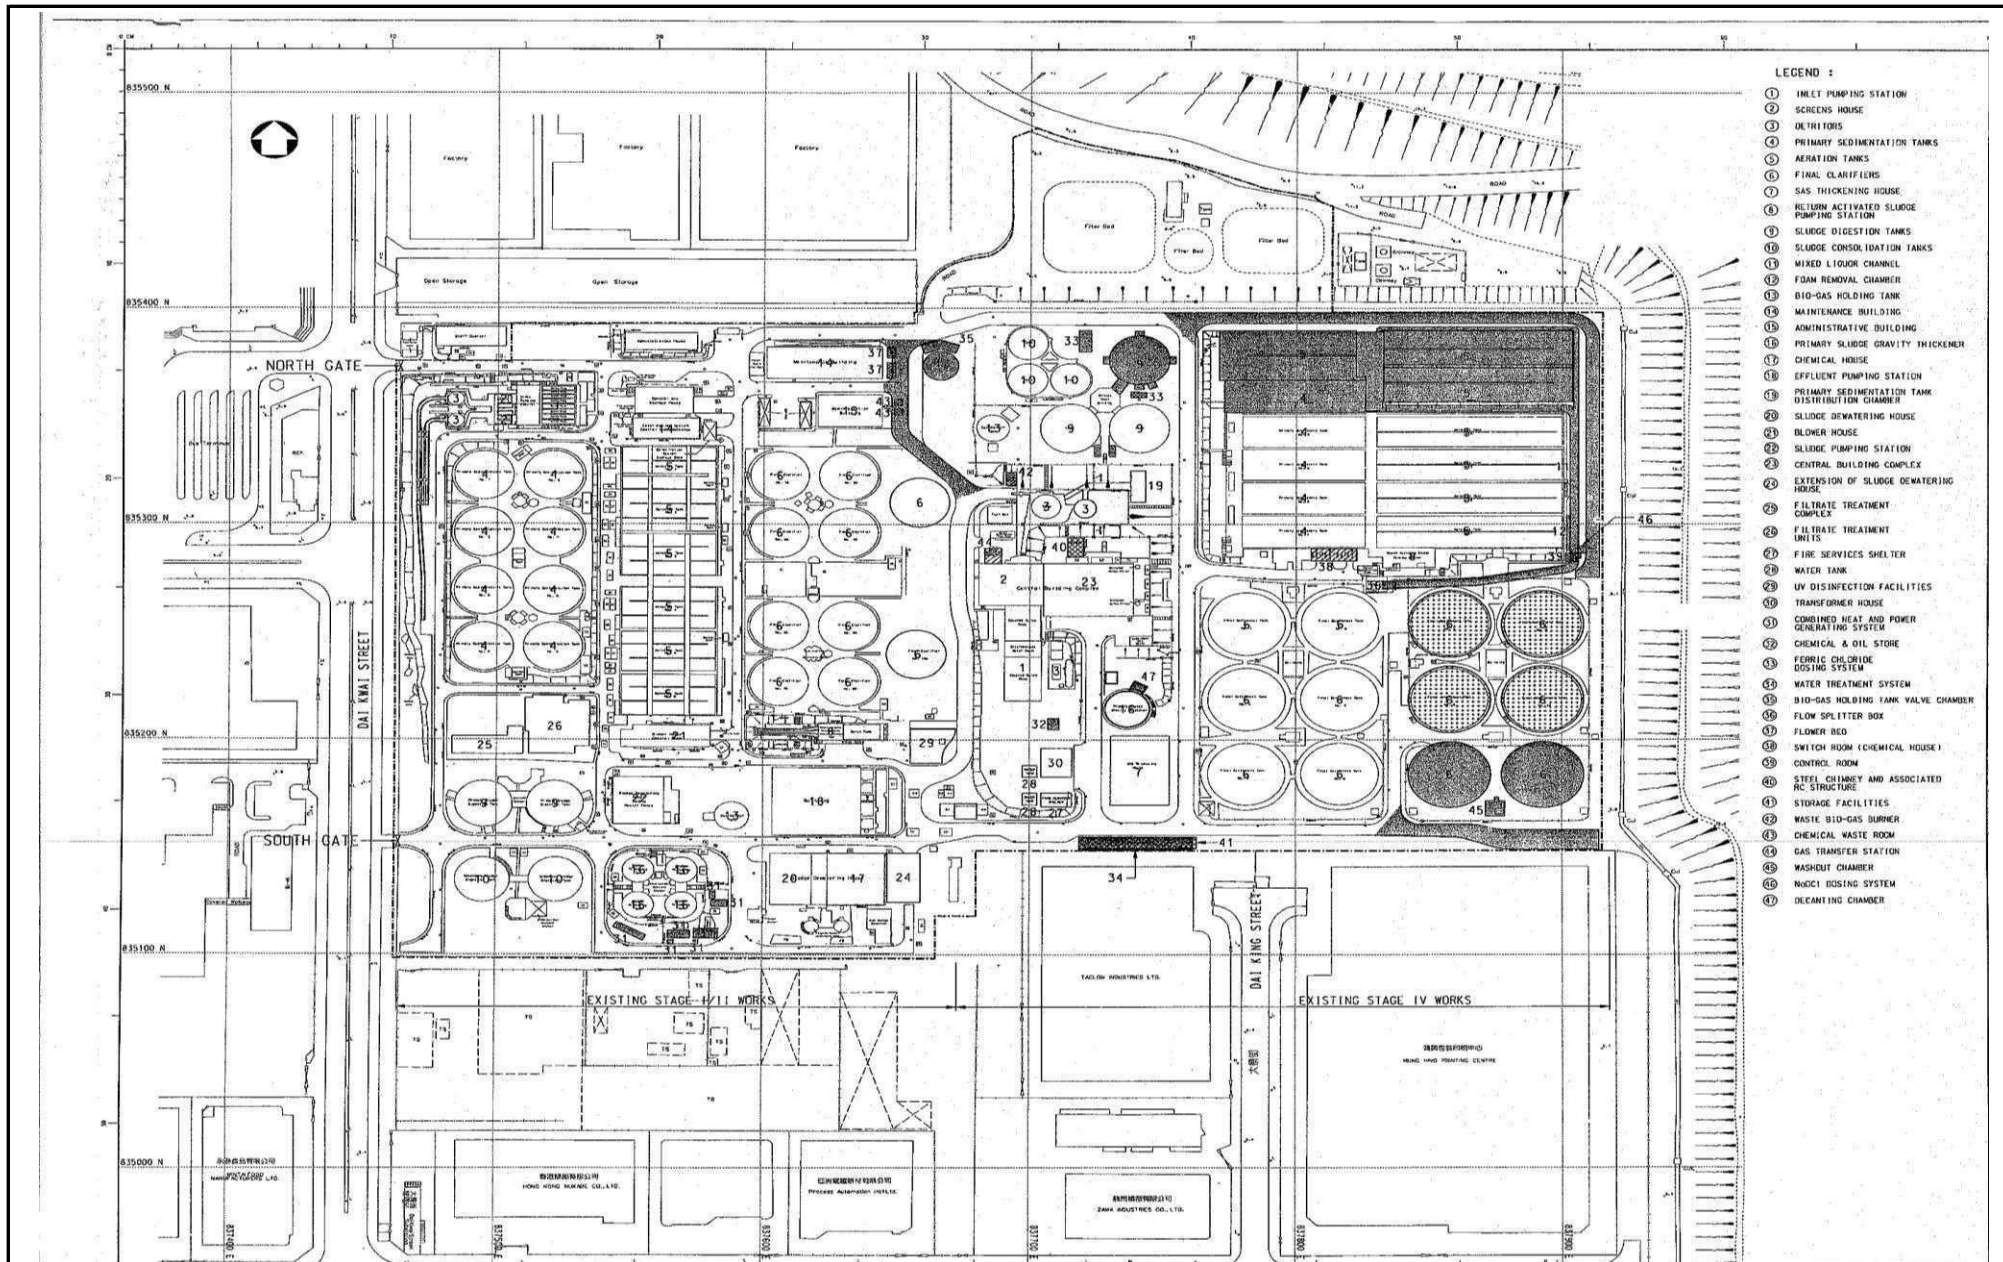
Scale	N.T.S	Project No.	MA0010	CINOTECH
Date	Jul-10	Figure	1.1

- LEGEND :**
- ① TRLET PUMPING STATION
 - ② SCREENS HOUSE
 - ③ ULTRAFIORS
 - ④ PRIMARY SEDIMENTATION TANKS
 - ⑤ AERATION TANKS
 - ⑥ FINAL CLARIFIERS
 - ⑦ SAS THICKENING HOUSE

- ⑧ RETURN ACTIVATED SLUDGE PUMPING STATION
 - ⑨ SLUDGE DIGESTION TANKS
 - ⑩ SLUDGE CONSOLIDATION TANKS
 - ⑪ MIXED LIQUOR CHANNEL
 - ⑫ FDM REMOVAL CHAMBER

PROJECT SITE LAYOUT PLAN (TPSTW)

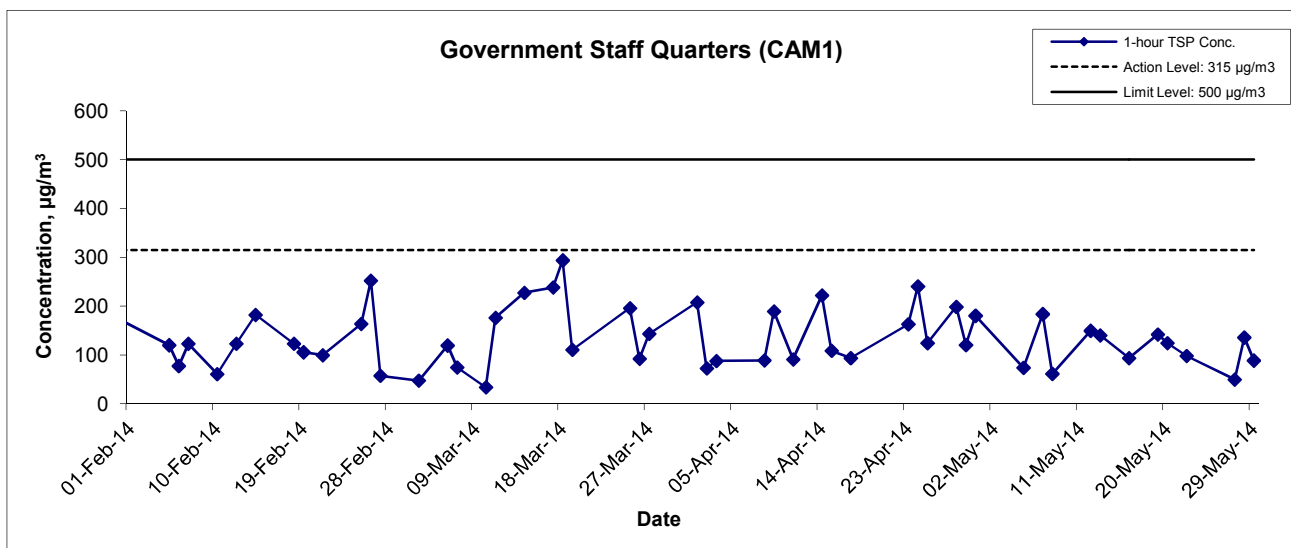
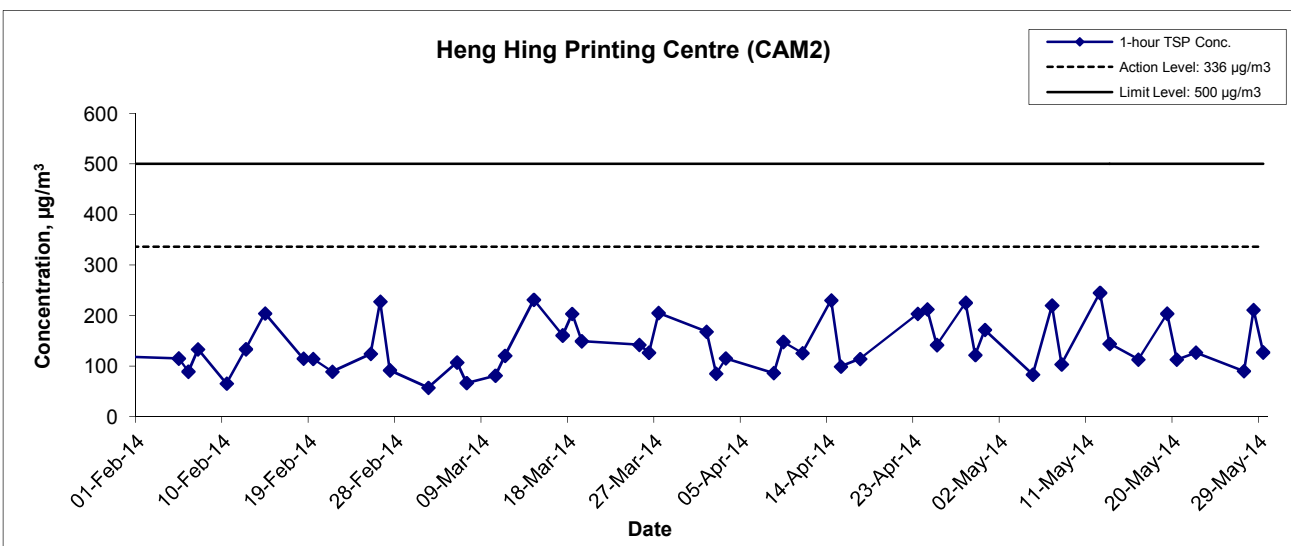
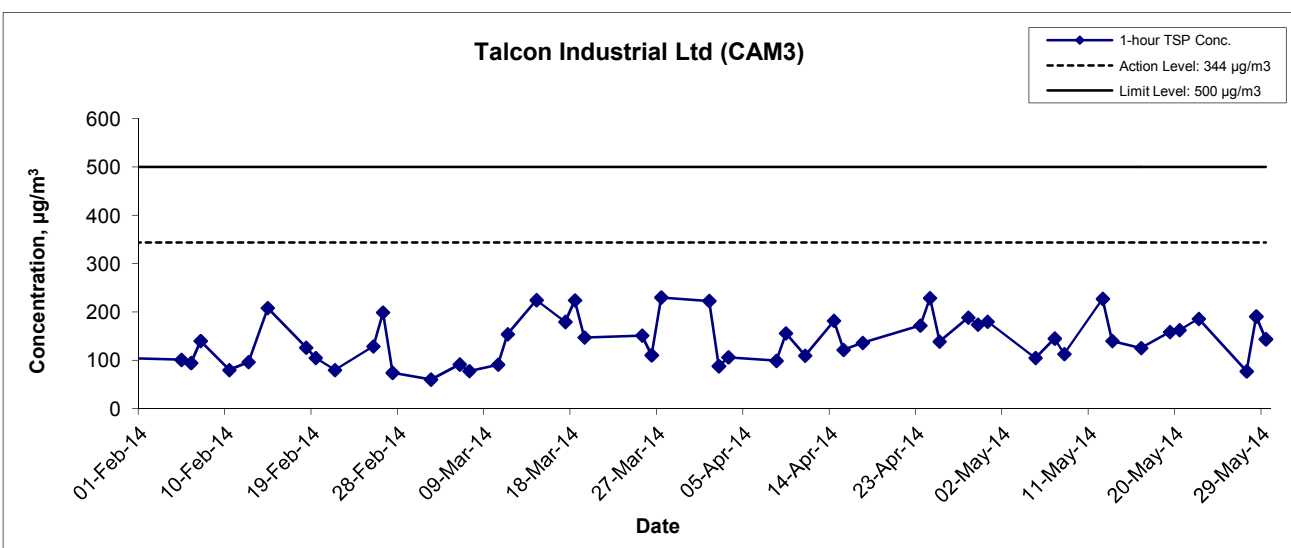
1-hr TSP Concentration Levels

Title
 Contract No. DC/2009/09
 Construction of Tai Po Sewage Treatment Works - Stage V Phase II B
 Graphical Presentation of 1-hour TSP Impact Monitoring Results

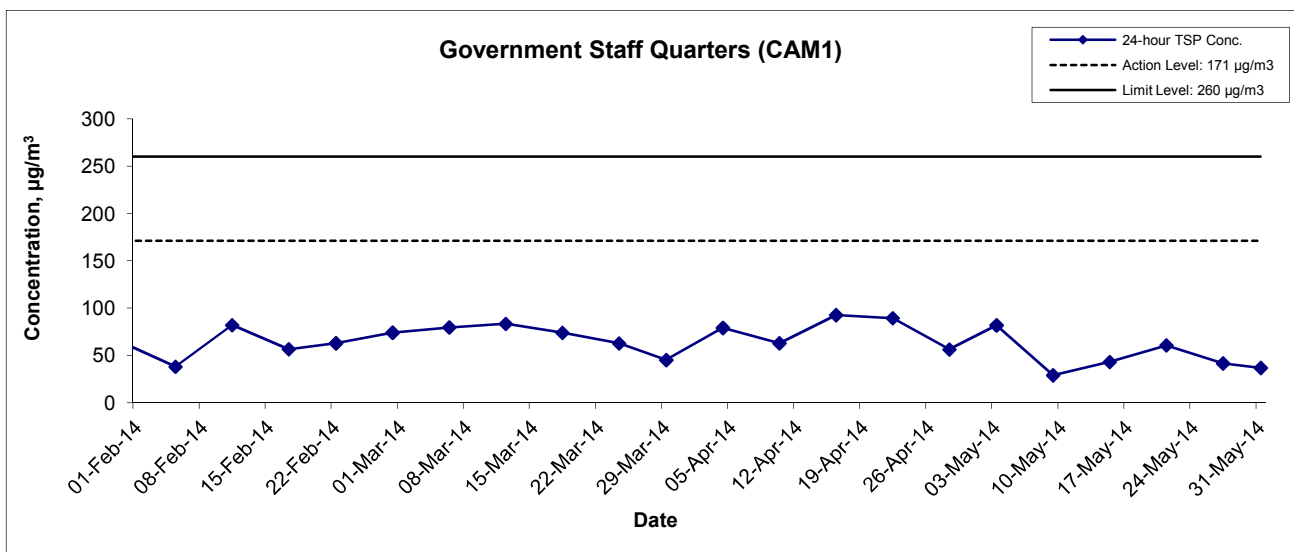
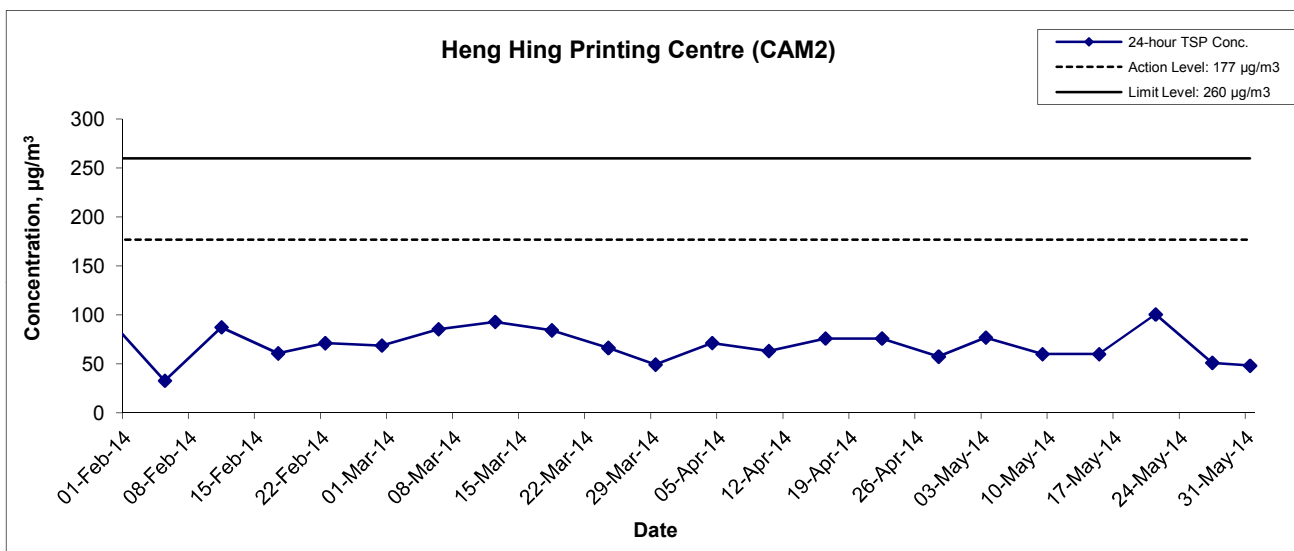
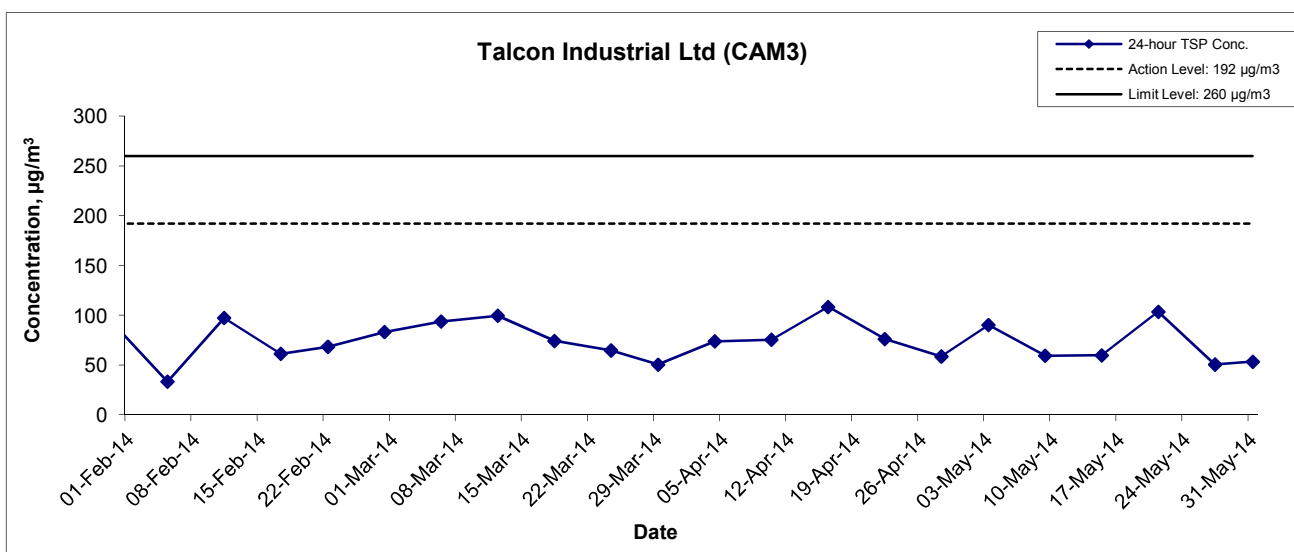
24-hr TSP Concentration Levels

Title Construction of Tai Po Sewage Treatment Works - Stage V Phase II B Graphical Presentation of 24-hour TSP Impact Monitoring Results	Contract No. DC/2009/09	Scale N.T.S	Project No. MA0010	
	Date May 14	Appendix E

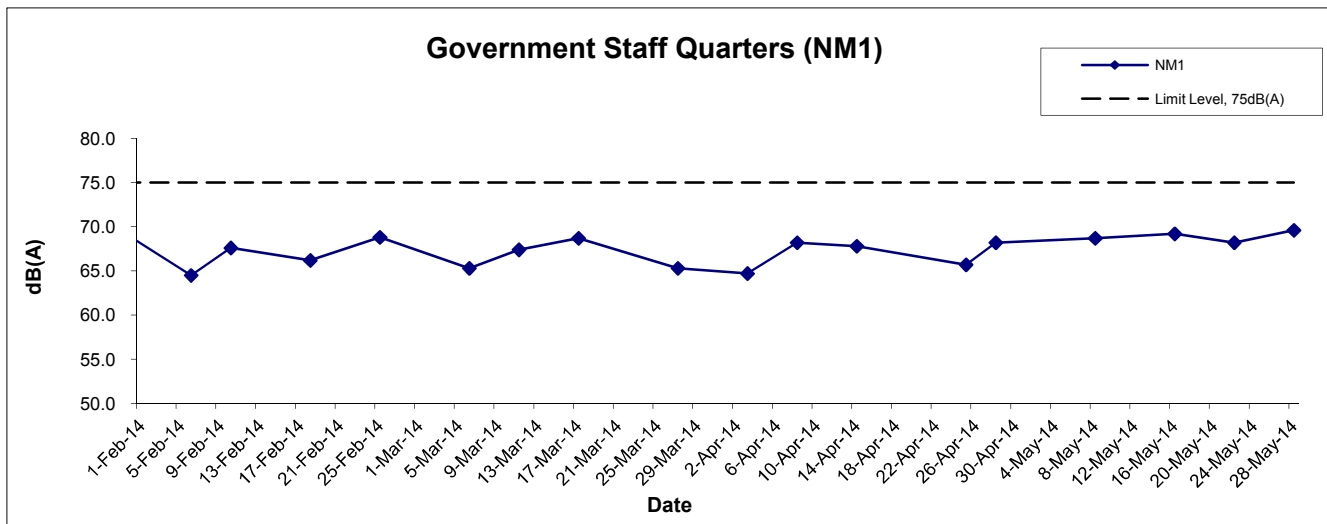
Location NM1 - Government Staff Quarters					
Date	Time	Weather	dB (A) (30-min)		
			L _{eq}	L ₁₀	L ₉₀
8-May-14	13:00	Cloudy	68.7	72.1	65.4
16-May-14	16:00	Fine	69.2	71.4	65.7
22-May-14	10:00	Cloudy	68.2	71.3	65.1
28-May-14	11:30	Sunny	69.6	71.7	65.3
		Average	69.0	71.6	65.4
		Minimum	68.2	71.3	65.1
		Maximum	69.6	72.1	65.7

Noise Levels

Title Contract No. DC/2009/09 Construction of Tai Po Sewage Treatment Works - Stage V Phase II B Graphical Presentation of Construction Noise Monitoring Results	Scale N.T.S	Project No. MA0010	
	Date May 14	Appendix F
