Contract No. DE/2009/09
Supply and Installation of Electrical and
Mechanical Equipment for Tai Po Sewage
Treatment Works Stage 5 Phase 2B

Monthly Environmental Monitoring and Audit Report for June 2014

(Version 2.0)

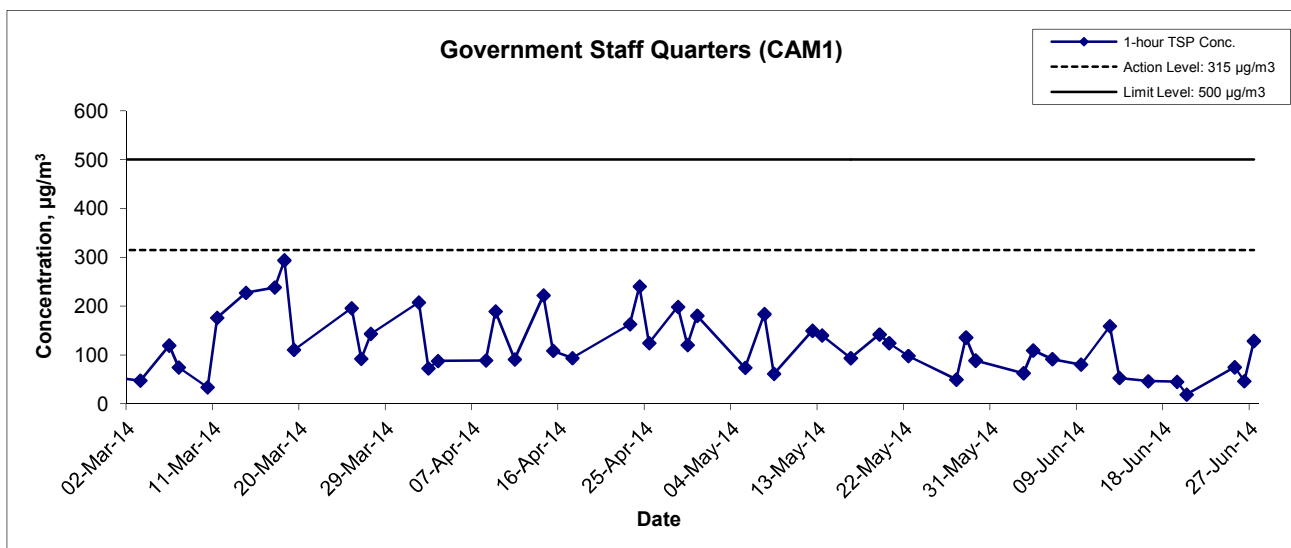
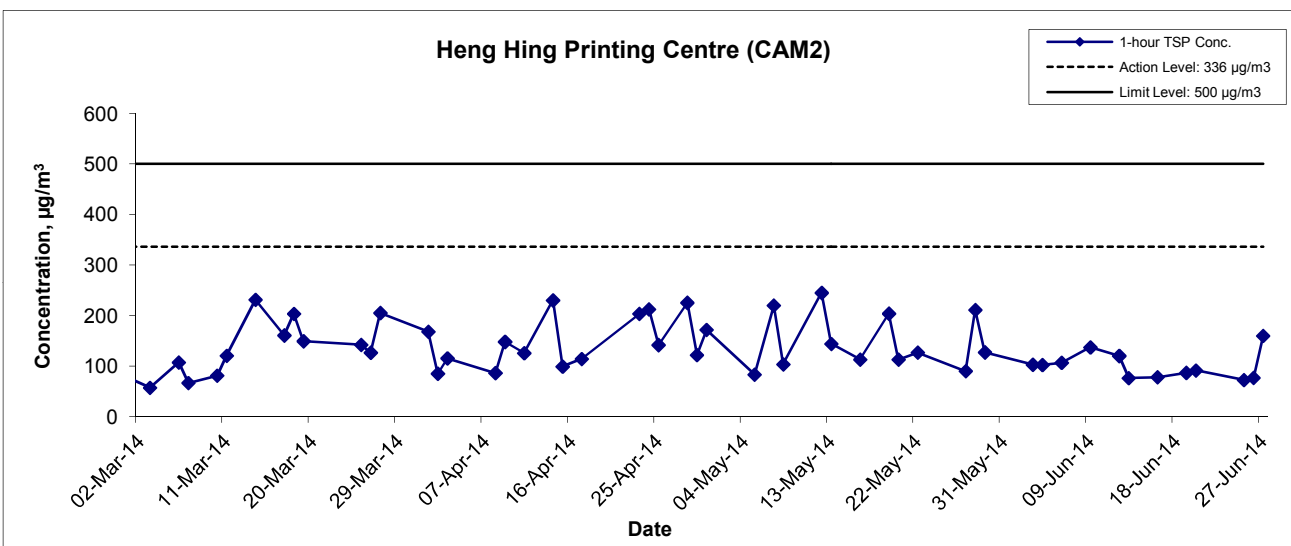
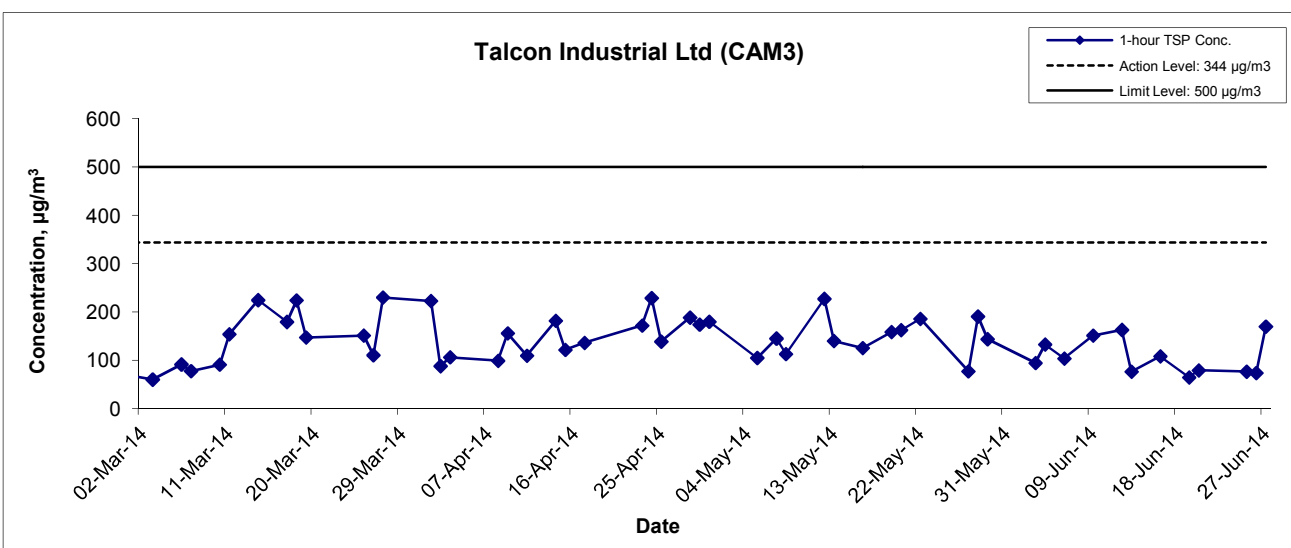
1-hr TSP Concentration Levels

Title Contract No. DC/2009/09 Construction of Tai Po Sewage Treatment Works - Stage V Phase II B Graphical Presentation of 1-hour TSP Impact Monitoring Results	Scale N.T.S	Project No. MA0010	
	Date Jun 14	Appendix D

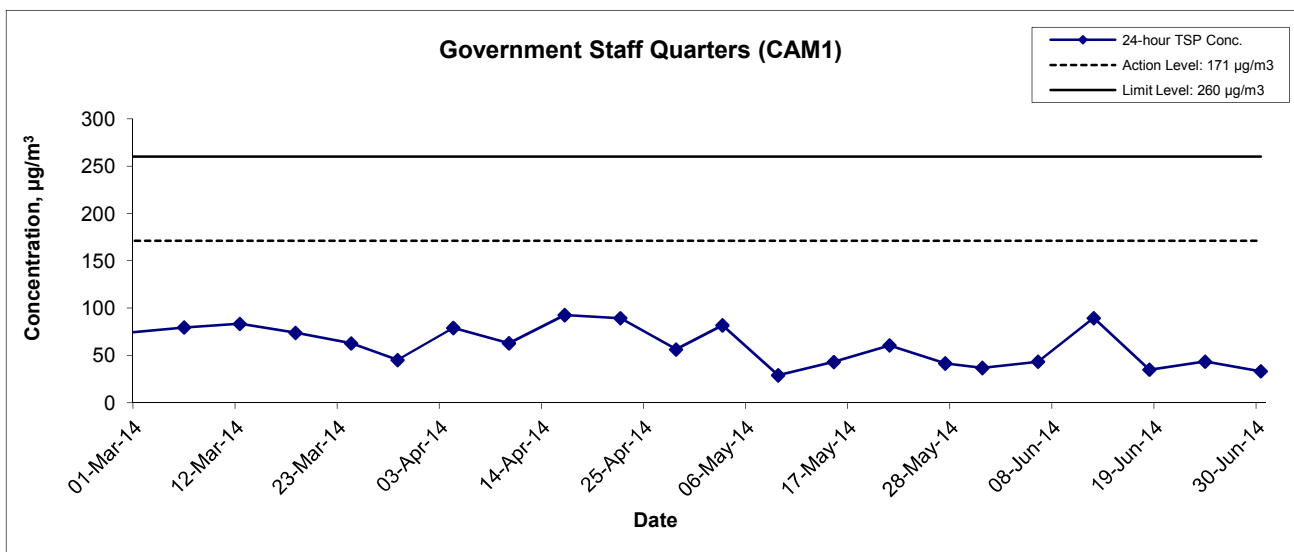
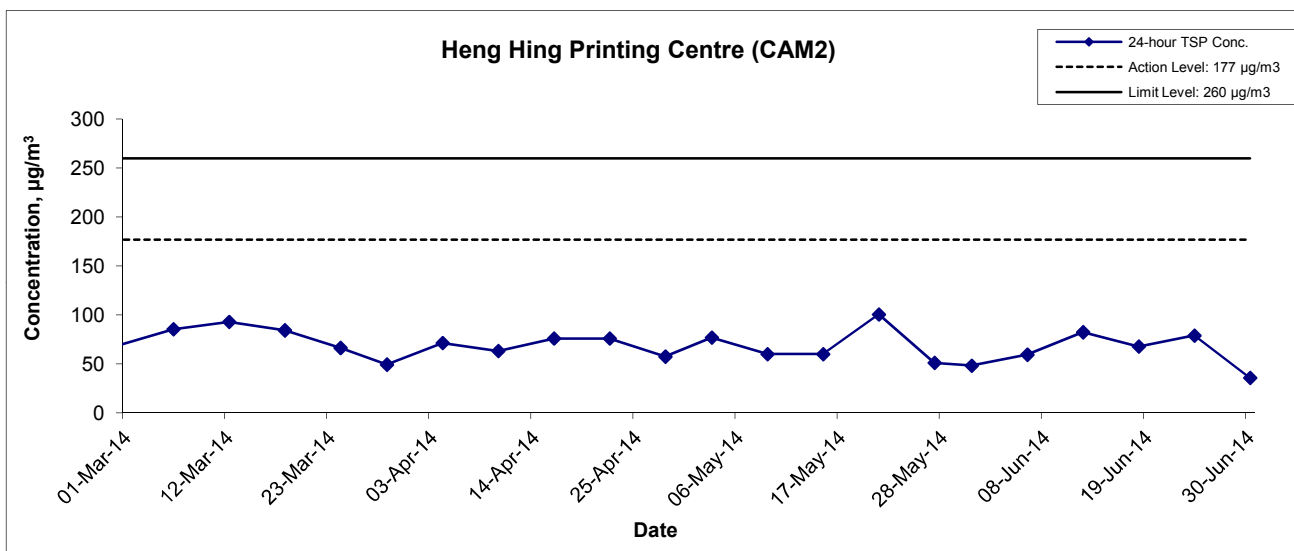
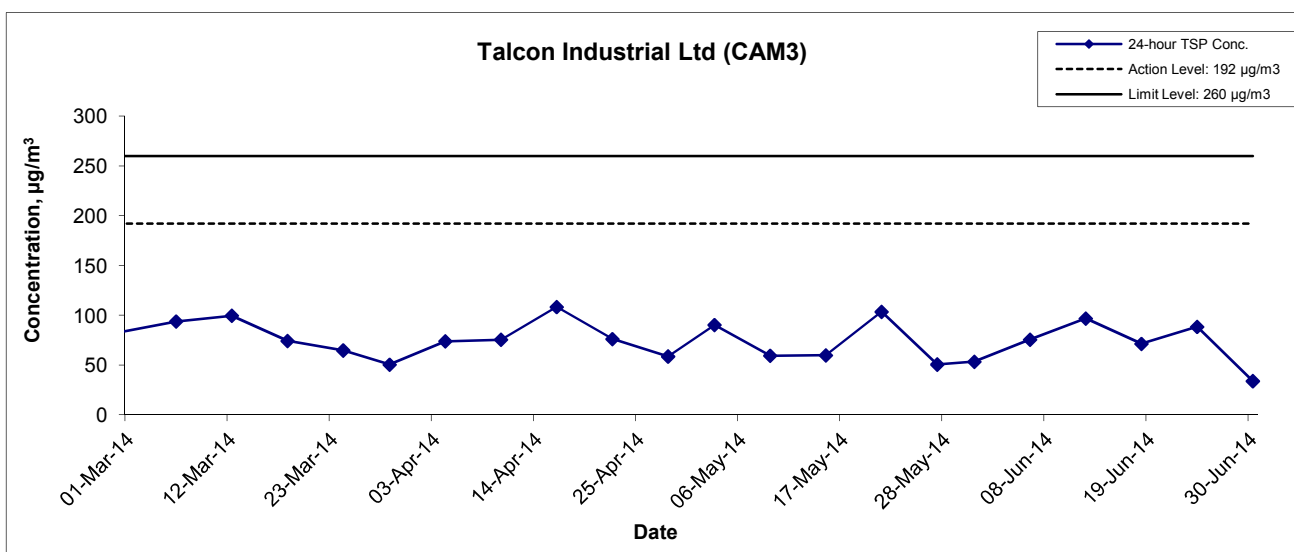
24-hr TSP Concentration Levels

Title Contract No. DC/2009/09 Construction of Tai Po Sewage Treatment Works - Stage V Phase II B Graphical Presentation of 24-hour TSP Impact Monitoring Results	Scale	Project No.	
	Date	Appendix	
	N.T.S	MA0010	
	Jun 14	E

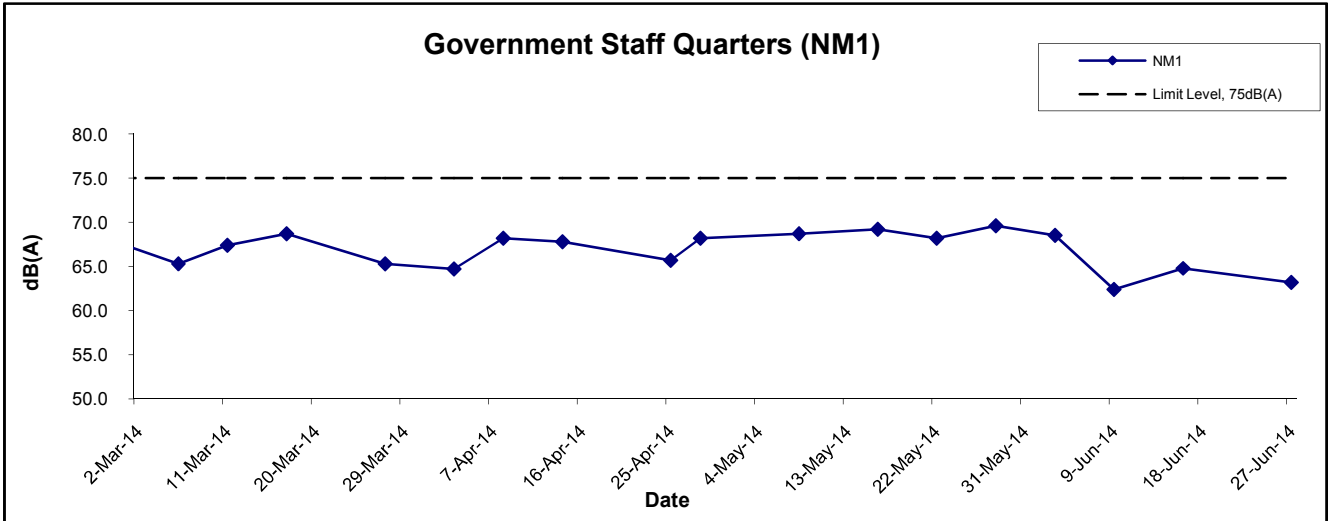
Noise Levels

Title Contract No. DC/2009/09 Construction of Tai Po Sewage Treatment Works - Stage V Phase II B Graphical Presentation of Construction Noise Monitoring Results	Scale N.T.S	Project No. MA0010	
	Date Jun 14	Appendix F
