Maeda - CRGL - SELI Joint Venture

Contract No. DC/2007/12 - Design and  
Construction of Tsuen Wan Drainage Tunnel

Monthly EM&A Report (May 2013)

**Report No** EB000364R0961

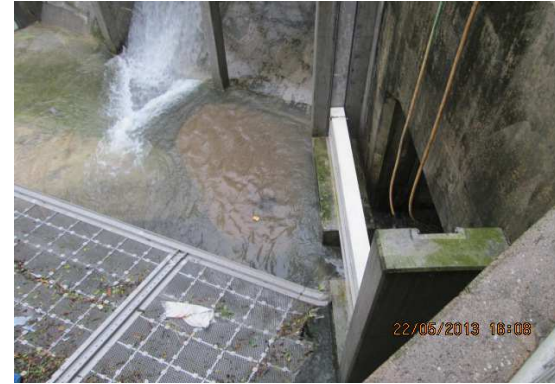
Photo taken at I-1

- 4.3.4 One exceedance of turbidity action level was recorded at I-1 on 22 May 2013. The measured turbidity level (11.25 NTU) was higher than the baseline action level, but lower than the turbidity level (11.45 NTU) of the upstream control station (I-1-C). Details of the construction activities conducted on the monitoring day are given in Appendix J. No direct disturbance was observed from the site. Heavy Rain was observed and about 205 mm rainfall was recorded at Tsuen Wan by the Hong Kong Observatory between 0:45 to 16:45 on the monitoring day. Therefore, the exceedance was considered to be contributed by heavy rainfall and high turbidity level at upstream location. Since the exceedance was non-project related, no further action was required.

**Photographic record for exceedance of Turbidity recorded at Sik Sik Yuen Ho Fung College (I-1) on 22-May-13**

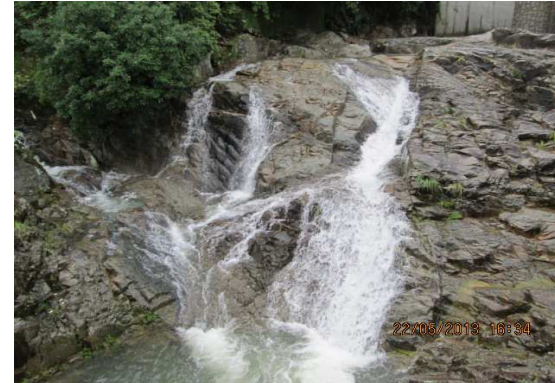
Photo taken at I-2

- 4.3.5 One exceedance of turbidity limit level was recorded at I-2 on 22 May 2013. The measured turbidity level (32.05 NTU) was higher than the baseline limit level, but lower than the turbidity level (32.25 NTU) of the upstream control station (I-2-C). Details of the construction activities conducted on the monitoring day are given in Appendix J. No direct disturbance was observed from the site. Heavy Rain was observed and about 205 mm rainfall was recorded at Tsuen Wan by the Hong Kong Observatory between 0:45 to 16:45 on the monitoring day. Therefore, the exceedance was considered to be contributed by heavy rainfall and high turbidity level at upstream location. Since the exceedance was non-project related, no further action was required.

**Photographic record for exceedance of Turbidity recorded at Hong Hoi Chee Hong Temple (I-2) on 22-May-13**

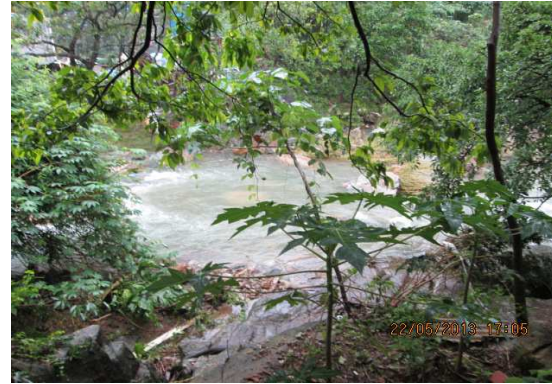
Photo taken at I-3

- 4.3.6 One exceedance of turbidity limit level was recorded at I-3 on 22 May 2013. The measured turbidity level (6.76 NTU) was higher than the baseline limit level, but lower than the turbidity level (6.91 NTU) of the upstream control station (I-3-C). Details of the construction activities conducted on the monitoring day are given in Appendix J. No direct disturbance was observed from the site. Heavy Rain was observed and about 205 mm rainfall was recorded at Tsuen Wan by the Hong Kong Observatory between 0:45 to 16:45 on the monitoring day. Therefore, the exceedance was considered to be contributed by heavy rainfall and high turbidity level at upstream location. Since the exceedance was non-project related, no further action was required.

**Photographic record for exceedance of Turbidity recorded at Squatters (I-3) on 22-May-13**

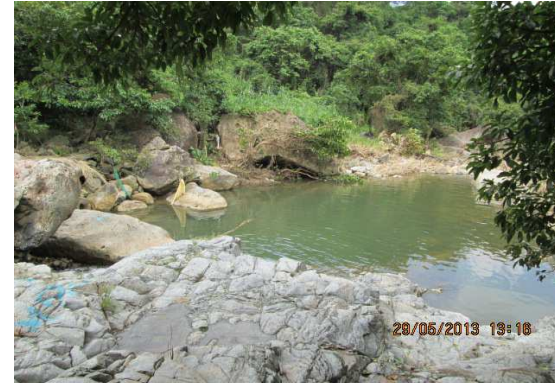
Photo taken at I-3

Details of the construction activities conducted on the monitoring day are given in Appendix J. No direct disturbance was observed from the site. Therefore, the exceedance was considered to be contributed by natural variation. Since the exceedance was non-project related, no further action was required.

**Photographic record for exceedance of Turbidity recorded at Squatters (I-3) on 29-May-13**

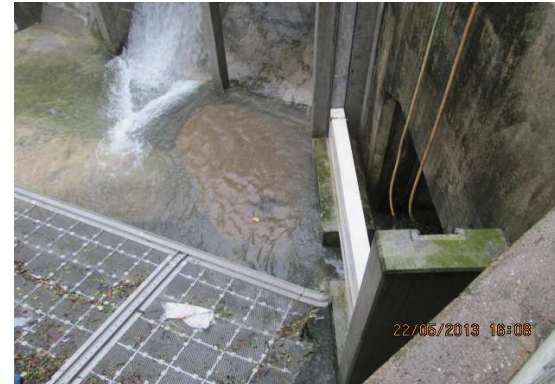
Photo taken at I-1

- 4.3.9 One exceedance of SS limit level was recorded at I-1 on 22 May 2013. The measured SS level (16.65 mg/L) was higher than the baseline limit level, and higher than 130% of the SS level (10.35 mg/L) of the upstream control station (I-1-C). Details of the construction activities conducted on the monitoring day are given in Appendix J. No direct disturbance was observed from the site. Heavy Rain was observed and about 205 mm rainfall was recorded at Tsuen Wan by the Hong Kong Observatory between 0:45 to 16:45 on the monitoring day. Therefore, the exceedance was considered to be contributed by heavy rainfall and high turbidity level at upstream location. Since the exceedance was non-project related, no further action was required.

**Photographic record for exceedance of Suspended Solids (SS) recorded at Sik Sik Yuen Ho Fung College (I-1) on 22-May-13**

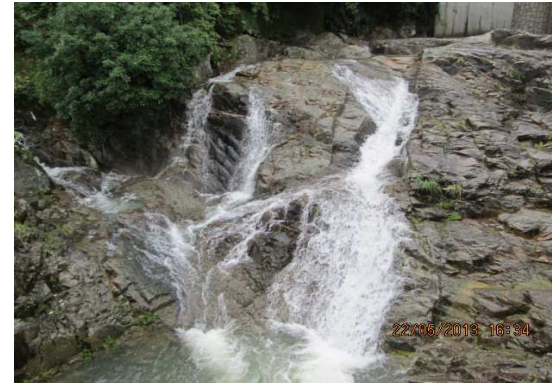
Photo taken at I-2

- 4.3.10 One exceedance of SS limit level was recorded at I-2 on 22 May 2013. The measured SS level (19.40 mg/L) was higher than the baseline limit level, but lower than the SS level (22.70 mg/L) of the upstream control station (I-2-C). Details of the construction activities conducted on the monitoring day are given in Appendix J. No direct disturbance was observed from the site. Heavy Rain was observed and about 205 mm rainfall was recorded at Tsuen Wan by the Hong Kong Observatory between 0:45 to 16:45 on the monitoring day. Therefore, the exceedance was considered to be contributed by heavy rainfall and high turbidity level at upstream location. Since the exceedance was non-project related, no further action was required.

**Photographic record for exceedance of Suspended Solids (SS) recorded at Hong Hoi Chee Hong Temple (I-2) on 22-May-13**

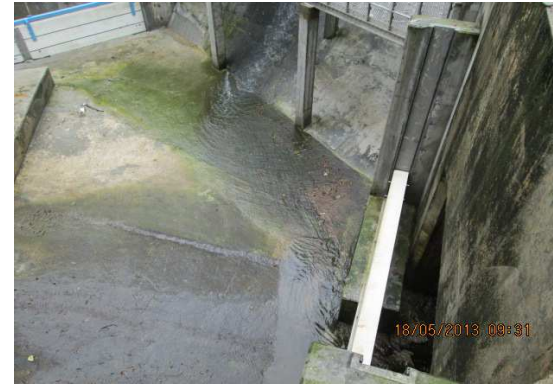
Photo taken at I-1

- 4.3.8 One exceedance of SS action level was recorded at I-1 on 18 May 2013. The measured SS level (5.35 mg/L) was lower than the baseline action level, but higher than 120% of the SS level (4.45 mg/L) of the upstream control station (I-1-C). Details of the construction activities conducted on the monitoring day are given in Appendix J. No direct disturbance was observed from the site. Therefore, the exceedance was considered to be contributed by natural variation. Since the exceedance was non-project related, no further action was required.

**Photographic record for exceedance of Suspended Solids (SS) recorded at Sik Sik Yuen Ho Fung College (I-1) on 18-May-13**
