MONTHLY ENVIRONMENTAL
MONITORING & AUDIT REPORT

Reprovisioning and Upgrading of Salt
Water Service Reservoirs in Western
District for Water Supplies Department:
*Second Monthly Environmental
Monitoring and Audit Report*

October 2007

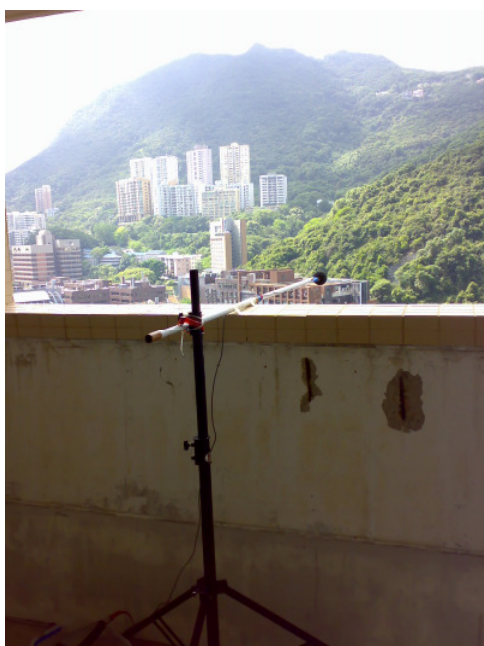
Noise Monitoring Station (NM1)

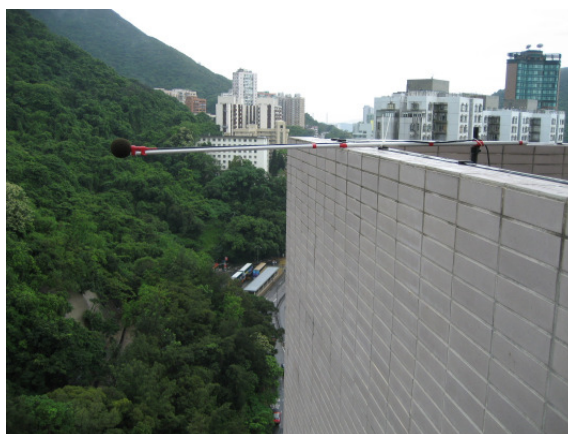
Baseline Noise Monitoring Station (NM2)

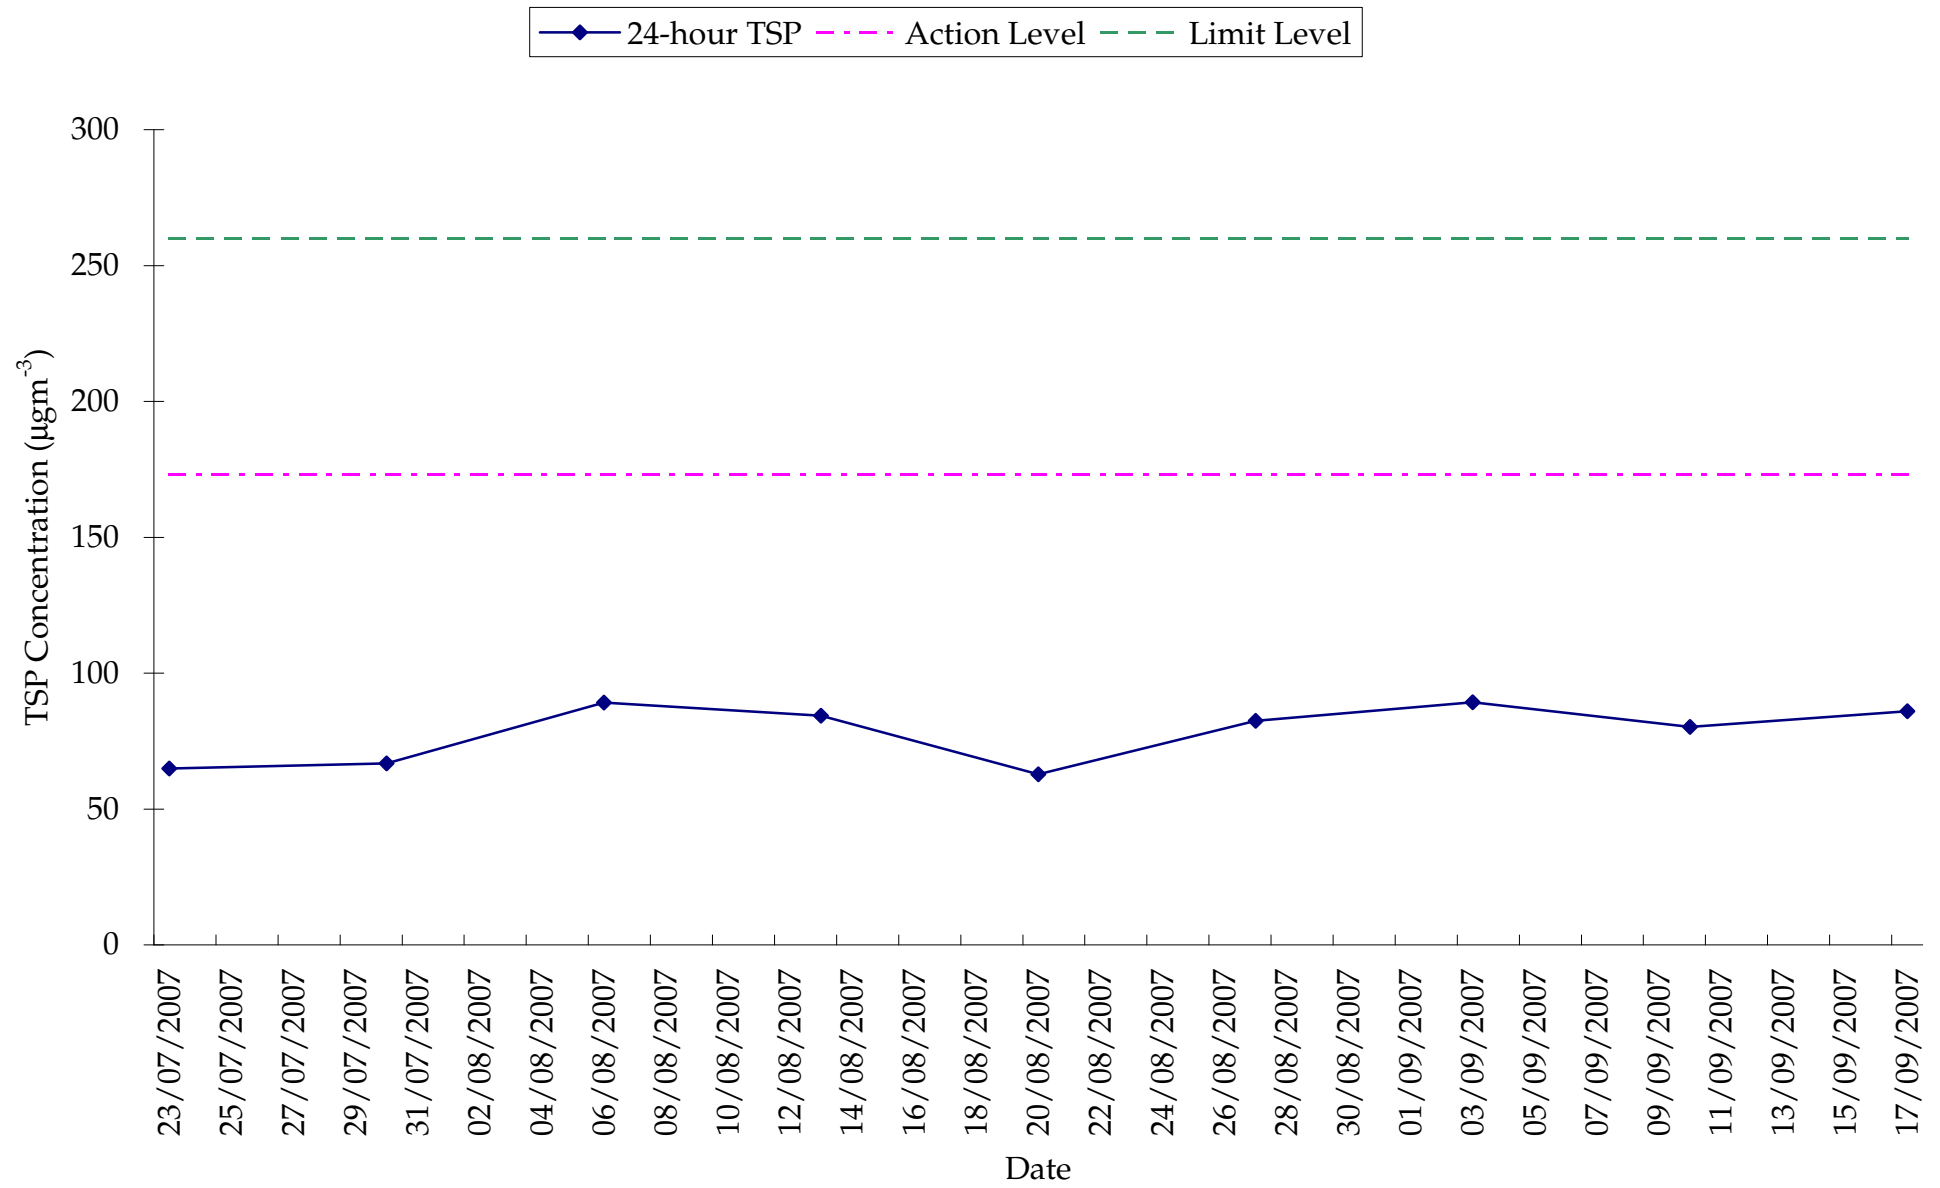
Figure H1 - Measured 24-hour TSP Concentration ($\mu\text{g}\text{m}^{-3}$) at AM1

Four sets of 24-hour TSP measurements were carried out at monitoring station AM1 during the reporting period. The monitoring data for 24-hour TSP together with wind data and graphical presentations are presented in *Annex F*. The weather condition during the monitoring period was sunny. The local impacts near the monitoring station were mainly associated with vehicle emissions along Pok Fu Lam Road. No exceedance of Action and Limit Levels of 24-hour TSP were recorded during the reporting period.

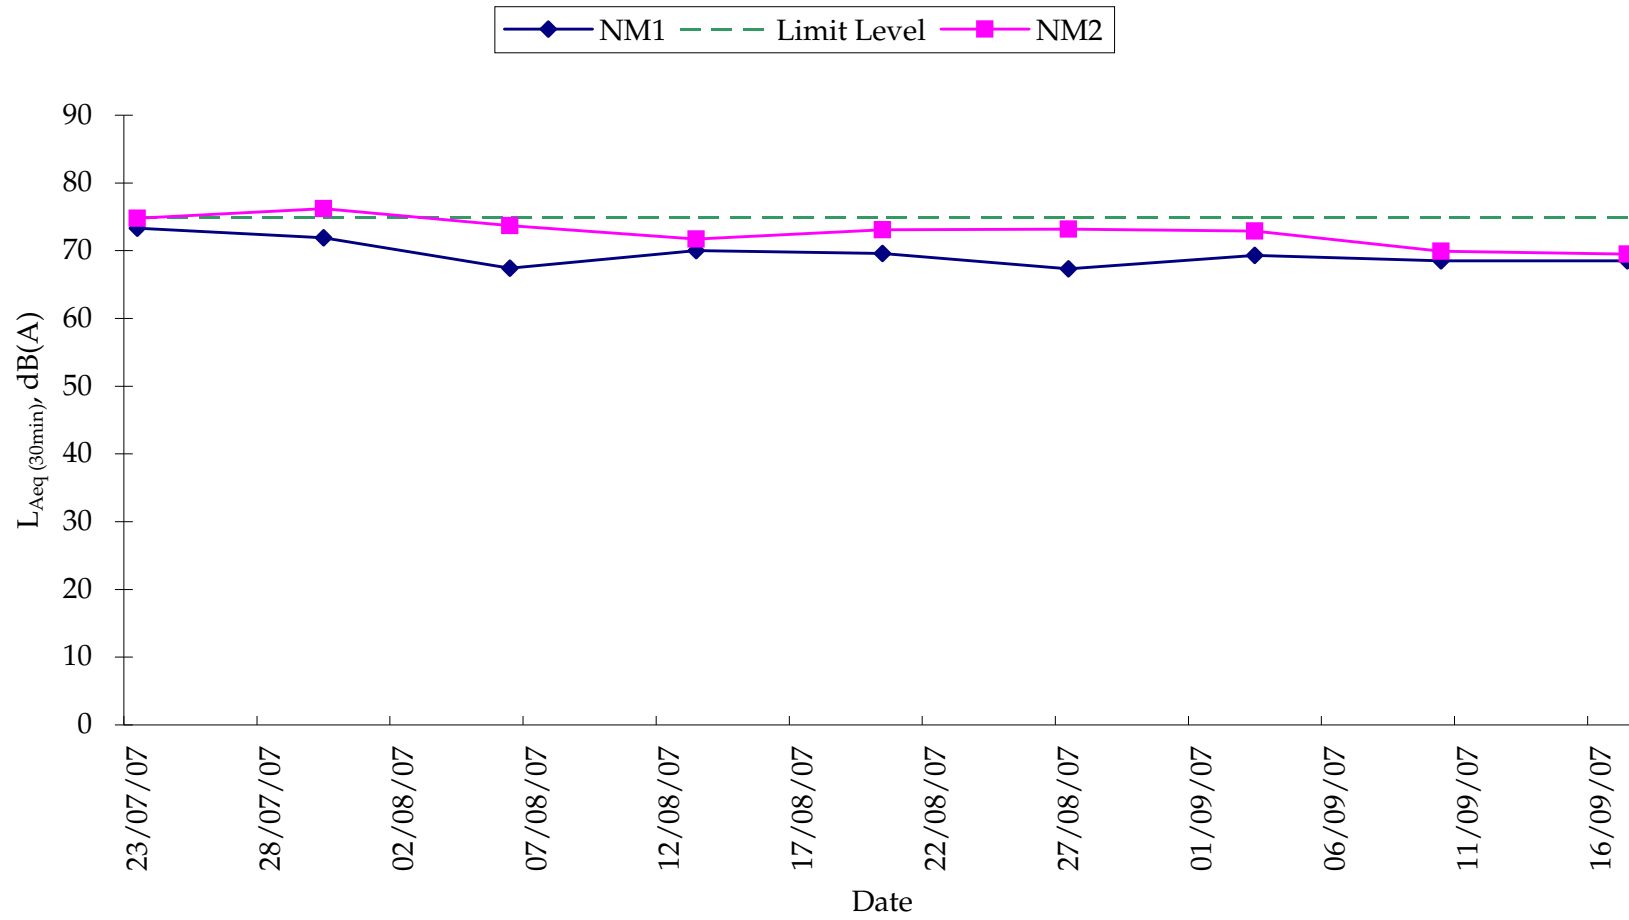
Figure I1 - Noise Monitoring Results ($L_{eq, 30min}$)

Four sets of 30-minute construction noise measurements were carried out at monitoring stations NM1 & NM2 during the reporting period. The monitoring results together with graphical presentations are presented in *Annex G*. The local impacts observed near the monitoring stations were mainly traffic noise from Pok Fu Lam Road and the concurrent projects undertaken in the vicinity. No exceedance of Action and Limit Levels of construction noise was recorded during the reporting period.

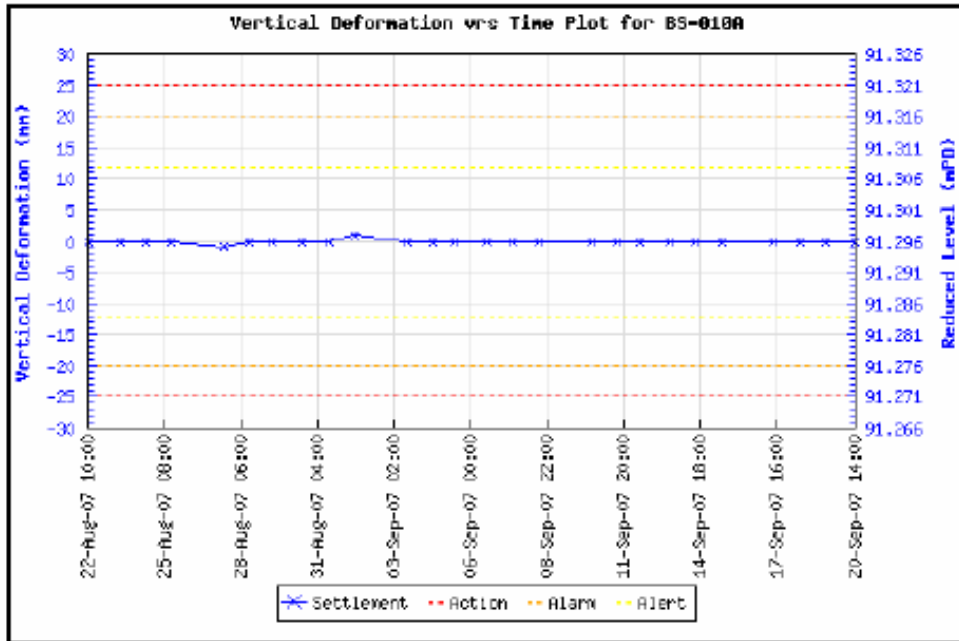
Instrument ID : BS-010A
 Easting : 831808.247
 Location : Valve House
 Remark :

Type : Building Settlement Marker Type DMP5
 Northing : 816016.001 Initial Level : 91.296 mPD

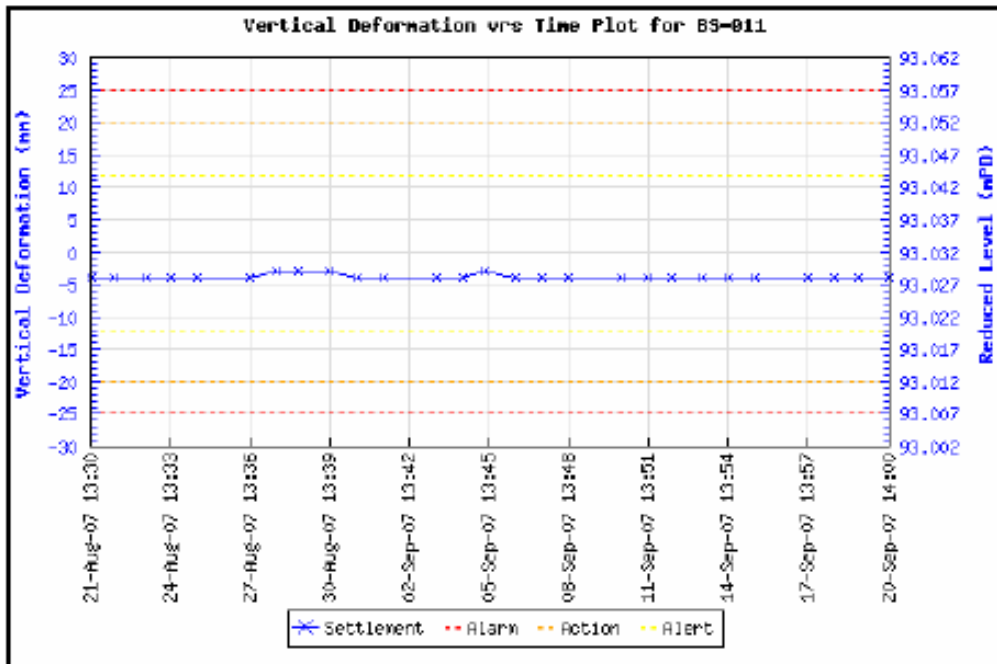
Instrument ID : BS-011
 Easting : 831795.830
 Location : Valve House
 Remark :

Type : Building Settlement Marker Type DMP5
 Northing : 815997.133 Initial Level : 93.032 mPD

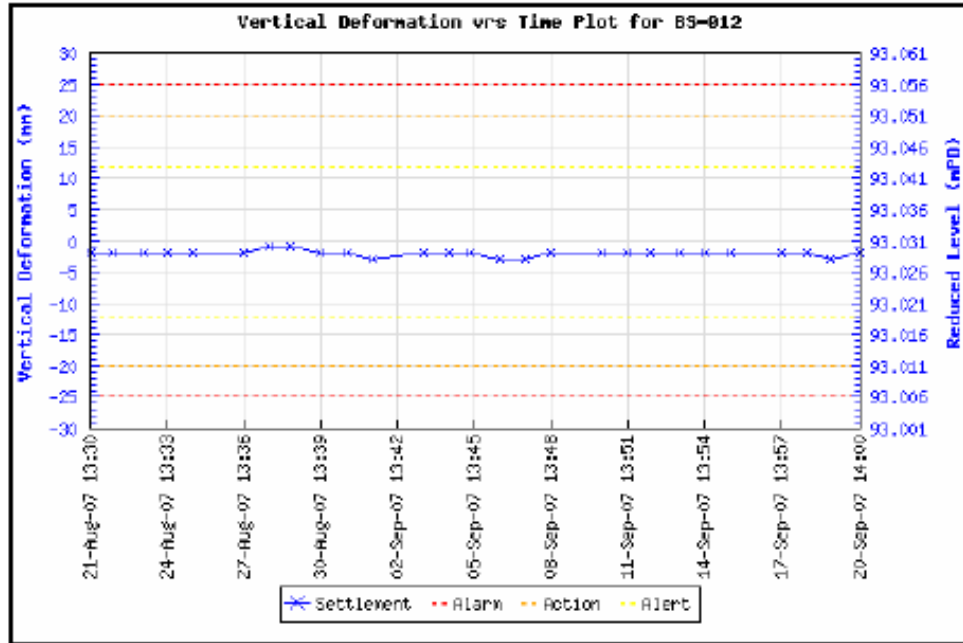
Instrument ID : BS-012
 Easting : 831796.239
 Location : Valve House
 Remark :

Type : Building Settlement Marker Type DMP5
 Northing : 816000.503 Initial Level : 93.031 mPD

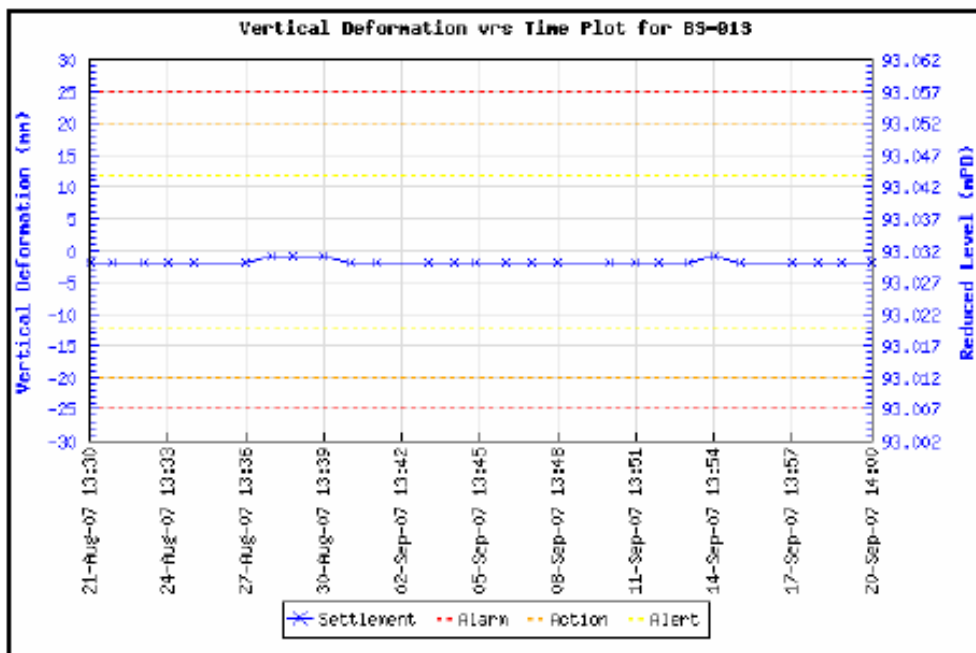
Instrument ID : BS-013
 Easting : 831800.605
 Location : Valve House
 Remark :

Type : Building Settlement Marker Type DMP5
 Northing : 816020.664 Initial Level : 93.032 mPD

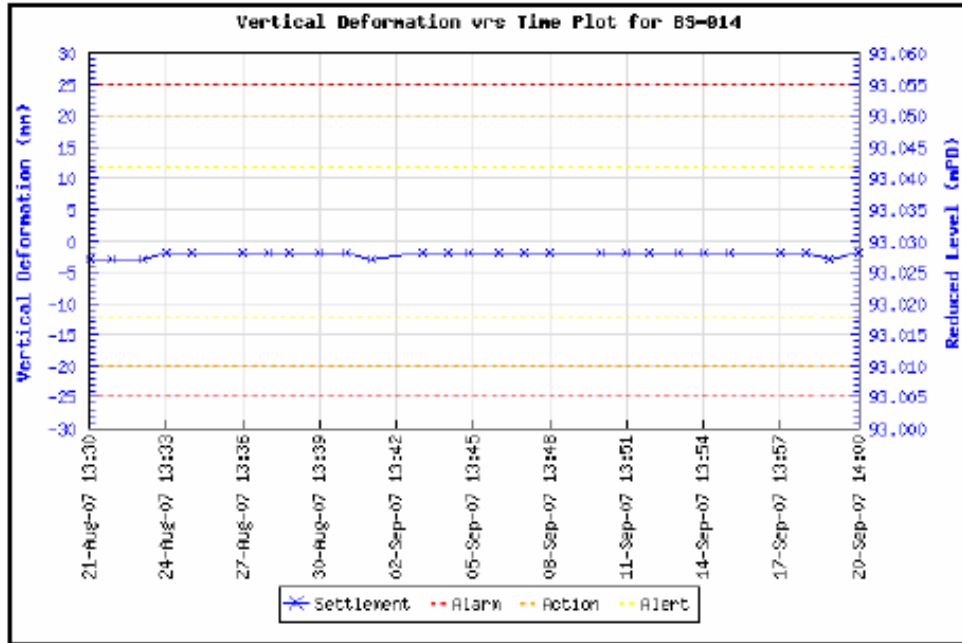
Instrument ID : BS-014
 Easting : 831781.965
 Location : Reservoir
 Remark :

Type : Building Settlement Marker Type DMP5
 Northing : 816004.142 Initial Level : 93.030 mPD
