Reprovisioning and Upgrading of Salt
Water Service Reservoirs in Western
District for Water Supplies Department:
*Third Monthly Environmental
Monitoring and Audit Report*

November 2007

MONTHLY ENVIRONMENTAL
MONITORING & AUDIT REPORT

Reference 0067560

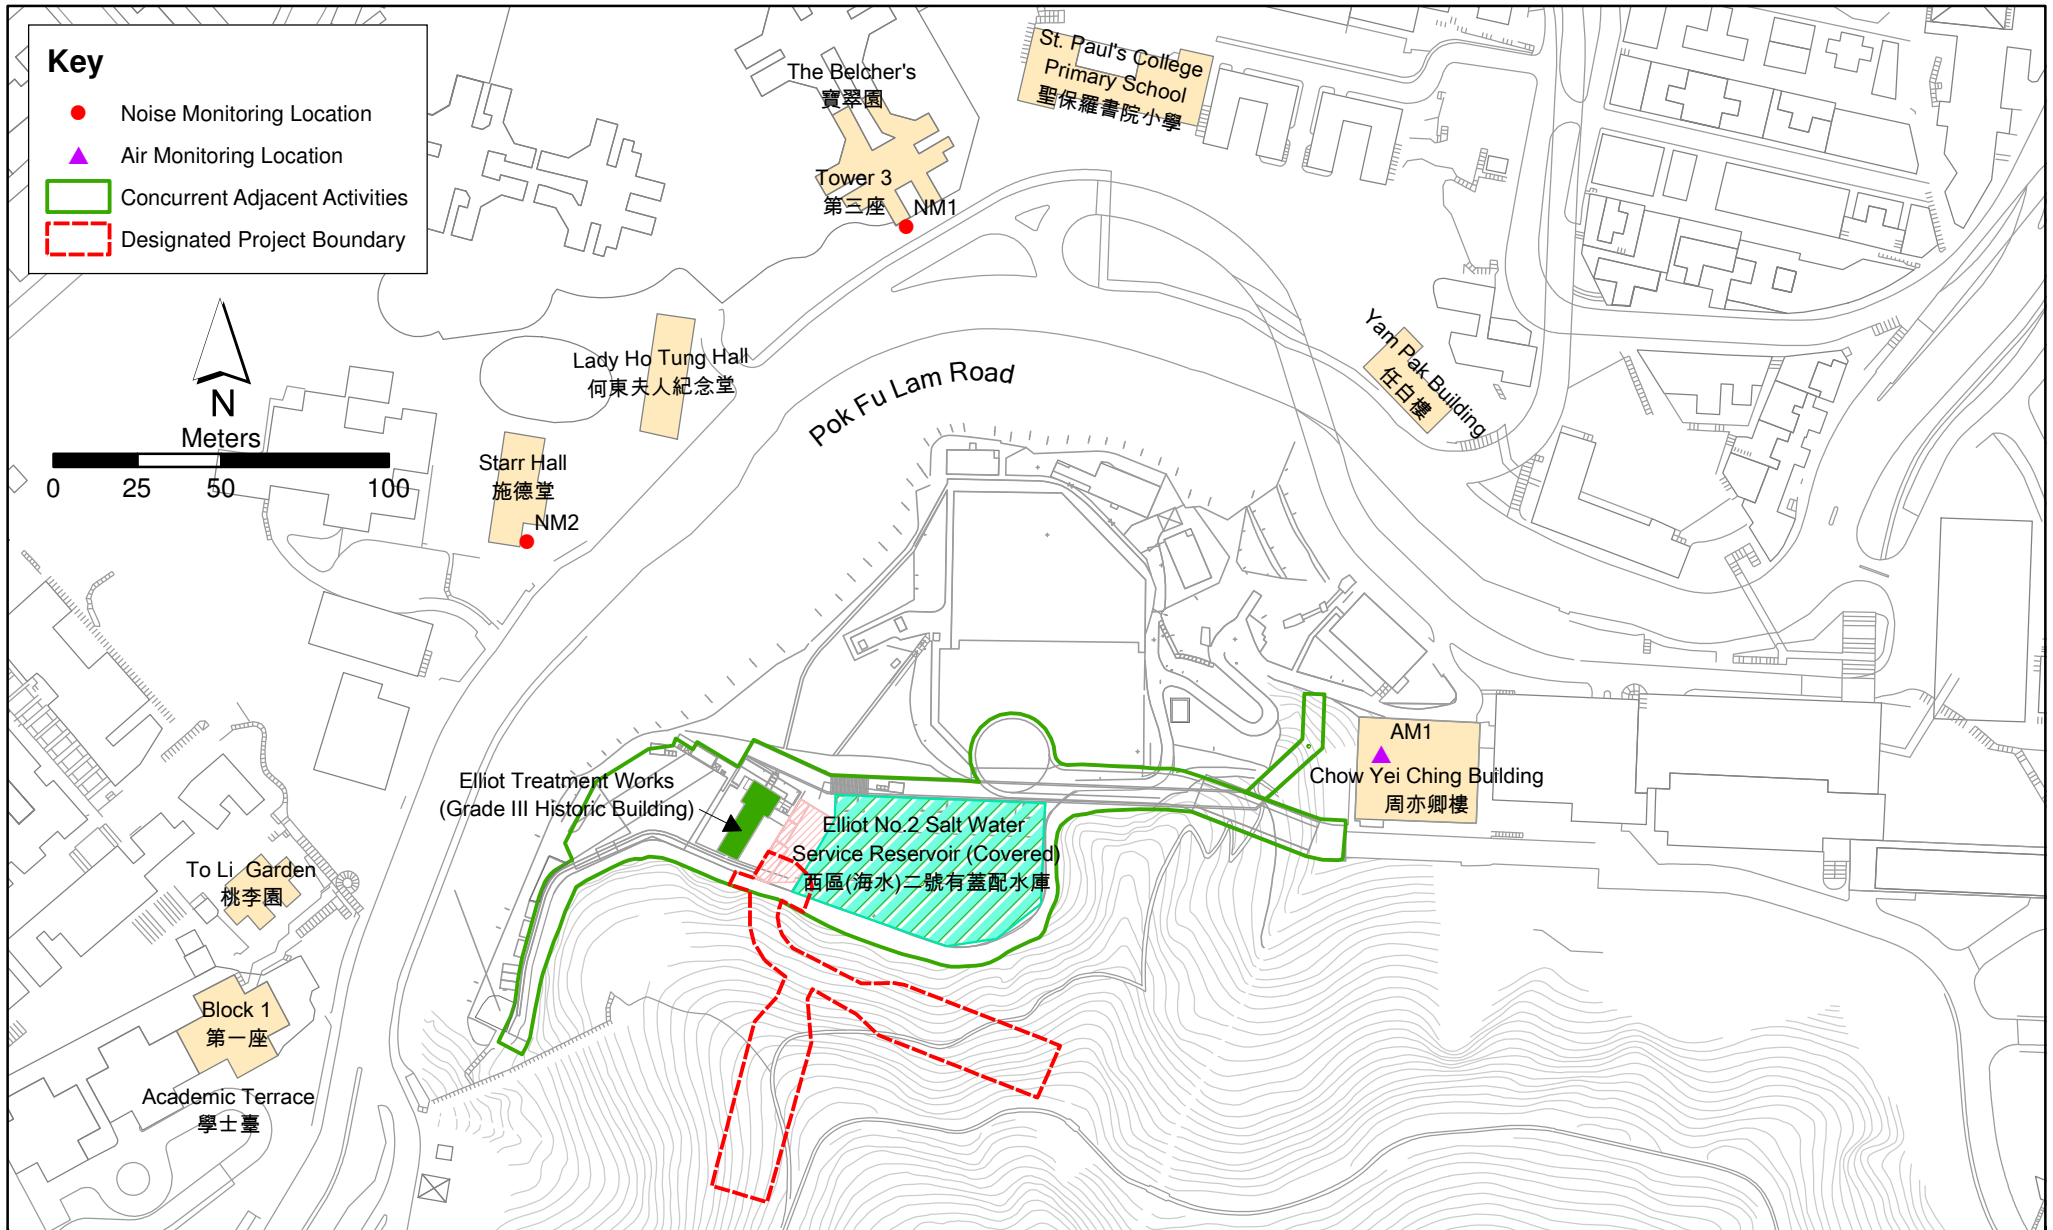
Figure B1

Air and Noise Monitoring Locations

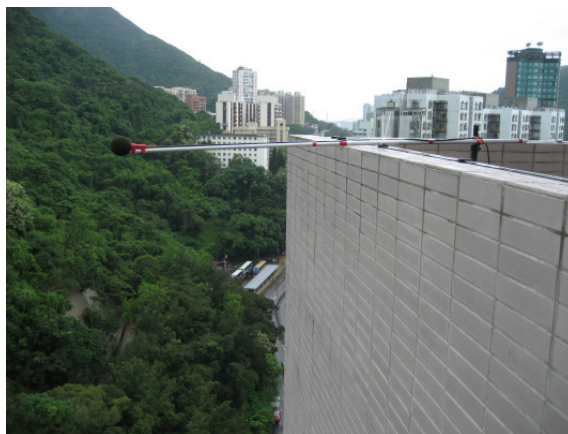
Baseline Noise Monitoring Station (NM2)

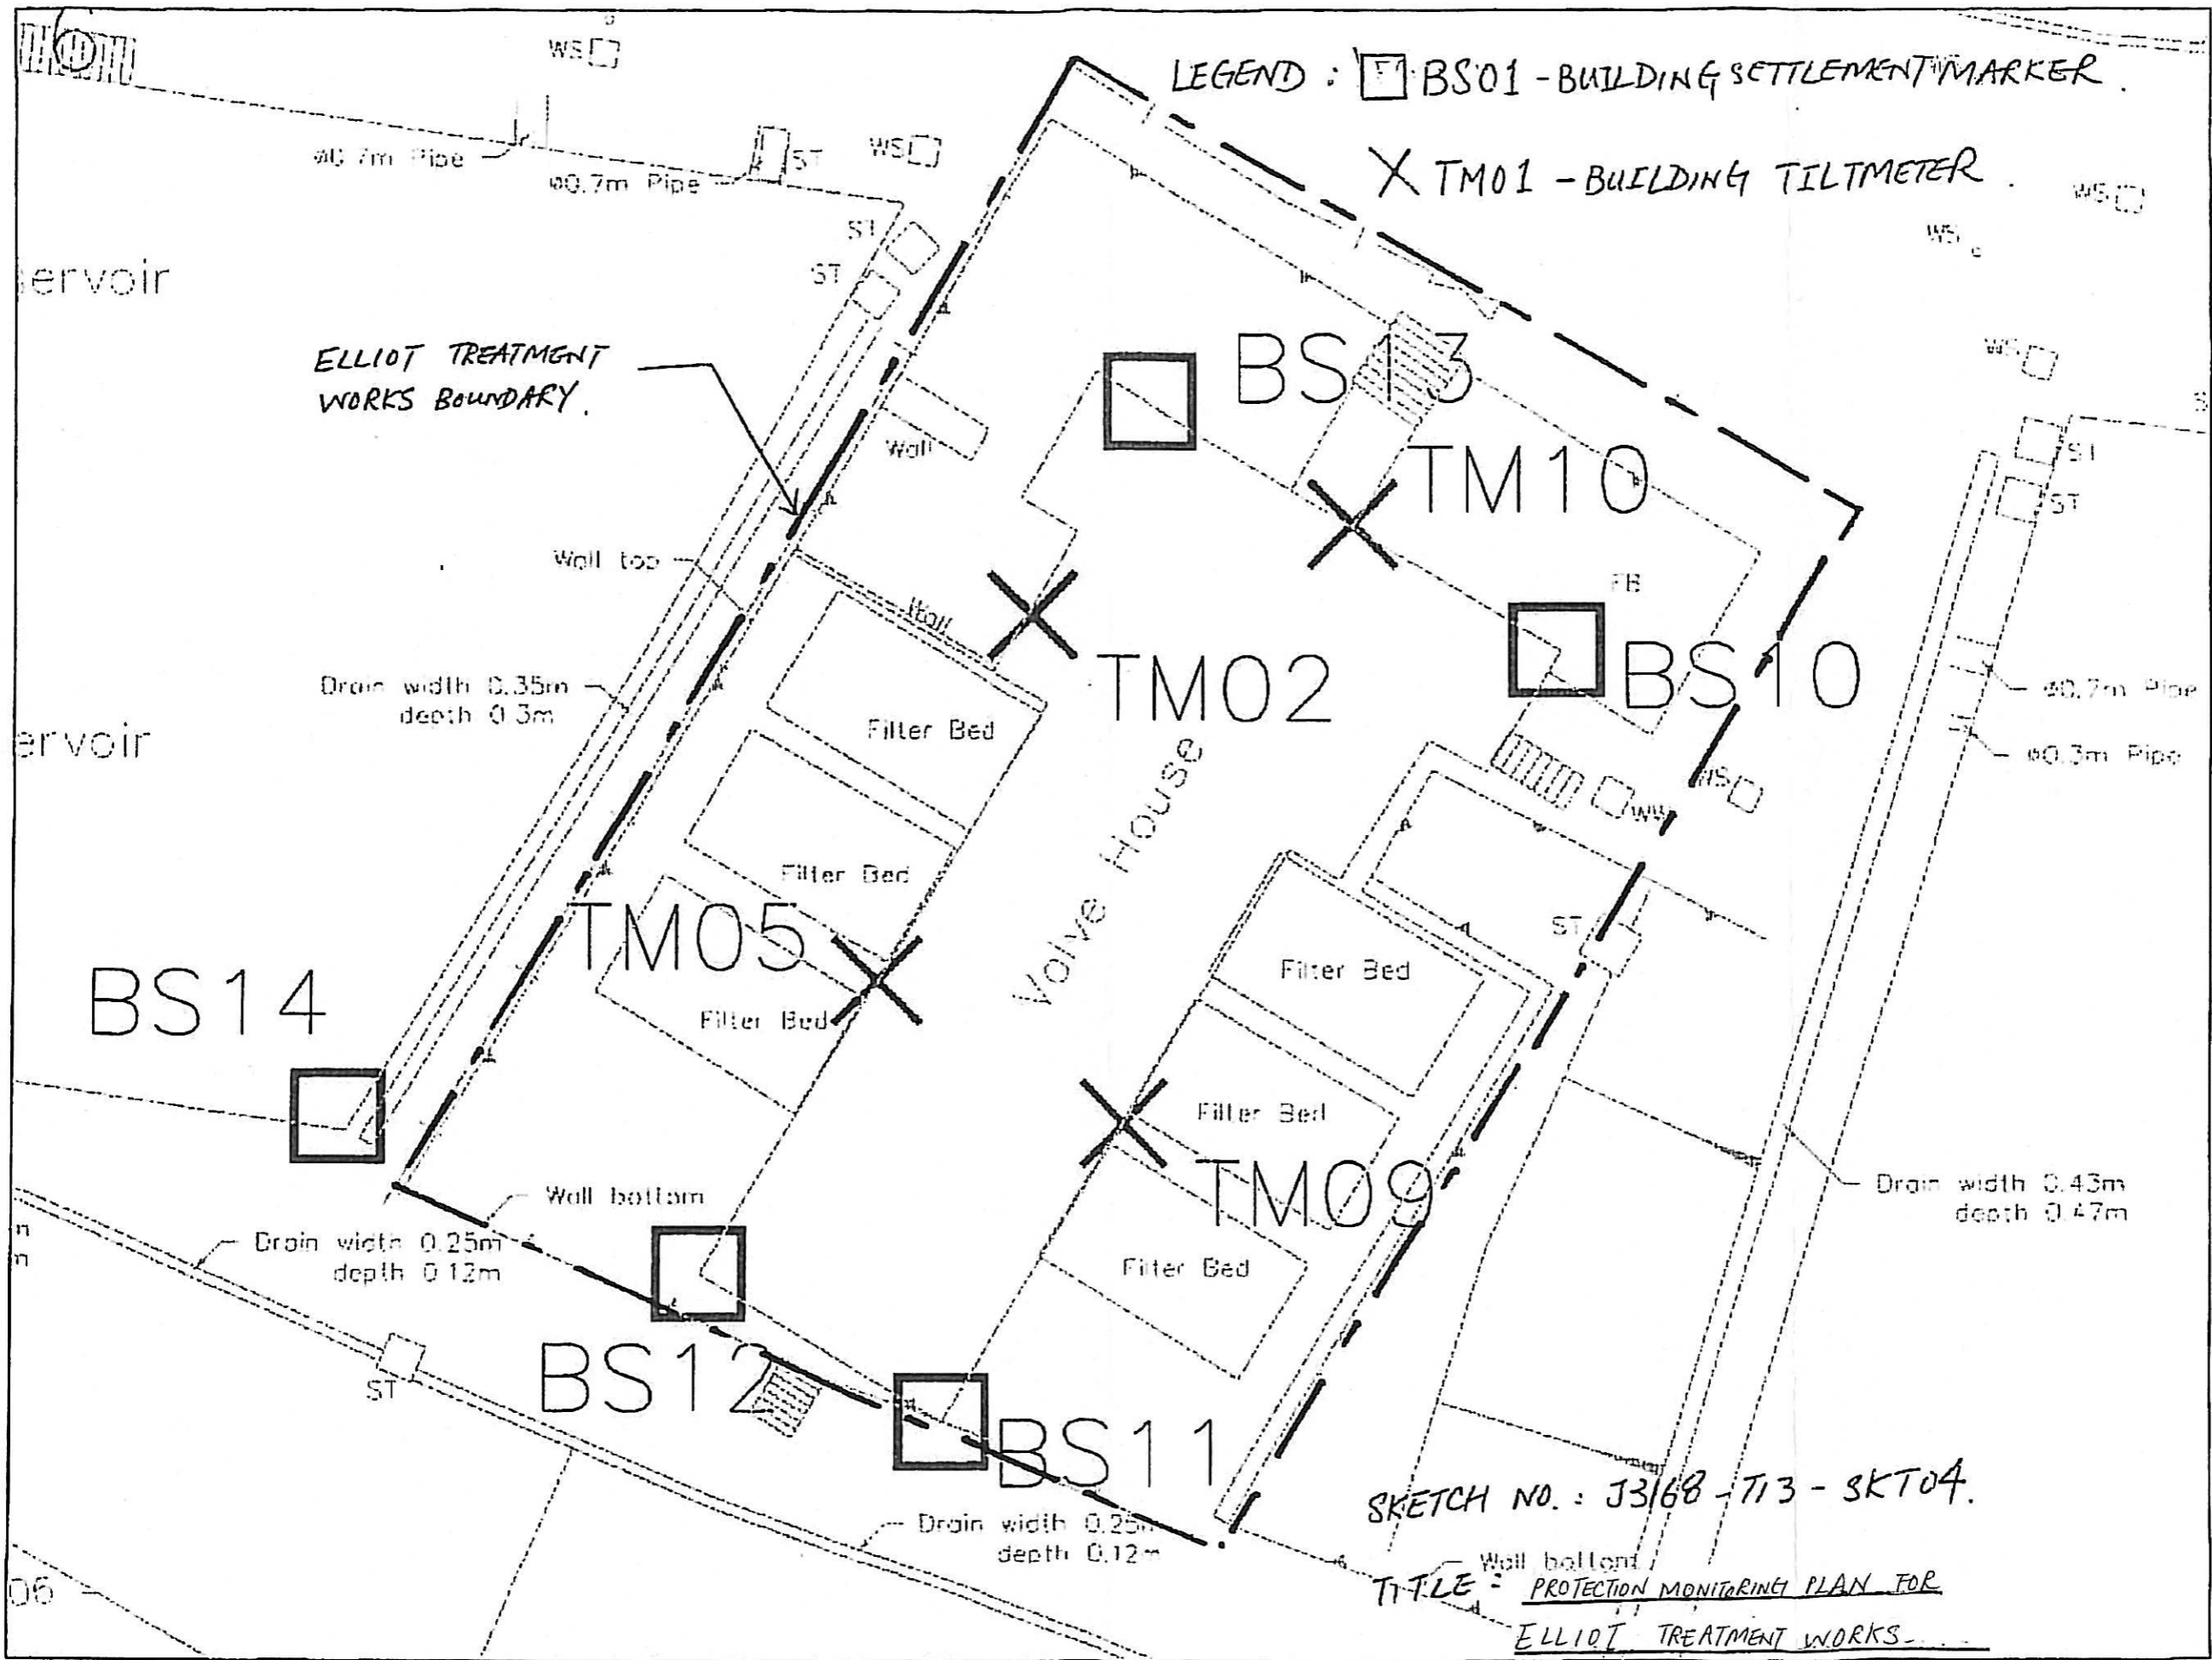
ELECTROLEVEL TILT SENSOR MONITORING RECORD SHEET

Instrument ID : TM2

Location : Valve House

Remark : Radio Transmitter Serial No. 50348; +ve Reading => Rotation towards West South
