Reprovisioning and Upgrading of Salt
Water Service Reservoirs in Western
District for Water Supplies Department:
*Sixth Monthly Environmental
Monitoring and Audit Report*

January 2008

MONTHLY ENVIRONMENTAL
MONITORING & AUDIT REPORT

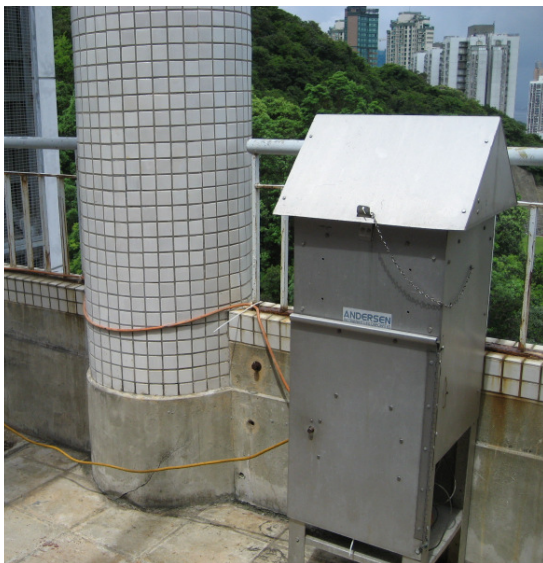
The HVS at AM1 were placed at the rooftop of Chow Yei Ching Building at about 33 m above local ground level. The HVS was free-standing with no obstruction.

Air Quality Monitoring Station (AM1)

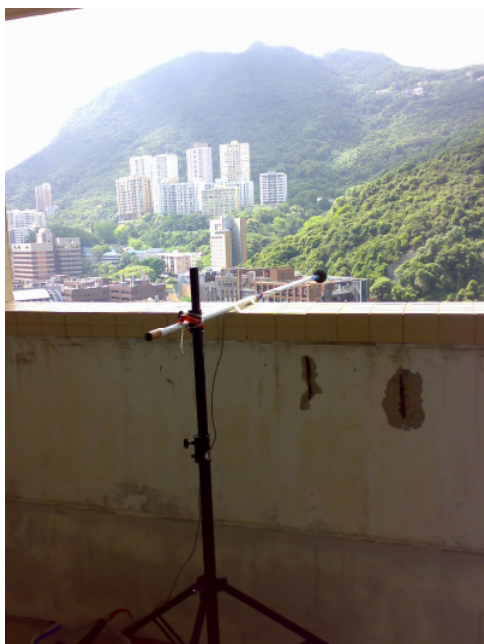
Noise Monitoring Station (NM1)

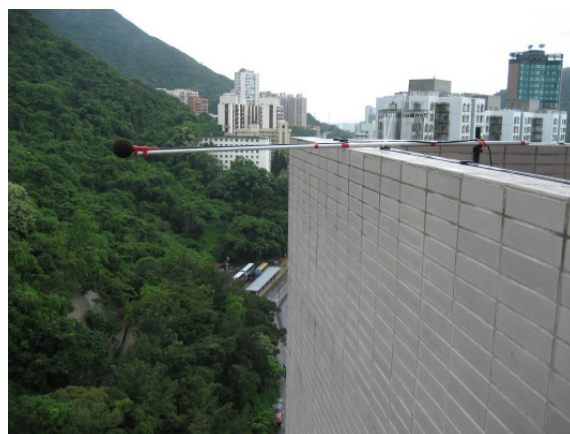
Baseline Noise Monitoring Station (NM2)
