KWAN ON CONSTRUCTION CO. LTD.

**Contract No. YL/2009/01
Hang Hau Tsuen Channel
at Lau Fau Shan**

**Monthly Environmental Monitoring and Audit Report
July 2010 (Version 1.1)**

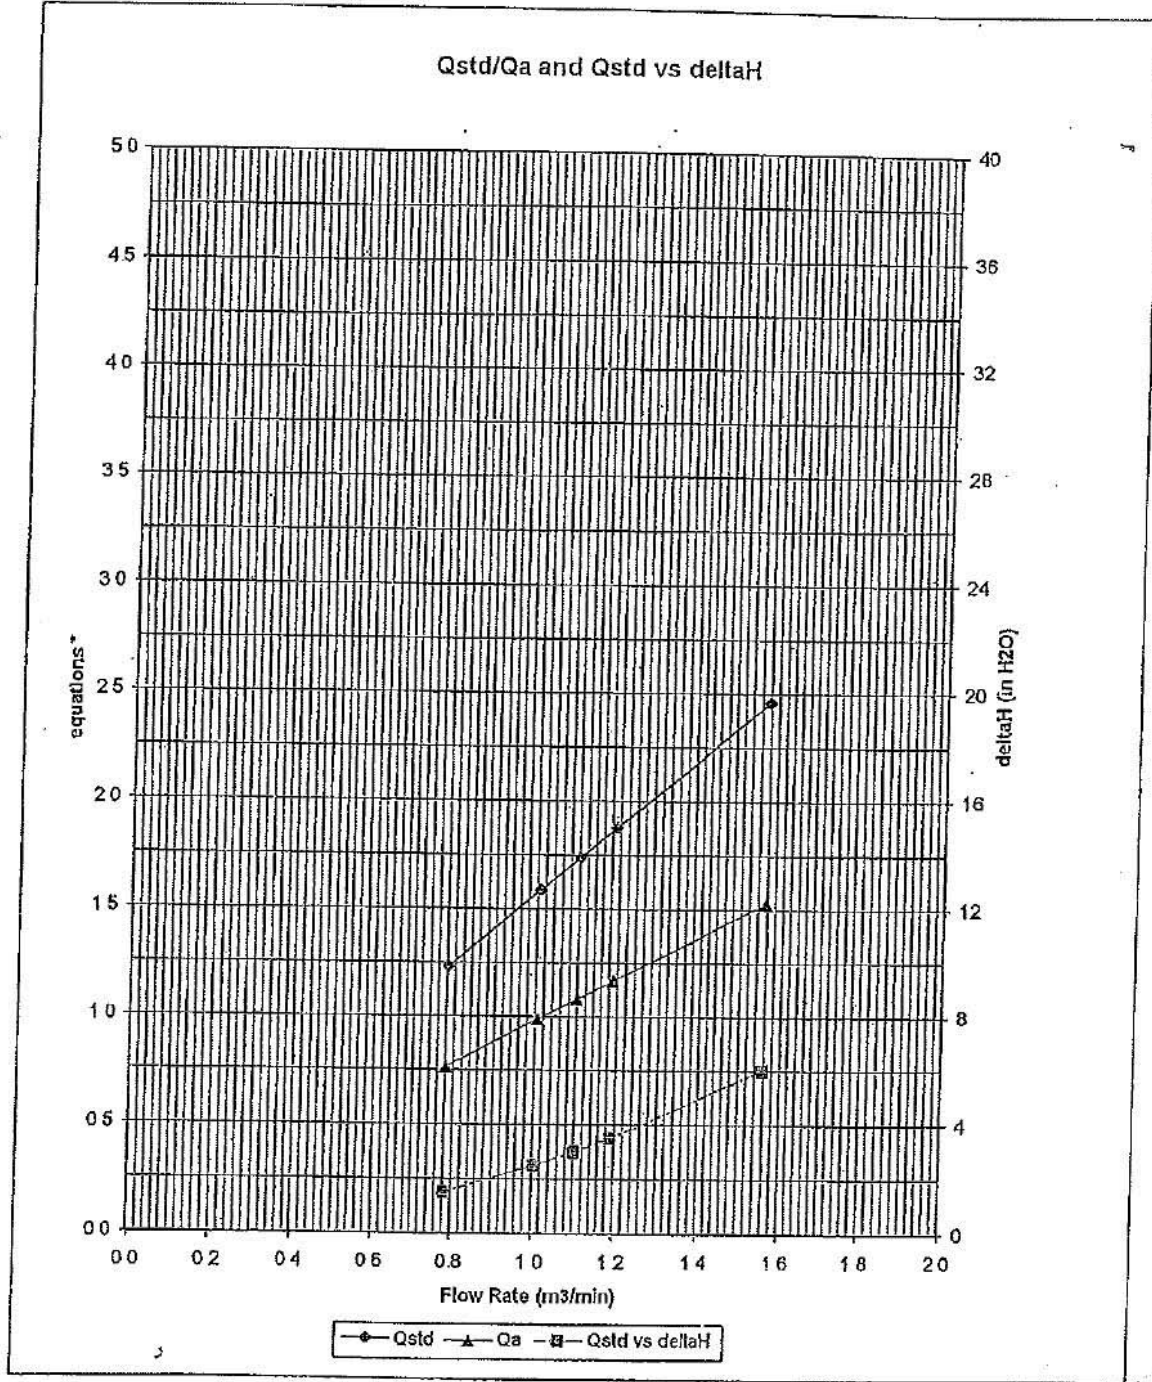
Qstd = 1/m{ [SQRT(H2O(Pa/760)(298/Ta))] - b}
 Qa = 1/m{ [SQRT H2O(Ta/Pa)] - b}

* y-axis equations:

Qstd series: $\sqrt{\Delta H \left(\frac{P_a}{P_{std}} \right) \left(\frac{T_{std}}{T_a} \right)}$

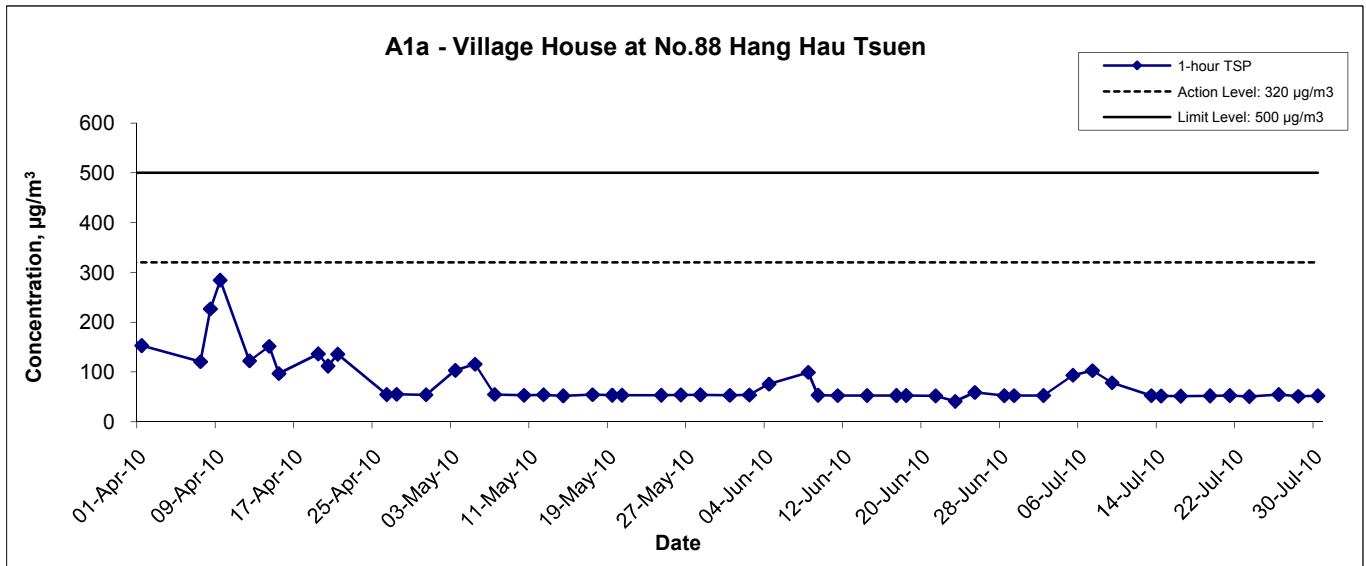
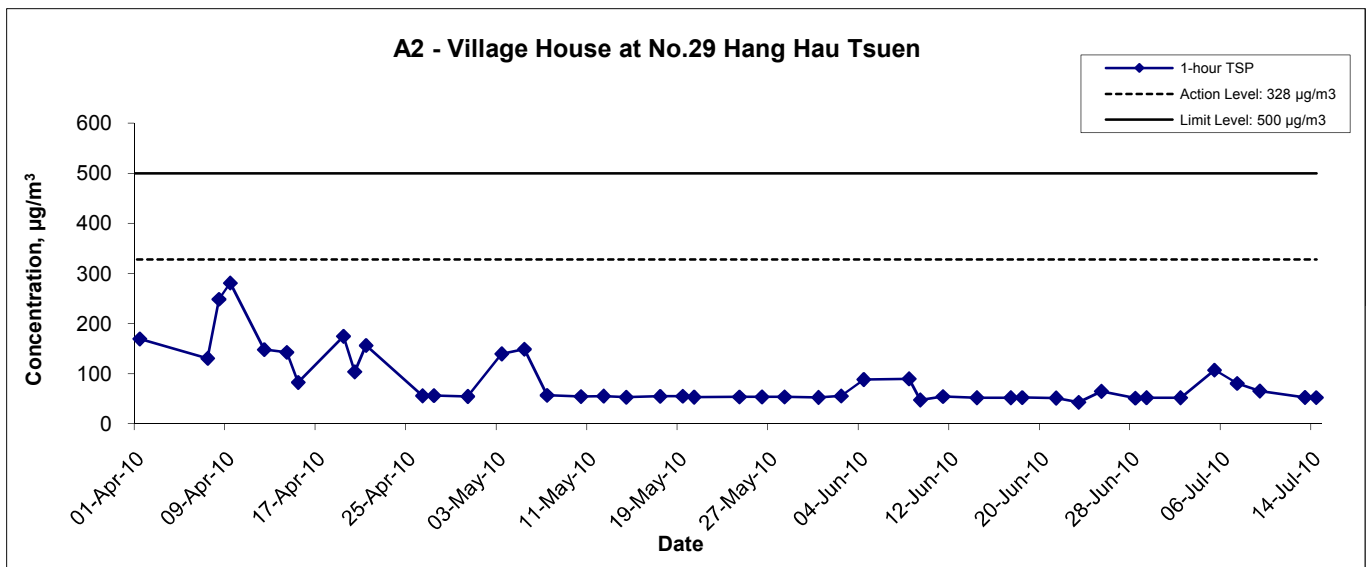
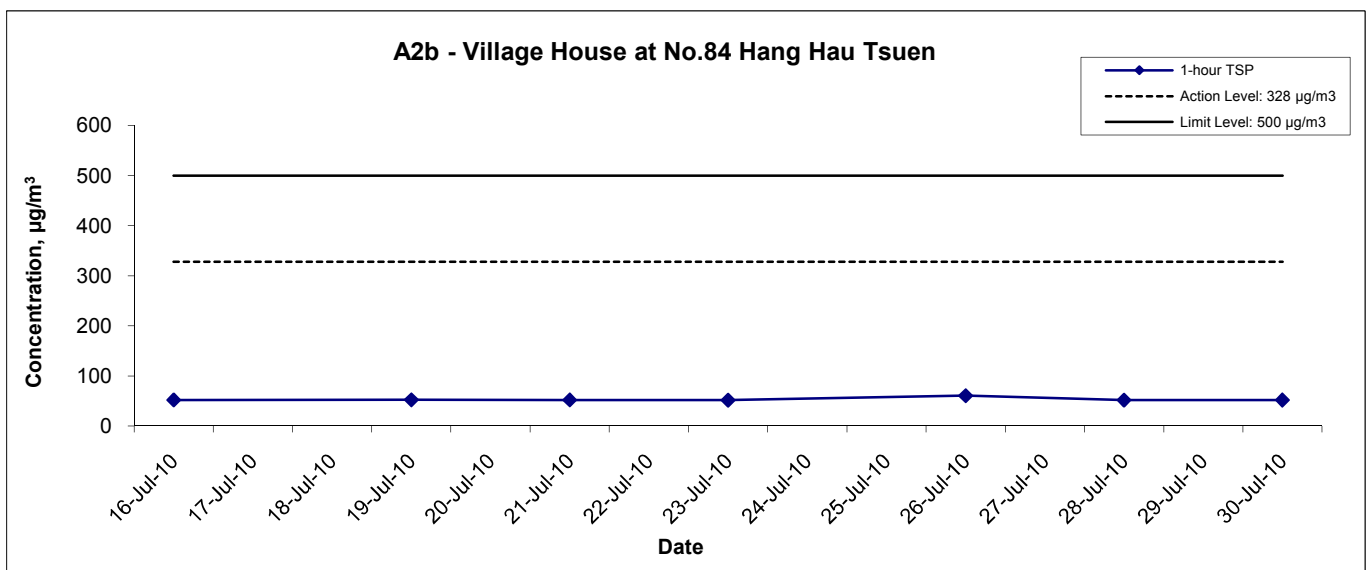
1-hr TSP Concentration Levels

Location A2b - Village House at No.84 Hang Hau Tsuen			
Date	Time	Weather	Particulate Concentration ($\mu\text{g}/\text{m}^3$)
16-Jul-10	10:10	Fine	52.0
19-Jul-10	9:00	Sunny	52.4
21-Jul-10	10:05	Cloudy	52.1
23-Jul-10	10:05	Cloudy	51.6
26-Jul-10	10:30	Sunny	60.6
28-Jul-10	10:10	Cloudy	51.8
30-Jul-10	10:10	Sunny	51.9
Average			53.2
Maximum			60.6
Minimum			51.6

Title Contract No. YL/2009/01 Hang Hau Tsuen Channel at Lau Fau Shan Graphical Presentation of 1-hour TSP Monitoring Results	Scale N.T.S	Project No. MA0002	
	Date Jul 10	Appendix E

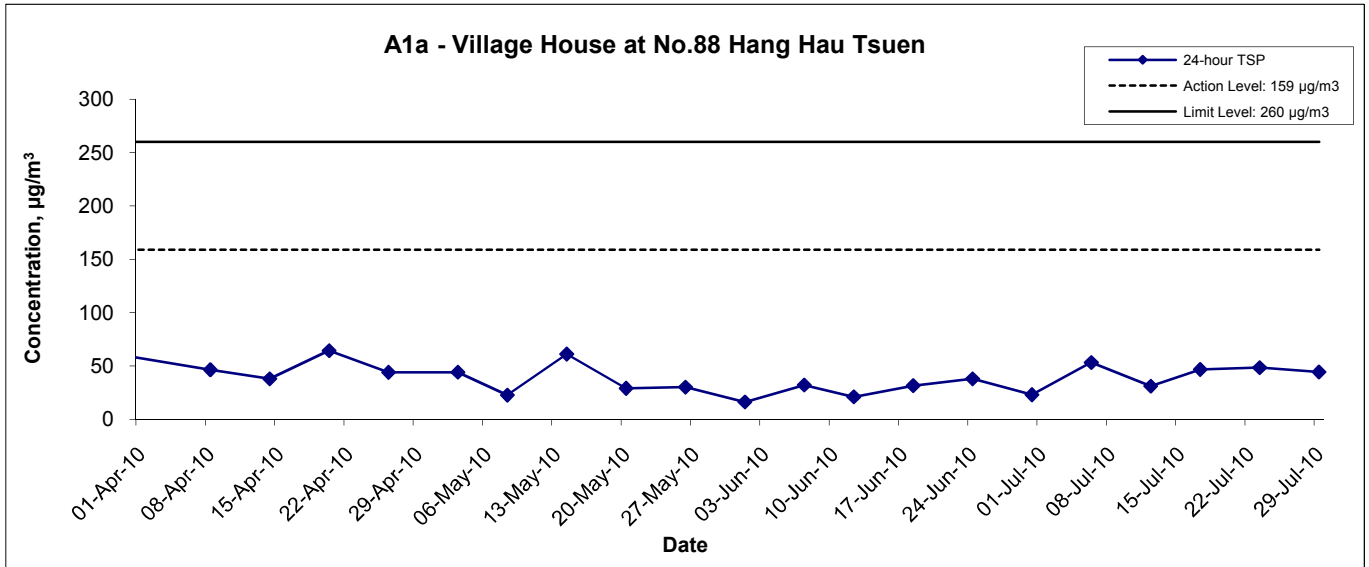
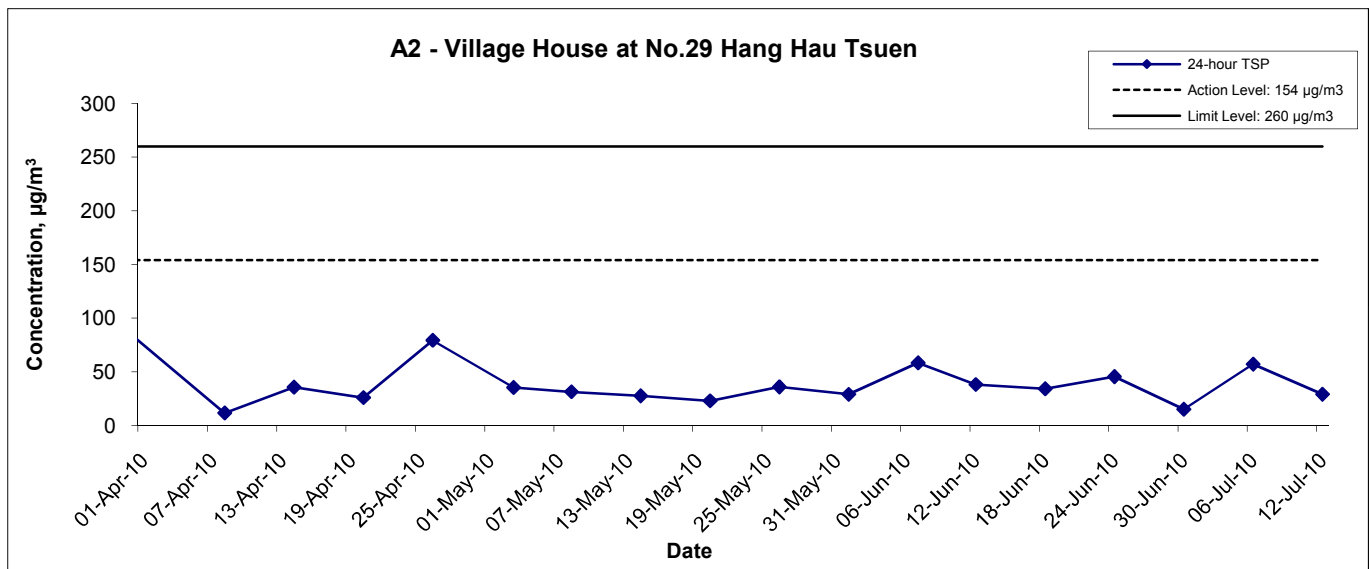
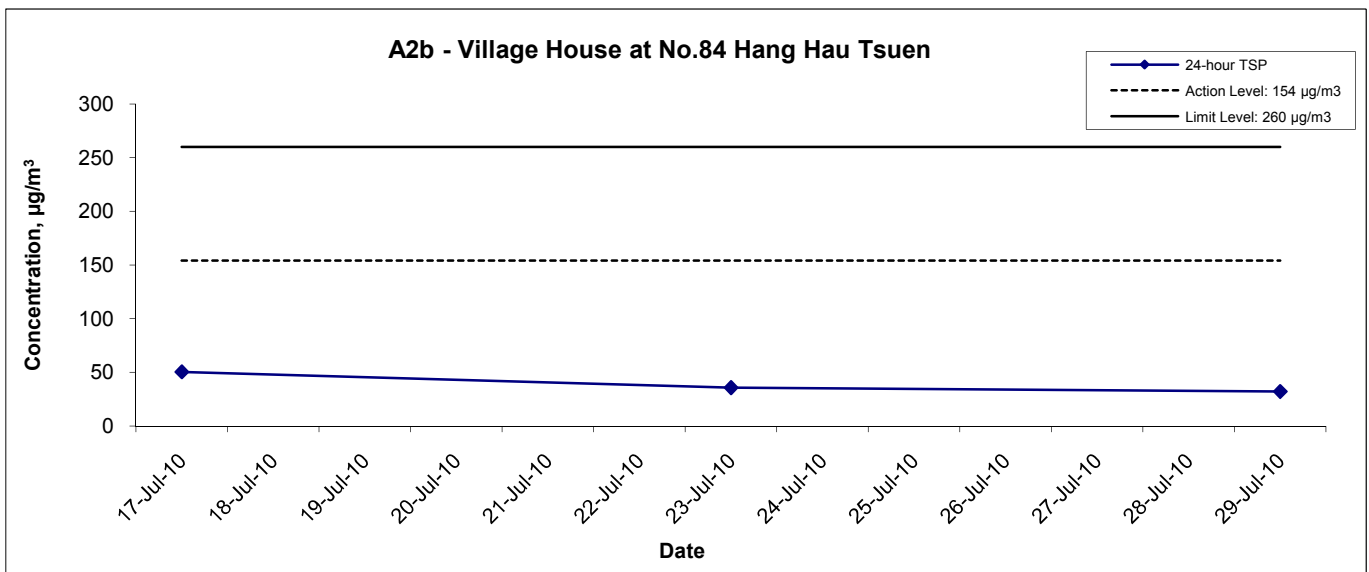
24-hr TSP Concentration Levels

Title Contract No. YL/2009/01 Hang Hau Tsuen Channel at Lau Fau Shan Graphical Presentation of 24-hour TSP Monitoring Results	Scale N.T.S	Project No. MA0002	CINOTECH
	Date Jul 10	Appendix F

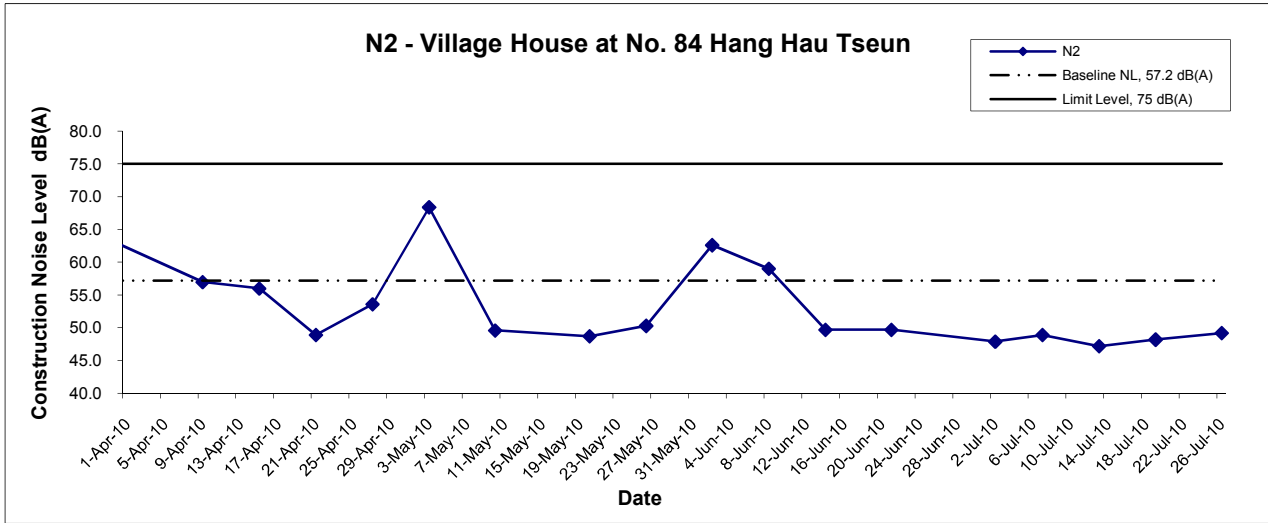
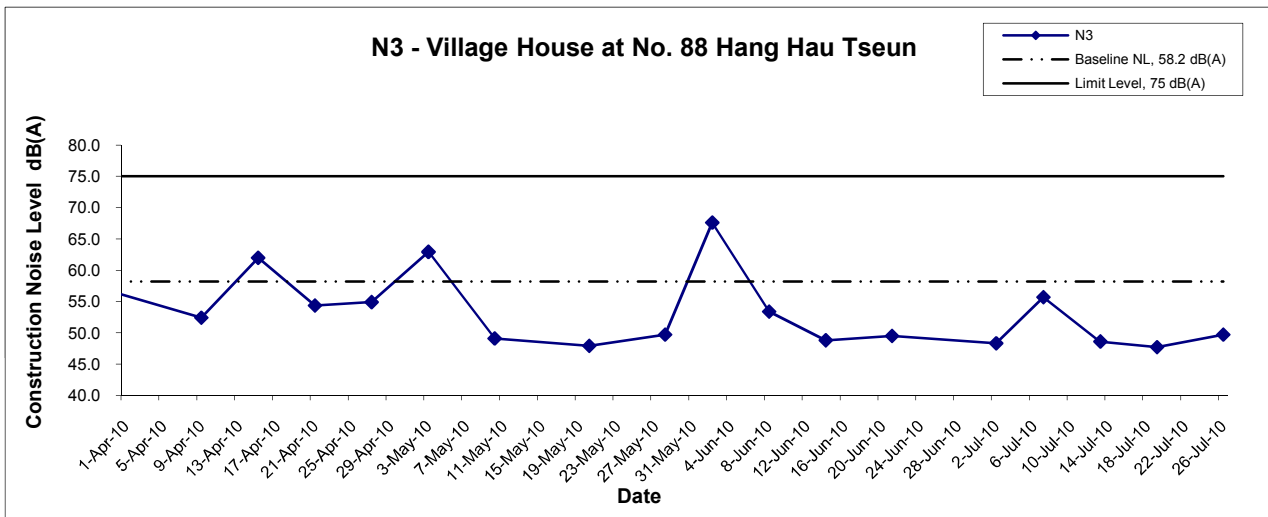
Noise Levels

* Free-field adjustment is adopted for monitoring results at station N2 and N3.

Title Contract No. YL/2009/01 Hang Hau Tsuen Channel at Lau Fau Shan Graphical Presentation of Construction Noise Monitoring Results	Scale N.T.S	Project No. MA0002	
	Date Jul 10	Appendix G

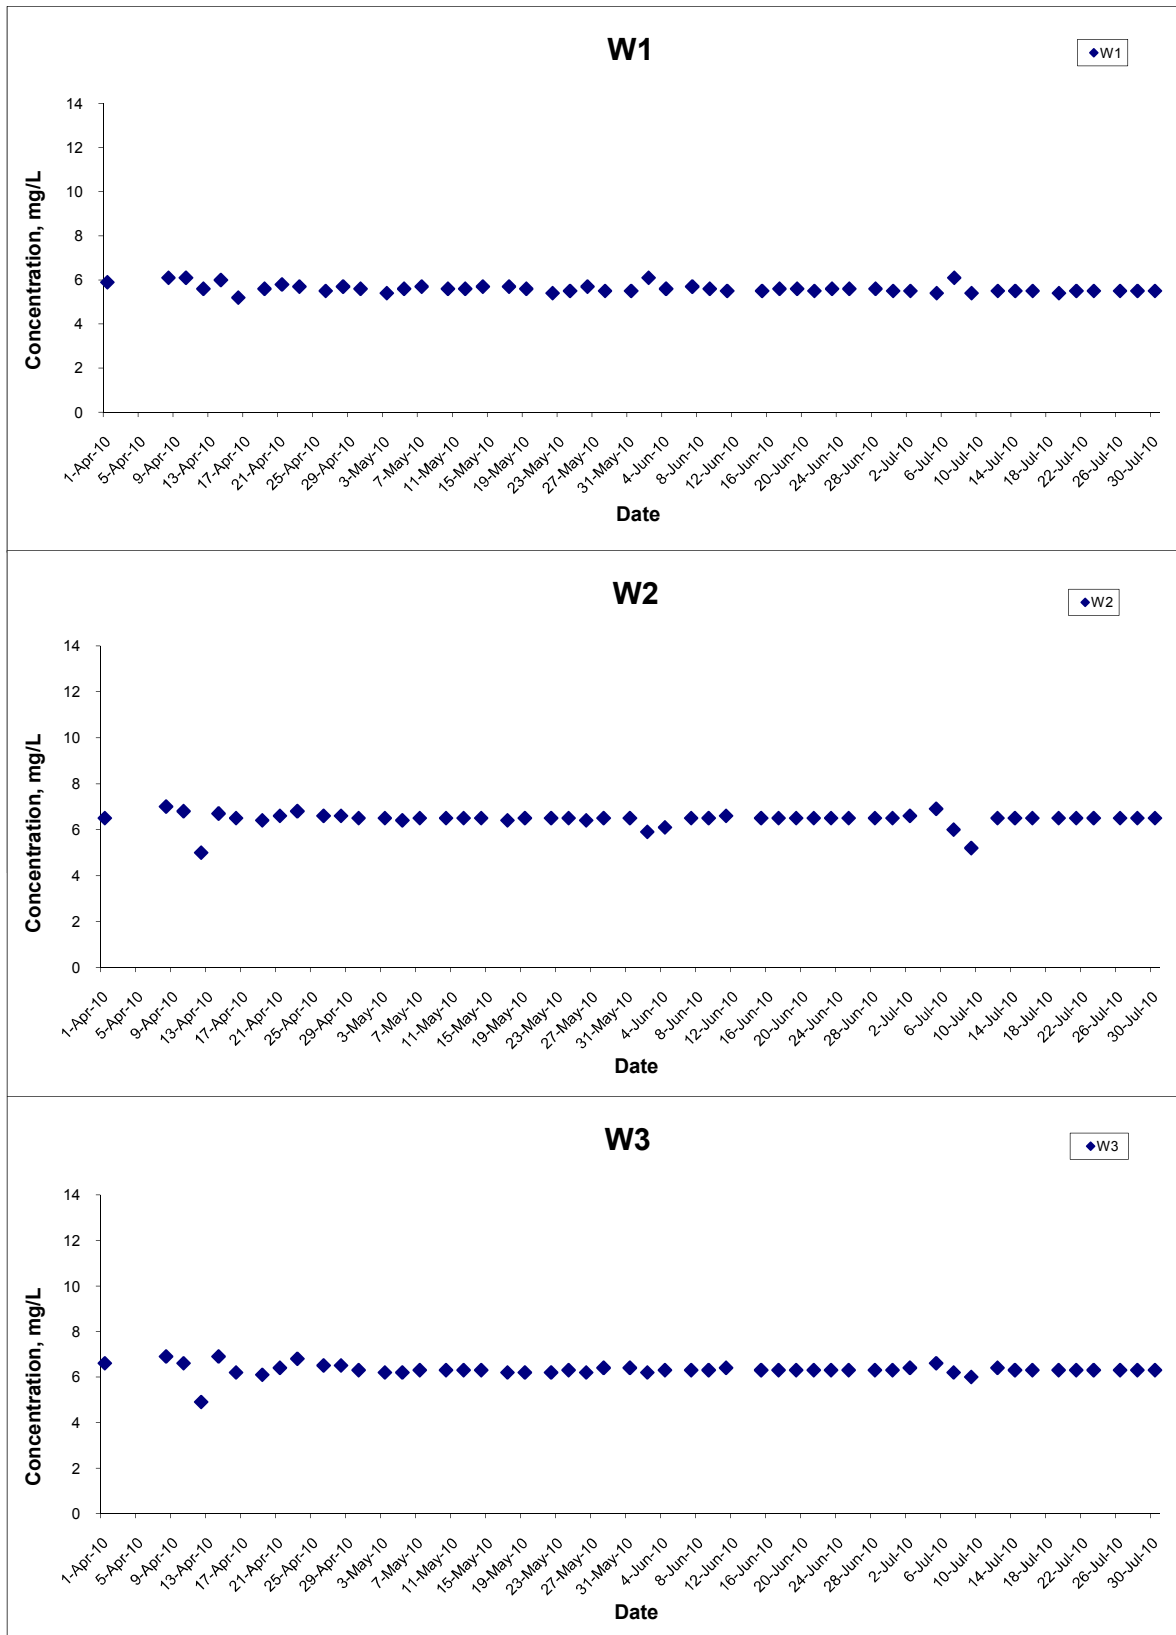
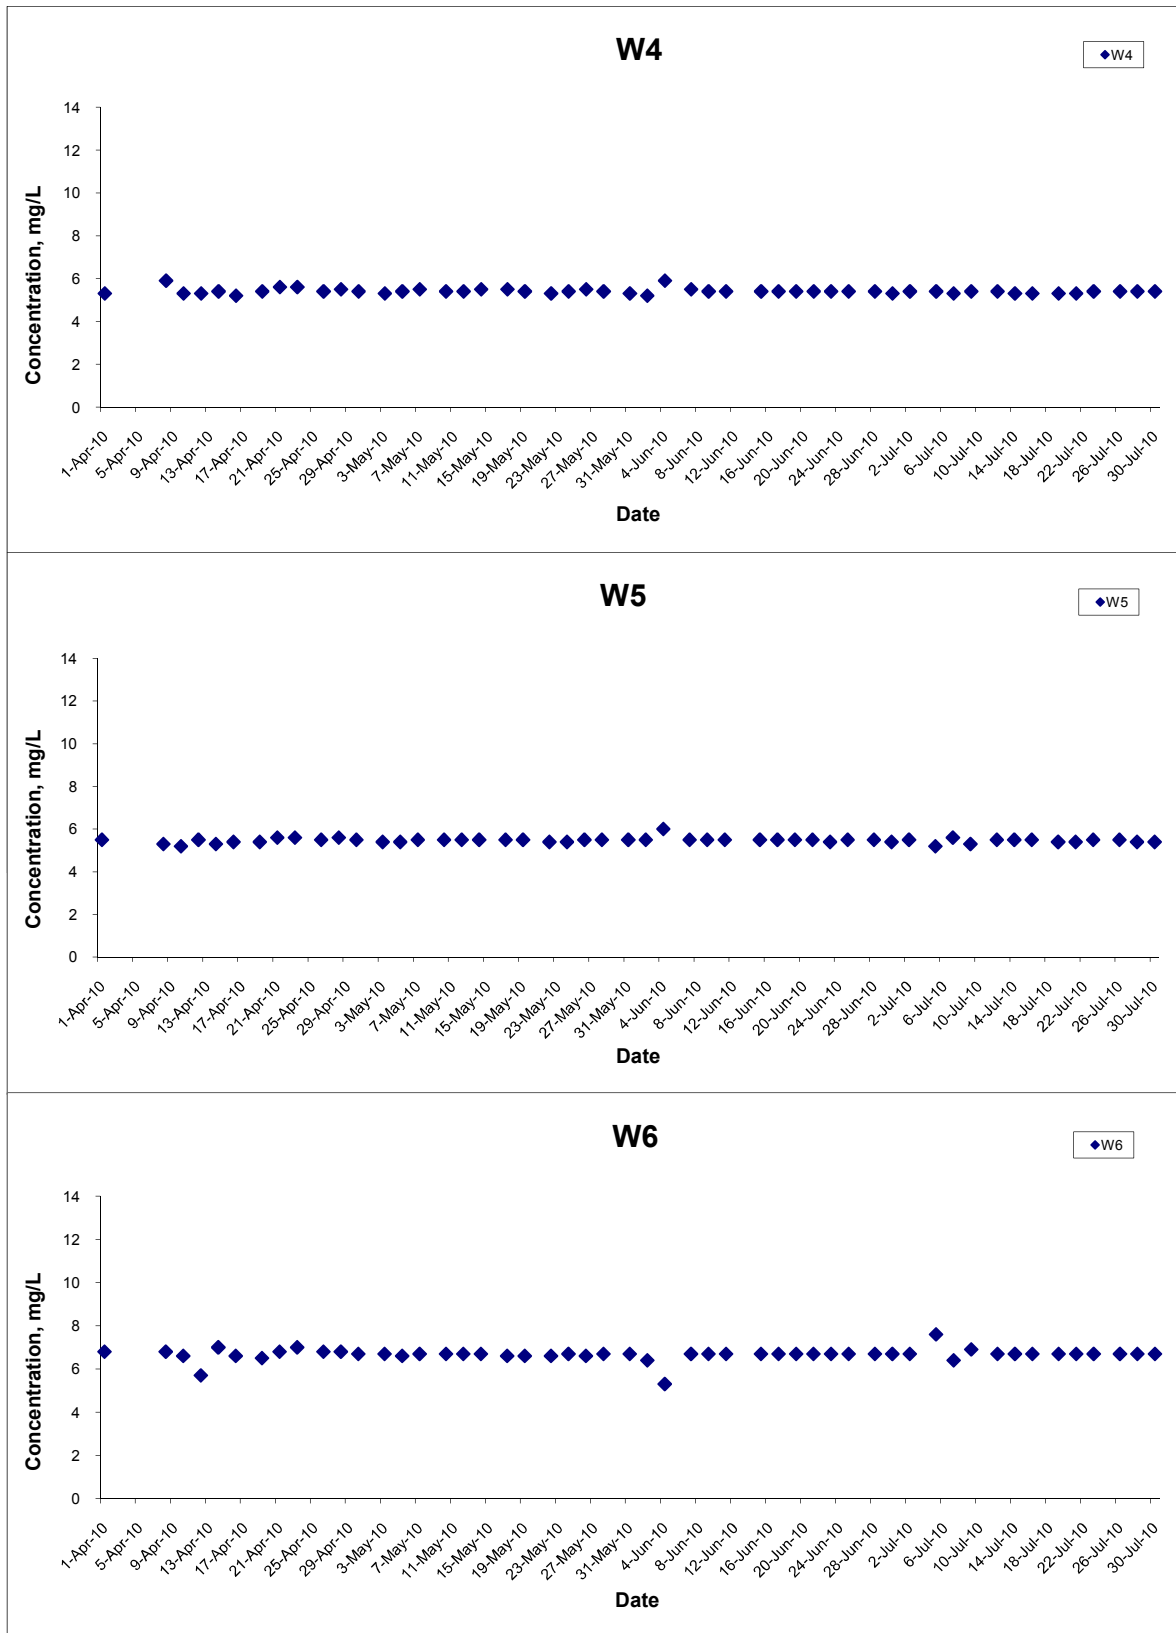
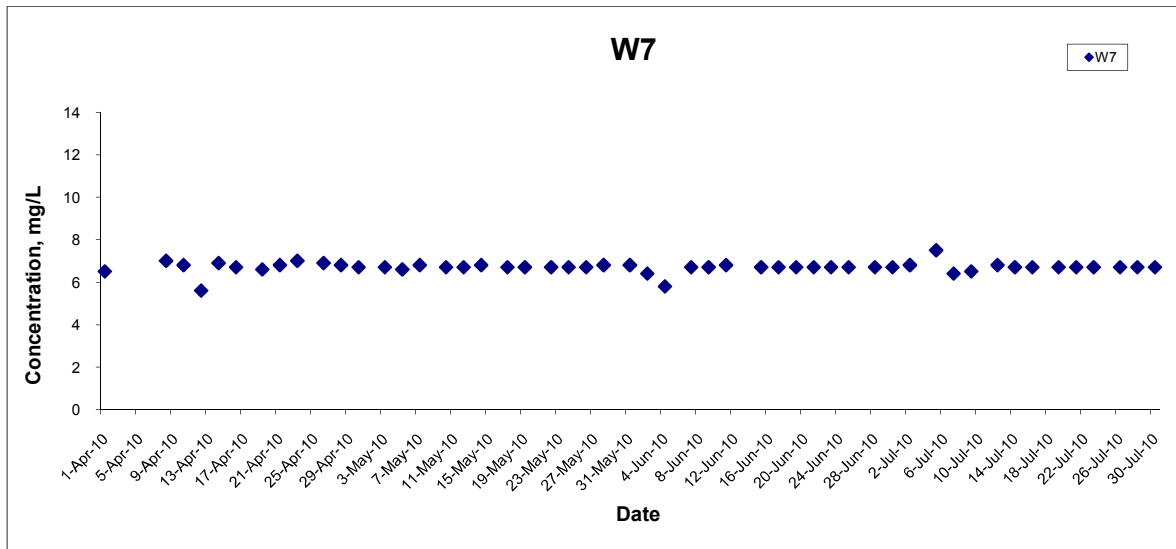
Dissolved Oxygen (Surface & Middle) at Mid-Ebb Tide

Title Contract No. YL/2009/01 Hang Hau Tsuen Channel at Lau Fau Shan Graphical Presentation of Water Quality Monitoring Results	Scale N.T.S	Project No. MA0002	
	Date Jul 10	Appendix H

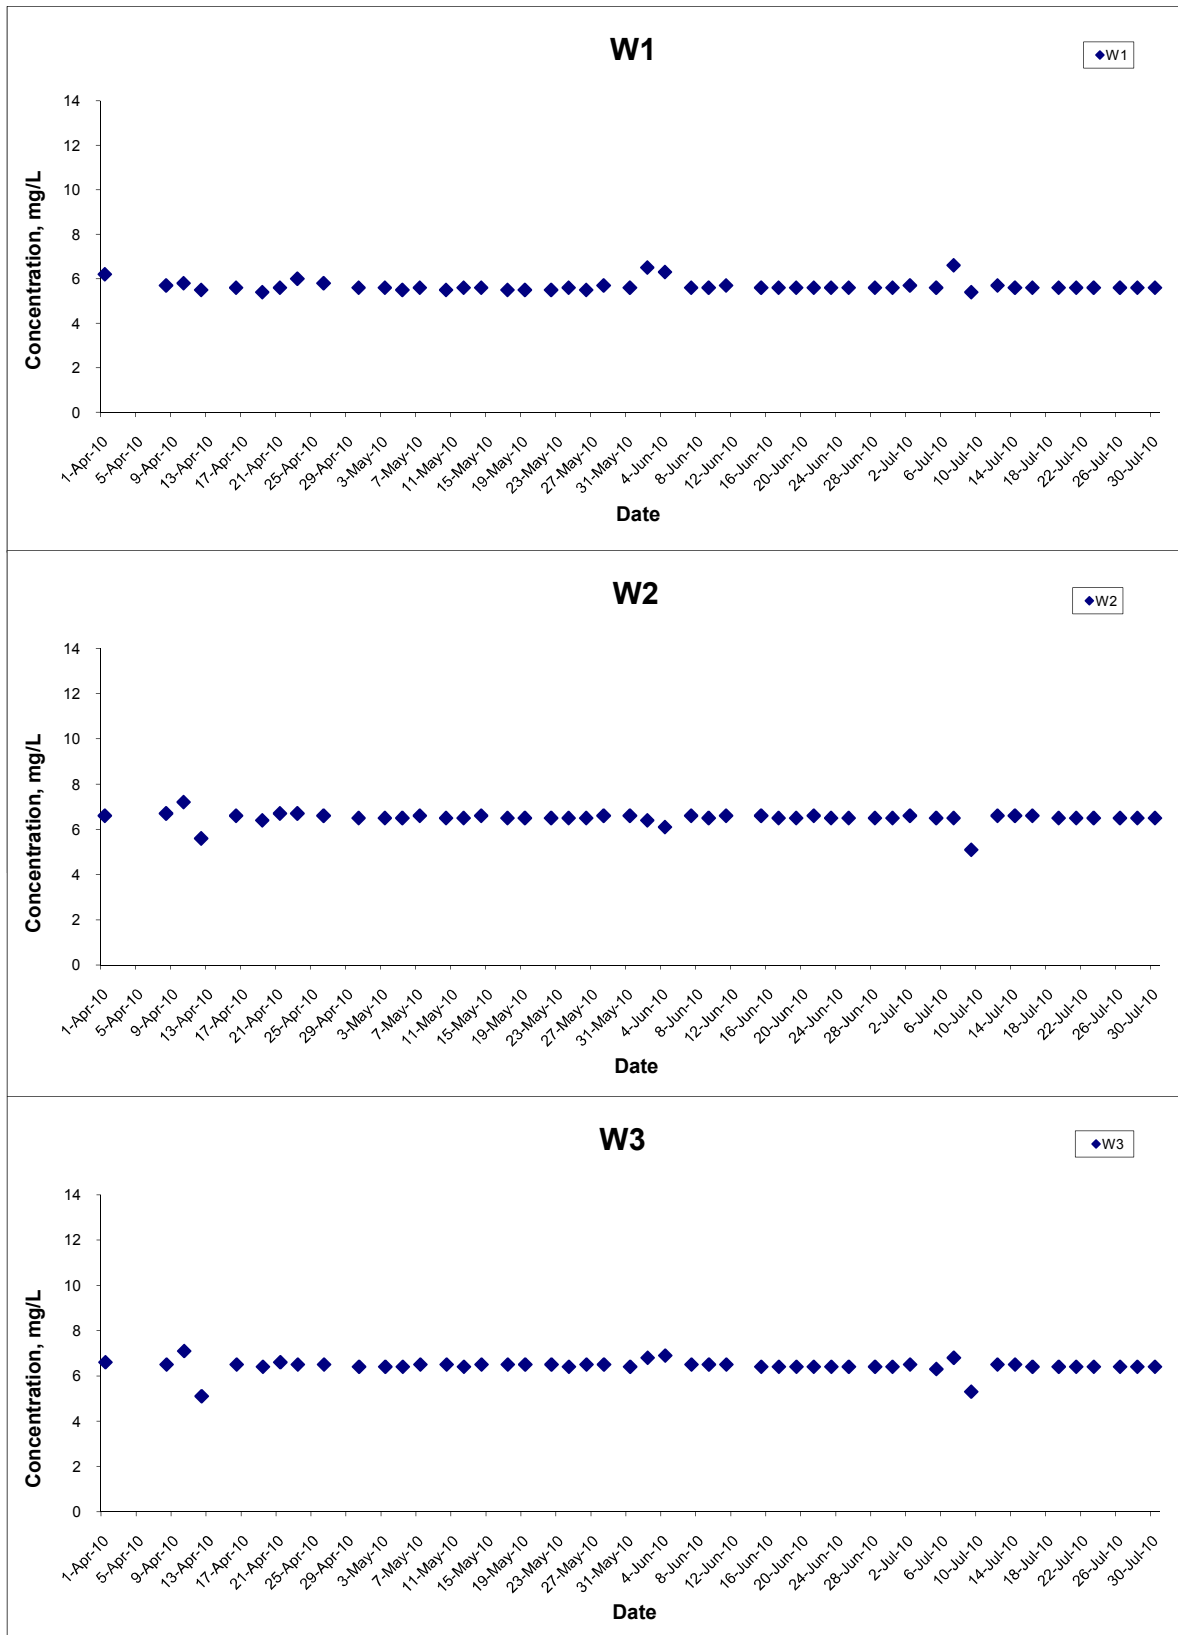
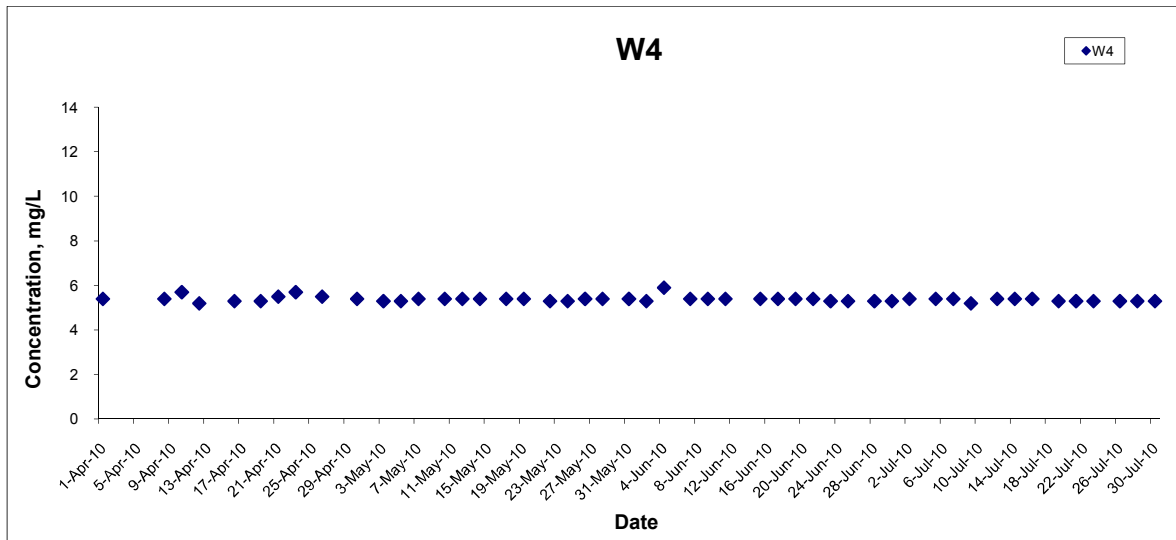
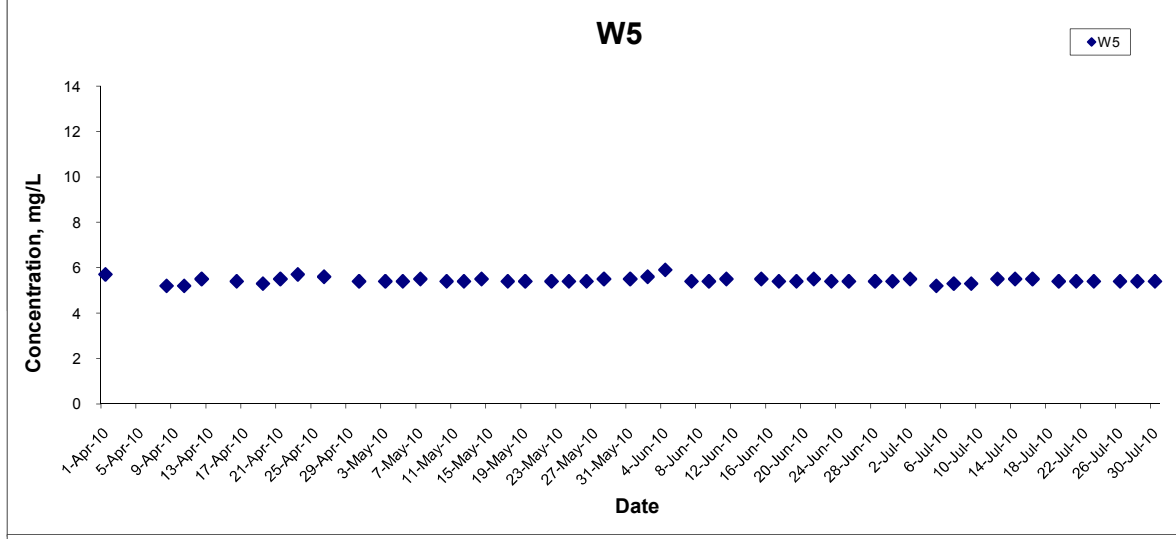
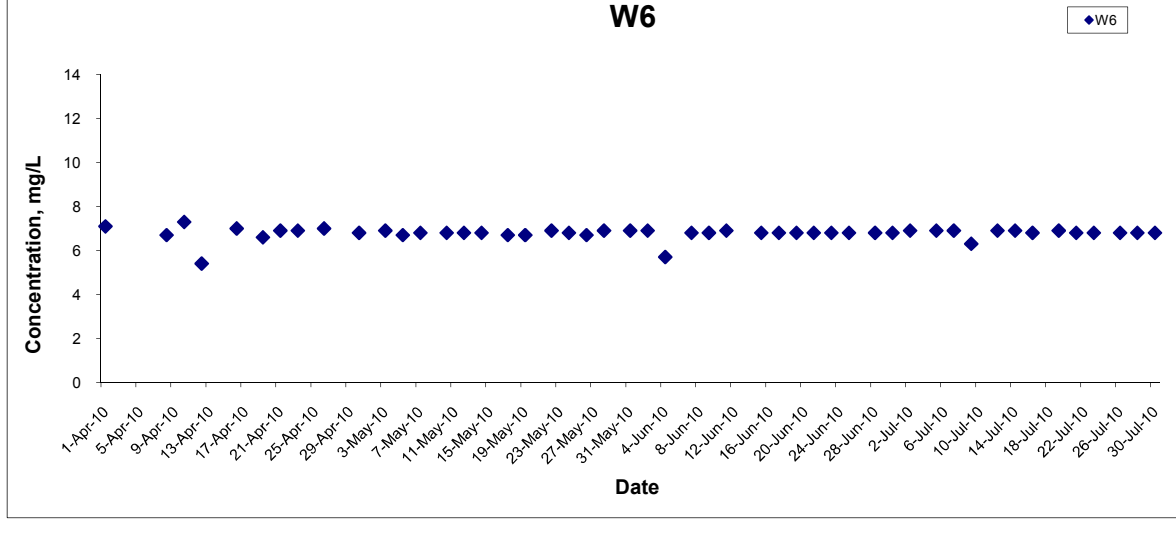
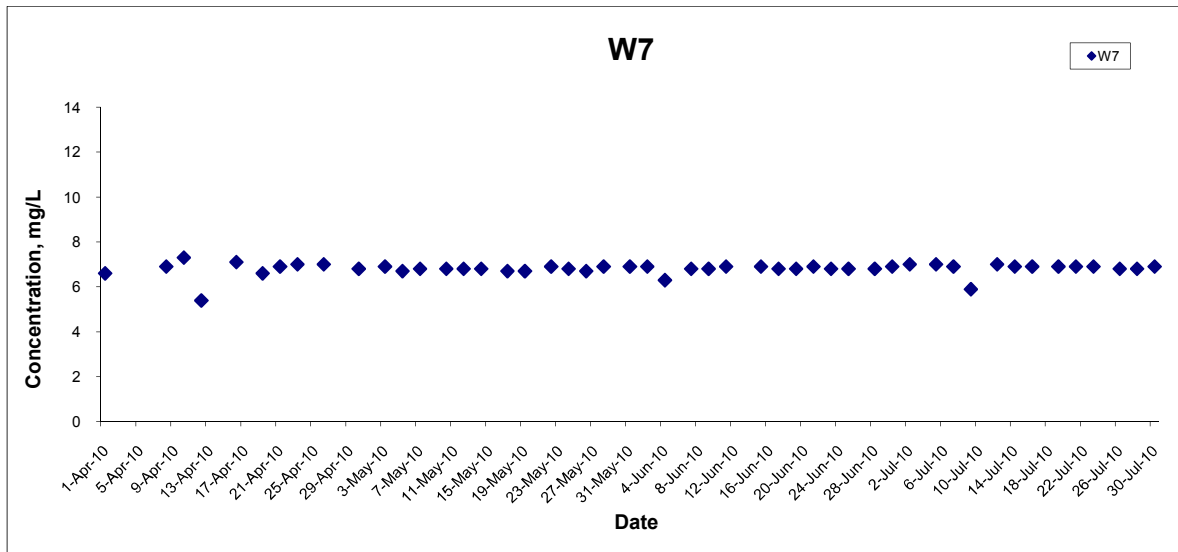
Dissolved Oxygen (Surface & Middle) at Mid-Flood Tide

Title Contract No. YL/2009/01 Hang Hau Tsuen Channel at Lau Fau Shan Graphical Presentation of Water Quality Monitoring Results	Scale	N.T.S	Project No. MA0002	CINOTECH
	Date	Jul 10	Appendix H

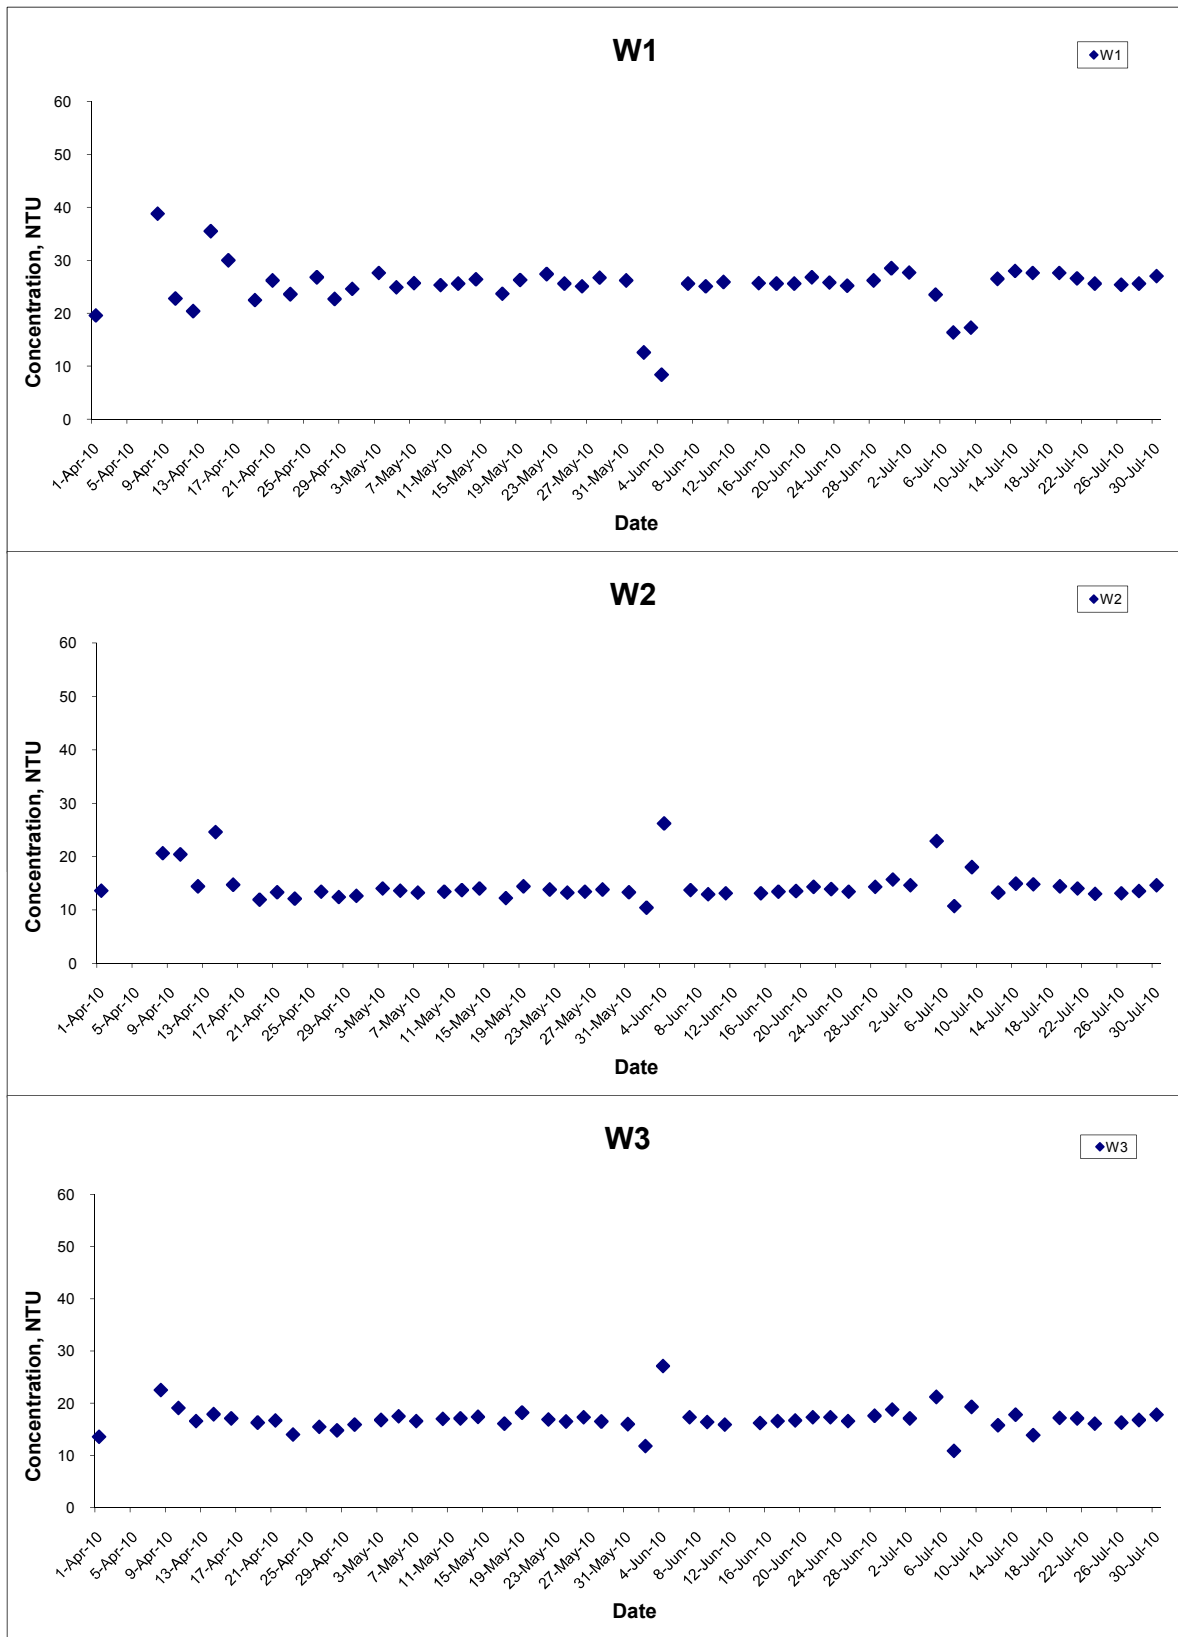
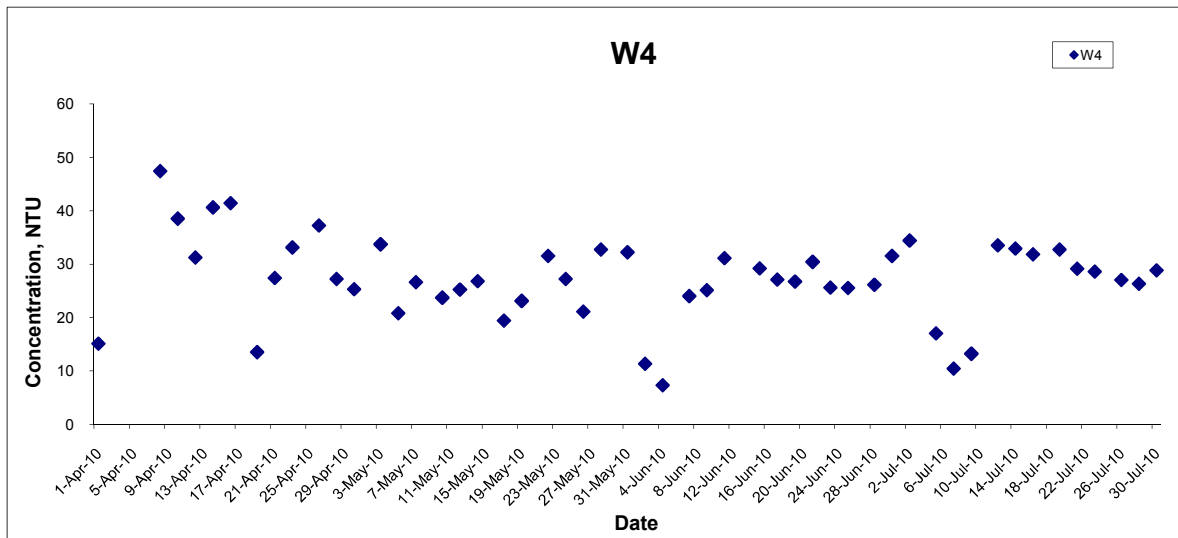
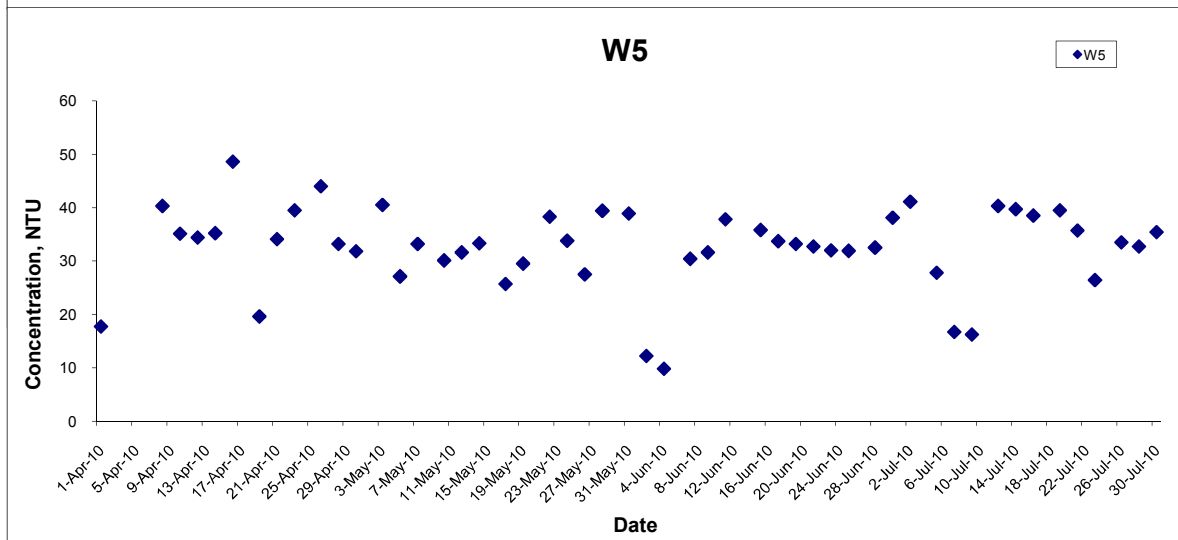
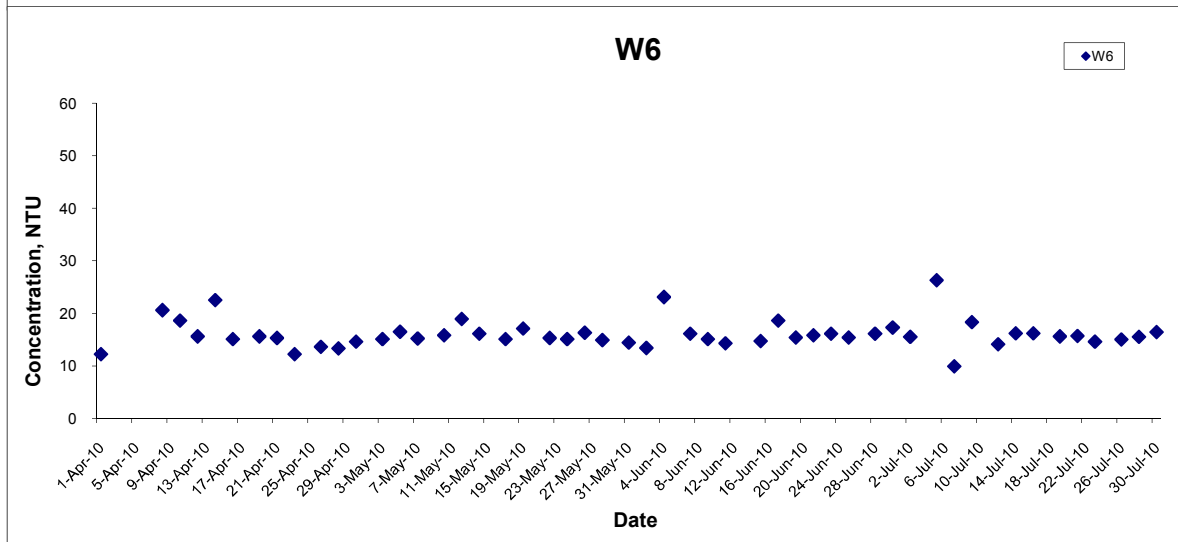
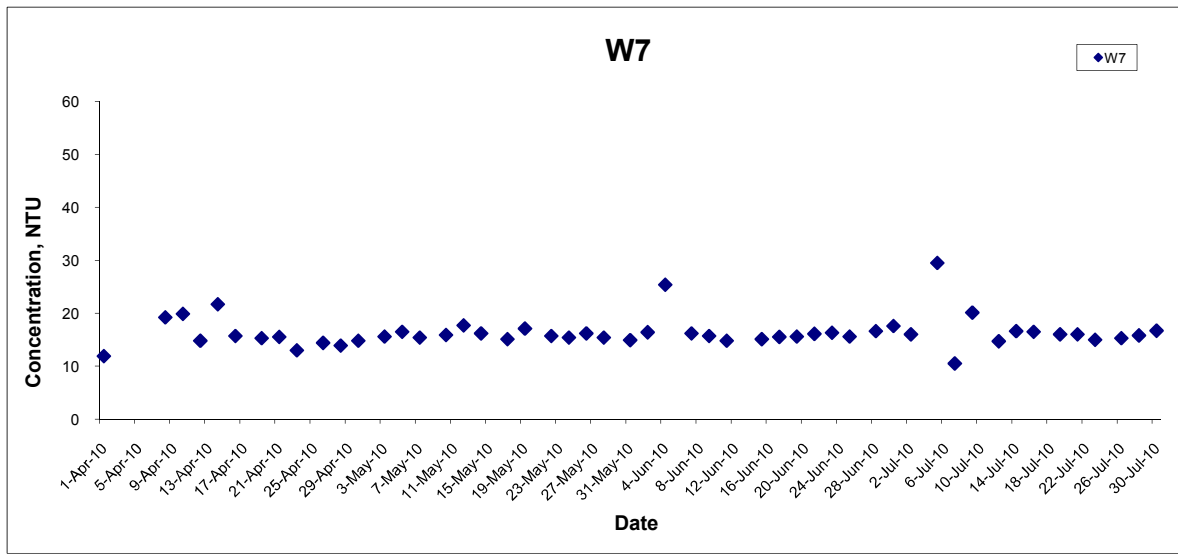
Turbidity (Depth-averaged) at Mid-Ebb Tide

Title Contract No. YL/2009/01 Hang Hau Tsuen Channel at Lau Fau Shan Graphical Presentation of Water Quality Monitoring Results	Scale N.T.S	Project No. MA0002	
	Date Jul 10	Appendix H
