KWAN ON CONSTRUCTION CO. LTD.

**Contract No. YL/2009/01
Hang Hau Tsuen Channel
at Lau Fau Shan**

**Monthly Environmental Monitoring and Audit Report
July 2010 (Version 1.1)**

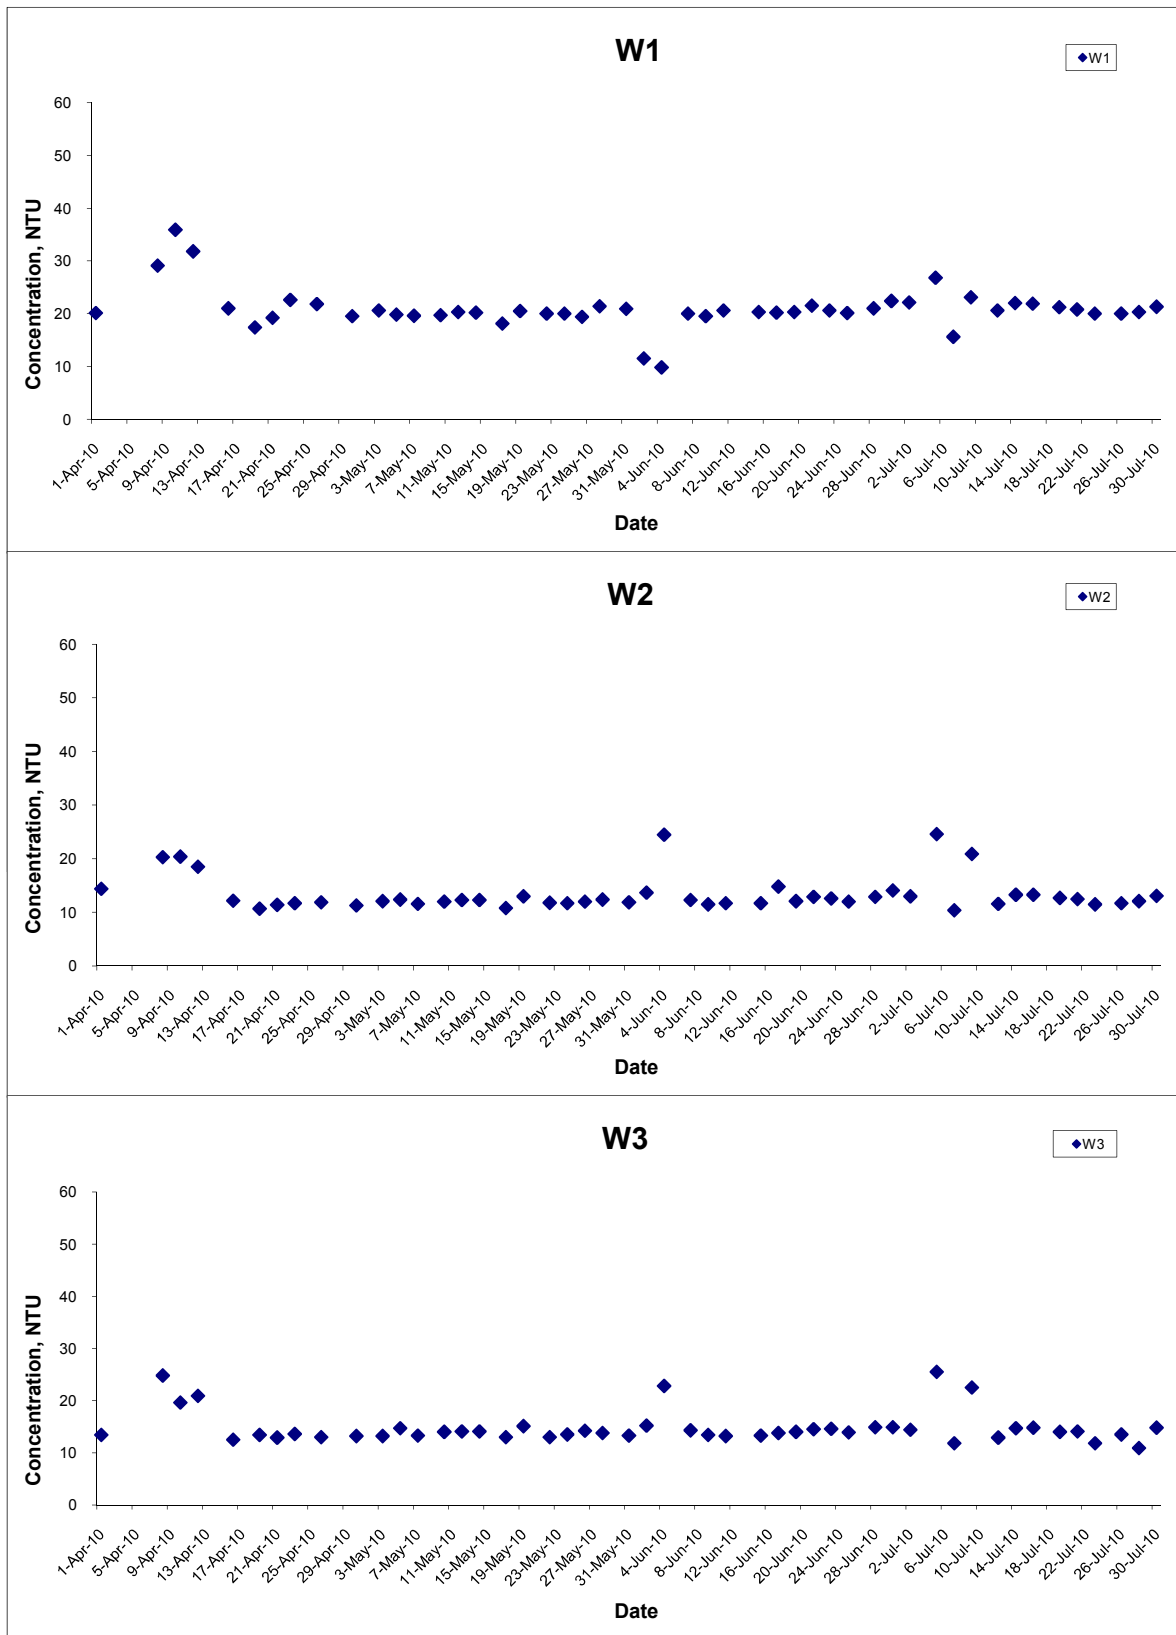
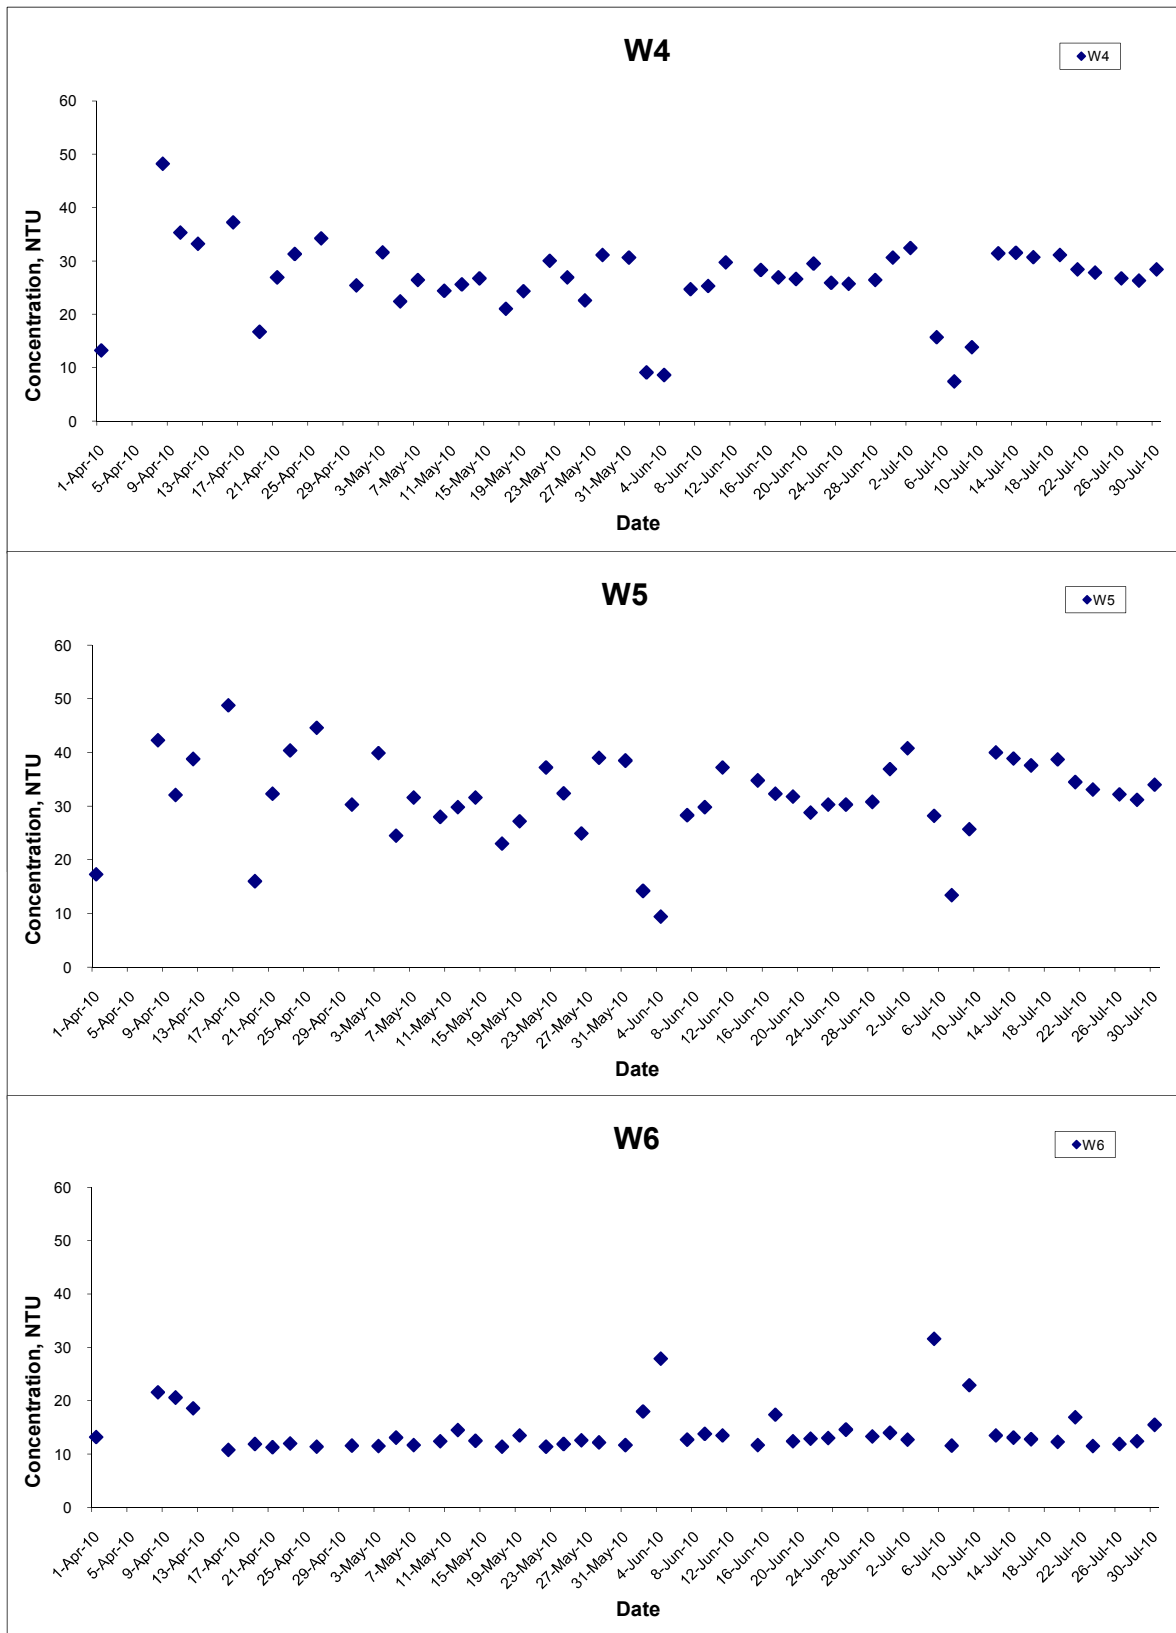
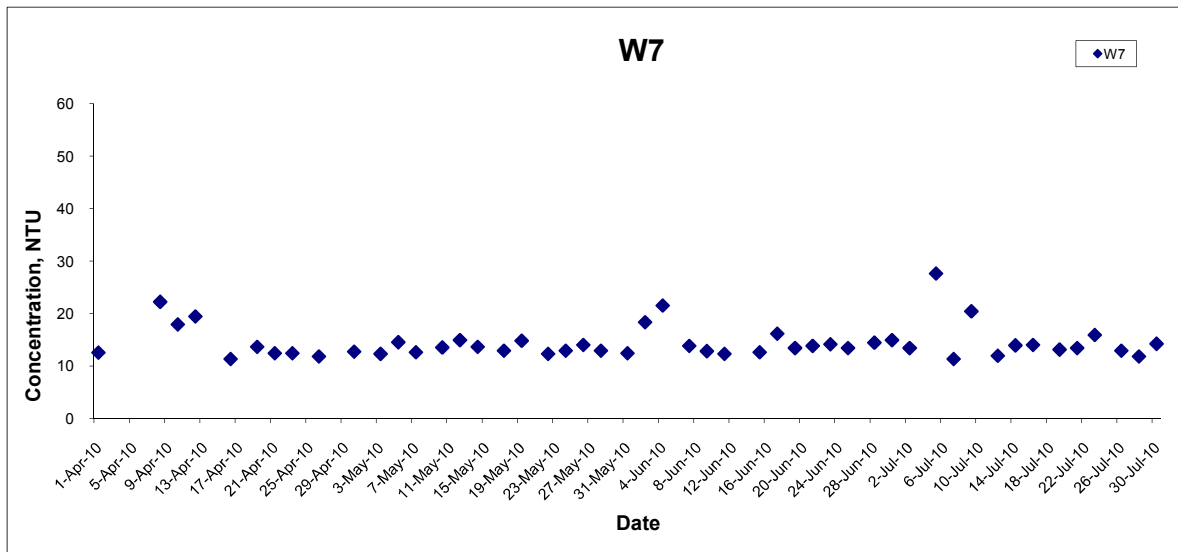
Turbidity (Depth-averaged) at Mid-Flood Tide

Title Contract No. YL/2009/01 Hang Hau Tsuen Channel at Lau Fau Shan Graphical Presentation of Water Quality Monitoring Results	Scale	N.T.S	Project No. MA0002	CINOTECH
	Date	Jul 10	Appendix H

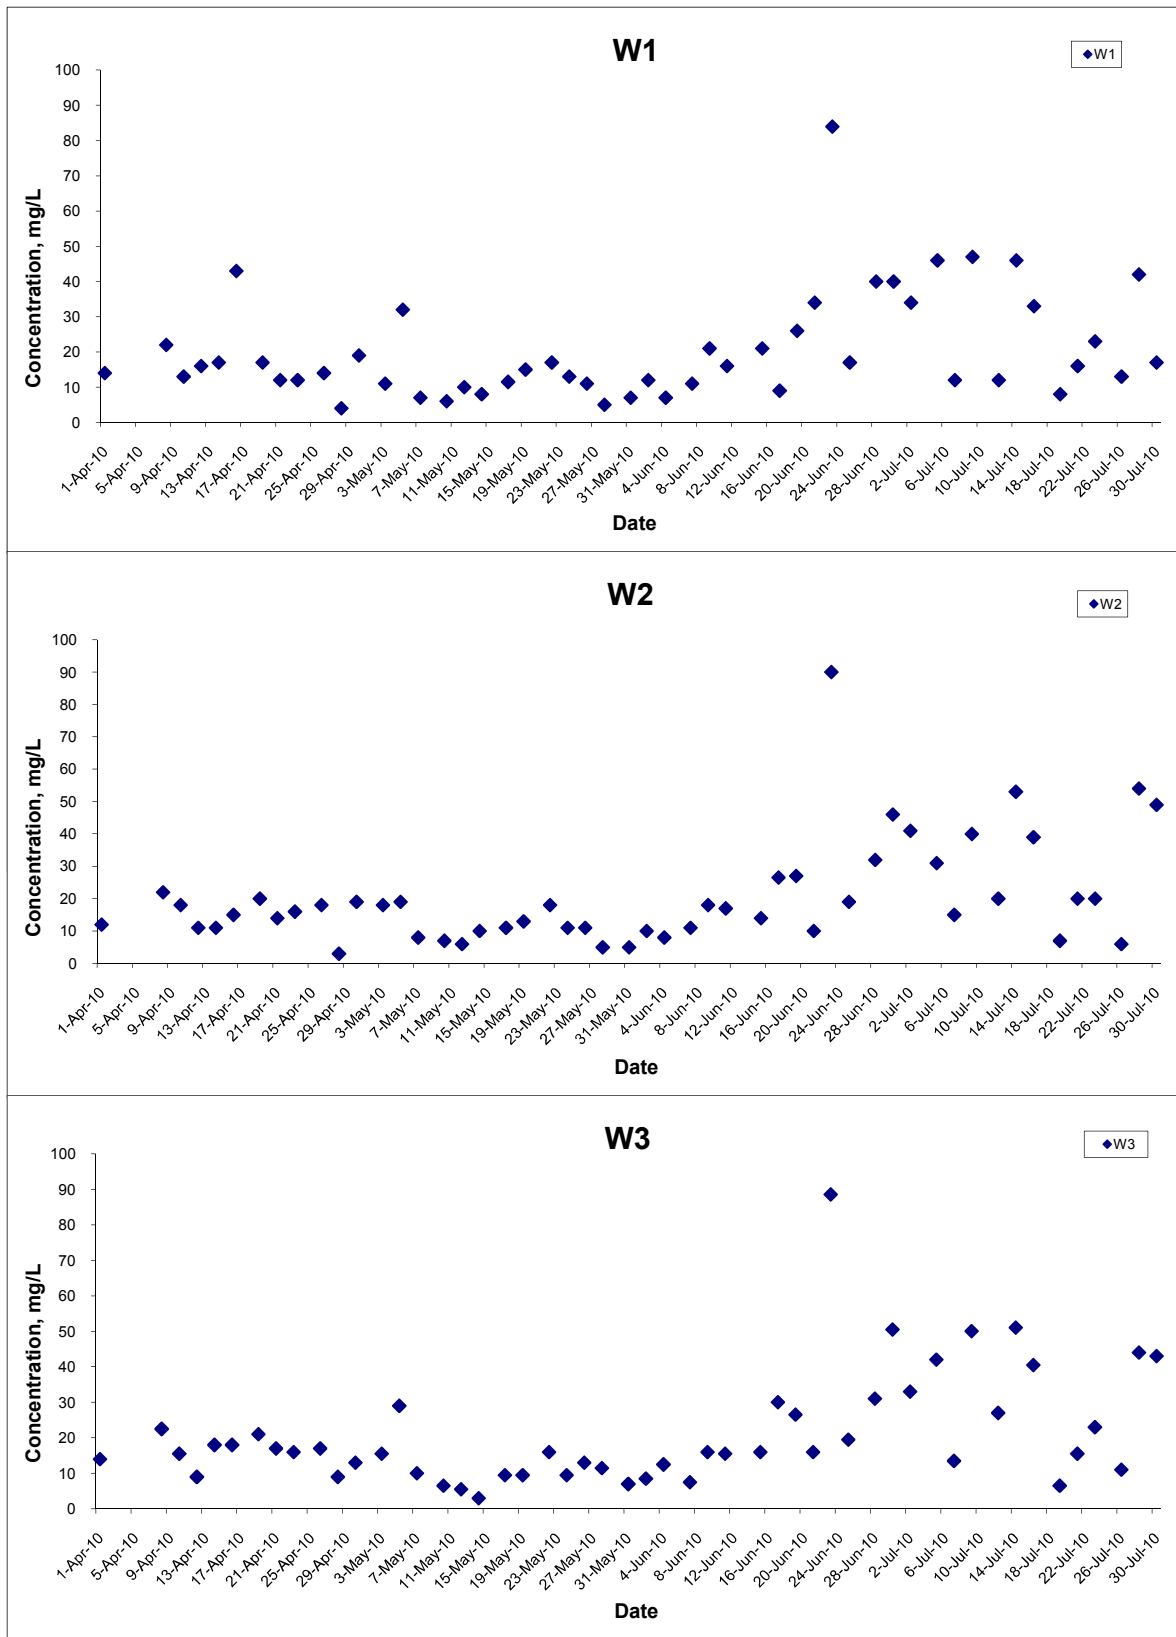
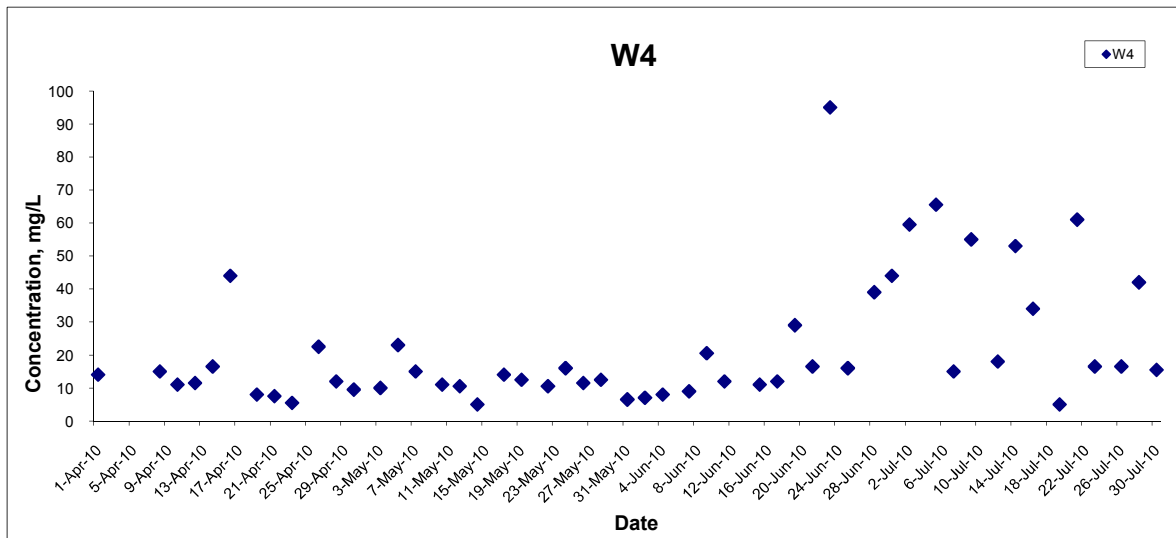
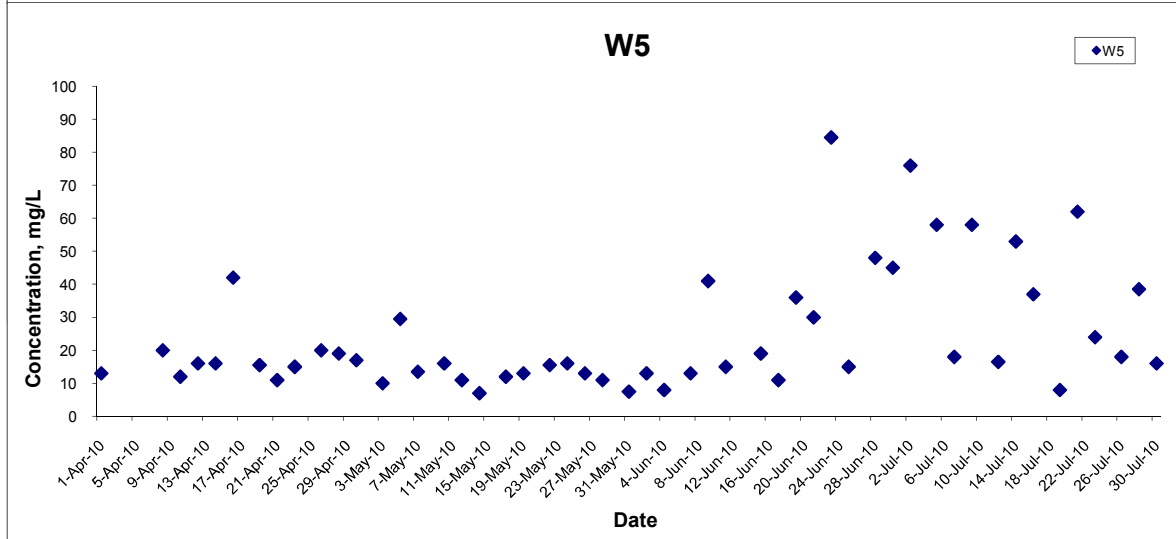
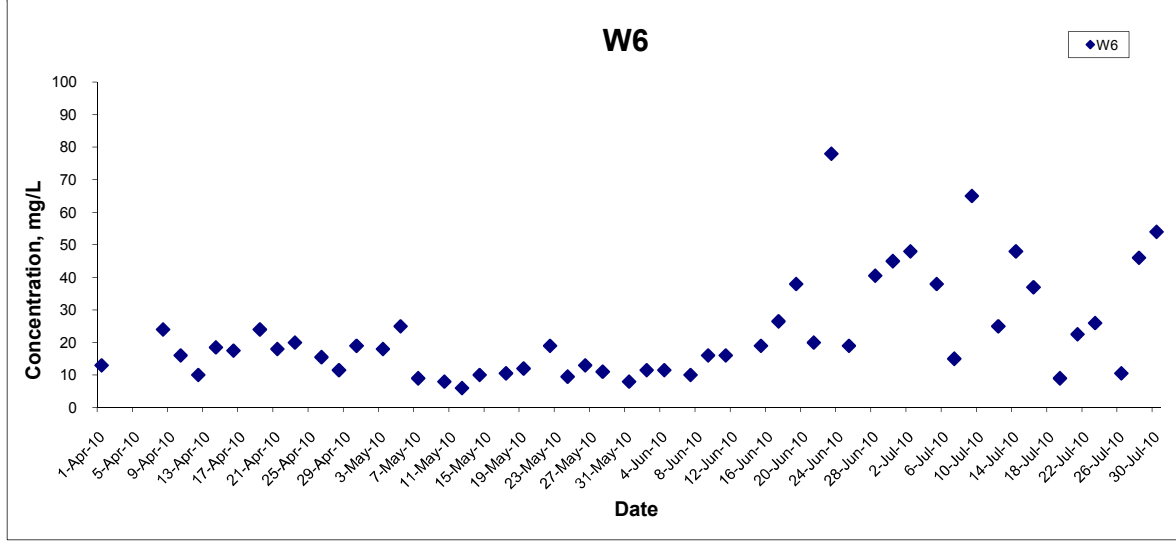
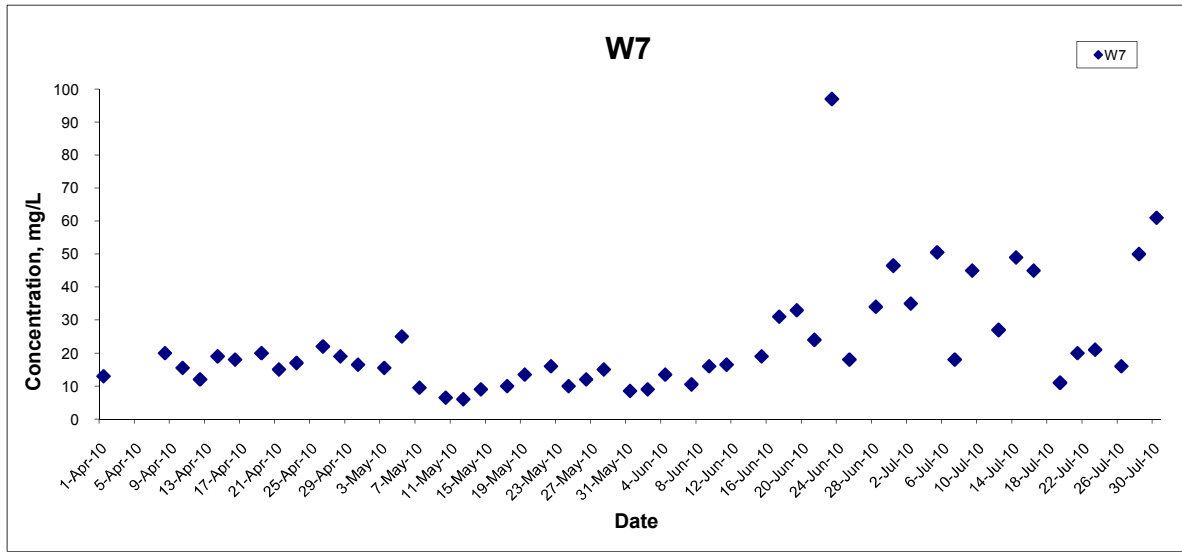
Suspended Solids (Depth-averaged) at Mid-Ebb Tide

Title Contract No. YL/2009/01 Hang Hau Tsuen Channel at Lau Fau Shan Graphical Presentation of Water Quality Monitoring Results	Scale N.T.S	Project No. MA0002	
	Date Jul 10	Appendix H

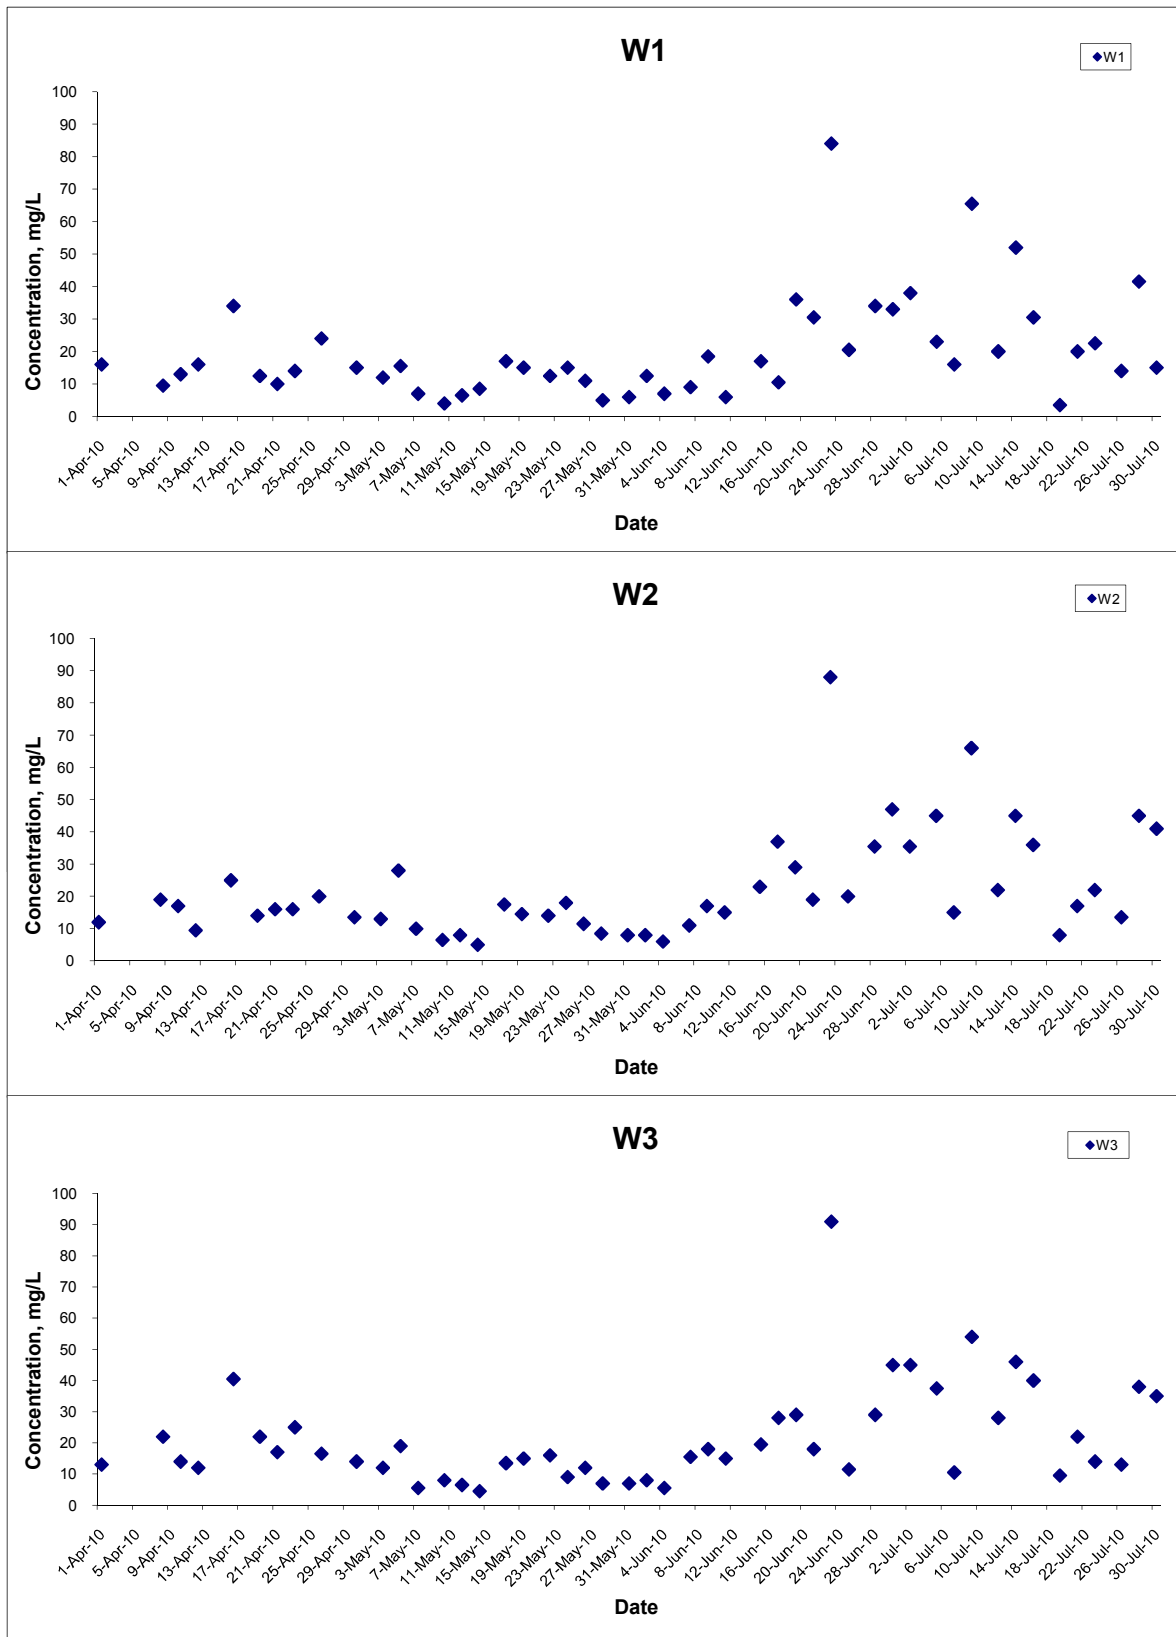
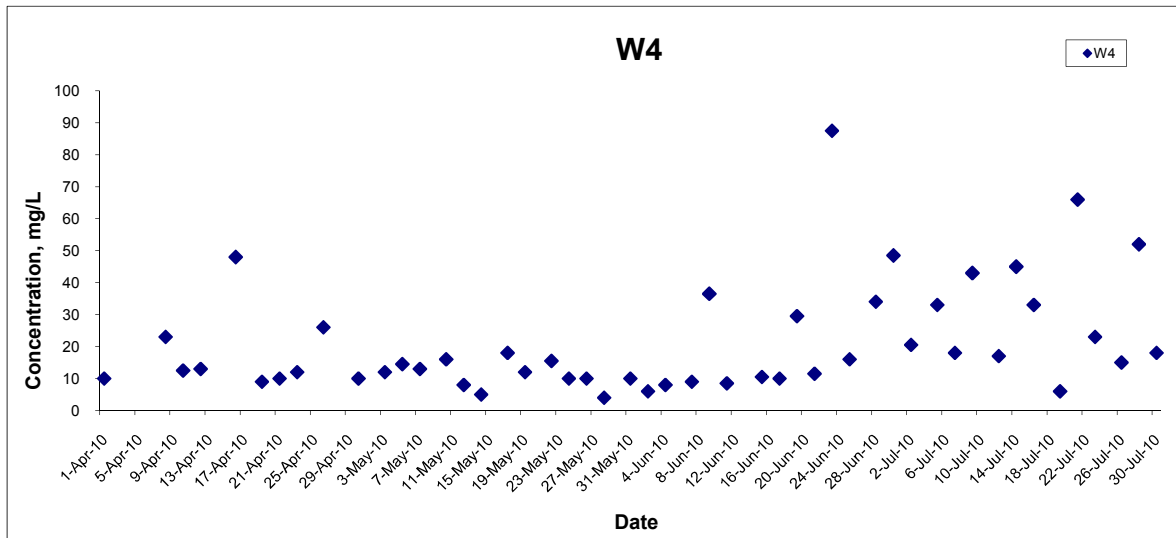
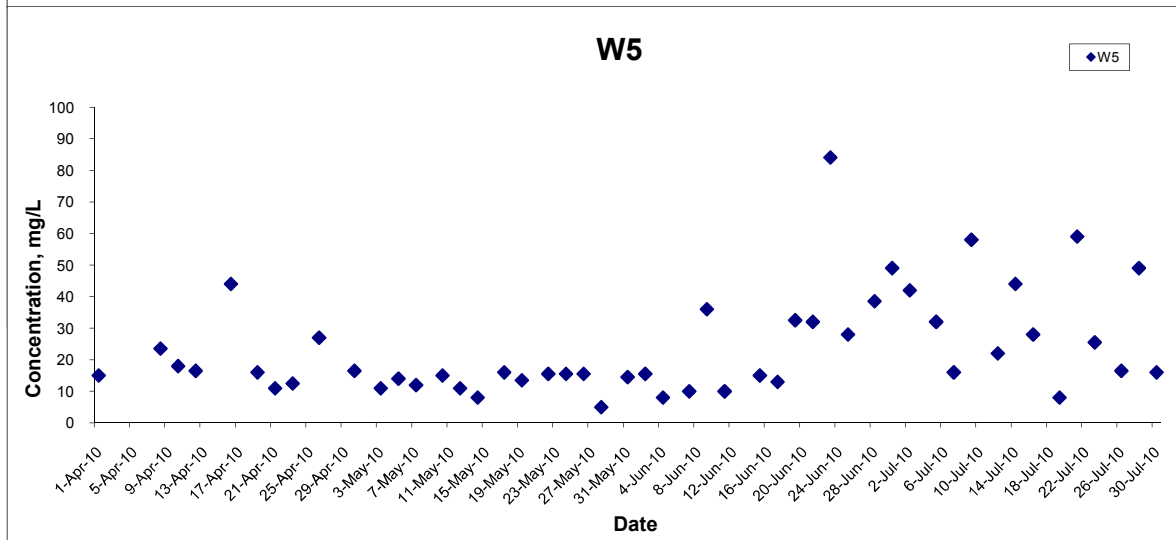
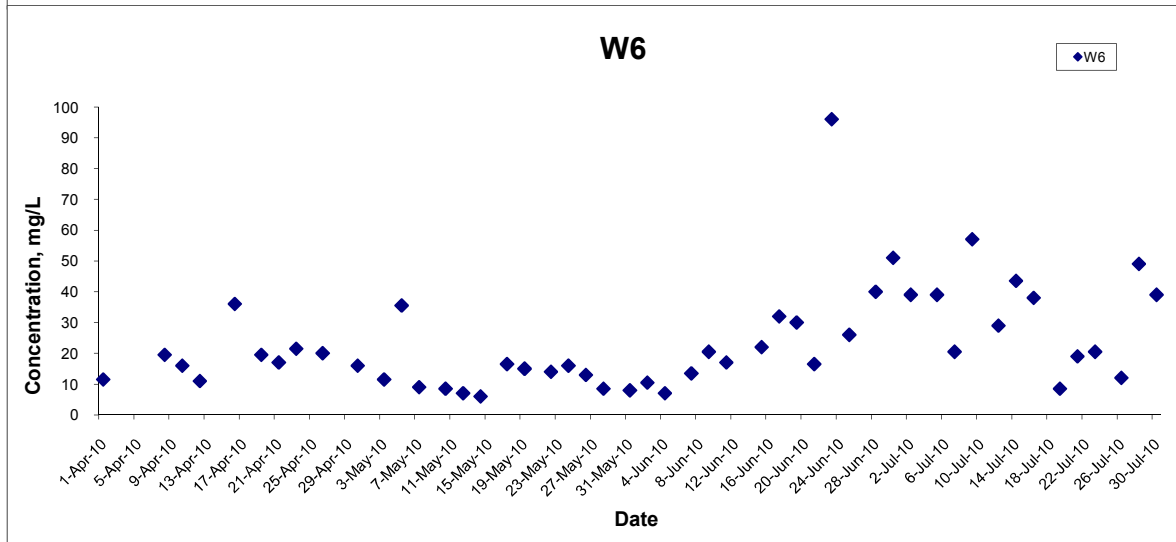
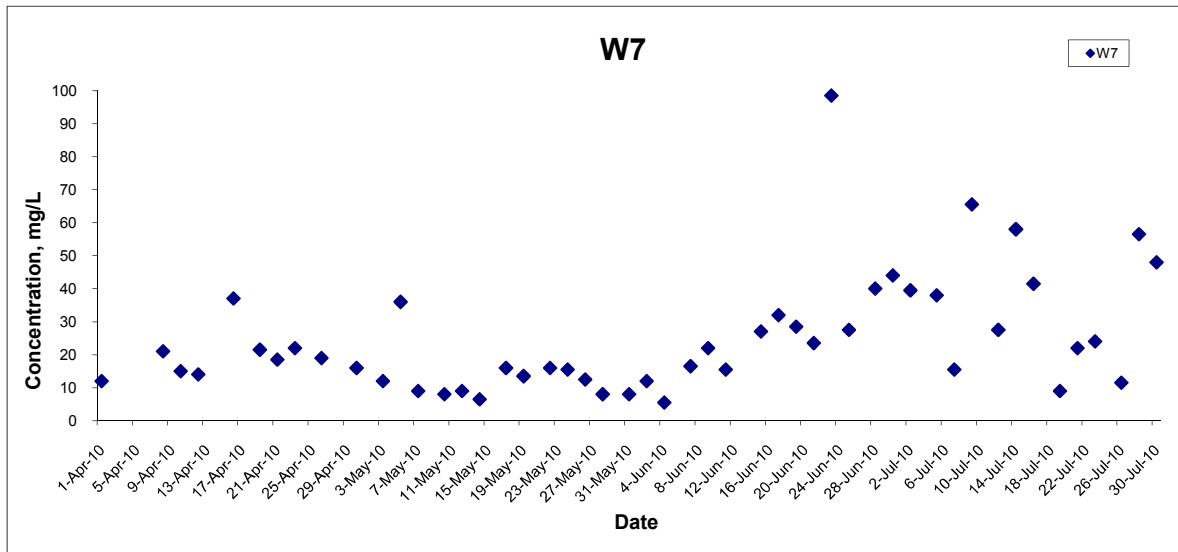
Suspended Solids (Depth-averaged) at Mid-Flood Tide

Title Contract No. YL/2009/01 Hang Hau Tsuen Channel at Lau Fau Shan Graphical Presentation of Water Quality Monitoring Results	Scale N.T.S	Project No. MA0002	
	Date Jul 10	Appendix H
