**Contract No. YL/2009/01
Hang Hau Tsuen Channel
at Lau Fau Shan**

**Monthly Environmental Monitoring and Audit Report
September 2010 (Version 1.1)**

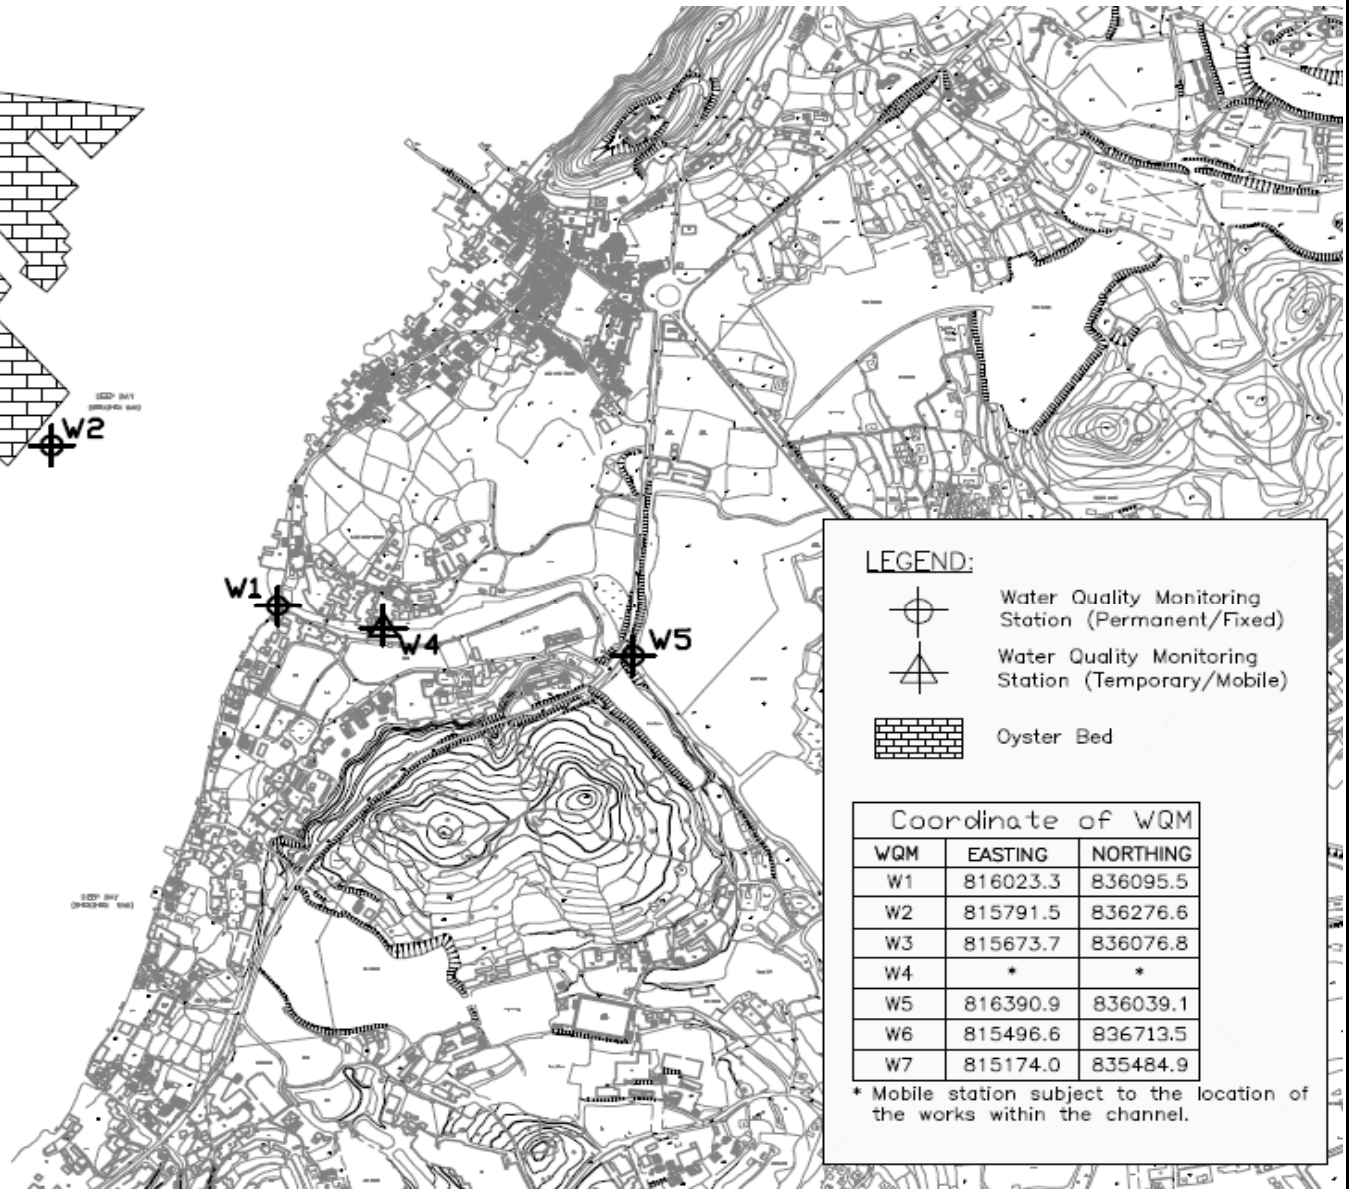
SCALE	N.T.S.	DATE	Jan-10
CHECK	CH	DRAWN	SL
JOB NO.	MA0002	DRAWING No.	Fig. 4
		Rev	-

* Mobile station subject to the location of the works within the channel.

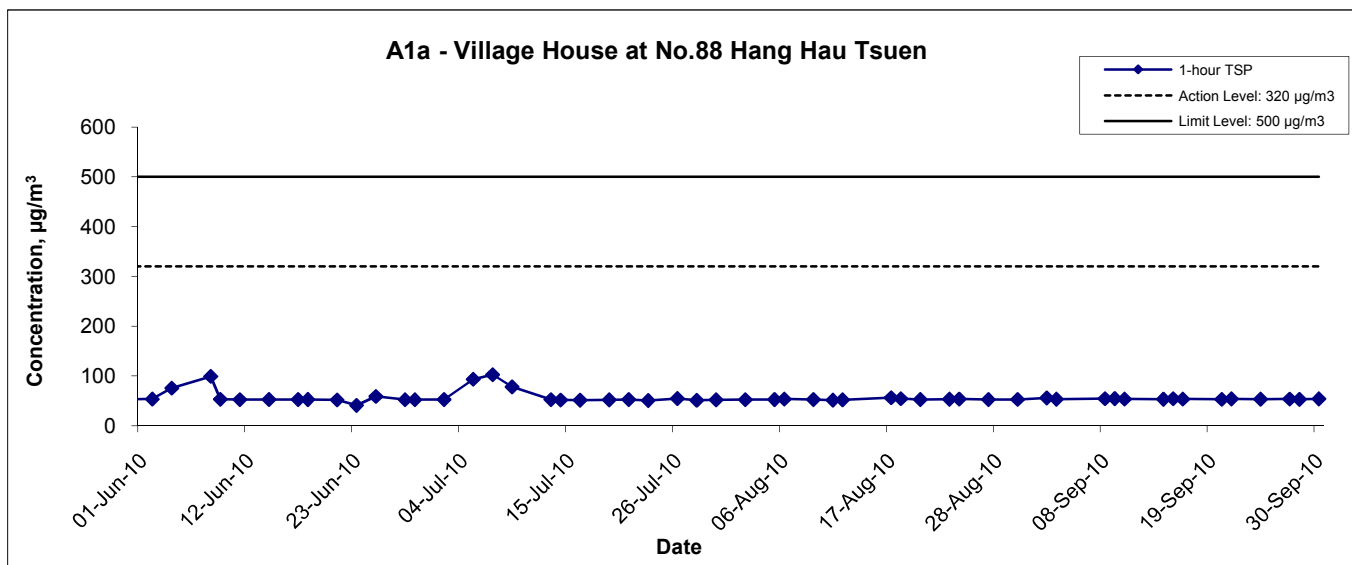
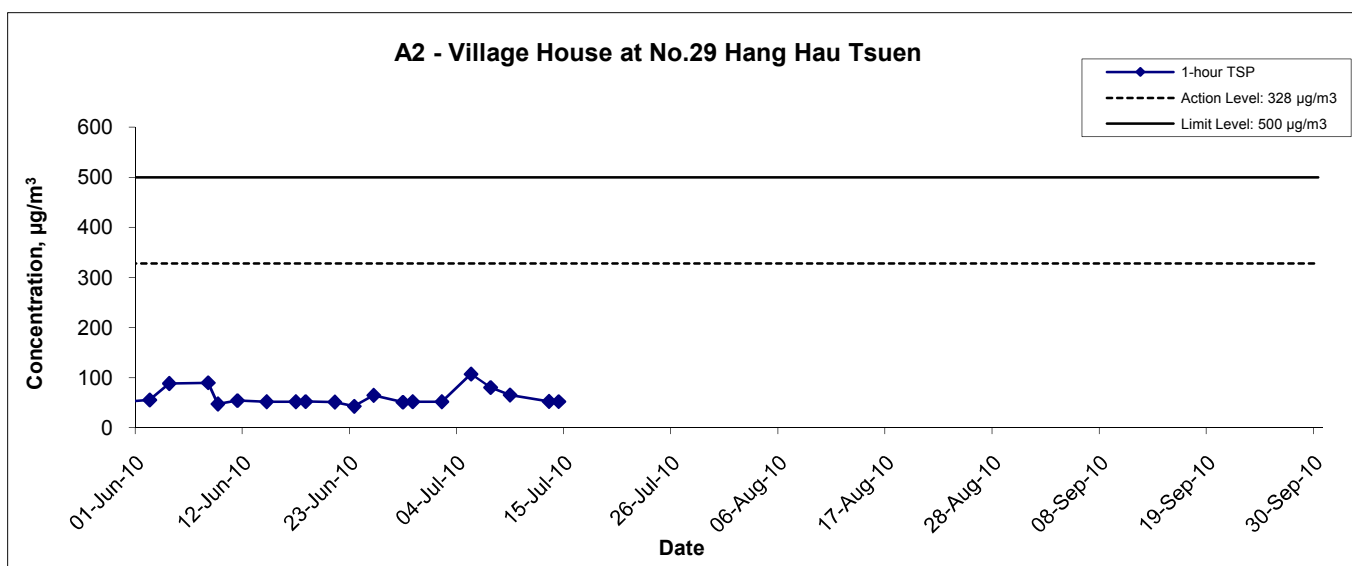
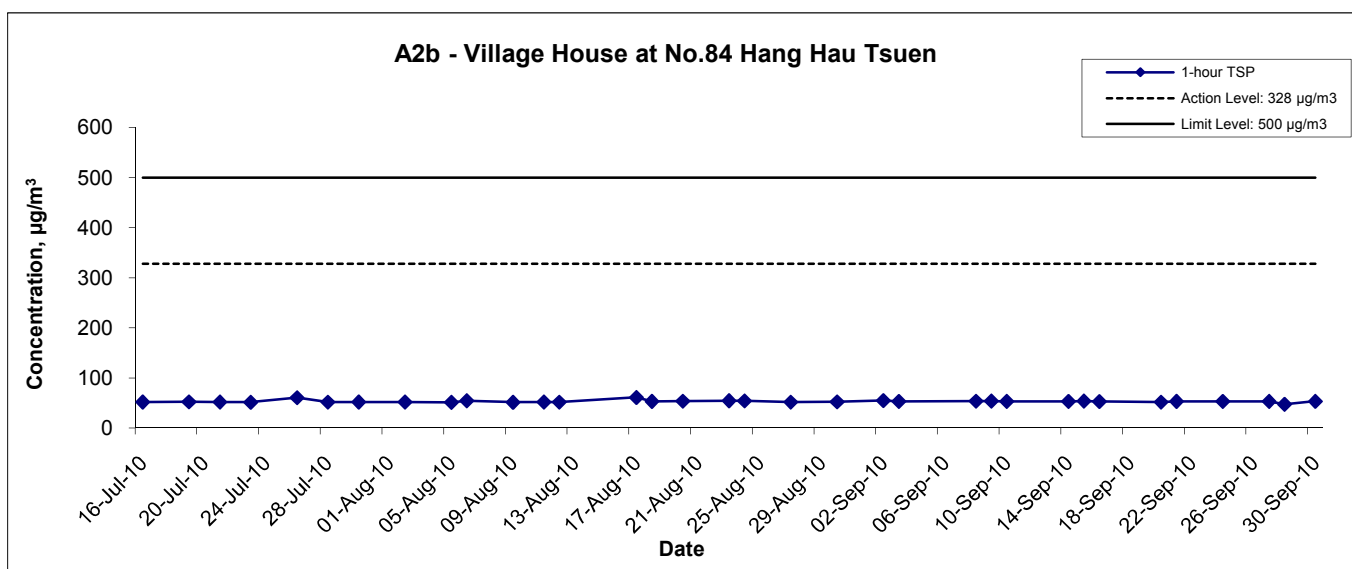
1-hr TSP Concentration Levels

Title Contract No. YL/2009/01 Hang Hau Tsuen Channel at Lau Fau Shan Graphical Presentation of 1-hour TSP Monitoring Results	Scale N.T.S	Project No. MA0002	
	Date Sep 10	Appendix E

- 2.23 The monitoring data and graphical presentations of 1-hour and 24-hour TSP monitoring results are shown in Appendices E and F respectively.
- 2.24 In accordance with Condition 4.2 of the EP, all environmental monitoring data was made available to the public via internet access at the website <http://www.cinotech.com.hk/projects/LFS>.

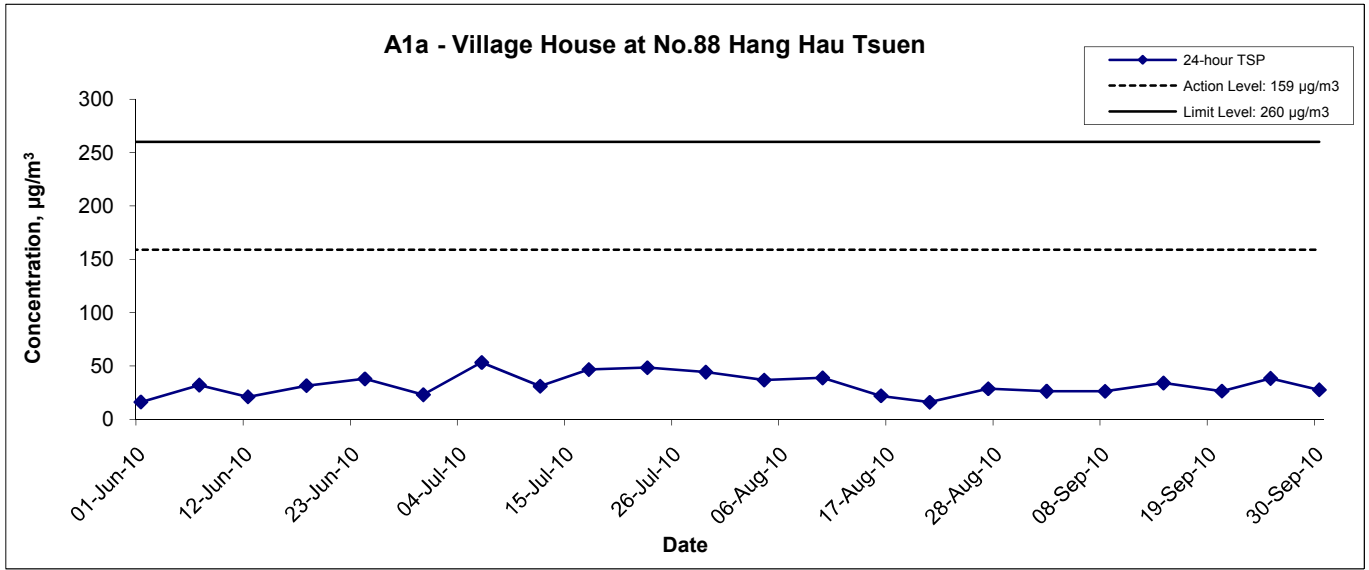
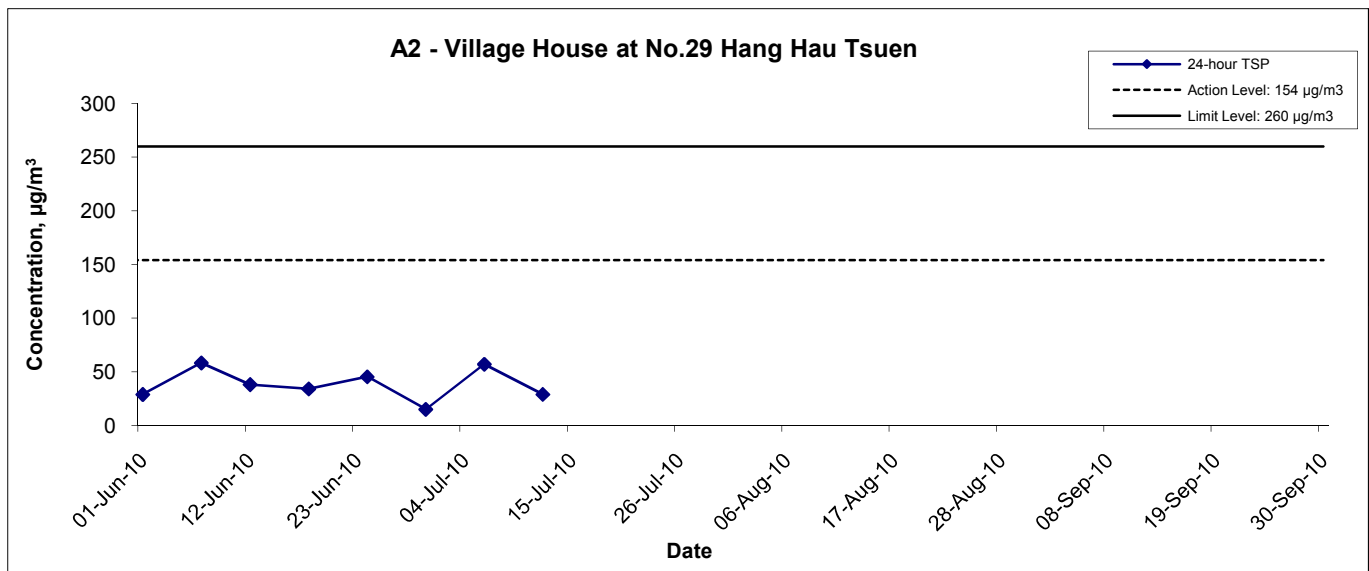
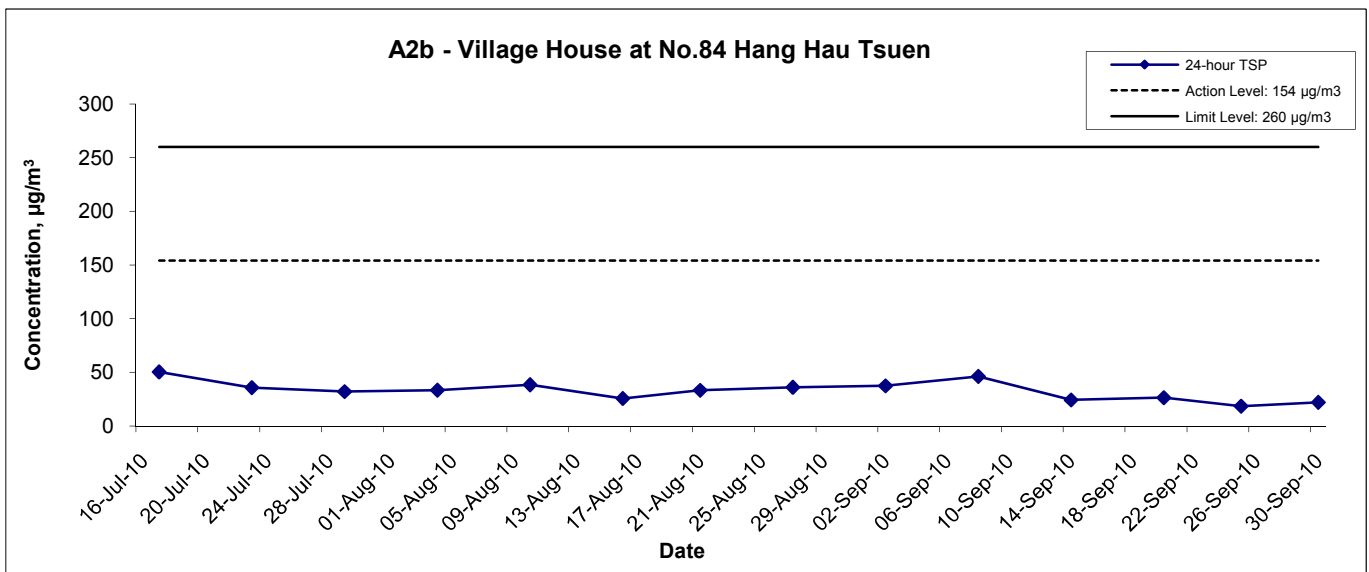
24-hr TSP Concentration Levels

Title Contract No. YL/2009/01 Hang Hau Tsuen Channel at Lau Fau Shan Graphical Presentation of 24-hour TSP Monitoring Results	Scale N.T.S	Project No. MA0002	<h1 style="margin: 0;">CINOTECH</h1>
	Date Sep 10	Appendix F

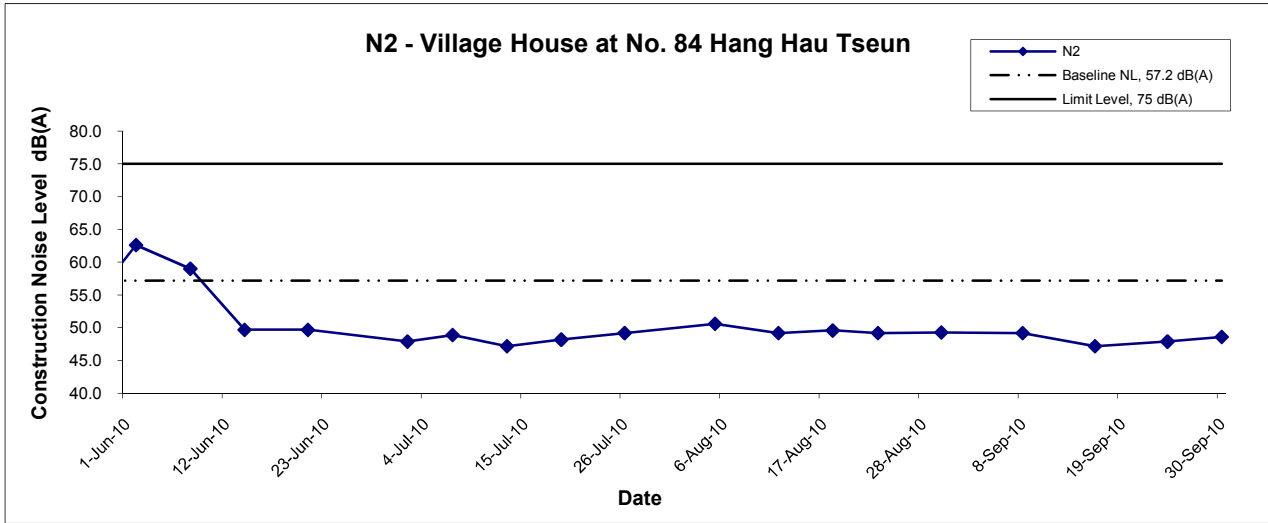
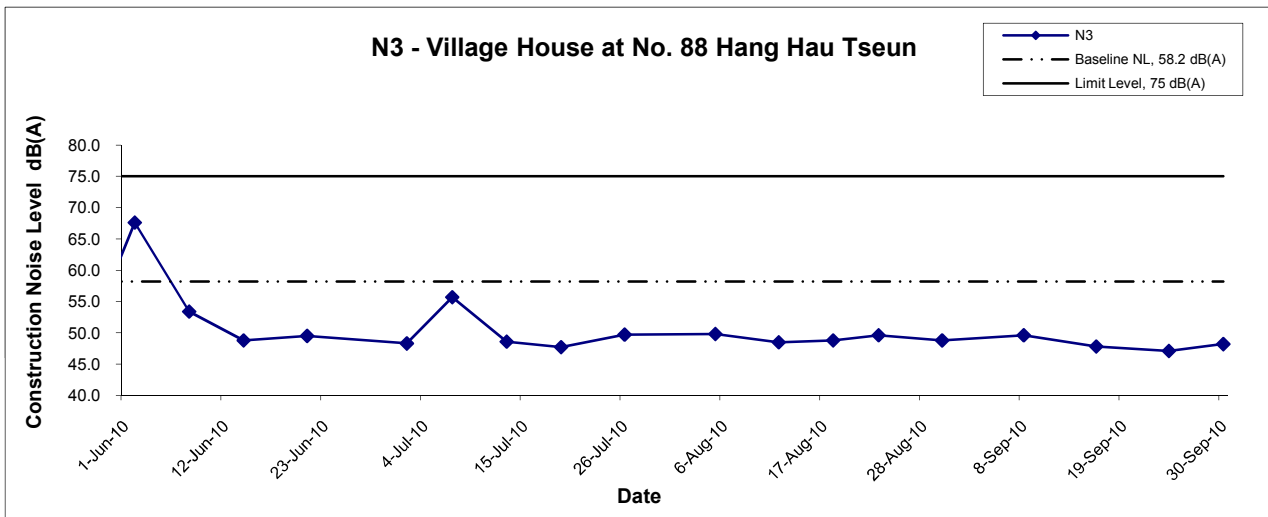
Noise Levels

Title Contract No. YL/2009/01 Hang Hau Tsuen Channel at Lau Fau Shan Graphical Presentation of Construction Noise Monitoring Results	Scale N.T.S	Project No. MA0002	
	Date Sep 10	Appendix G

- 3.11 Noise monitoring results and graphical presentations are shown in Appendix G. In accordance with Condition 4.2 of the EP, all environmental monitoring data was made available to the public via internet access at the website <http://www.cinotech.com.hk/projects/LFS>.
