**Contract No. YL/2009/01
Hang Hau Tsuen Channel
at Lau Fau Shan**

**Monthly Environmental Monitoring and Audit Report
October 2010 (Version 1.1)**

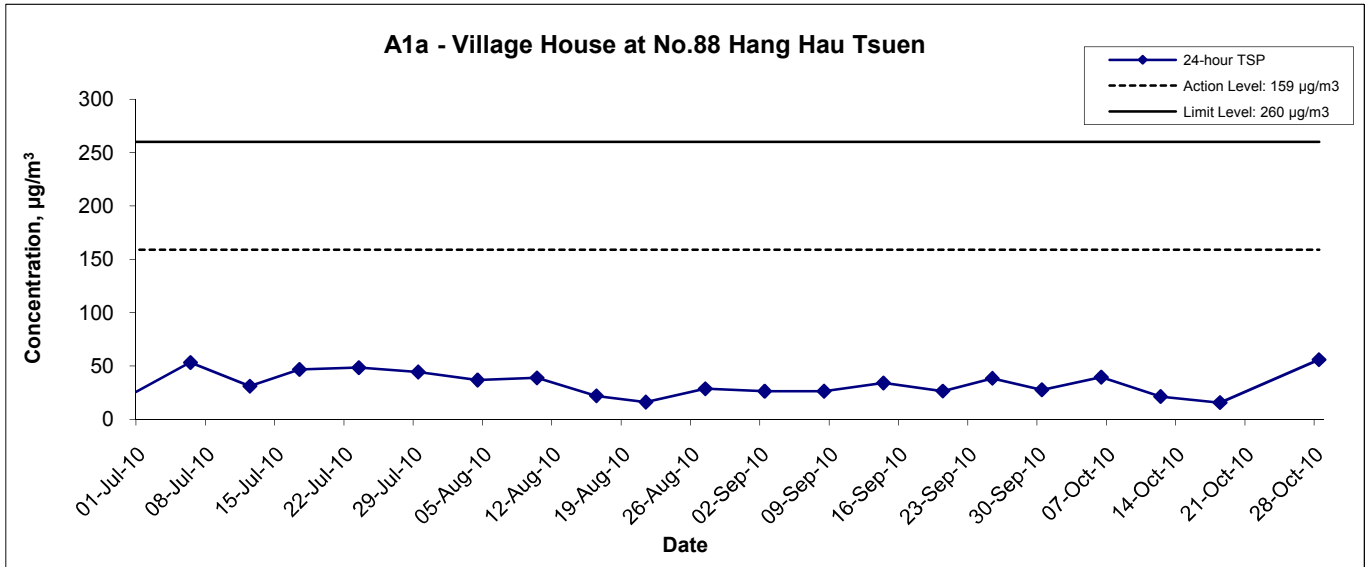
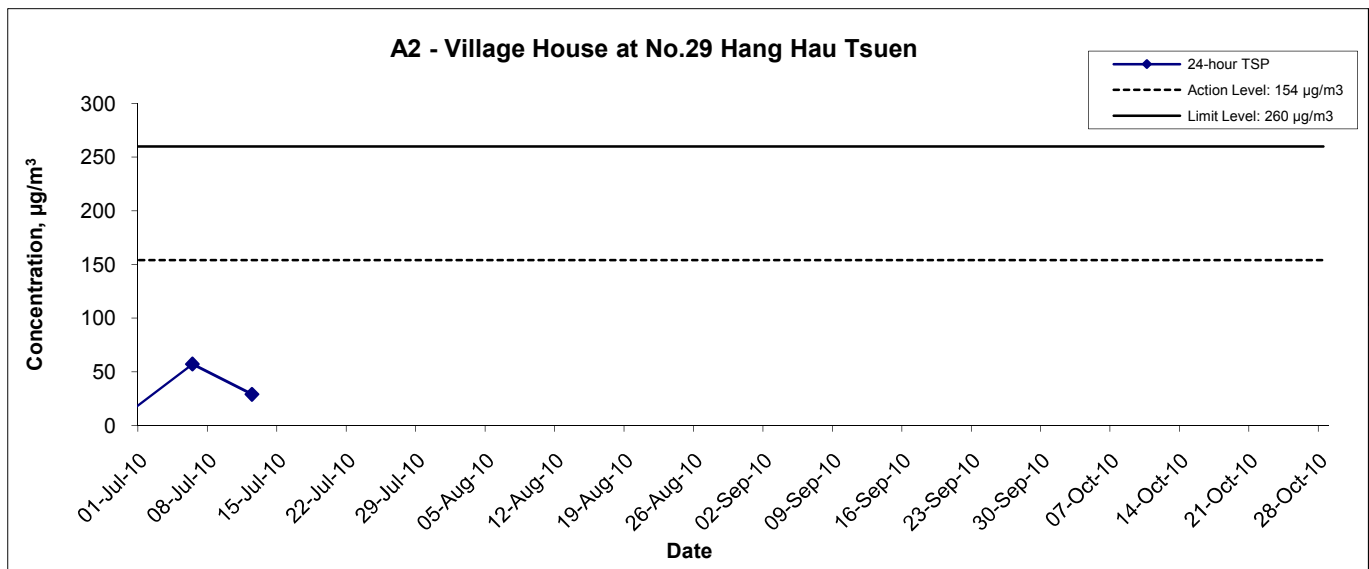
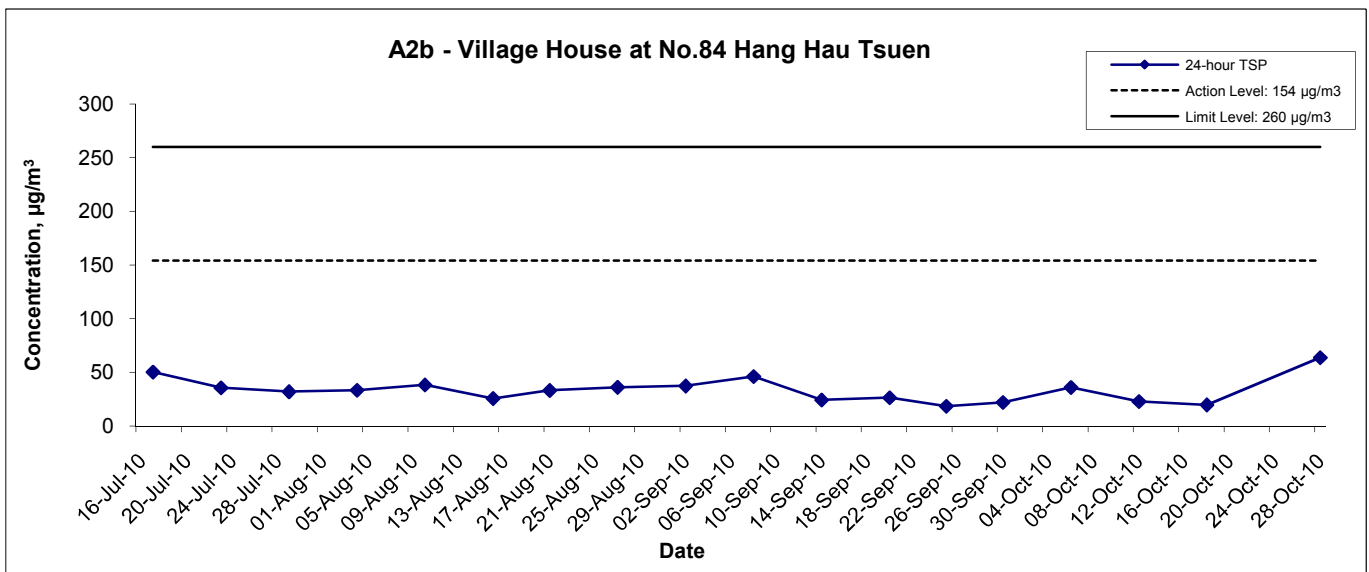
24-hr TSP Concentration Levels

Title Contract No. YL/2009/01 Hang Hau Tsuen Channel at Lau Fau Shan Graphical Presentation of 24-hour TSP Monitoring Results	Scale N.T.S	Project No. MA0002	CINOTECH
	Date Oct 10	Appendix F

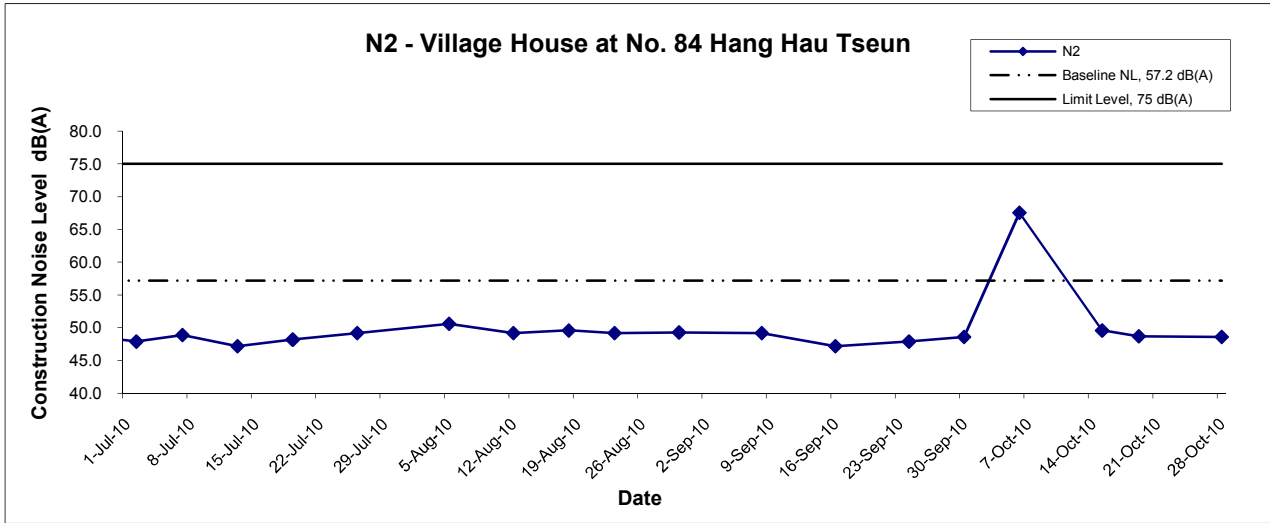
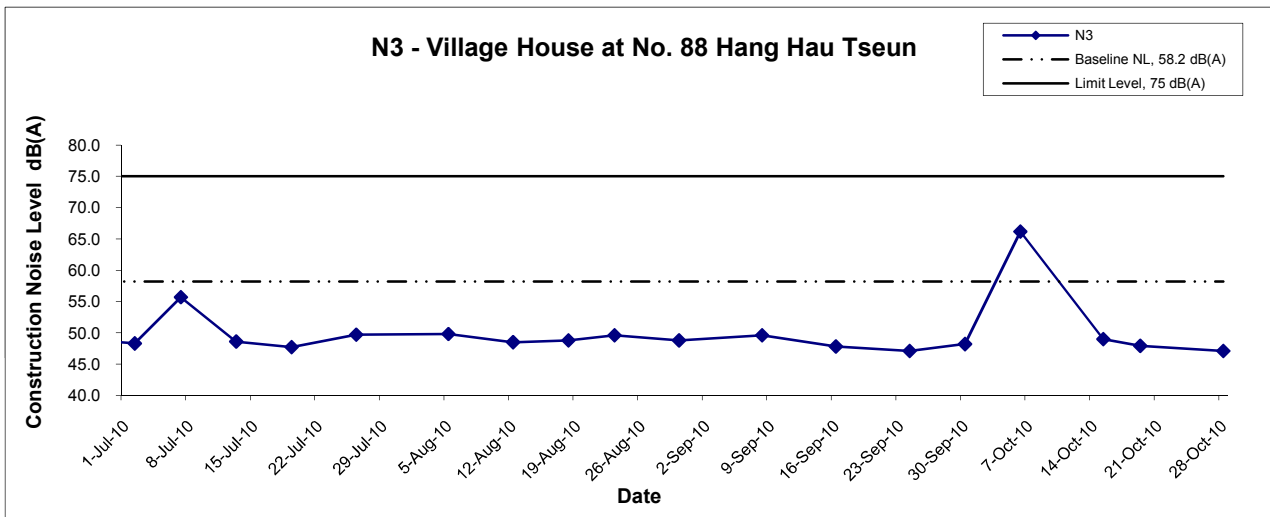
Noise Levels

* Free-field adjustment is adopted for monitoring results at station N2 and N3.

Title Contract No. YL/2009/01 Hang Hau Tsuen Channel at Lau Fau Shan Graphical Presentation of Construction Noise Monitoring Results	Scale N.T.S	Project No. MA0002	
	Date Oct 10	Appendix G
