KWAN ON CONSTRUCTION CO. LTD.

**Contract No. YL/2009/01
Hang Hau Tsuen-Channel
at Lau Fau Shan**

**Monthly Environmental Monitoring and Audit Report
September 2011**

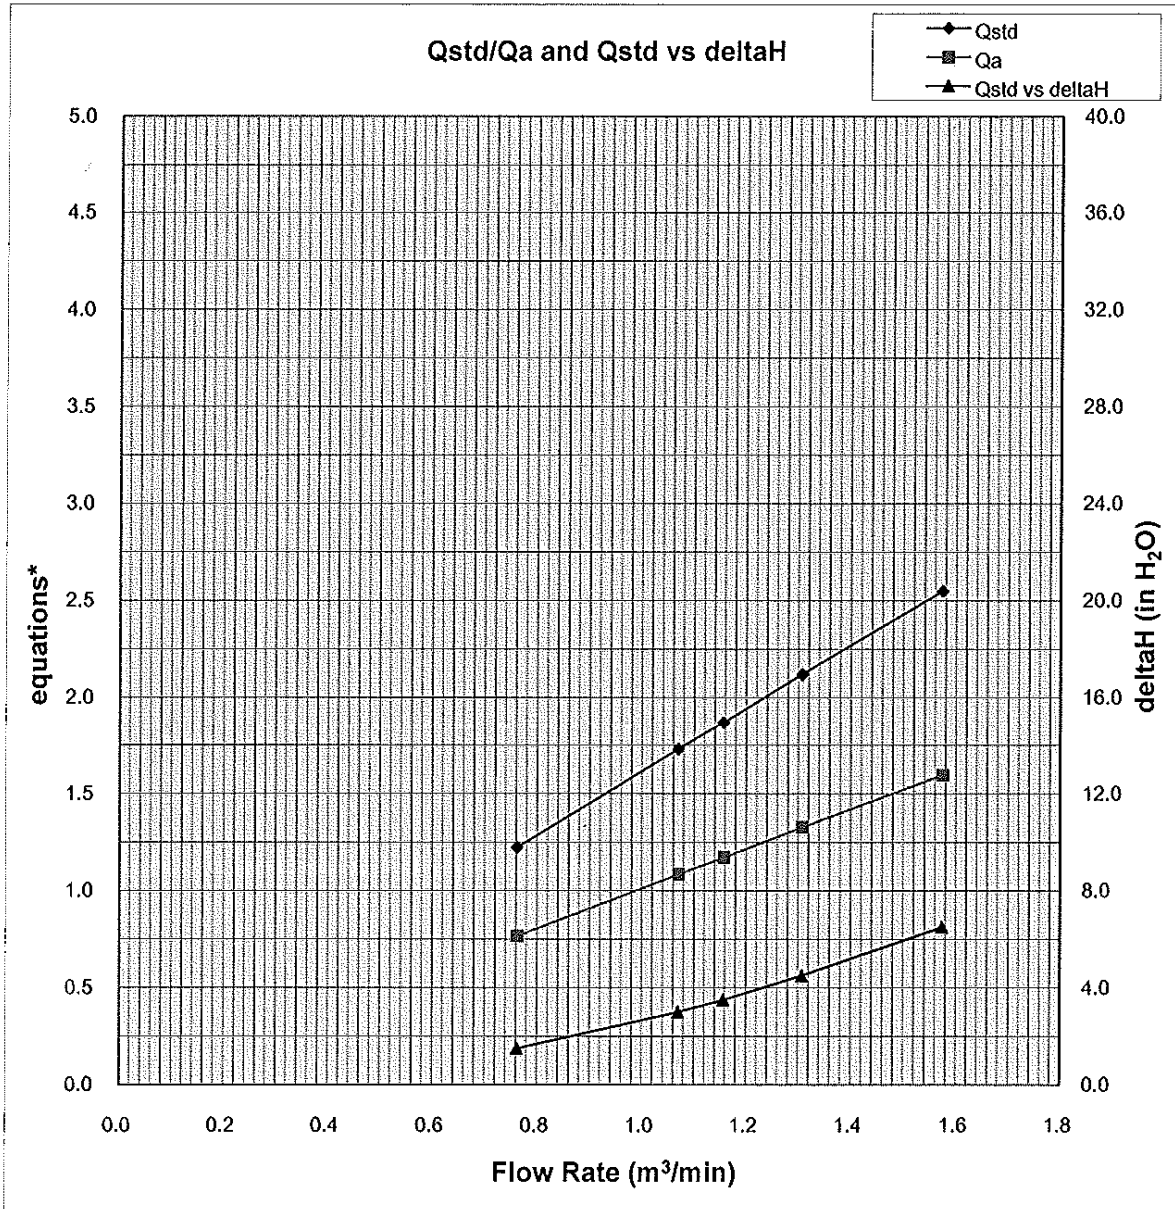
TEST REPORT

Y-axis equations:

Qstd series: $\text{SQRT}[\Delta H(Pa/Pstd)(Tstd/Ta)]$

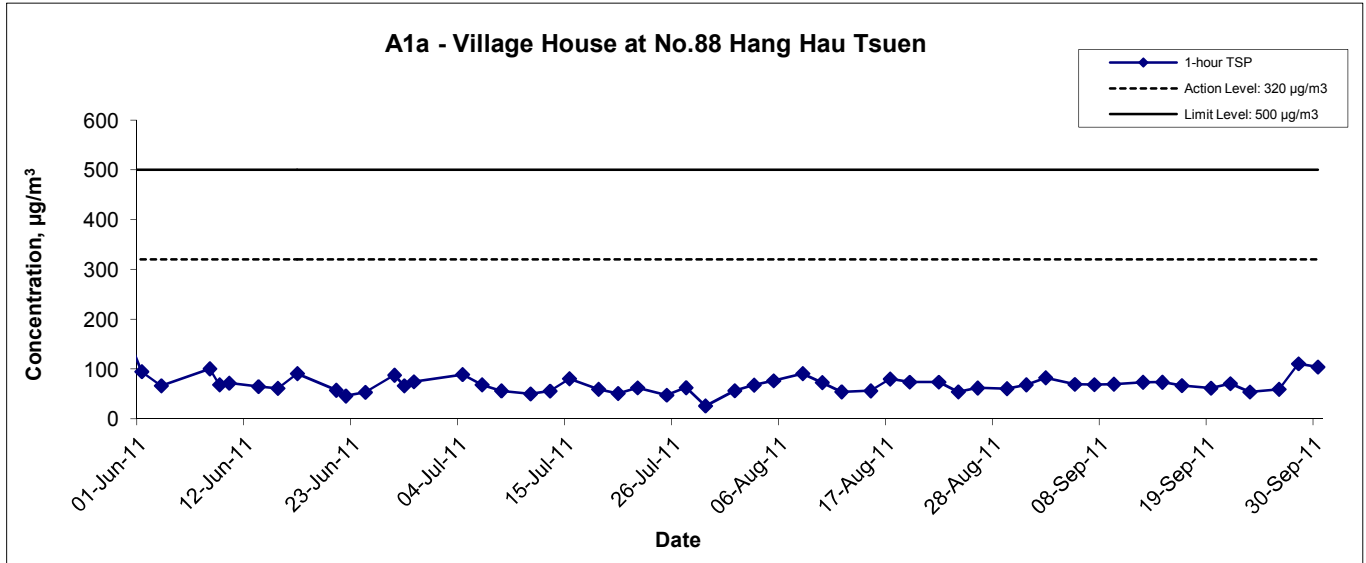
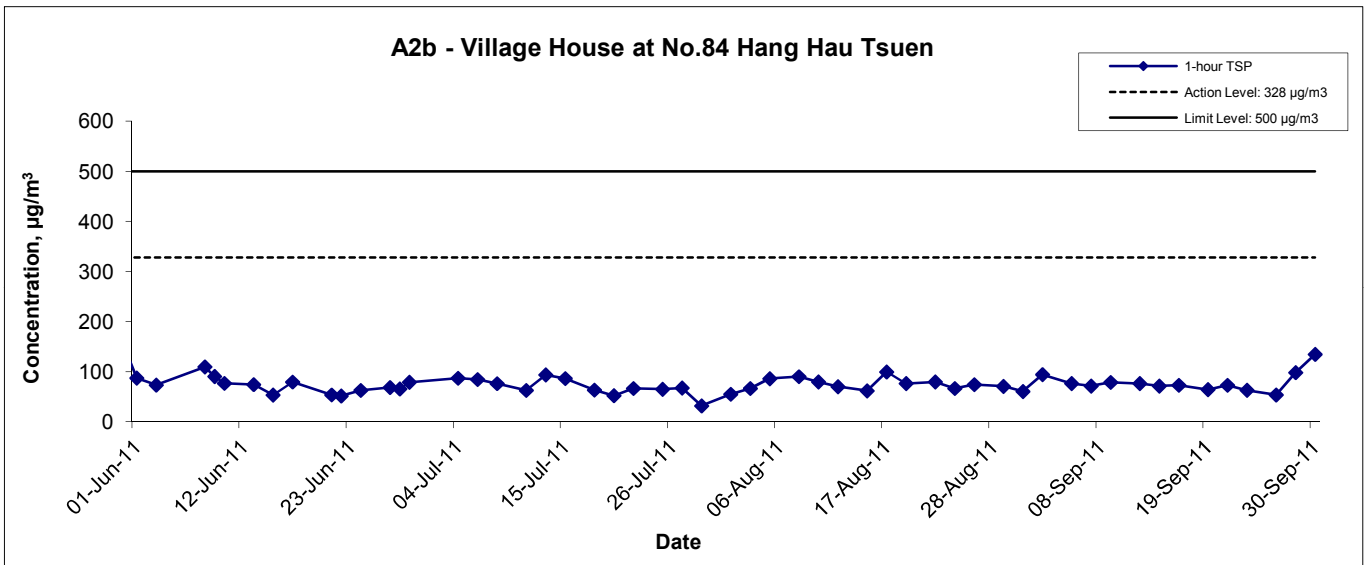
1-hr TSP Concentration Levels

- 2.25 The monitoring data and graphical presentations of 1-hour and 24-hour TSP monitoring results are shown in Appendices E and F respectively.
- 2.26 In accordance with Condition 4.2 of the EP, all environmental monitoring data was made available to the public via internet access at the website

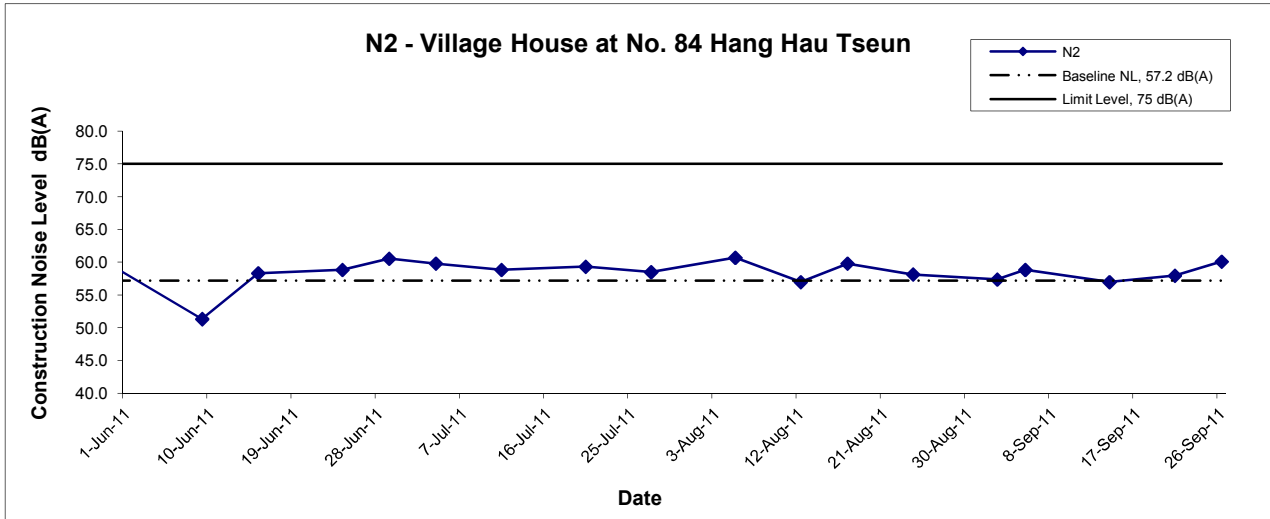
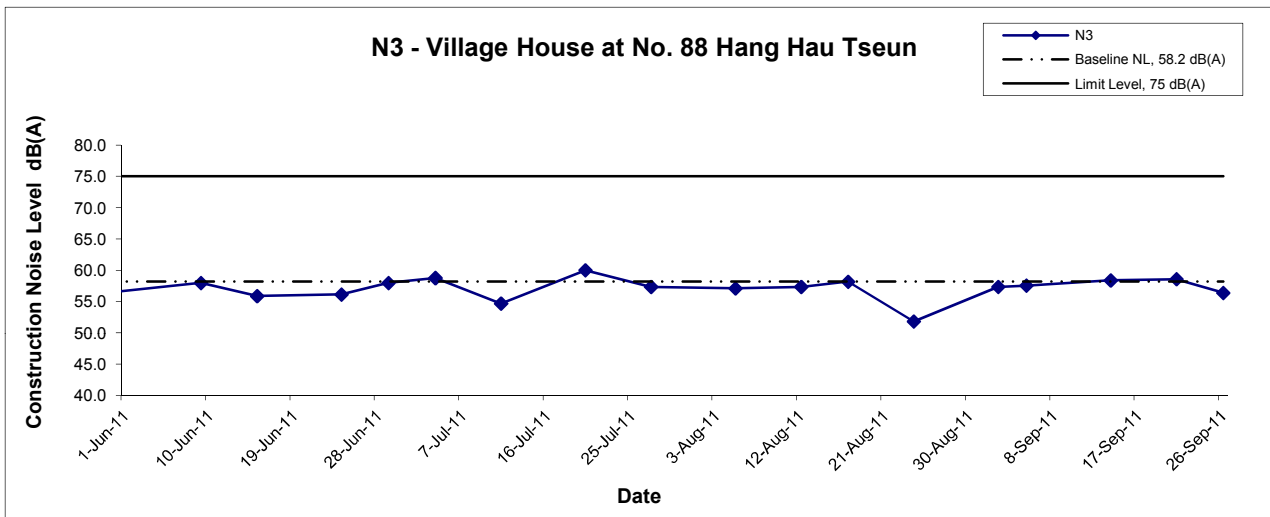
Noise Levels

- 3.11 Noise monitoring results and graphical presentations are shown in Appendix G. In accordance with Condition 4.2 of the EP, all environmental monitoring data was made available to the public via internet access at the website <http://www.cinotech.com.hk/projects/LFS>.
