KWAN ON CONSTRUCTION CO. LTD.

**Contract No. YL/2009/01
Hang Hau Tsuen Channel
at Lau Fau Shan**

**Monthly Environmental Monitoring and Audit Report
December 2011**

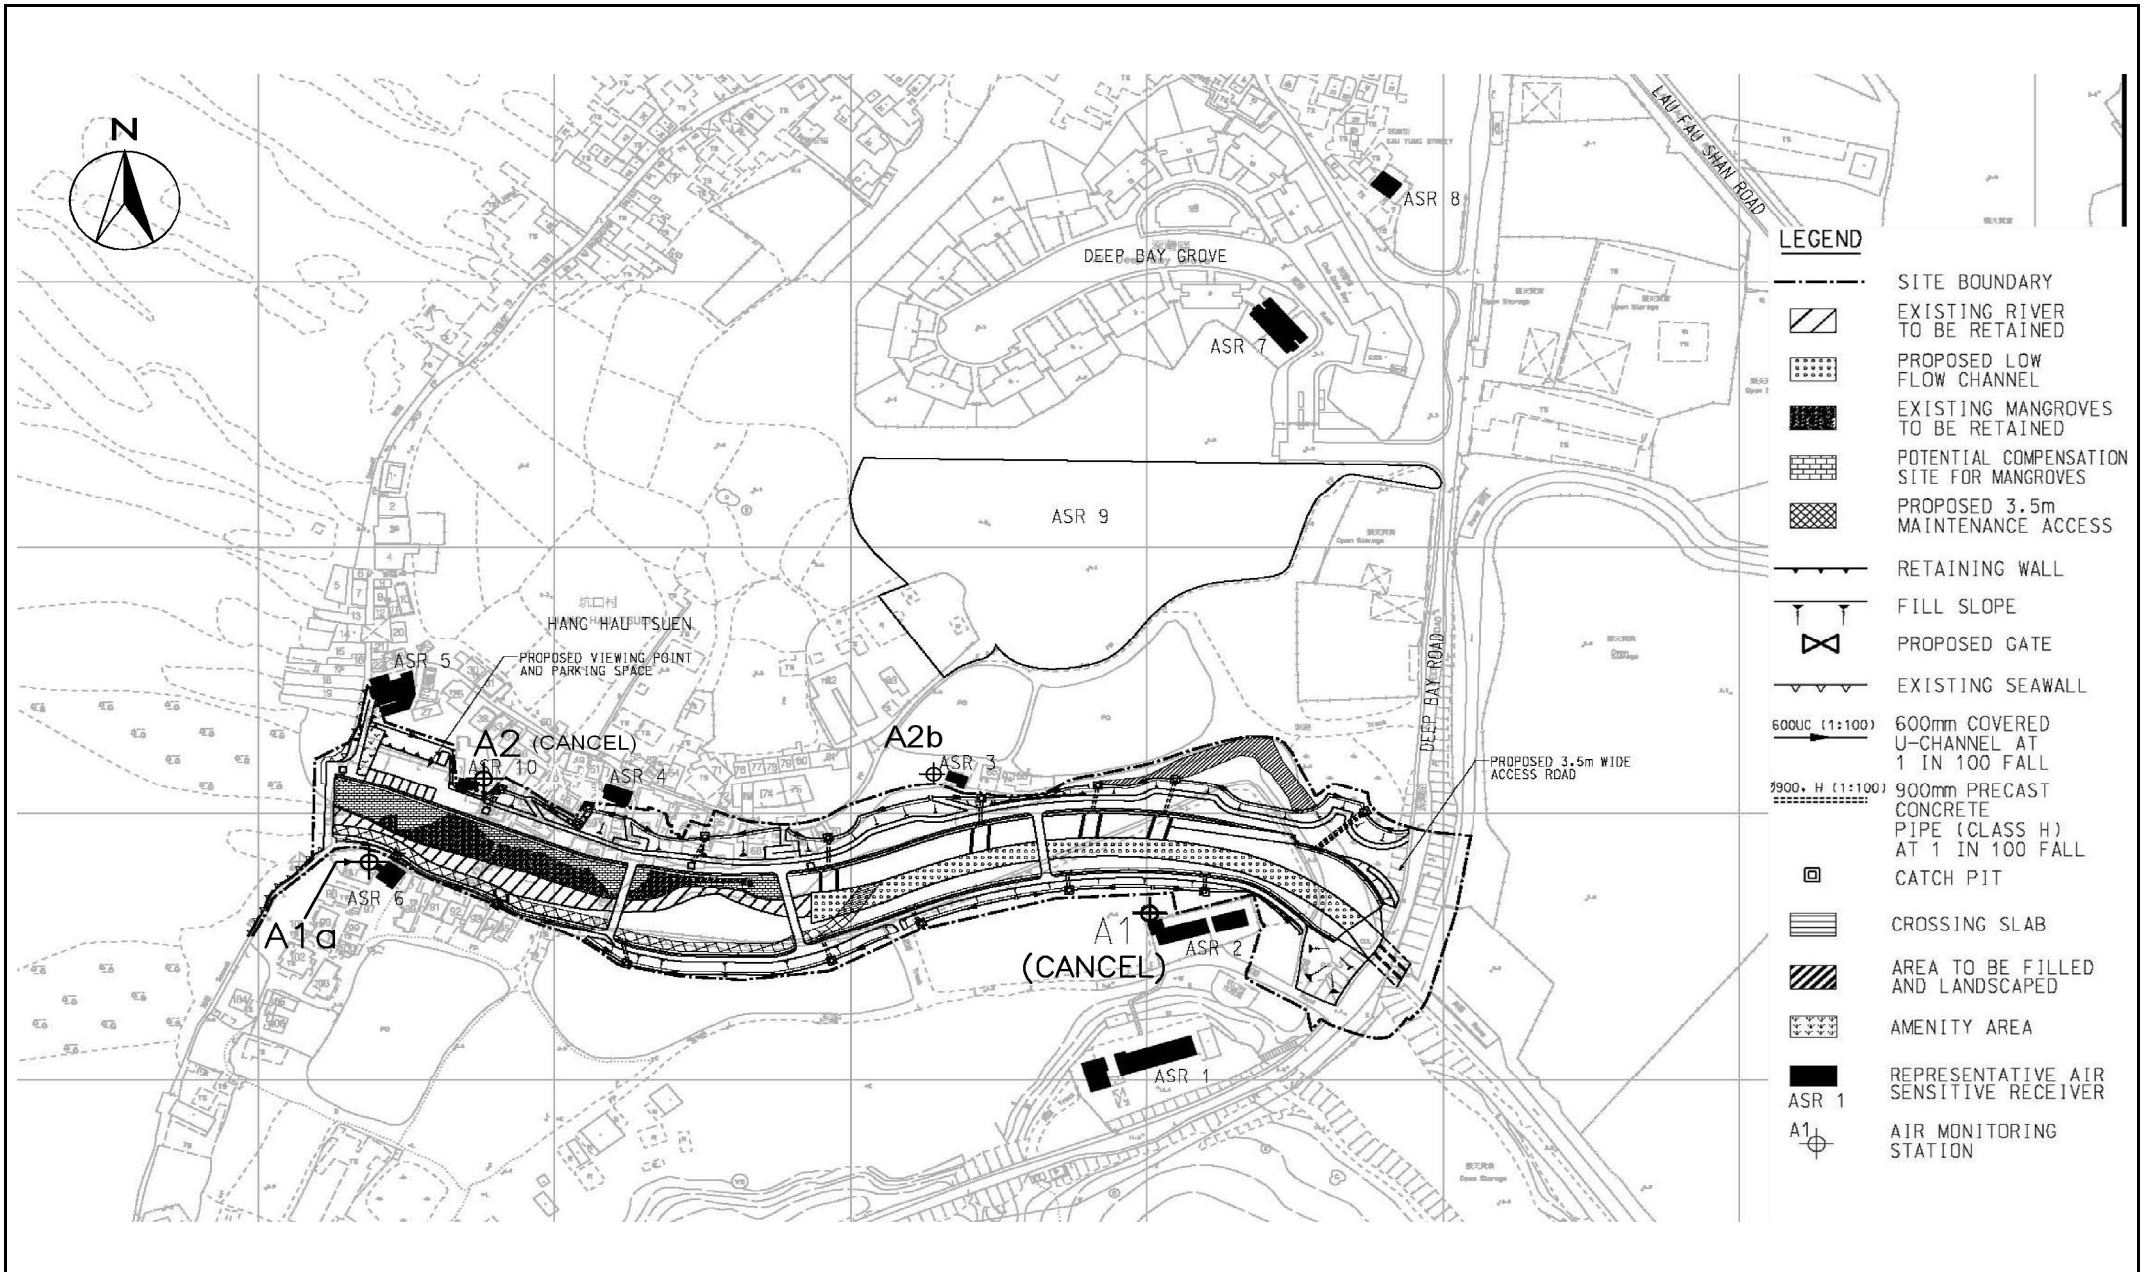
SCALE	N.T.S.	DATE	Apr-10
CHECK	CH	DRAWN	SL
JOB NO.	MA0002	DRAWING No.	Fig. 2
		Rev	-

- LEGEND**
- SITE BOUNDARY
 - EXISTING RIVER TO BE RETAINED
 - PROPOSED LOW FLOW CHANNEL
 - EXISTING MANGROVES TO BE RETAINED
 - POTENTIAL COMPENSATION SITE FOR MANGROVES
 - PROPOSED 3.5m MAINTENANCE ACCESS
 - RETAINING WALL
 - FILL SLOPE
 - PROPOSED GATE
 - EXISTING SEAWALL
 - 600mm COVERED U-CHANNEL AT 1 IN 100 FALL
 - 900mm PRECAST CONCRETE PIPE (CLASS H) AT 1 IN 100 FALL
 - CATCH PIT
 - CROSSING SLAB
 - AREA TO BE FILLED AND LANDSCAPED
 - AMENITY AREA
 - REPRESENTATIVE AIR SENSITIVE RECEIVER ASR 1
 - AIR MONITORING STATION A1

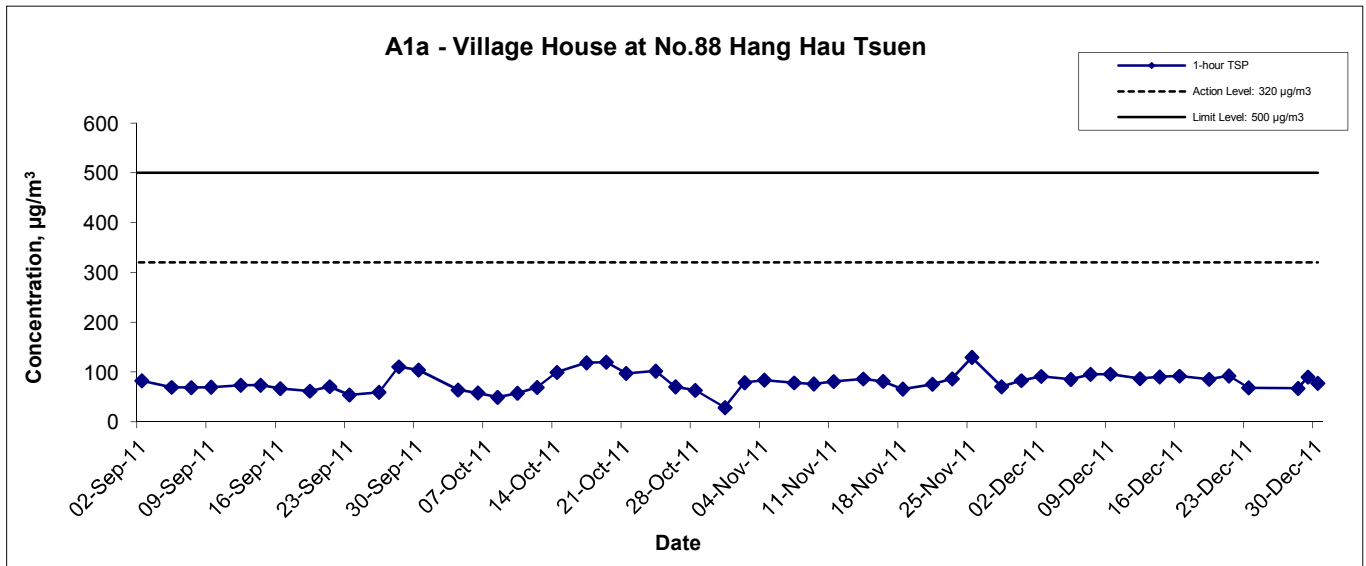
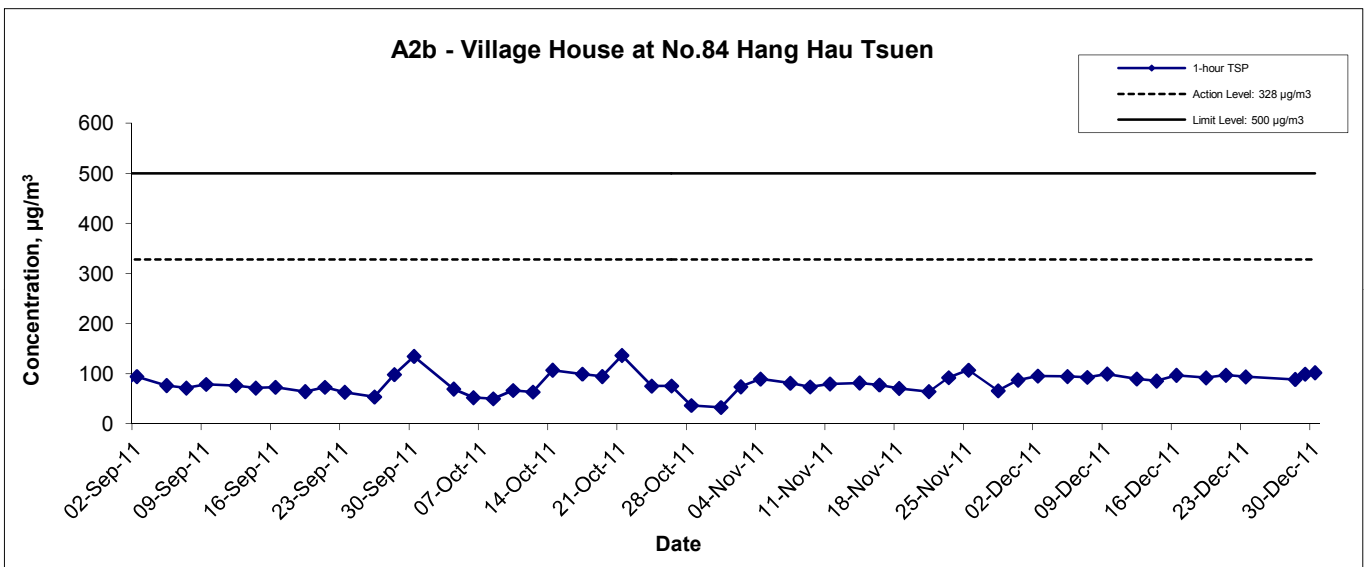
Title Contract No. YL/2009/01 Hang Hau Tsuen Channel at Lau Fau Shan Graphical Presentation of 1-hour TSP Monitoring Results	Scale N.T.S	Project No. MA0002	
	Date Dec 11	Appendix E

Location A2b - Village House at No.84 Hang Hau Tsuen			
Date	Time	Weather	Particulate Concentration ($\mu\text{g}/\text{m}^3$)
2-Dec-11	14:05	Sunny	95.2
5-Dec-11	9:05	Sunny	94.3
7-Dec-11	17:05	Sunny	92.6
9-Dec-11	11:05	Sunny	99.4
12-Dec-11	9:00	Sunny	89.5
14-Dec-11	17:05	Sunny	85.5
16-Dec-11	11:10	Sunny	96.7
19-Dec-11	13:00	Sunny	91.8
21-Dec-11	16:10	Sunny	97.0
23-Dec-11	15:00	Cloudy	93.8
28-Dec-11	10:30	Cloudy	88.4
29-Dec-11	11:00	Cloudy	99.0
30-Dec-11	14:30	Cloudy	101.8
		Average	94.2
		Maximum	101.8
		Minimum	85.5

1-hr TSP Concentration Levels

- 2.25 The monitoring data and graphical presentations of 1-hour and 24-hour TSP monitoring results are shown in Appendices E and F respectively.
- 2.26 In accordance with Condition 4.2 of the EP, all environmental monitoring data was made available to the public via internet access at the website

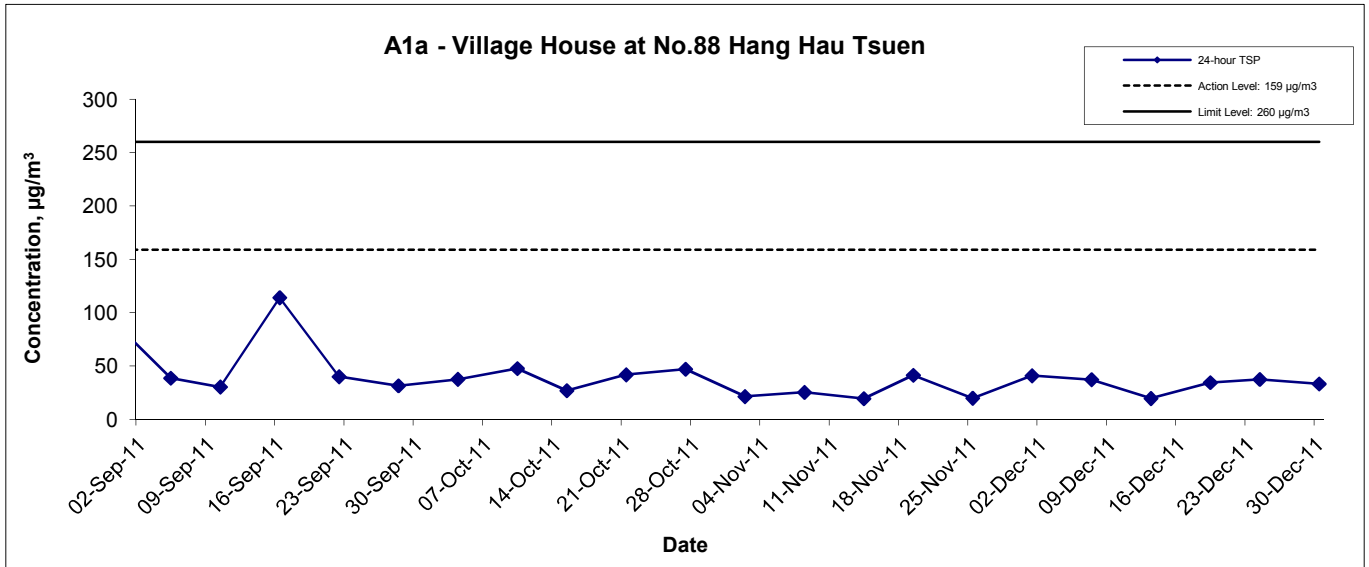
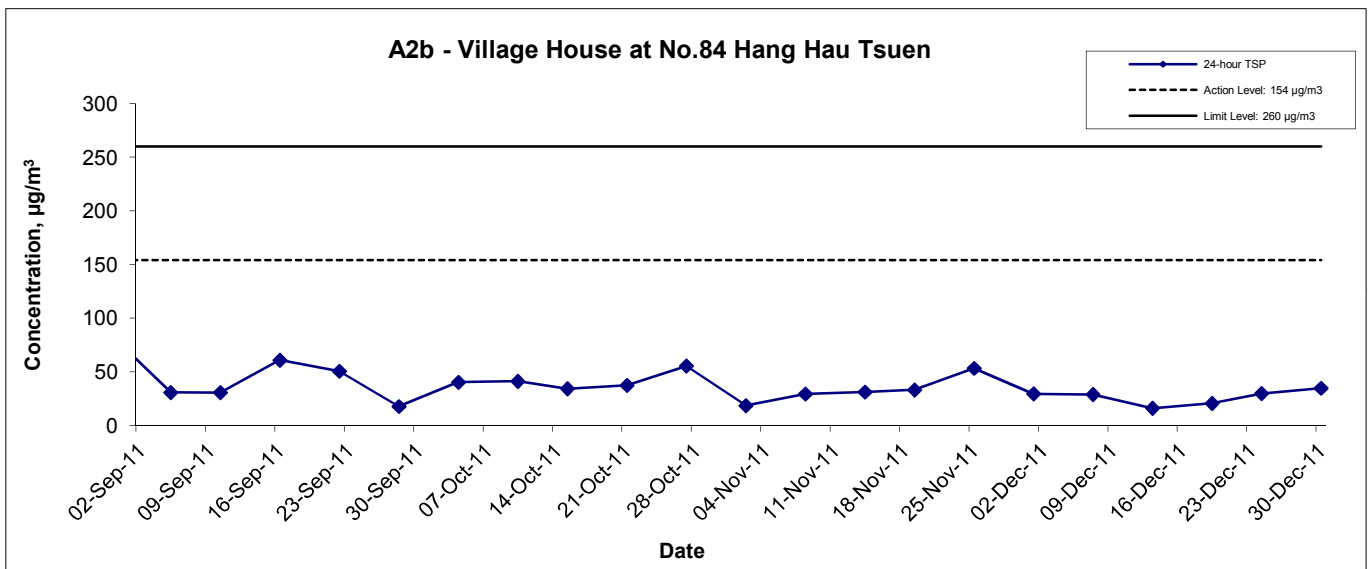
Title Contract No. YL/2009/01 Hang Hau Tsuen Channel at Lau Fau Shan Graphical Presentation of 24-hour TSP Monitoring Results	Scale N.T.S	Project No. MA0002	
	Date Dec 11	Appendix F

Start Date	Weather Condition	Air Temp. (K)	Atmospheric Pressure, Pa (mmHg)	Filter Weight (g)		Particulate weight (g)	Elapse Time		Sampling Time(hrs.)	Flow Rate (m ³ /min.)		Av. flow (m ³ /min)	Total vol. (m ³)	Conc. (µg/m ³)
				Initial	Final		Initial	Final		Initial	Final			
1-Dec-11	Sunny	296.5	764.9	3.1216	3.1727	0.0511	6178.3	6202.3	24.0	1.20	1.20	1.20	1733.1	29.5
7-Dec-11	Sunny	286.0	771.5	3.1278	3.1789	0.0511	6202.3	6226.3	24.0	1.23	1.23	1.23	1770.3	28.9
13-Dec-11	Sunny	290.9	768.5	3.2384	3.2666	0.0282	6226.3	6250.3	24.0	1.22	1.22	1.22	1752.8	16.1
19-Dec-11	Sunny	291.3	768.1	3.2192	3.2554	0.0362	6250.3	6274.3	24.0	1.22	1.22	1.22	1751.1	20.7
24-Dec-11	Cloudy	285.1	770.3	3.2638	3.3166	0.0528	6274.3	6298.3	24.0	1.23	1.23	1.23	1771.6	29.8
30-Dec-11	Cloudy	289.3	771.4	3.2721	3.3333	0.0612	6298.3	6322.3	24.0	1.22	1.22	1.22	1760.5	34.8
													Min	16.1
													Max	34.8
													Average	26.6

24-hr TSP Concentration Levels

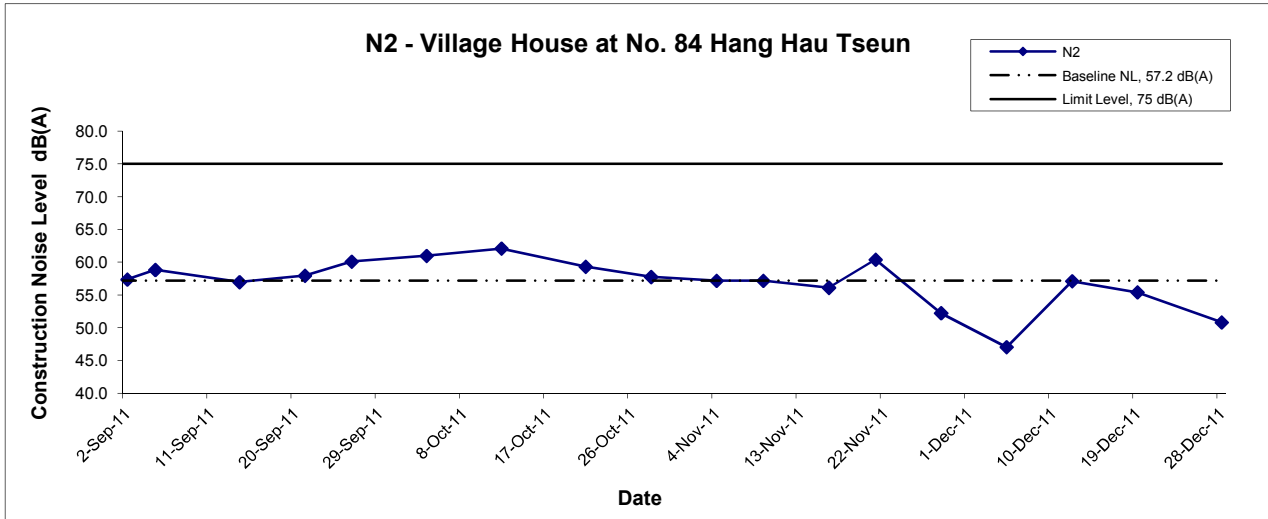
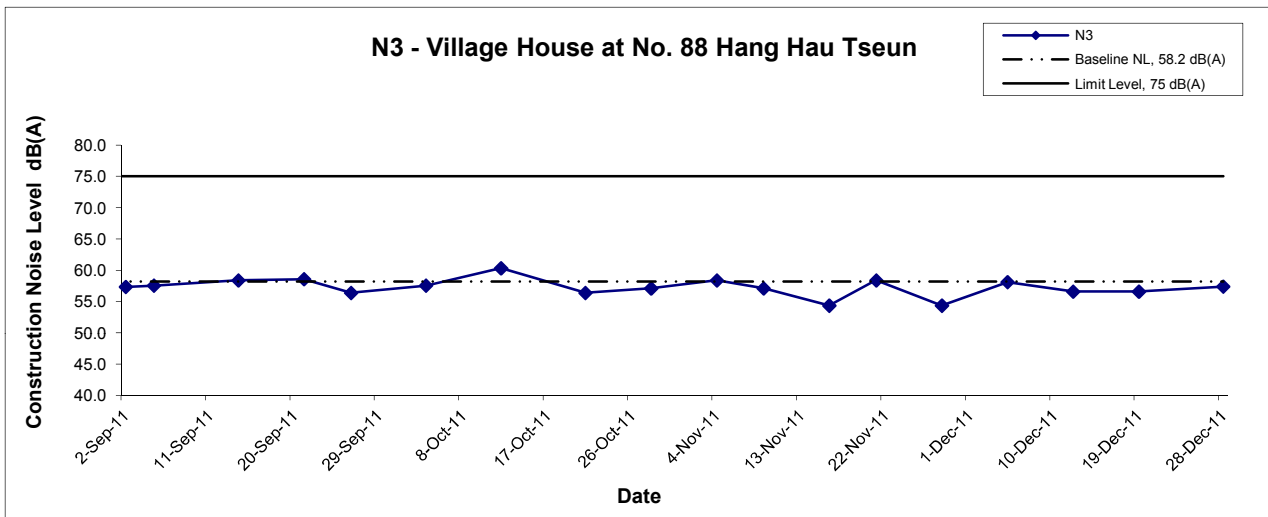
Title Contract No. YL/2009/01 Hang Hau Tsuen Channel at Lau Fau Shan Graphical Presentation of Construction Noise Monitoring Results	Scale N.T.S	Project No. MA0002	
	Date Dec 11	Appendix G

* Free-field adjustment is adopted for monitoring results at station N2 and N3.

Noise Levels

- 3.11 Noise monitoring results and graphical presentations are shown in Appendix G. In accordance with Condition 4.2 of the EP, all environmental monitoring data was made available to the public via internet access at the website <http://www.cinotech.com.hk/projects/LFS>.

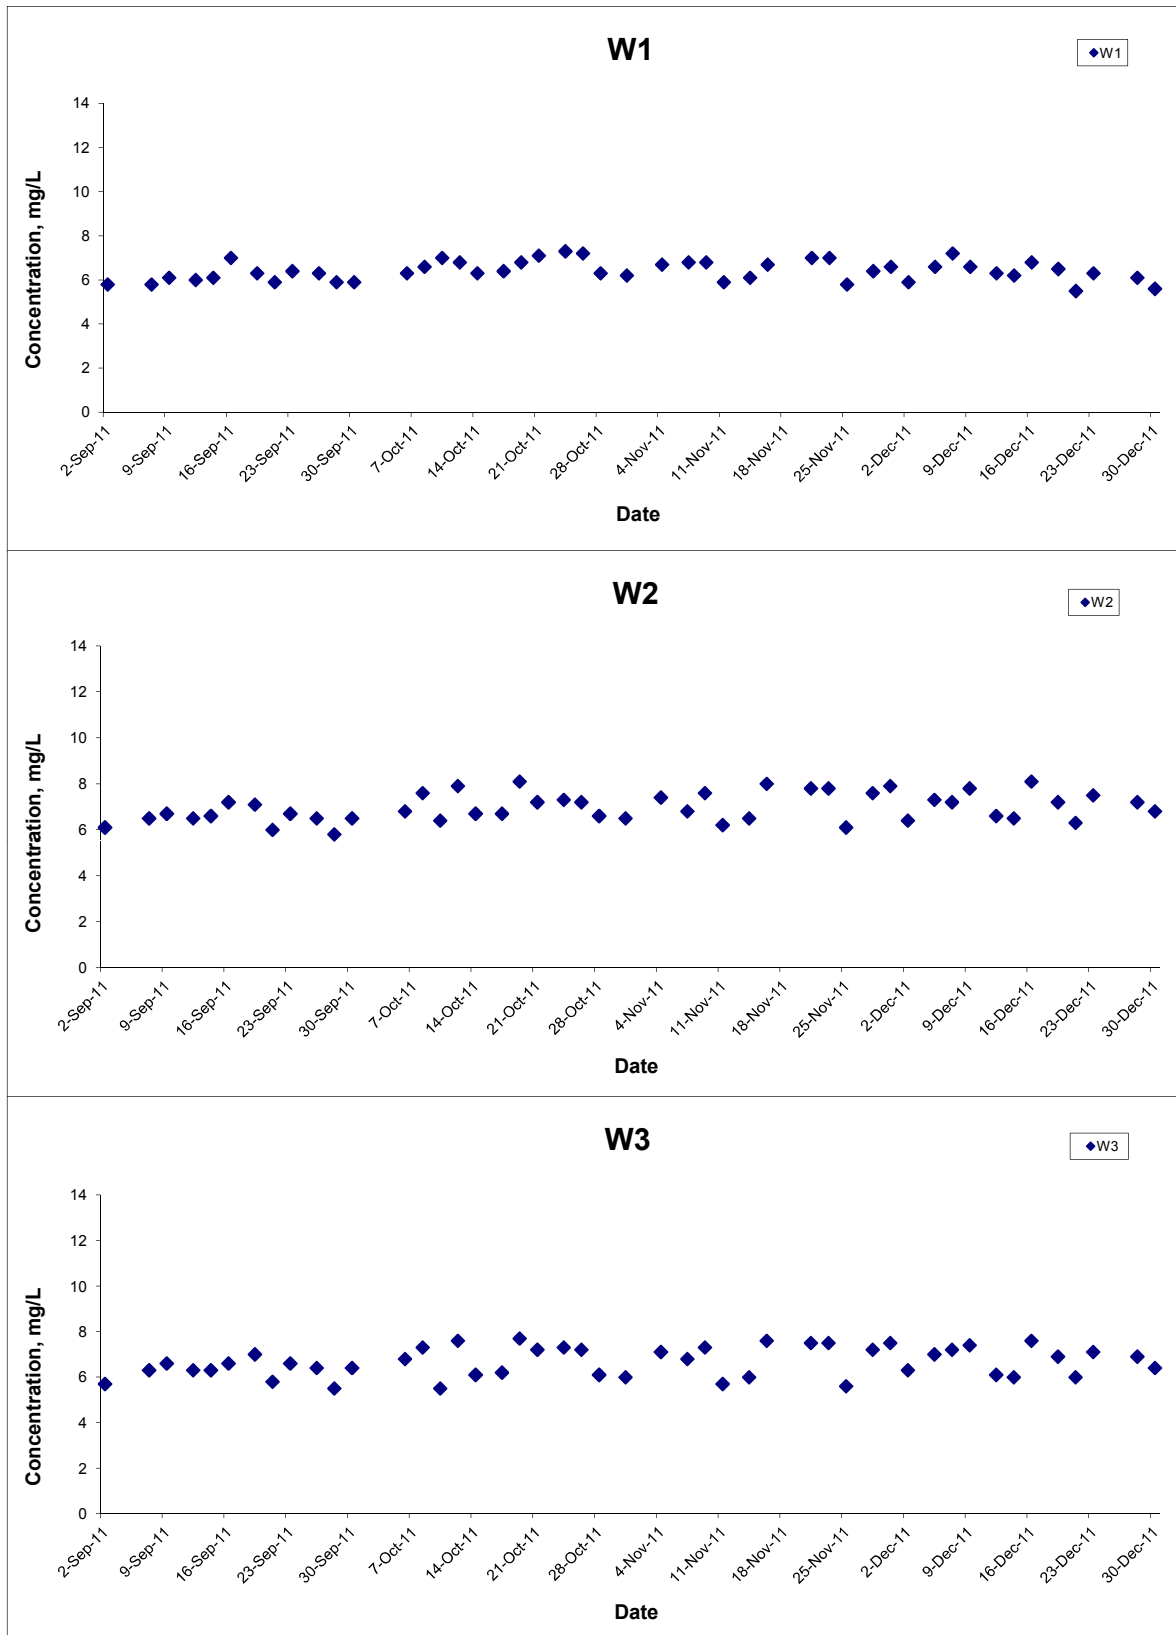
Title Contract No. YL/2009/01 Hang Hau Tsuen Channel at Lau Fau Shan Graphical Presentation of Water Quality Monitoring Results	Scale	N.T.S	Project No. MA0002	CINOTECH
	Date	Dec 11	Appendix H

Dissolved Oxygen (Surface & Middle) at Mid-Ebb Tide

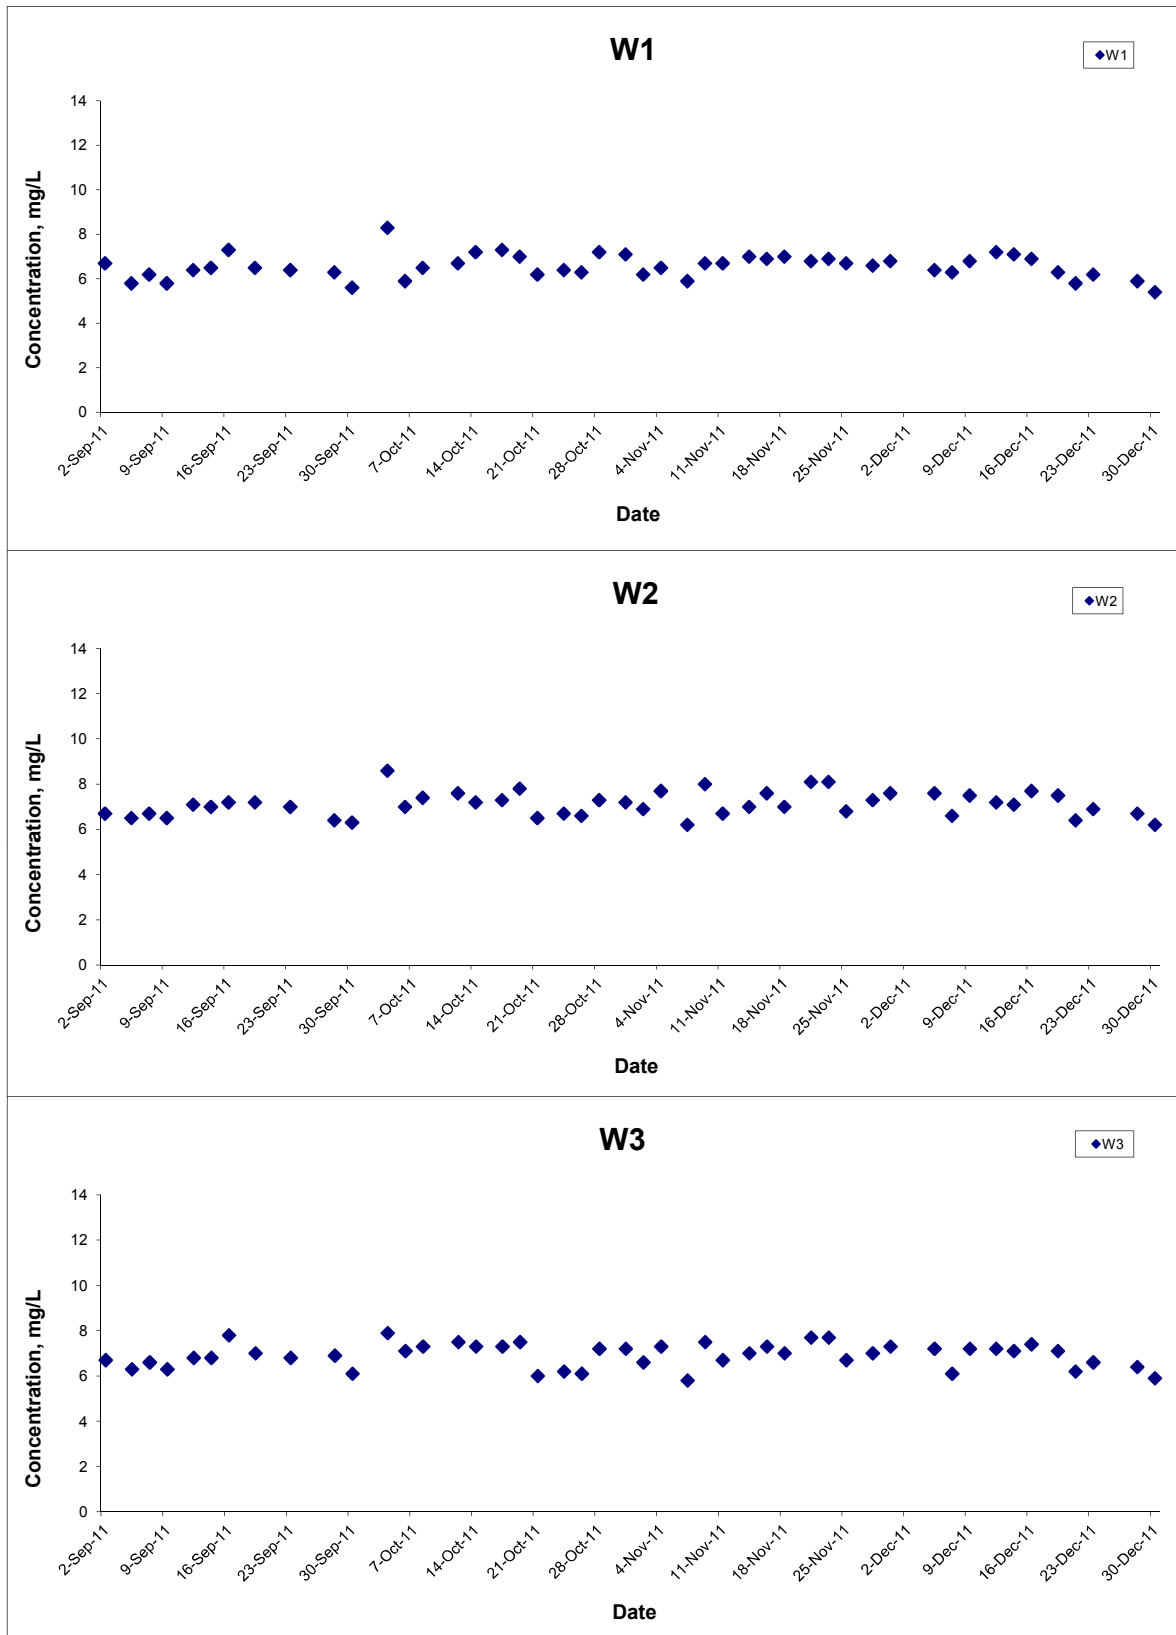
Title Contract No. YL/2009/01 Hang Hau Tsuen Channel at Lau Fau Shan Graphical Presentation of Water Quality Monitoring Results	Scale	N.T.S	Project No. MA0002	CINOTECH
	Date	Dec 11	Appendix H

Dissolved Oxygen (Surface & Middle) at Mid-Flood Tide

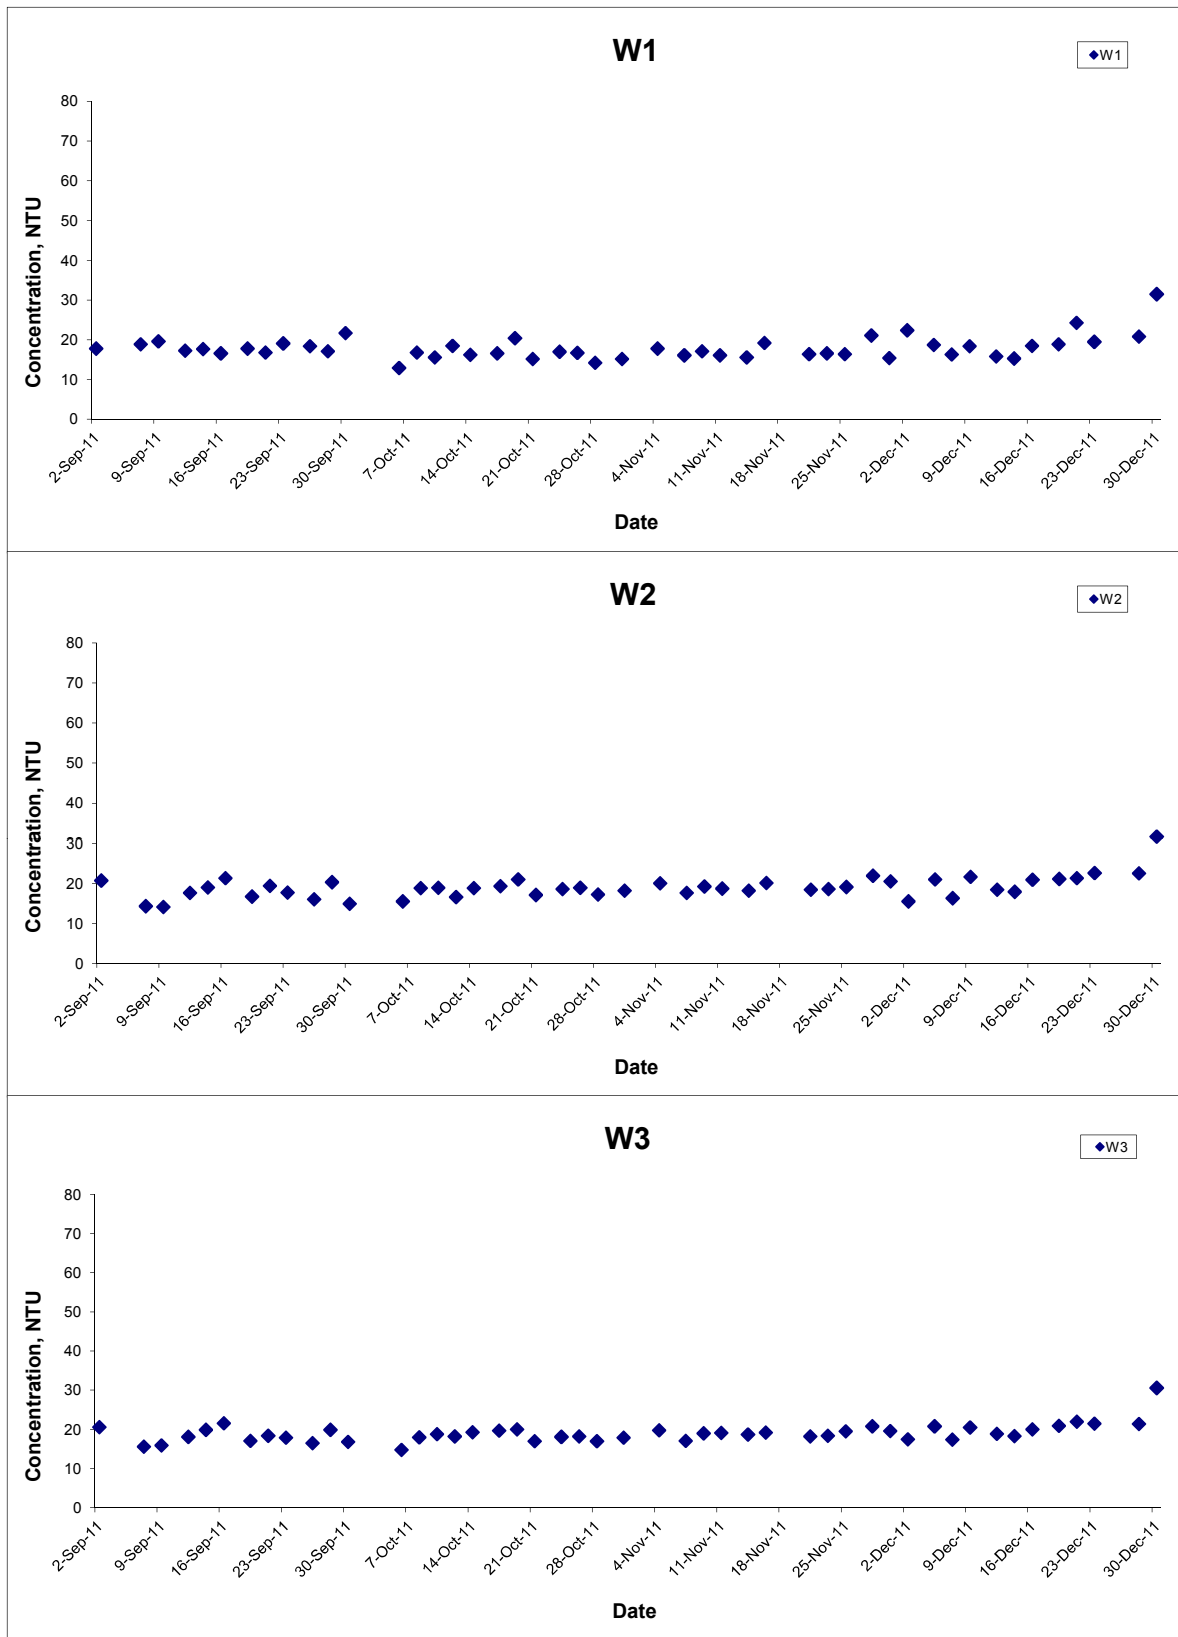
Title Contract No. YL/2009/01 Hang Hau Tsuen Channel at Lau Fau Shan Graphical Presentation of Water Quality Monitoring Results	Scale	N.T.S	Project No. MA0002	CINOTECH
	Date	Dec 11	Appendix H

Turbidity (Depth-averaged) at Mid-Ebb Tide

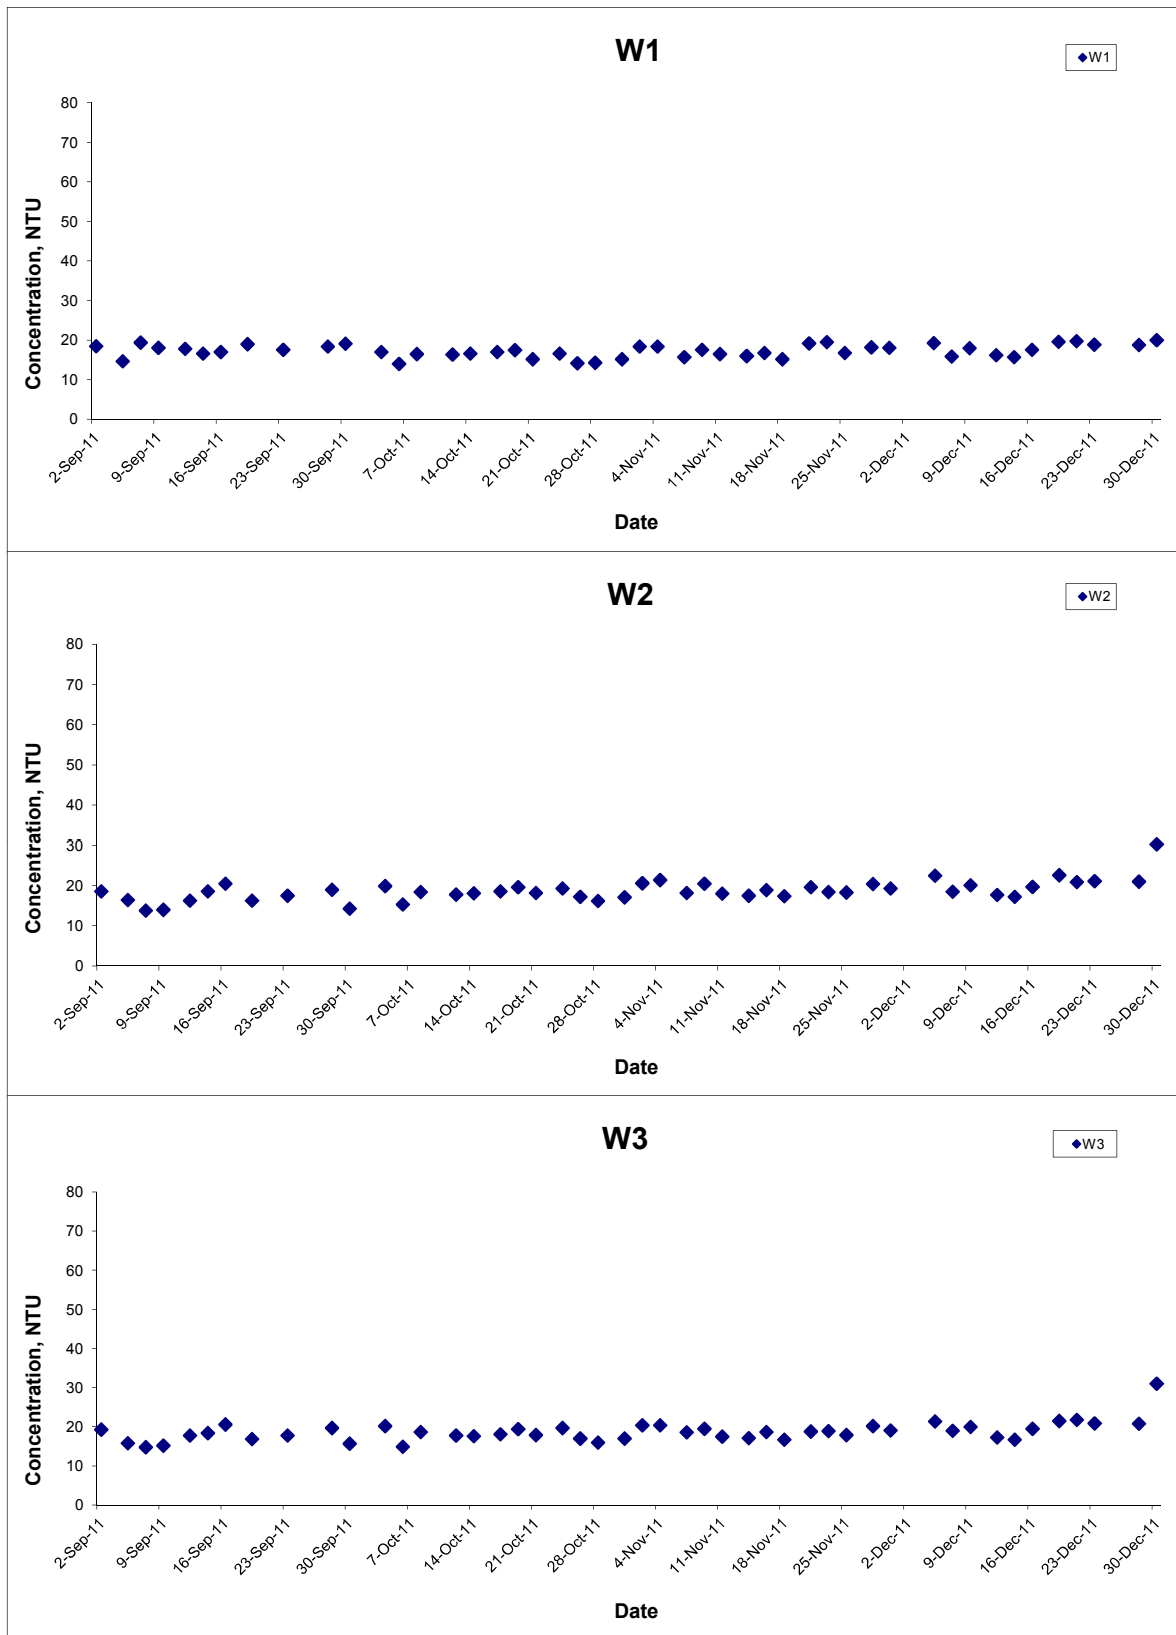
Title Contract No. YL/2009/01 Hang Hau Tsuen Channel at Lau Fau Shan Graphical Presentation of Water Quality Monitoring Results	Scale N.T.S	Project No. MA0002	
	Date Dec 11	Appendix H

Turbidity (Depth-averaged) at Mid-Flood Tide

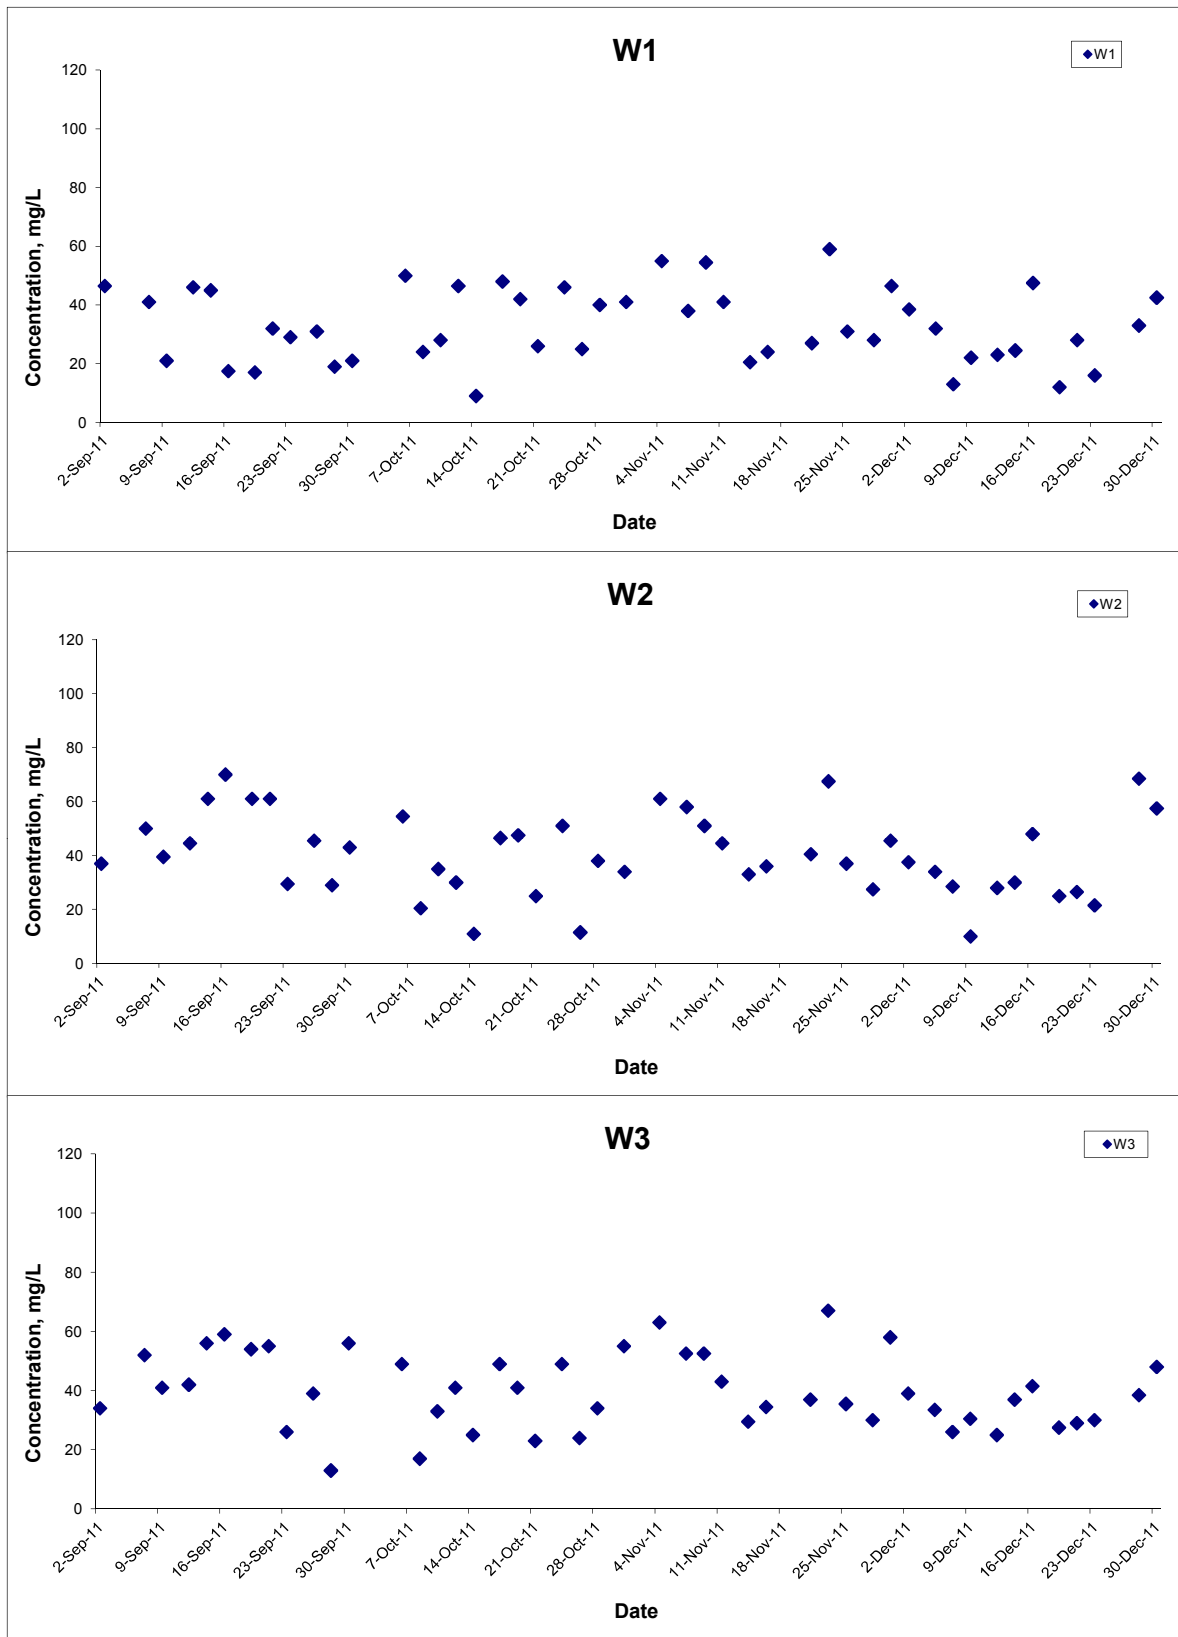
Title Contract No. YL/2009/01 Hang Hau Tsuen Channel at Lau Fau Shan Graphical Presentation of Water Quality Monitoring Results	Scale	N.T.S	Project No. MA0002	CINOTECH
	Date	Dec 11	Appendix H

Suspended Solids (Depth-averaged) at Mid-Ebb Tide

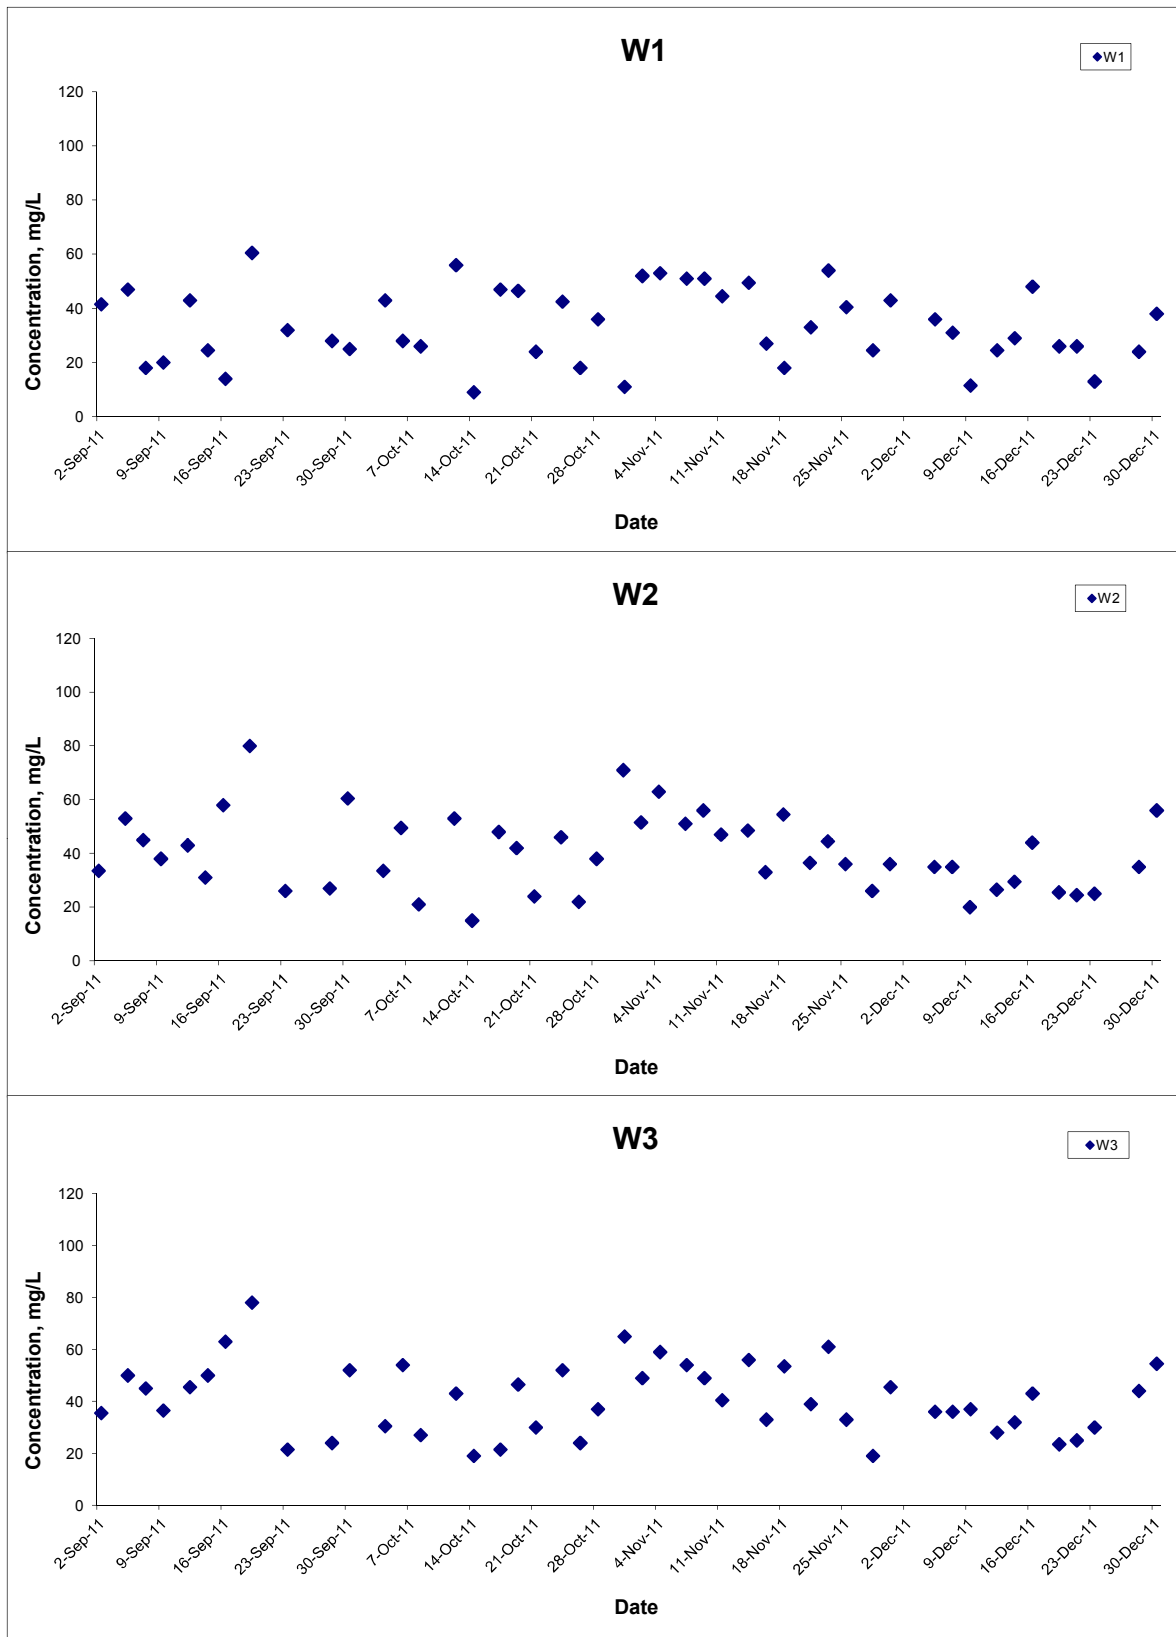
Title Contract No. YL/2009/01 Hang Hau Tsuen Channel at Lau Fau Shan Graphical Presentation of Water Quality Monitoring Results	Scale N.T.S	Project No. MA0002	
	Date Dec 11	Appendix H

Suspended Solids (Depth-averaged) at Mid-Flood Tide
