KWAN ON CONSTRUCTION CO. LTD.

**Contract No. YL/2009/01
Hang Hau Tsuen Channel
at Lau Fau Shan**

**Monthly Environmental Monitoring and Audit Report
August 2012**

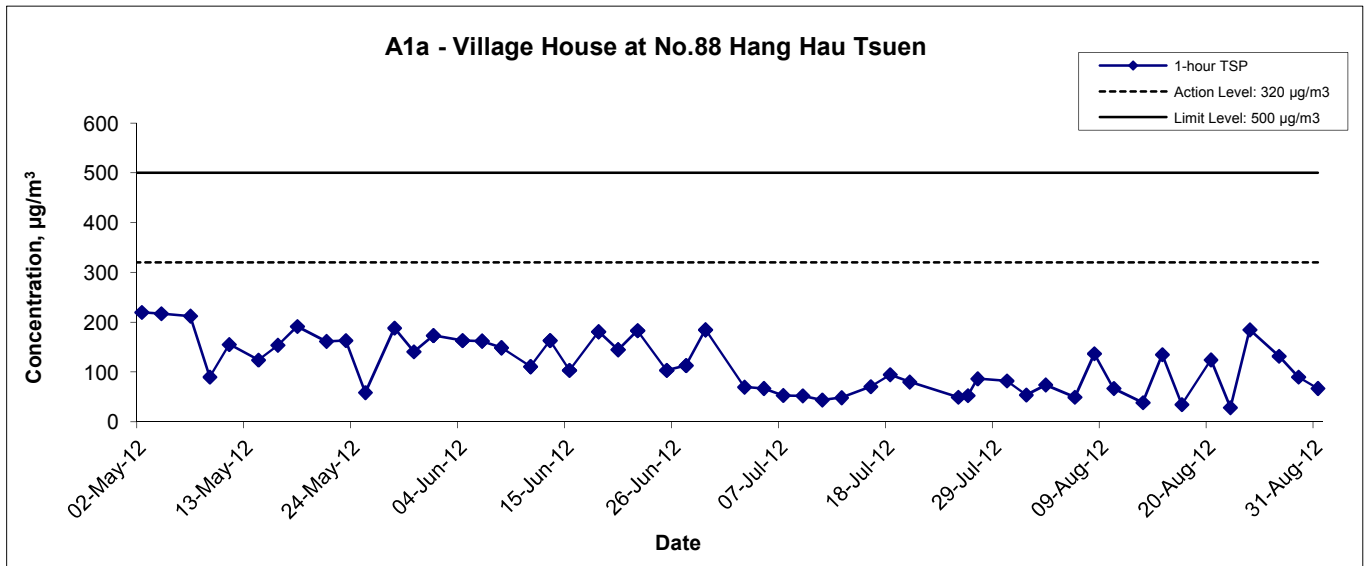
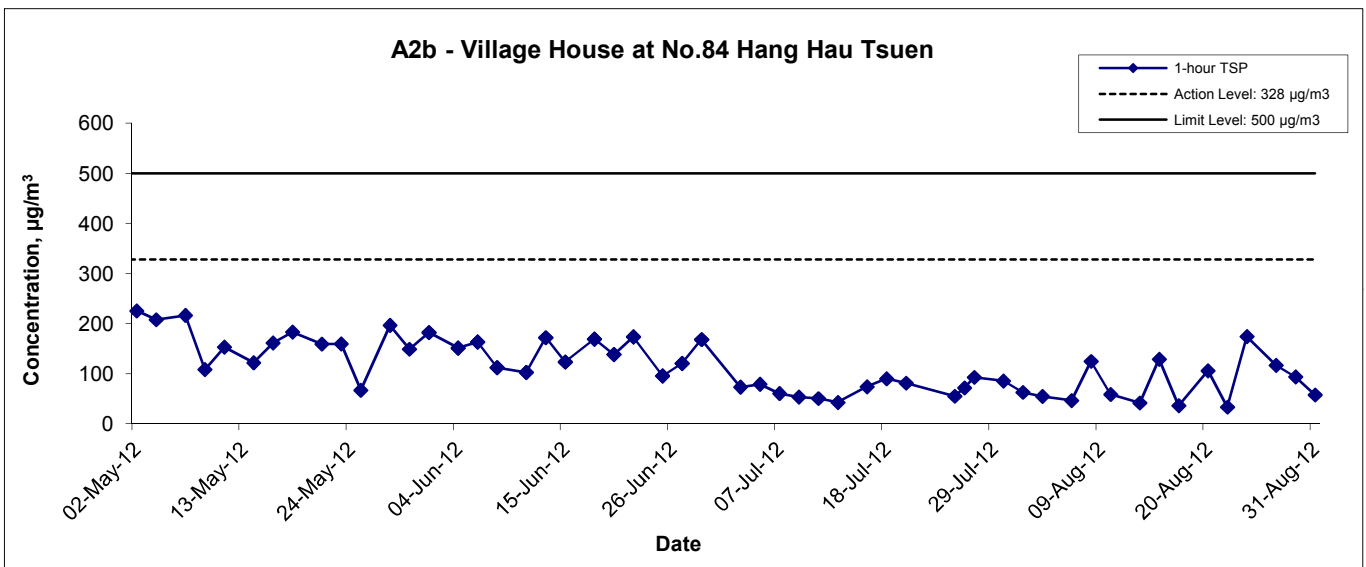
Title Contract No. YL/2009/01 Hang Hau Tsuen Channel at Lau Fau Shan Graphical Presentation of 1-hour TSP Monitoring Results	Scale N.T.S	Project No. MA0002	
	Date Aug 12	Appendix E

Location A2b - Village House at No.84 Hang Hau Tsuen			
Date	Time	Weather	Particulate Concentration ($\mu\text{g}/\text{m}^3$)
1-Aug-12	10:30	Sunny	62.7
3-Aug-12	11:00	Fine	54.6
6-Aug-12	13:00	Cloudy	46.5
8-Aug-12	10:00	Sunny	124.6
10-Aug-12	14:00	Fine	58.7
13-Aug-12	10:05	Rainy	41.7
15-Aug-12	13:00	Sunny	128.9
17-Aug-12	15:25	Rainy	36.0
20-Aug-12	10:30	Sunny	105.9
22-Aug-12	15:15	Cloudy	33.2
24-Aug-12	14:15	Sunny	174.1
27-Aug-12	10:55	Sunny	116.6
29-Aug-12	10:35	Cloudy	93.6
31-Aug-12	13:40	Cloudy	57.6
		Average	81.1
		Maximum	174.1
		Minimum	33.2

1-hr TSP Concentration Levels

- 2.25 The monitoring data and graphical presentations of 1-hour and 24-hour TSP monitoring results are shown in Appendices E and F respectively.
- 2.26 In accordance with Condition 4.2 of the EP, all environmental monitoring data was made available to the public via internet access at the website <http://www.cinotech.com.hk/projects/LFS>.

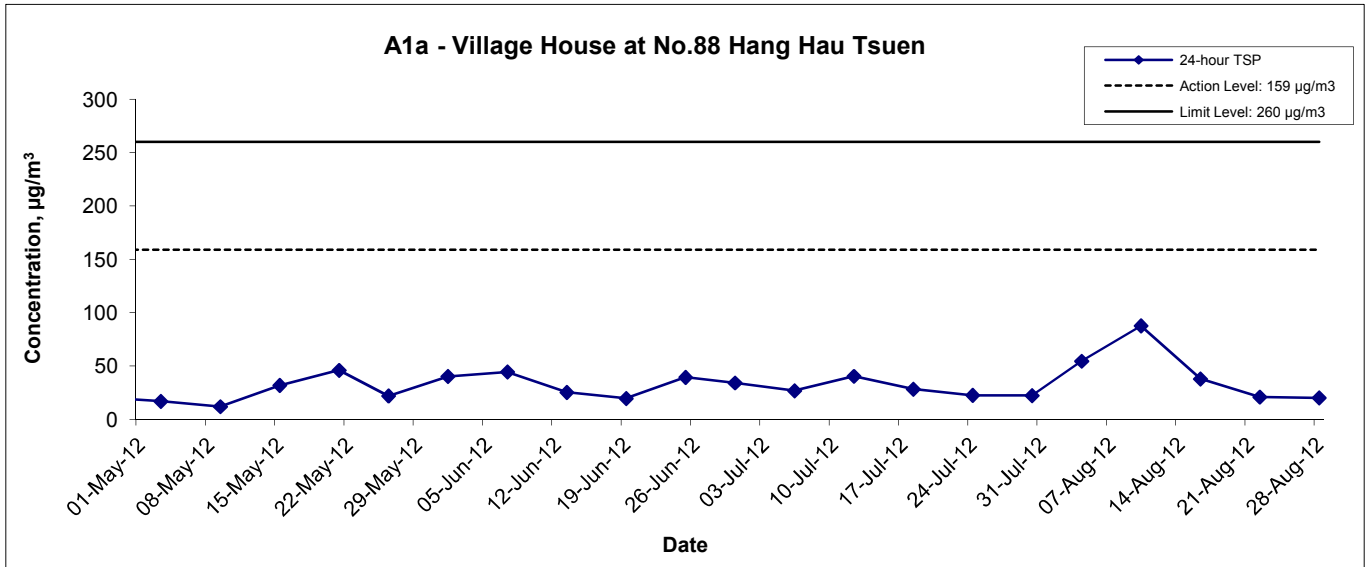
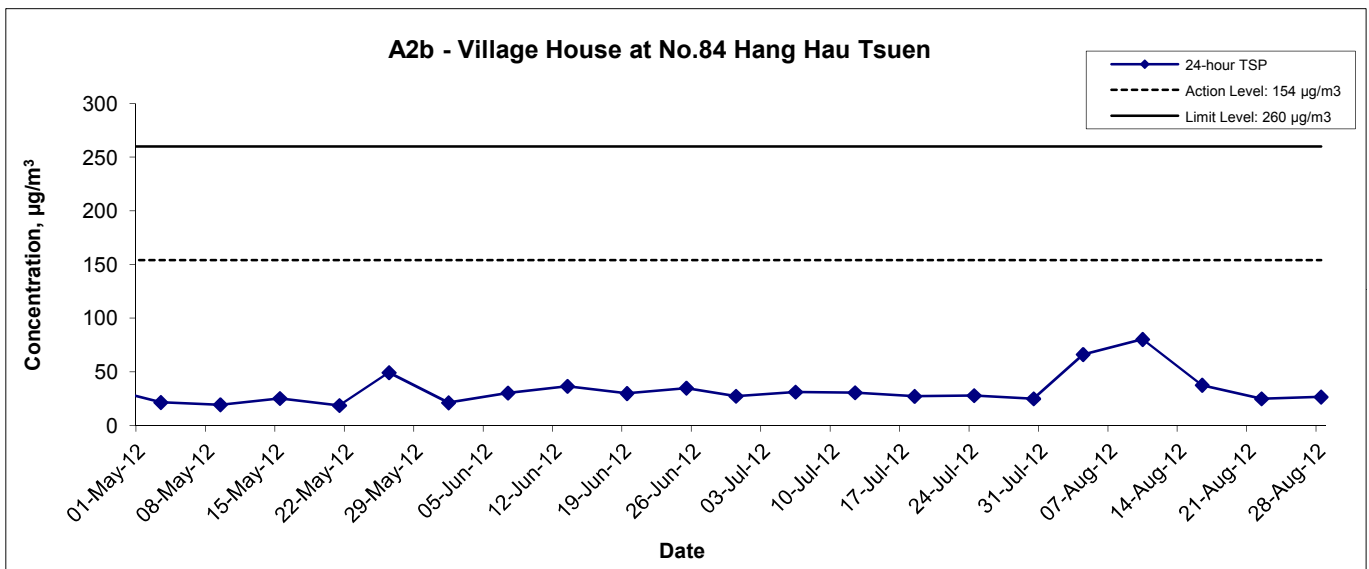
Title Contract No. YL/2009/01 Hang Hau Tsuen Channel at Lau Fau Shan Graphical Presentation of 24-hour TSP Monitoring Results	Scale N.T.S	Project No. MA0002	
	Date Aug 12	Appendix F

24-hr TSP Concentration Levels

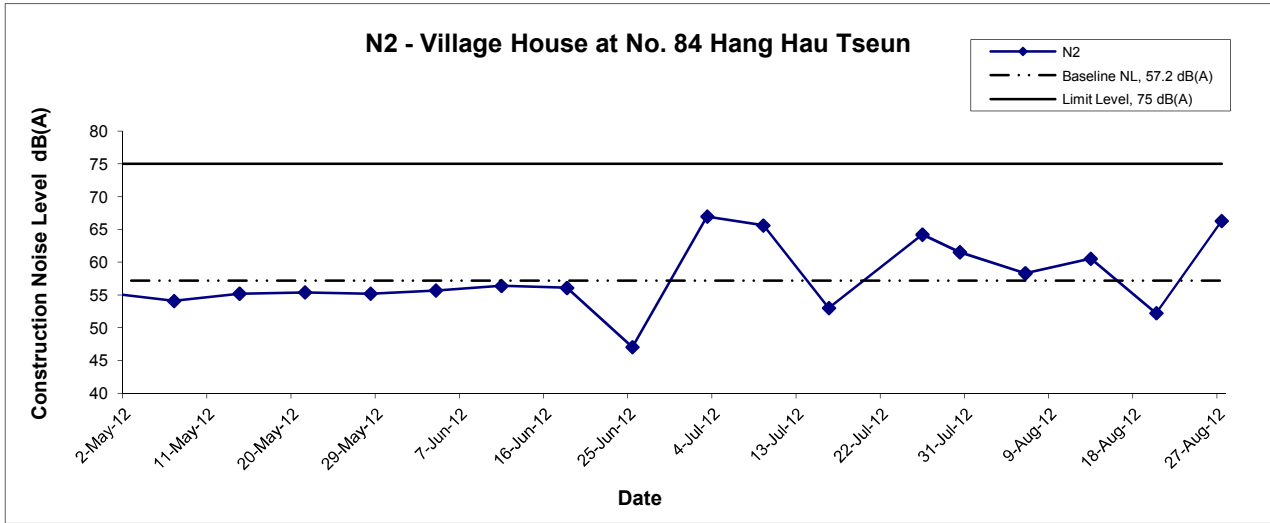
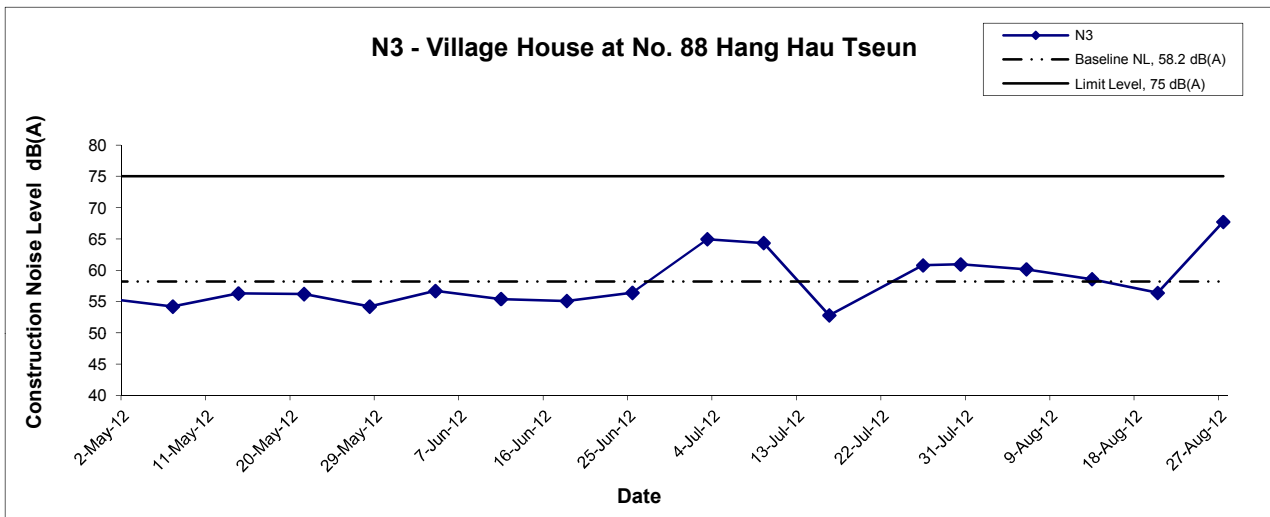
Title Contract No. YL/2009/01 Hang Hau Tsuen Channel at Lau Fau Shan Graphical Presentation of Construction Noise Monitoring Results	Scale N.T.S	Project No. MA0002	
	Date Aug 12	Appendix G

* Free-field adjustment is adopted for monitoring results at station N2 and N3.

Noise Levels

- 3.11 Noise monitoring results and graphical presentations are shown in Appendix G. In accordance with Condition 4.2 of the EP, all environmental monitoring data was made available to the public via internet access at the website <http://www.cinotech.com.hk/projects/LFS>.

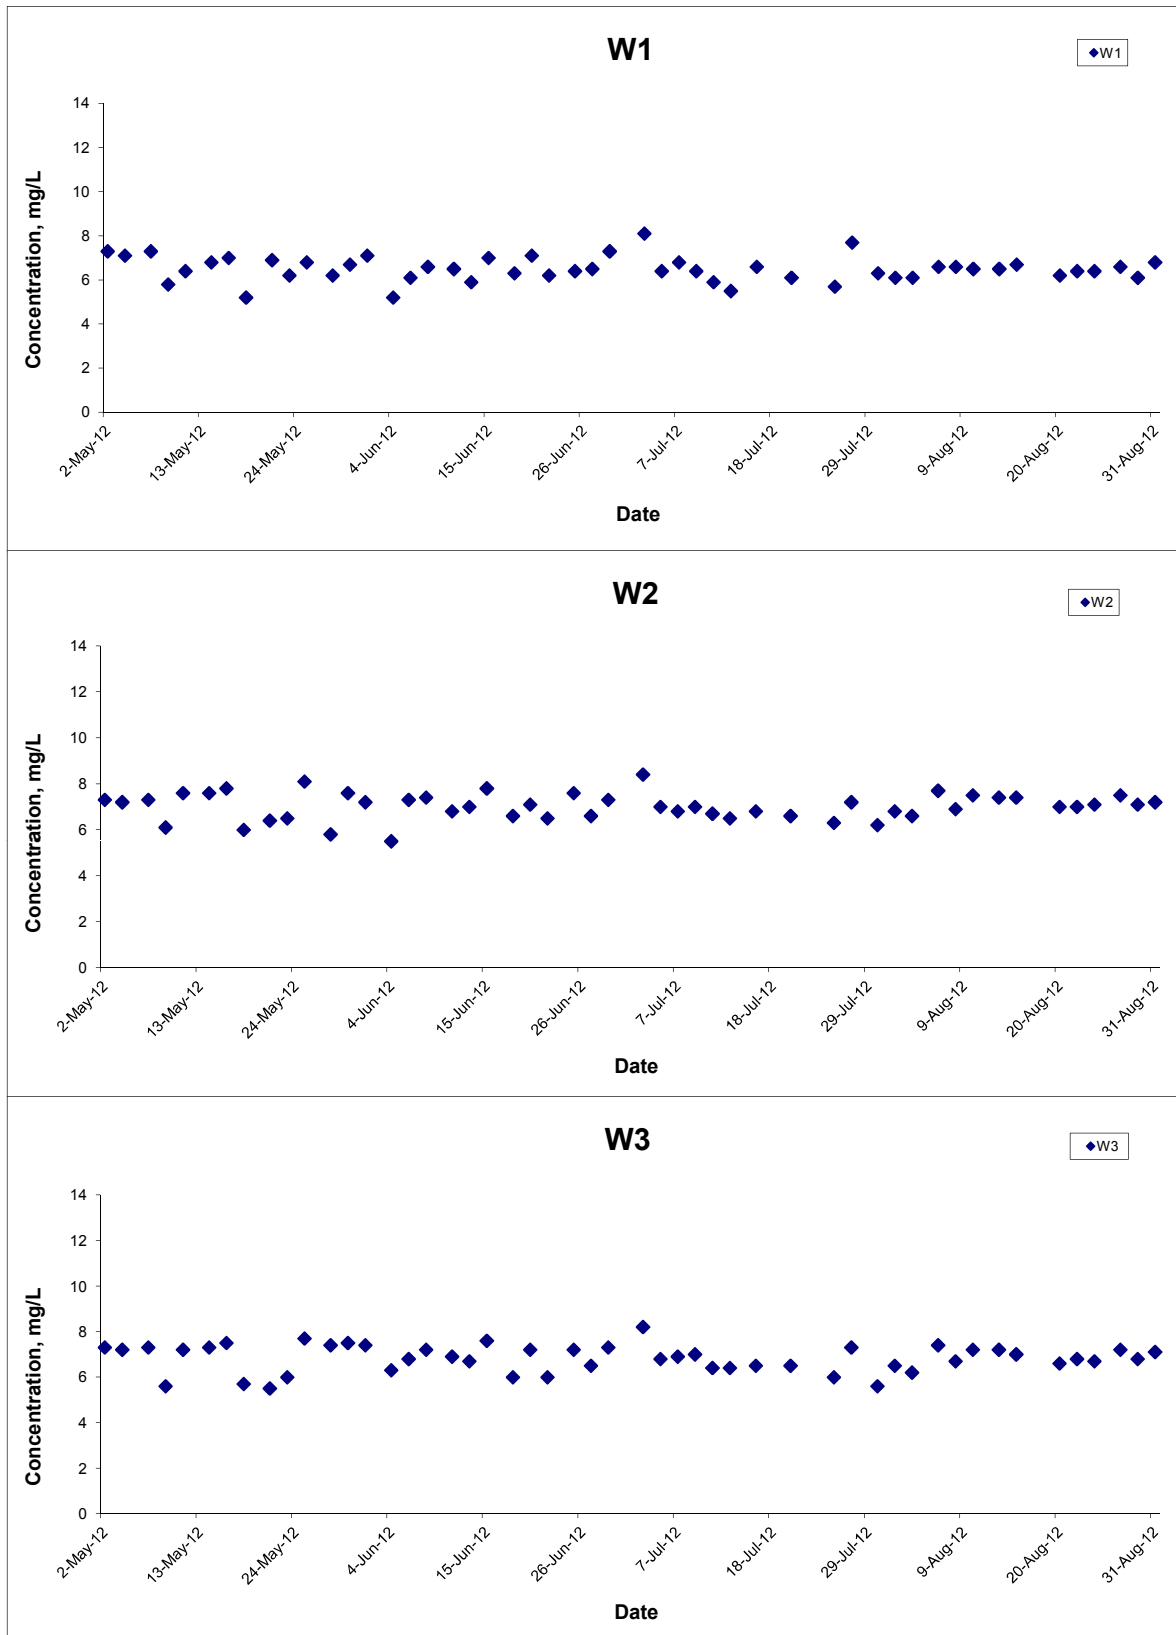
Title Contract No. YL/2009/01 Hang Hau Tsuen Channel at Lau Fau Shan Graphical Presentation of Water Quality Monitoring Results	Scale N.T.S	Project No. MA0002	CINOTECH
	Date Aug 12	Appendix H

Dissolved Oxygen (Surface & Middle) at Mid-Ebb Tide

- 4.10 All water quality monitoring were conducted as scheduled in the reporting month. No Action/Limit Level exceedance was recorded. Summary of exceedance is presented in Appendix I.
- 4.11 The monitoring data and graphical presentations of the monitoring results are shown in Appendix H.
- 4.12 Since the proposal of change of water quality monitoring station W2 and W3 was not approved by the EPD, all water quality monitoring stations will be maintained as that stated in the approved EM&A Manual.
- 4.13 In accordance with Condition 4.2 of the EP, all environmental monitoring data was made available to the public via internet access at the website: <http://www.cinotech.com.hk/projects/LFS>.

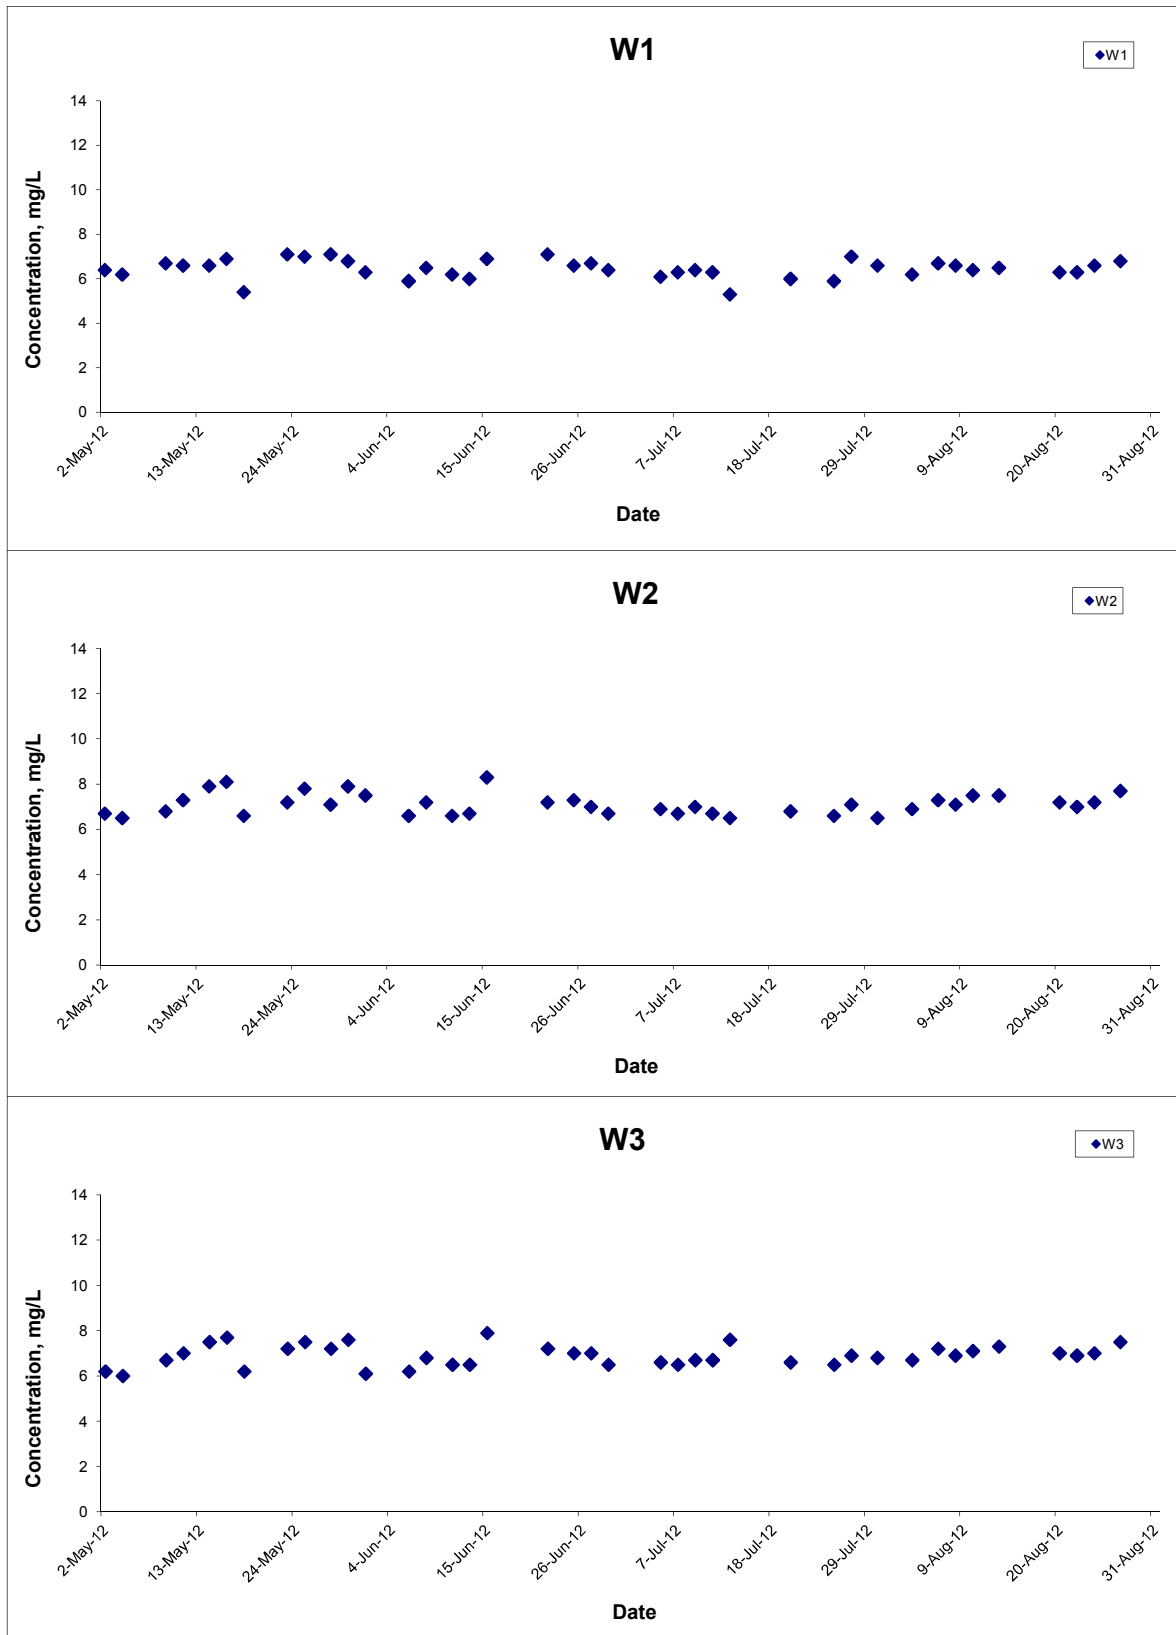
Title Contract No. YL/2009/01 Hang Hau Tsuen Channel at Lau Fau Shan Graphical Presentation of Water Quality Monitoring Results	Scale	N.T.S	Project No. MA0002	
	Date	Aug 12	Appendix H

Dissolved Oxygen (Surface & Middle) at Mid-Flood Tide

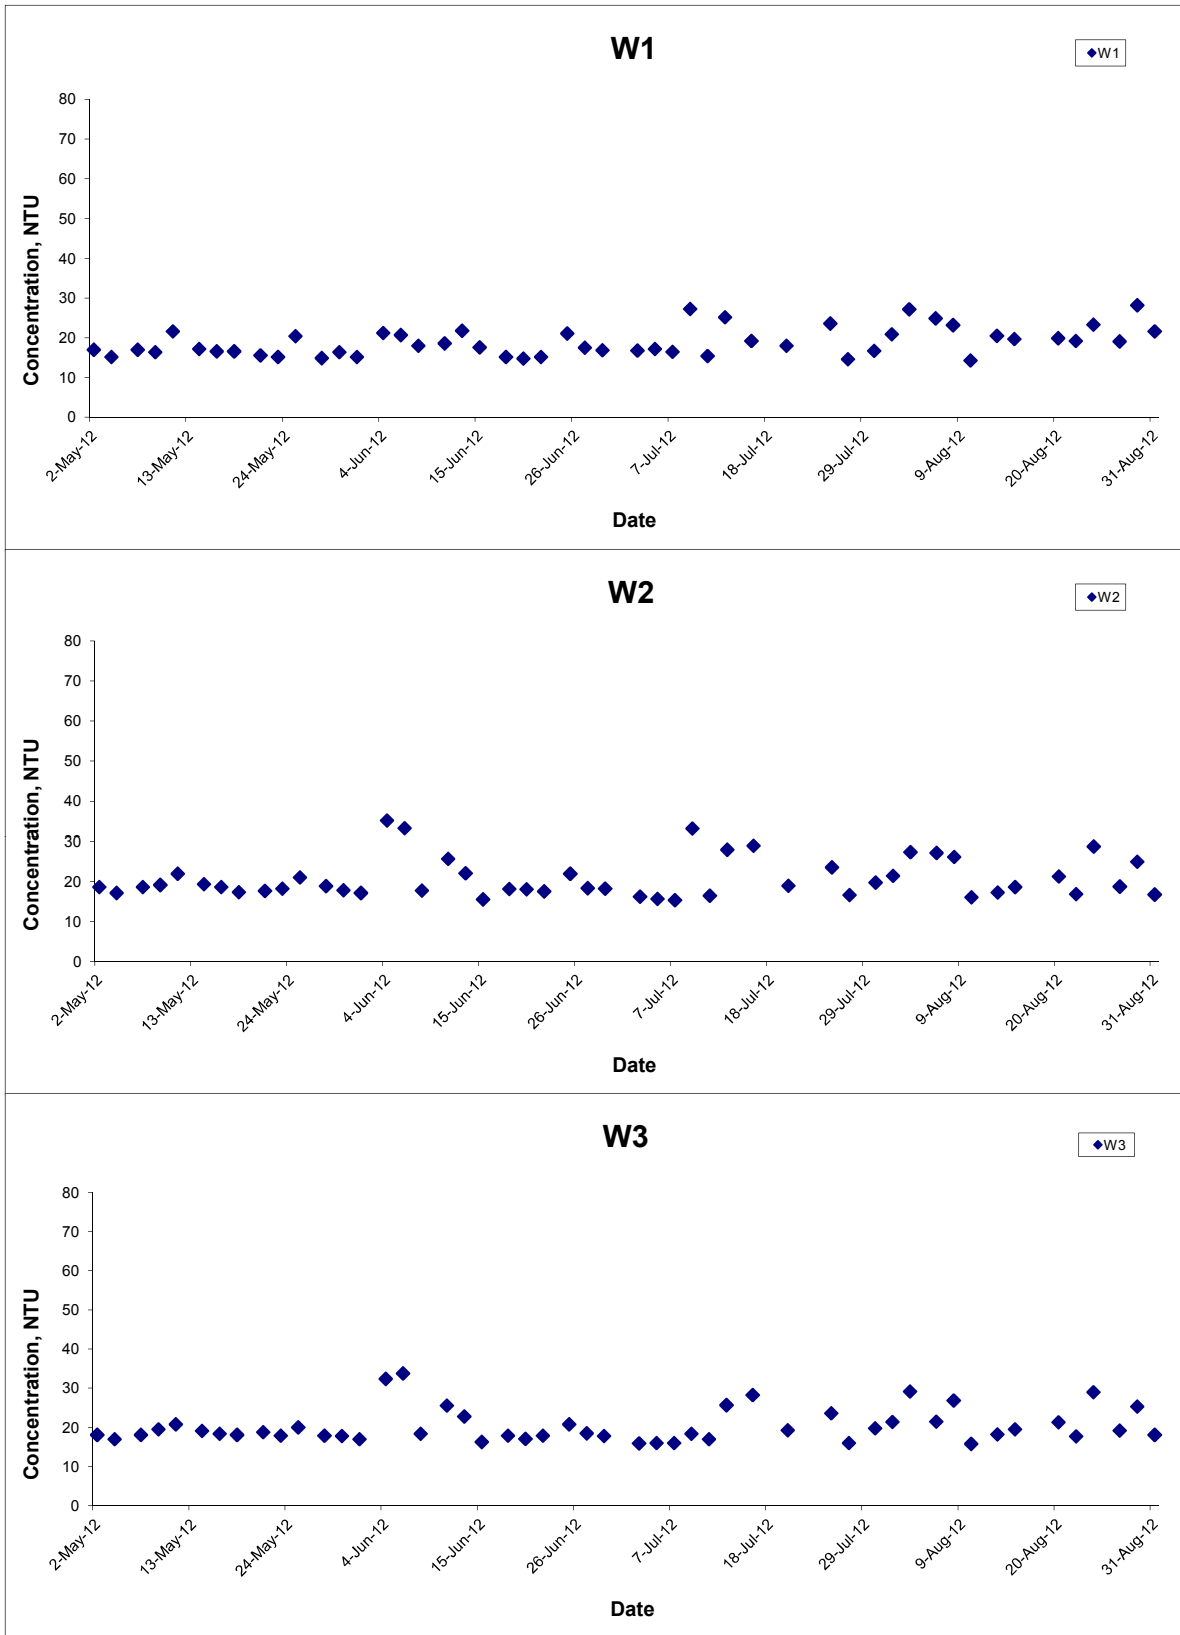
Title Contract No. YL/2009/01 Hang Hau Tsuen Channel at Lau Fau Shan Graphical Presentation of Water Quality Monitoring Results	Scale N.T.S	Project No. MA0002	
	Date Aug 12	Appendix H

Turbidity (Depth-averaged) at Mid-Ebb Tide

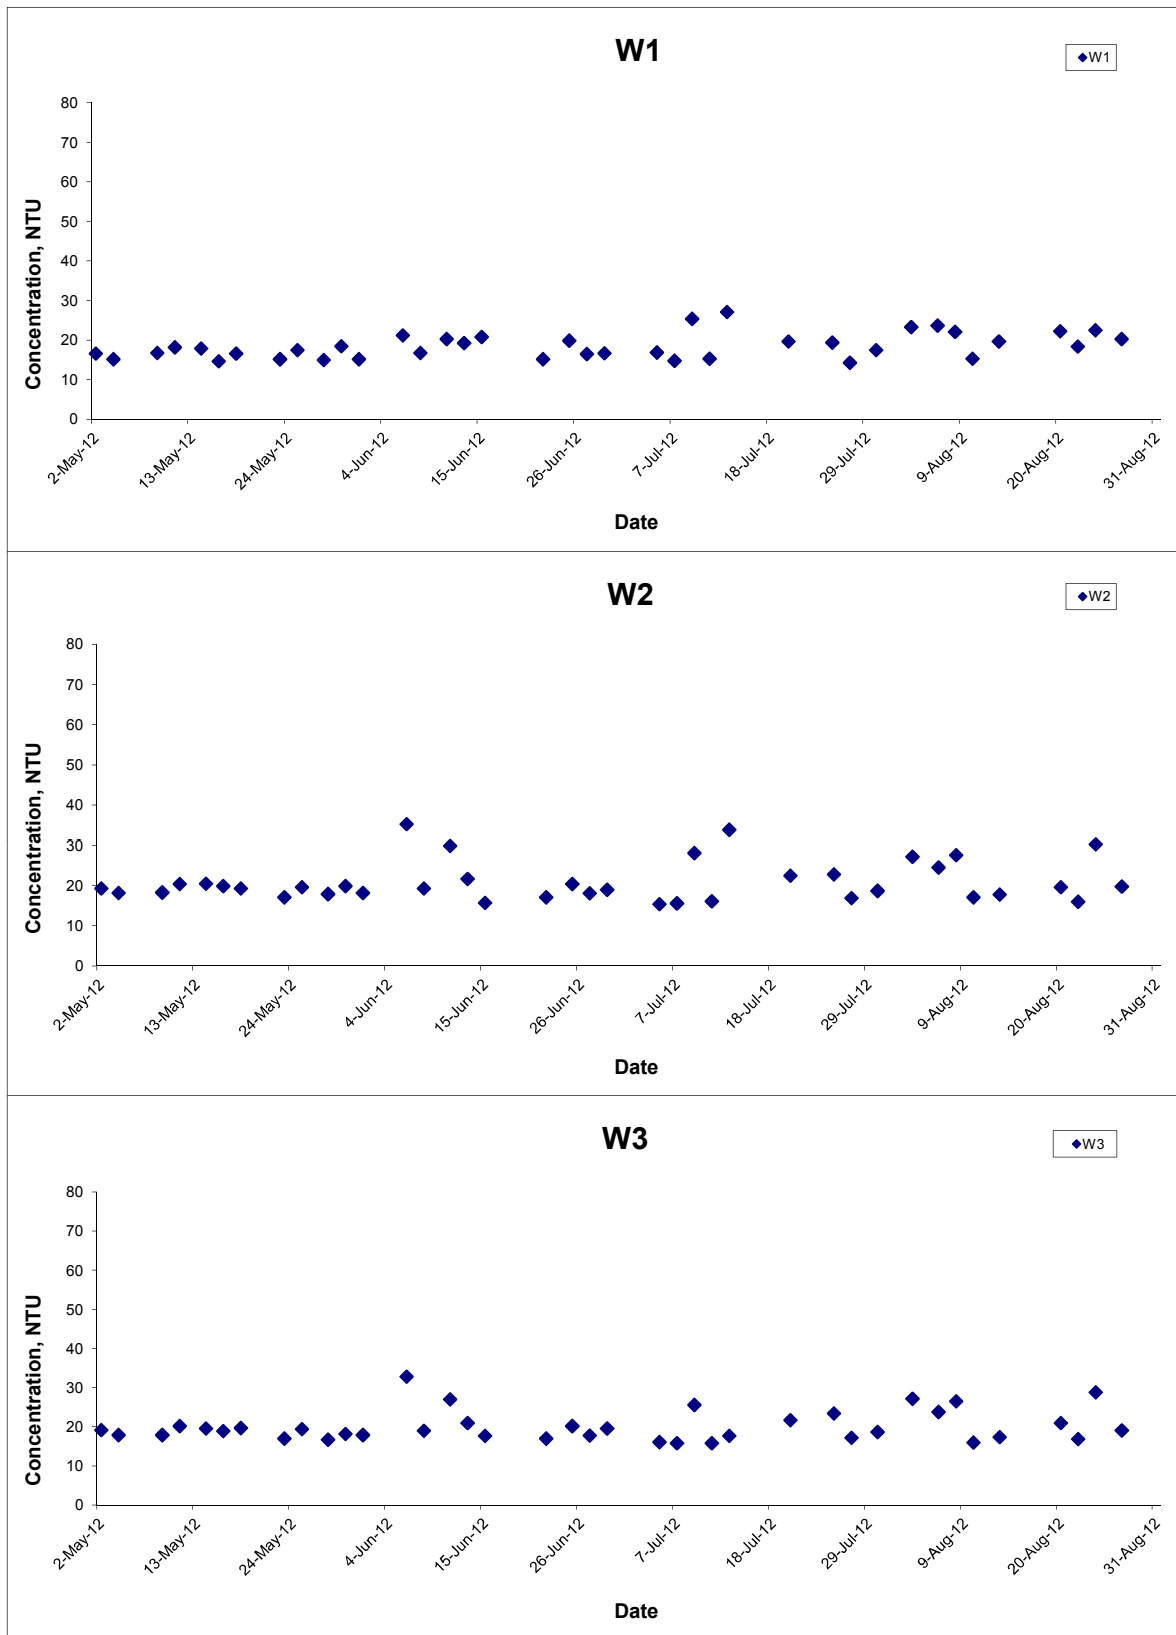
Title	Contract No. YL/2009/01 Hang Hau Tsuen Channel at Lau Fau Shan	Scale	N.T.S	Project No.	MA0002	CINOTECH
	Graphical Presentation of Water Quality Monitoring Results	Date	Aug 12	Appendix	H

Turbidity (Depth-averaged) at Mid-Flood Tide

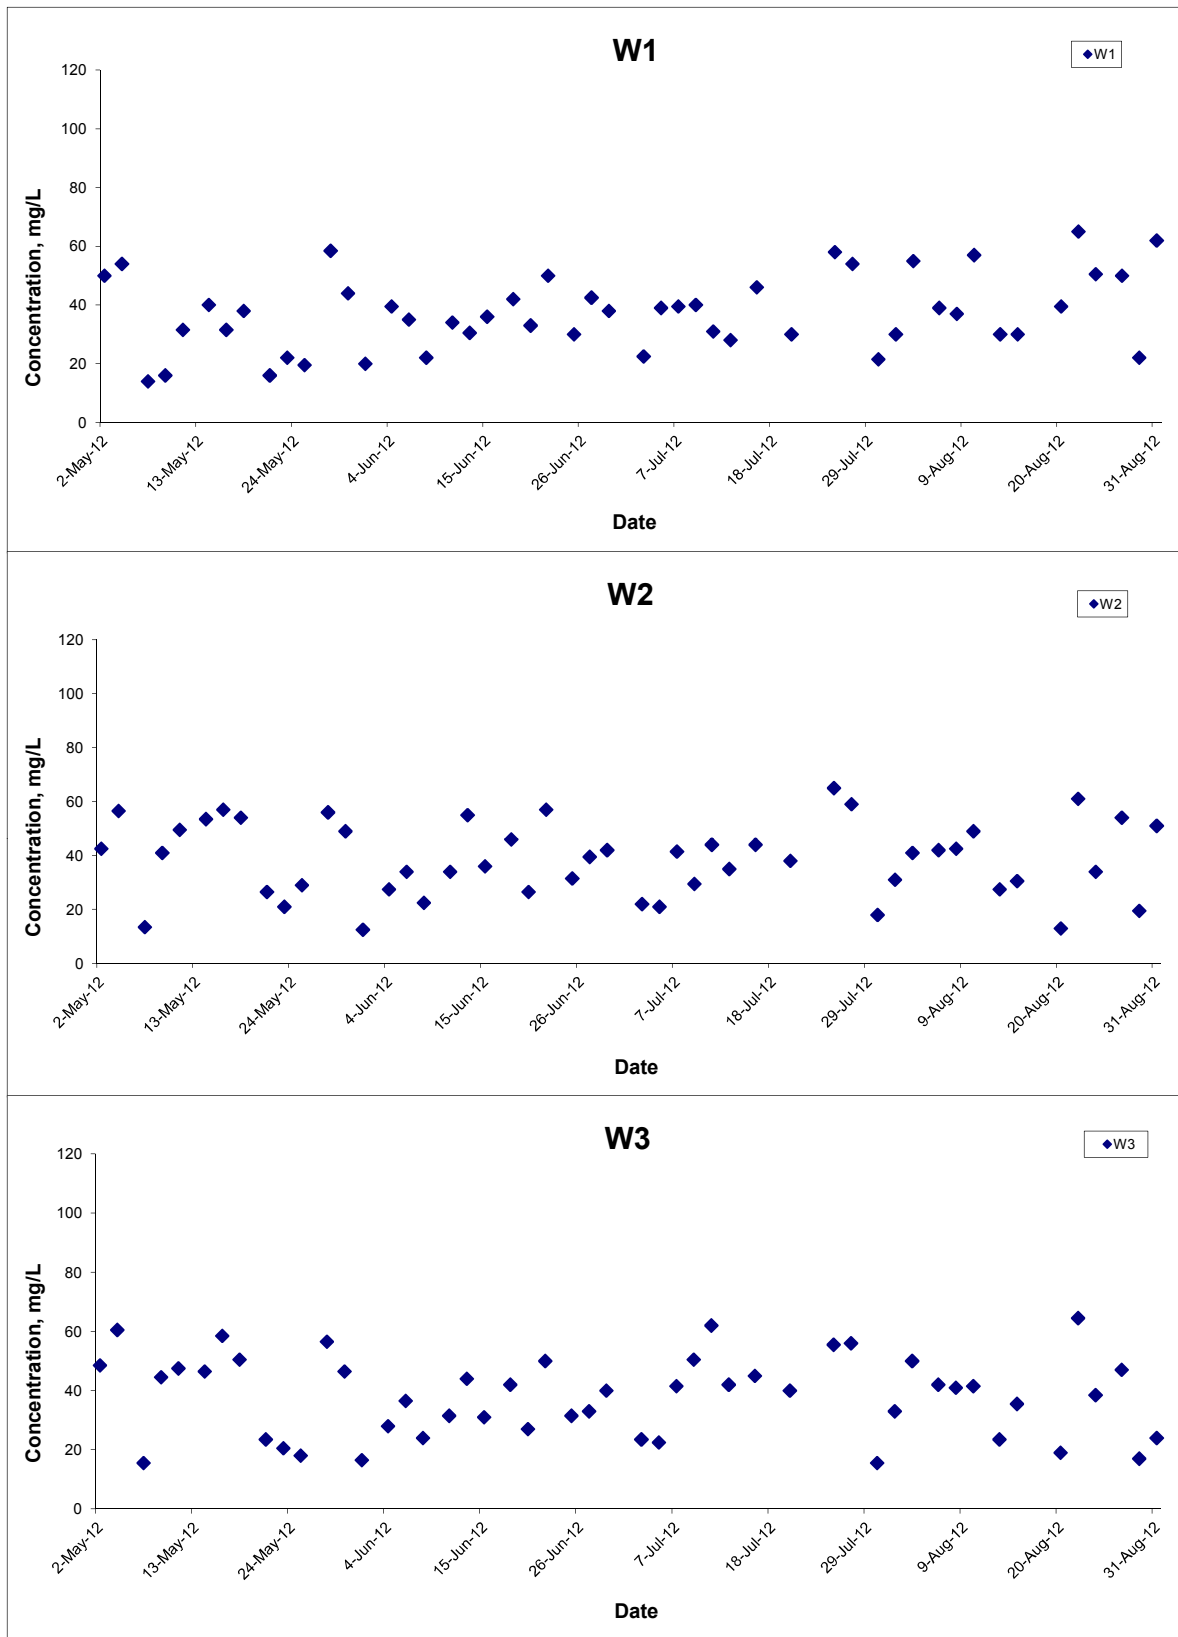
Title Contract No. YL/2009/01 Hang Hau Tsuen Channel at Lau Fau Shan Graphical Presentation of Water Quality Monitoring Results	Scale N.T.S	Project No. MA0002	CINOTECH
	Date Aug 12	Appendix H

Suspended Solids (Depth-averaged) at Mid-Ebb Tide

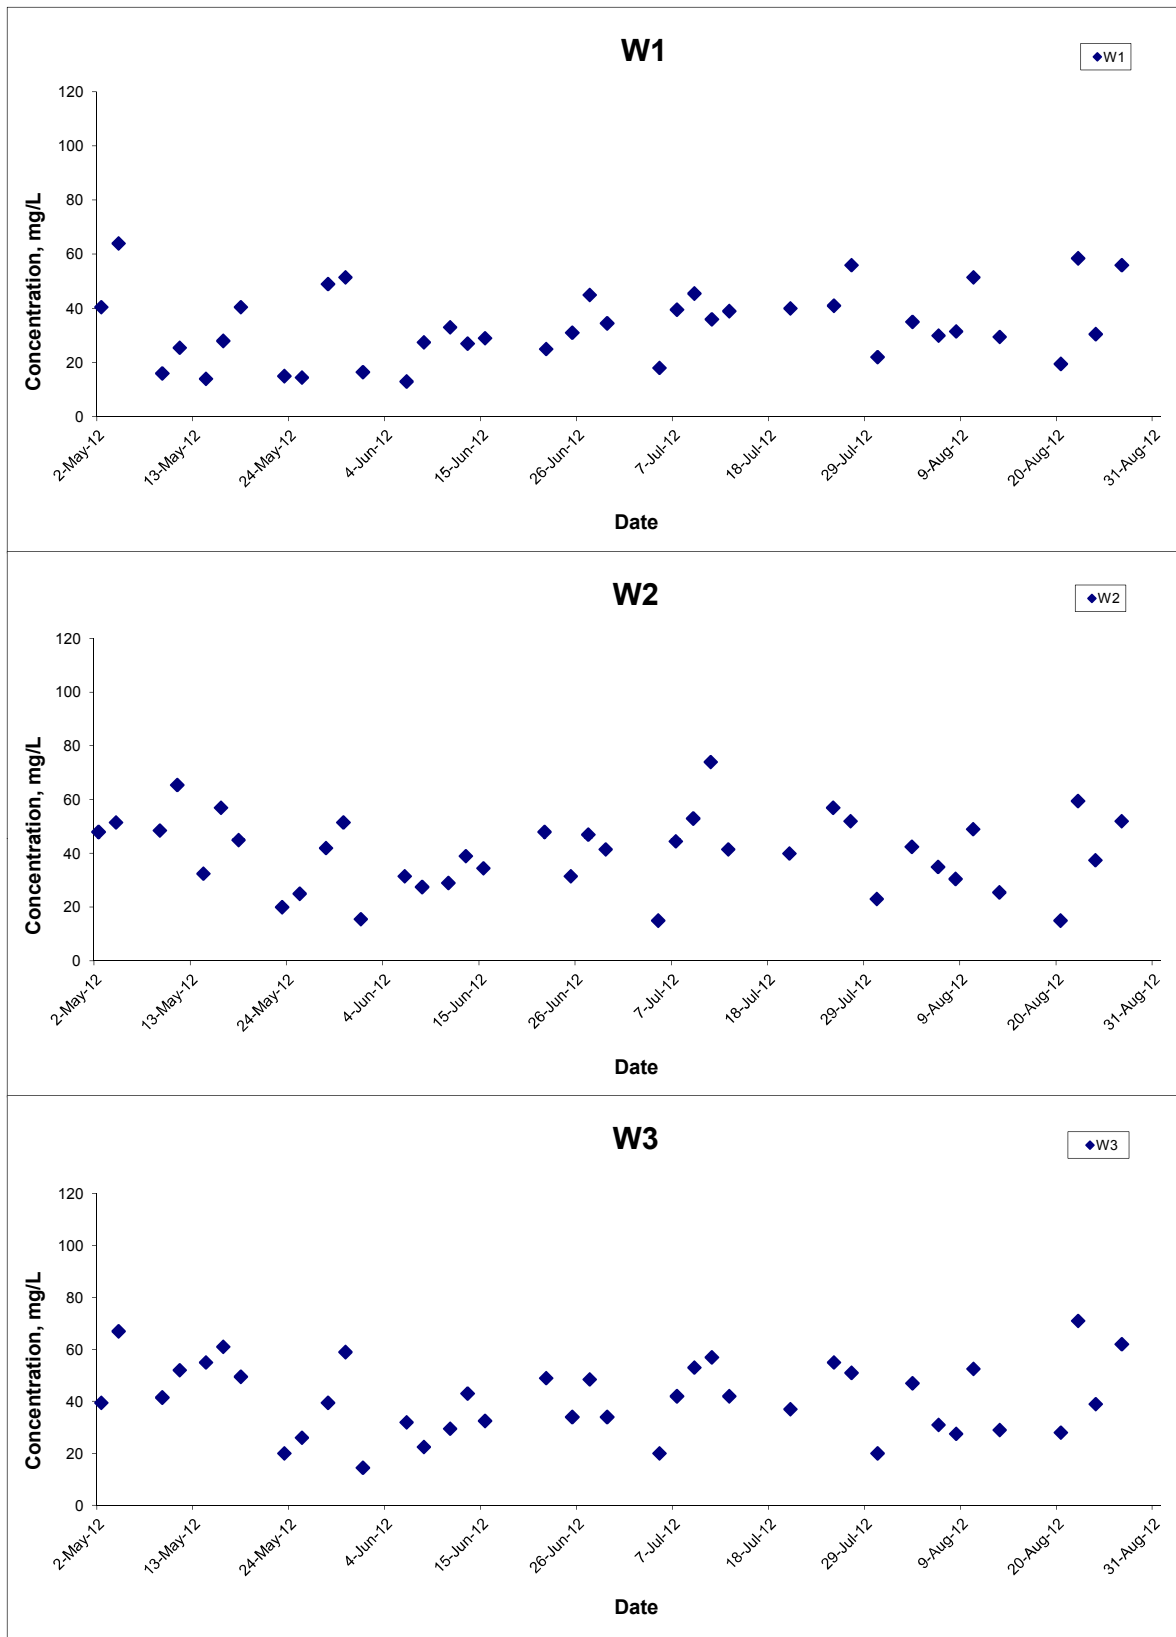
Title Contract No. YL/2009/01 Hang Hau Tsuen Channel at Lau Fau Shan Graphical Presentation of Water Quality Monitoring Results	Scale N.T.S	Project No. MA0002	
	Date Aug 12	Appendix H

Suspended Solids (Depth-averaged) at Mid-Flood Tide
