JOB No.: TCS00874/16

CEDD CONTRACT NO. CV/2012/05  
DEVELOPMENT OF A BATHING BEACH AT LUNG MEI,  
TAI PO

2<sup>ND</sup> ANNUAL ENVIRONMENTAL MONITORING AND AUDIT  
REVIEW REPORT (DECEMBER 2018 – NOVEMBER 2019)

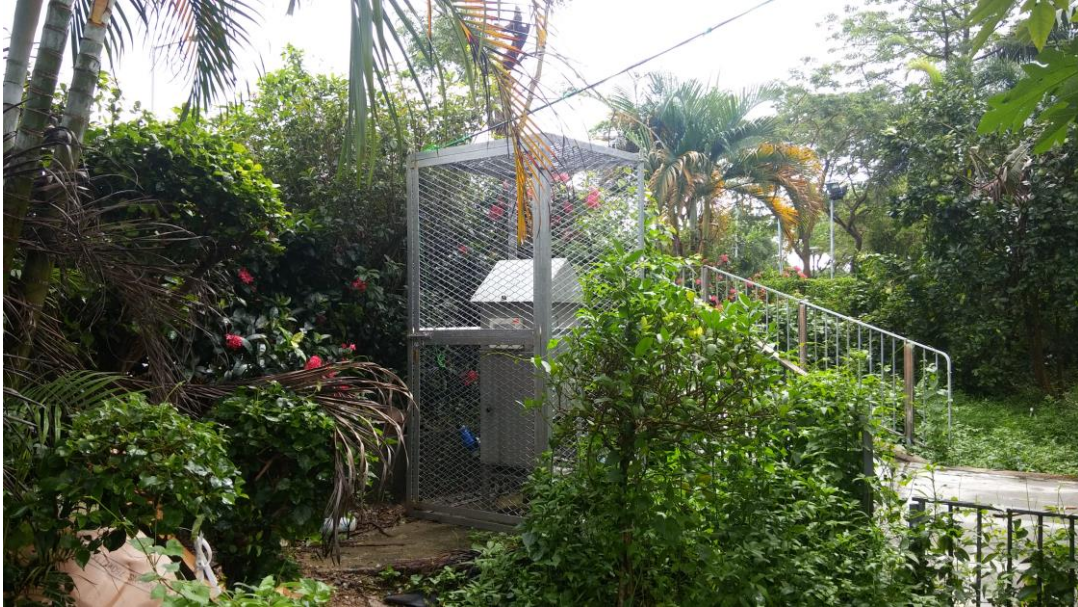
**A4**

**Air Quality Monitoring (24-Hour TSP & 1-Hour TSP)**

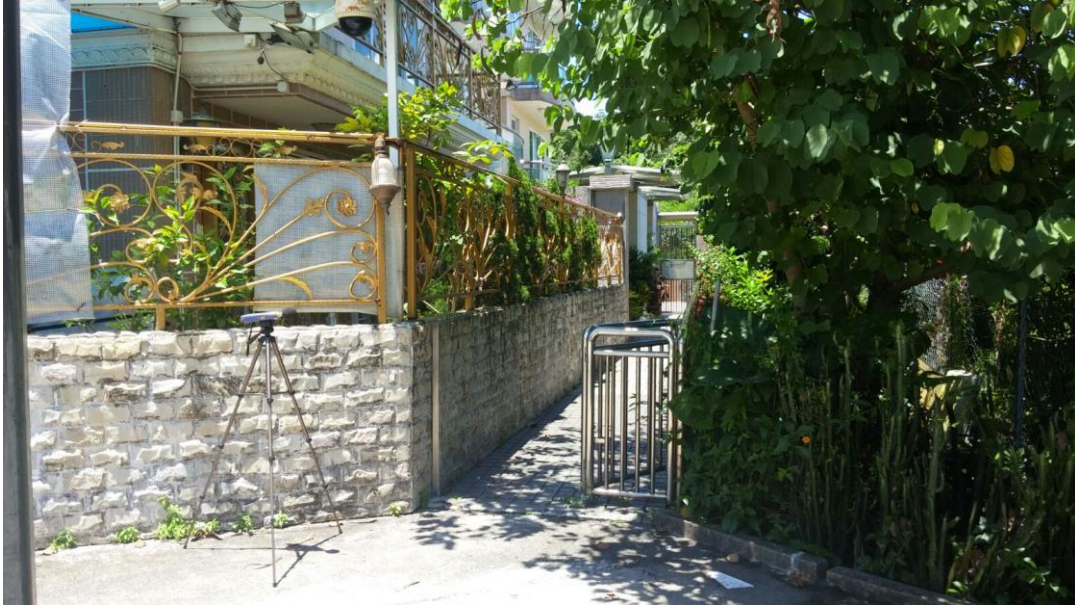
3.3.3 As confirmed on the first day of baseline monitoring, N2a (House no. 101 Lung Mei) has been changed to residential use. Therefore, the noise monitoring is conducted at N2a and to replace N2. Moreover, due to the lack of accessibility of noise monitoring at NSR N3 (Village house – No. 70 Lo Tsz Tin), alternative location was proposed to replace N3 to carry out the noise monitoring. Having reviewed the surrounding condition, NSR N3a (Village house – No. 66C Lo Tsz Tin) was proposed with the rationales summarized in below.

- 1) The distance between N3 and N3a is about 18 meter apart and N3a locates at close proximity of the project site and major site activities which are likely to have noise impacts;
- 2) N3a is a village type residential house and it is a noise sensitive receiver (NSR);
- 3) Accessibility for noise monitoring work at N3a is available; and
- 4) Minimal disturbance would be only caused to the proposed monitoring location N3a.

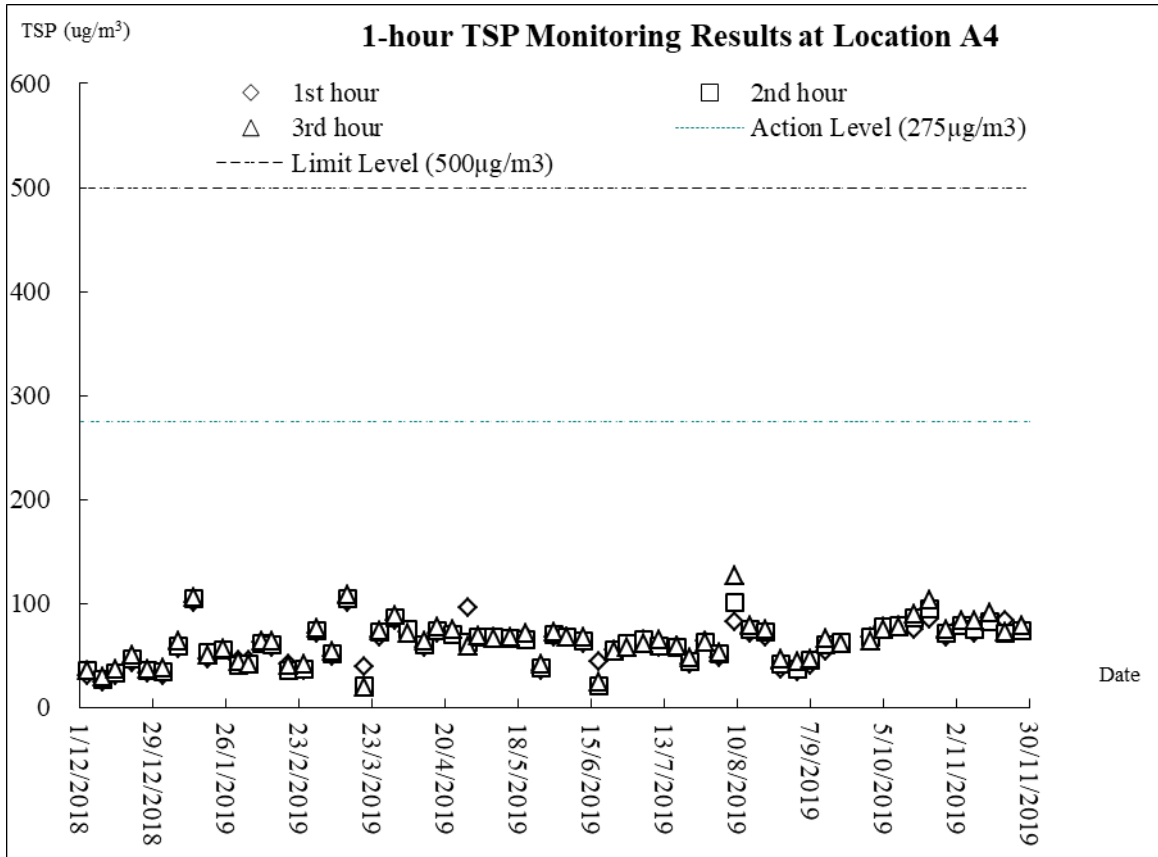
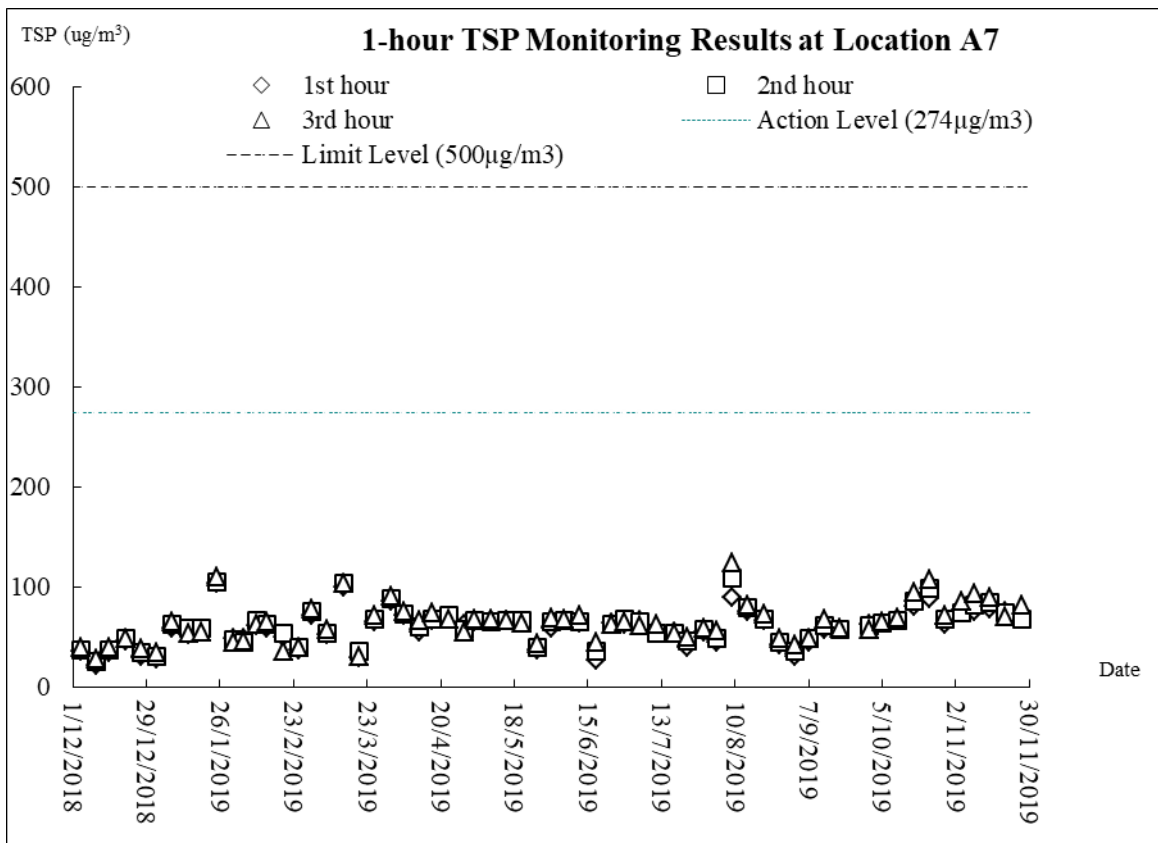
**Air Quality – 1-hour TSP**

- 4.2.5 In this Reporting Period, all the 1-hour TSP and 24-hour TSP monitoring results were below the Action/Limit Levels. No Notification of Exceedance (NOE) was therefore issued. The baseline air quality monitoring was conducted in June 2017 during typical rainy season. The data collected therefore may not reflect the air quality condition of dry seasons in Hong Kong which normally significantly different. However, with implementation of construction dust suppression measures and good site practices provided by the Contractor, the impact monitoring results recorded zero exceedance of the environmental quality criteria of the parameter.

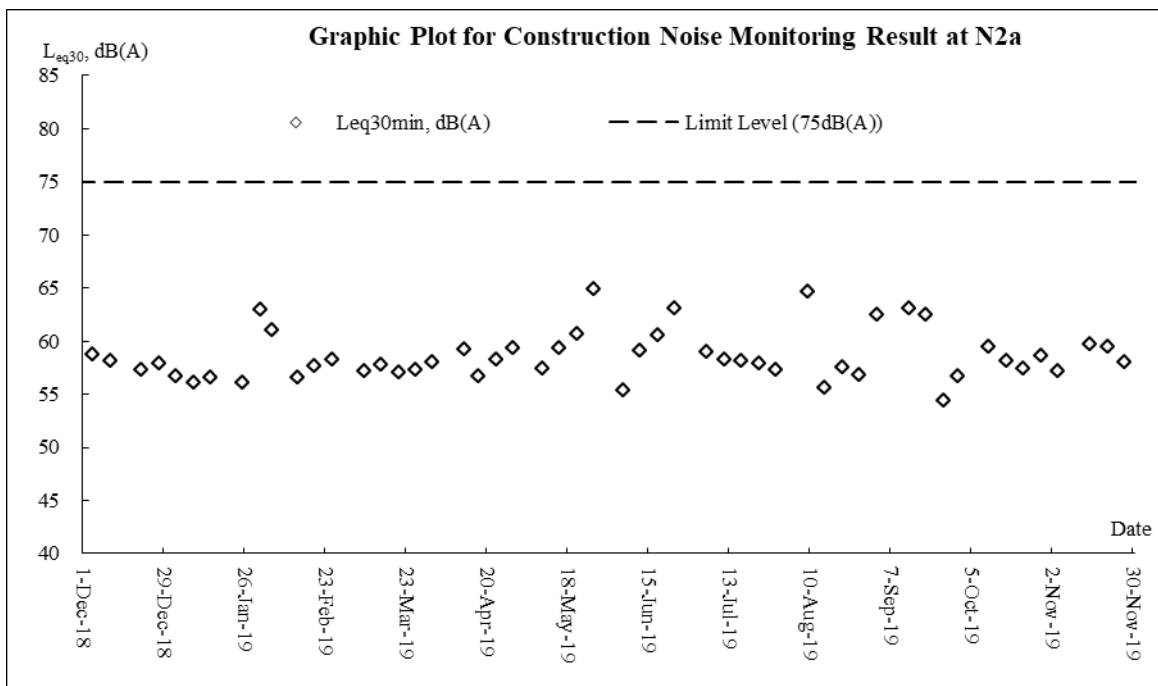
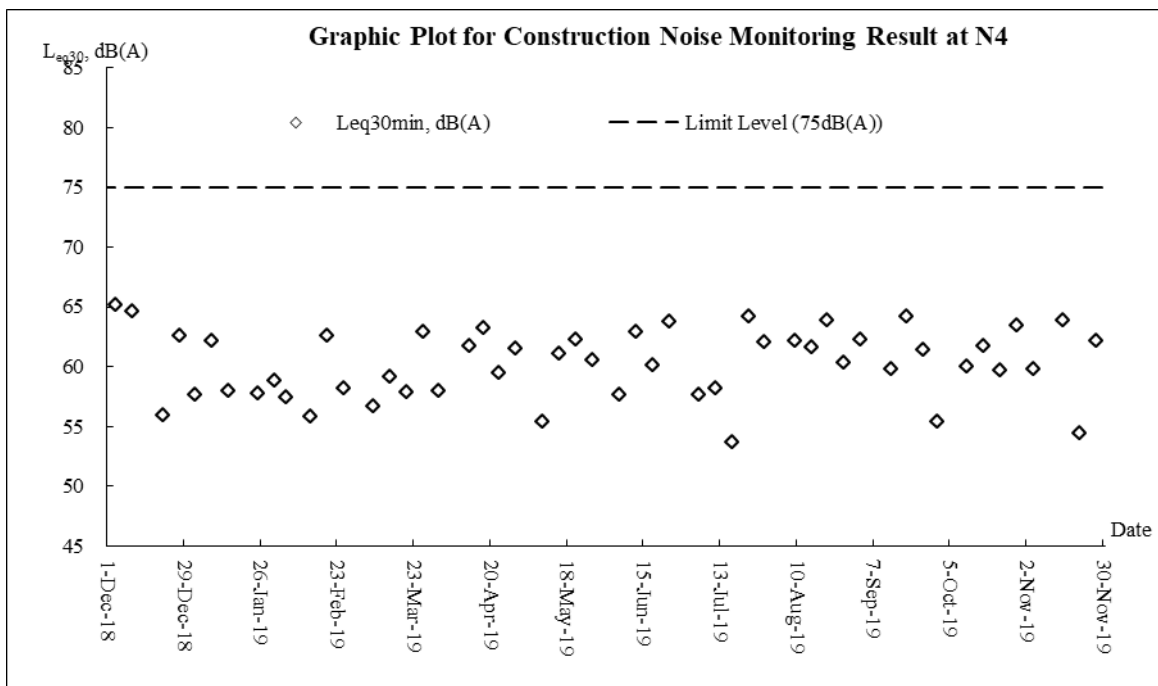
**Construction Noise**

- 5.2.6  $L_{eq(30min)}$  monitoring results registered consistent compliance of the parameter with environmental quality criteria throughout the Reporting Period, indicating that the prediction of Final EIA prediction on the adverse noise nuisance to be generated from the construction of the Project is in general acceptable and the recommended environmental mitigation measures as stipulated in ISEMM is also adequate.
- 5.2.7 In order to ensure full compliance of the construction noise with the environmental quality criteria, environmental mitigation measures as stipulated in ISEMM should be strictly observed throughout the remaining construction period..

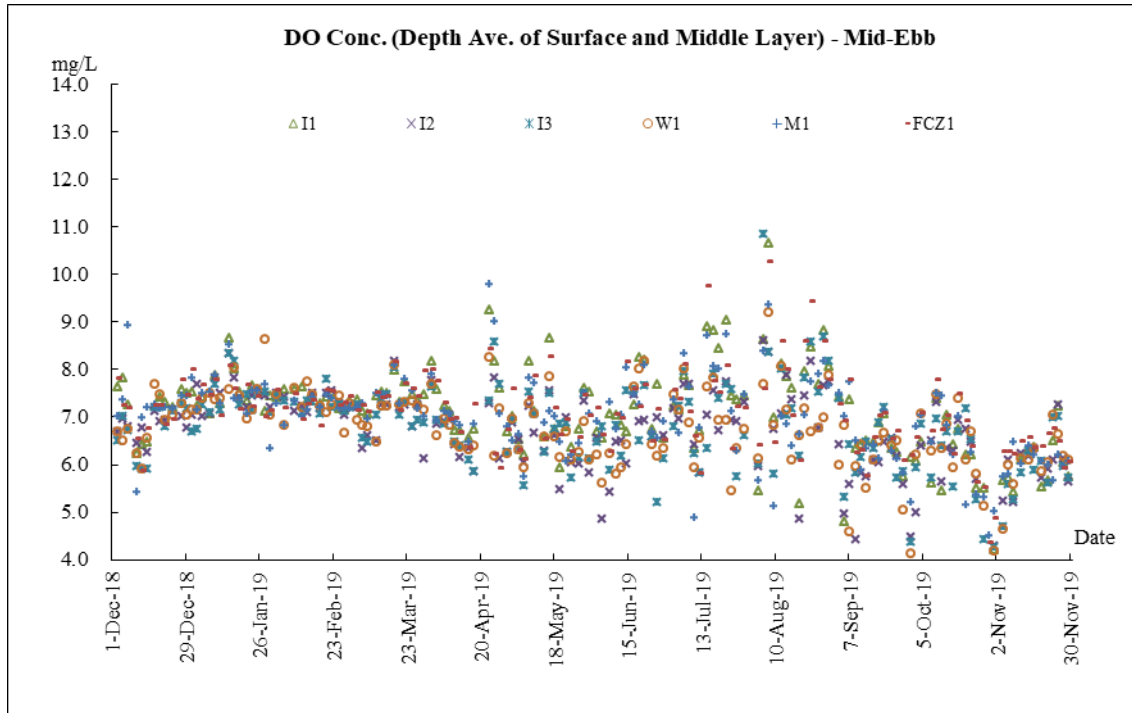
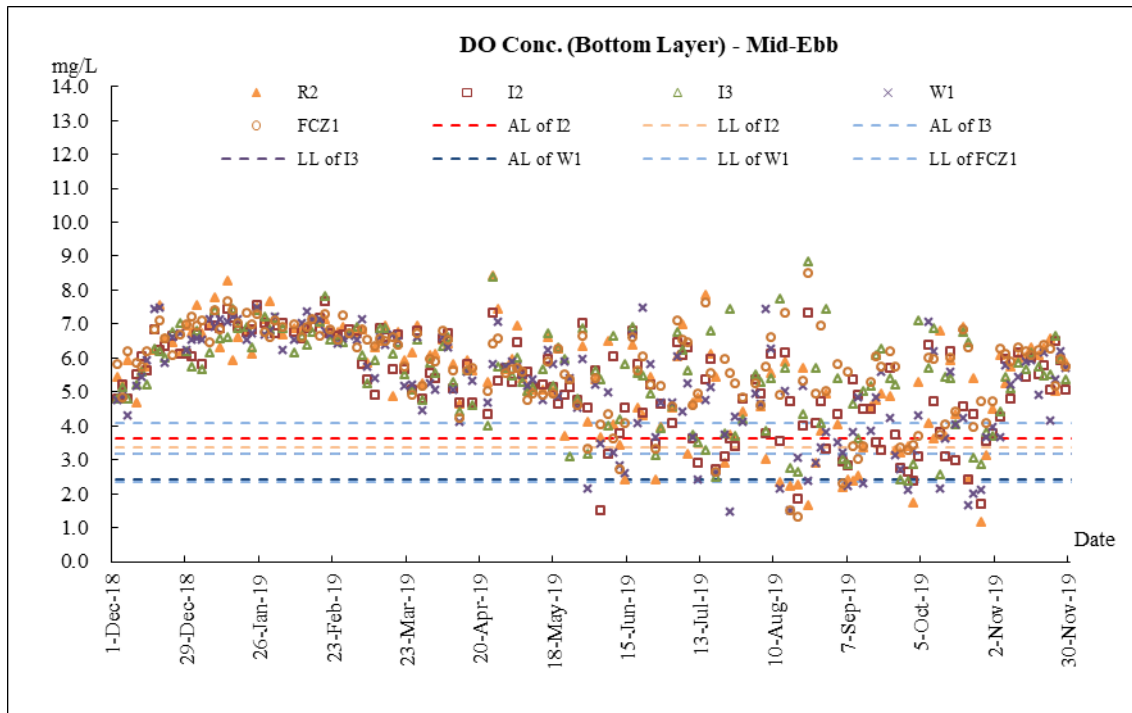
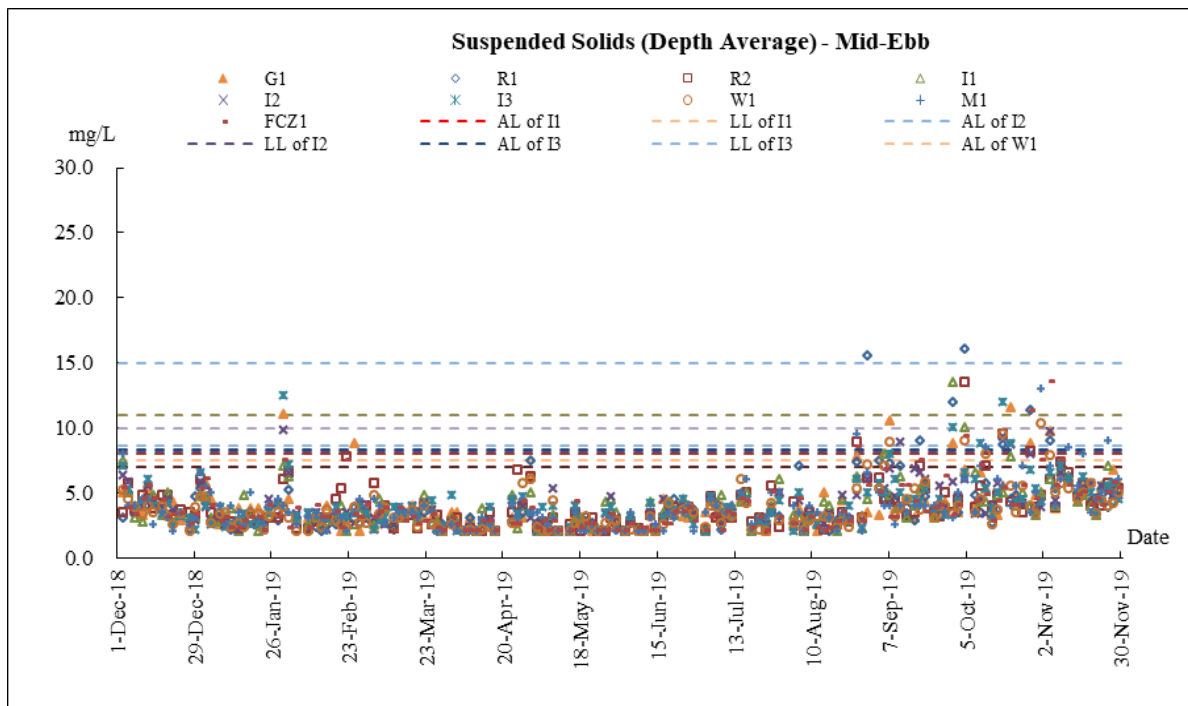
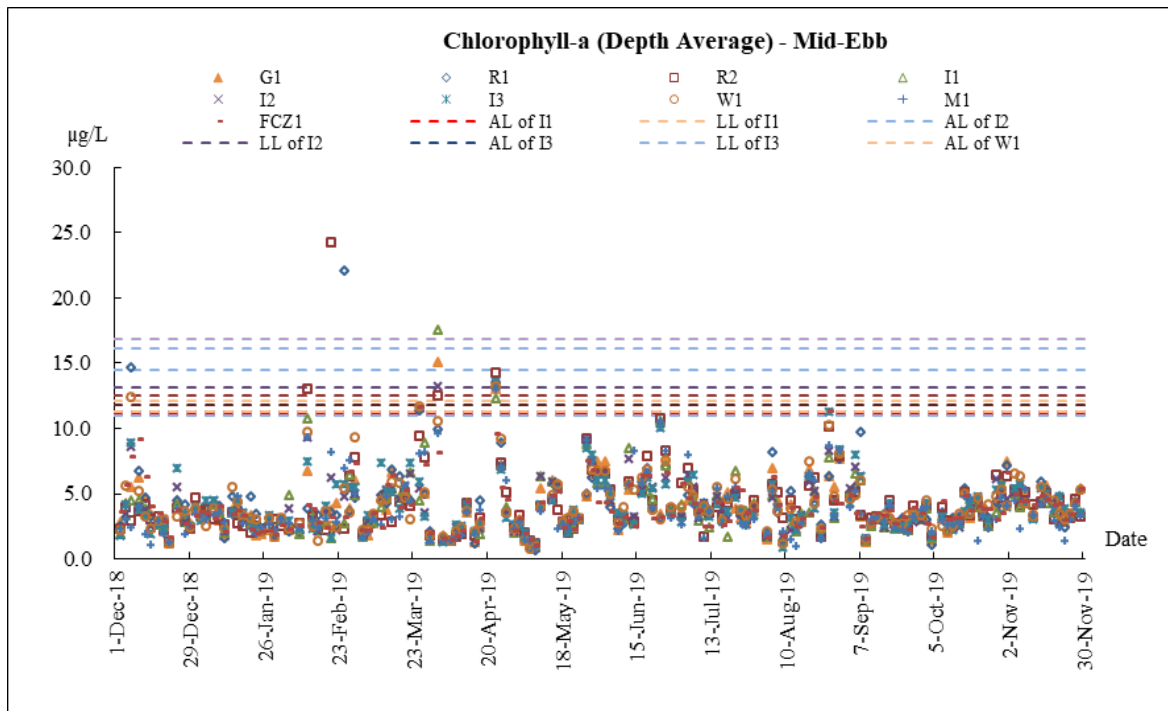
**Water Quality**

6.2.1 In this Reporting Period, a total of 153 sampling days were performed for marine water quality monitoring. Due to the inclement weather condition, marine water quality monitoring on 31 Jul and 1 Aug were cancelled. Monitoring results of 4 key parameters: dissolved oxygen (DO), turbidity, suspended solids and Chlorophyll-*a* are summarized in [Tables 6-1 to 6-5](#).

- 6.2.5 Baseline monitoring was carried out during the period between 23 September 2017 and 21 October 2017. It is important to point out that the baseline SS and turbidity conditions at the monitoring locations may differ significantly during raining, in particular under high tide flow conditions. The monitoring results in the Reporting Period are generally comparable with the baseline. With implementation of water quality mitigation measures and good site practices provided by the Contractor, except for the exceedances of Chlorophyll-a recorded on 1 April 2019, no project-related exceedances were recorded.

- 6.2.6 Overall, with the implementation of water quality mitigation measures, except for the exceedances of Chlorophyll-a recorded on 1 April 2019, all the exceedances were likely related to natural variation and not caused by the works under the Project. No remedial actions associated with the exceedances were therefore taken during the Reporting Period. Nevertheless, the Contractor was reminded to strictly implement the water quality mitigation measure as recommended implementation schedule for environmental mitigation measures in the EM&A Manual and EP's condition.
