**CEDD CONTRACT NO. CV/2012/05
DEVELOPMENT OF A BATHING BEACH AT LUNG MEI,
TAI PO**

**3RD ANNUAL ENVIRONMENTAL MONITORING AND AUDIT
REVIEW REPORT (DECEMBER 2019 – NOVEMBER 2020)**

**PREPARED FOR
WELCOME CONSTRUCTION CO., LTD**

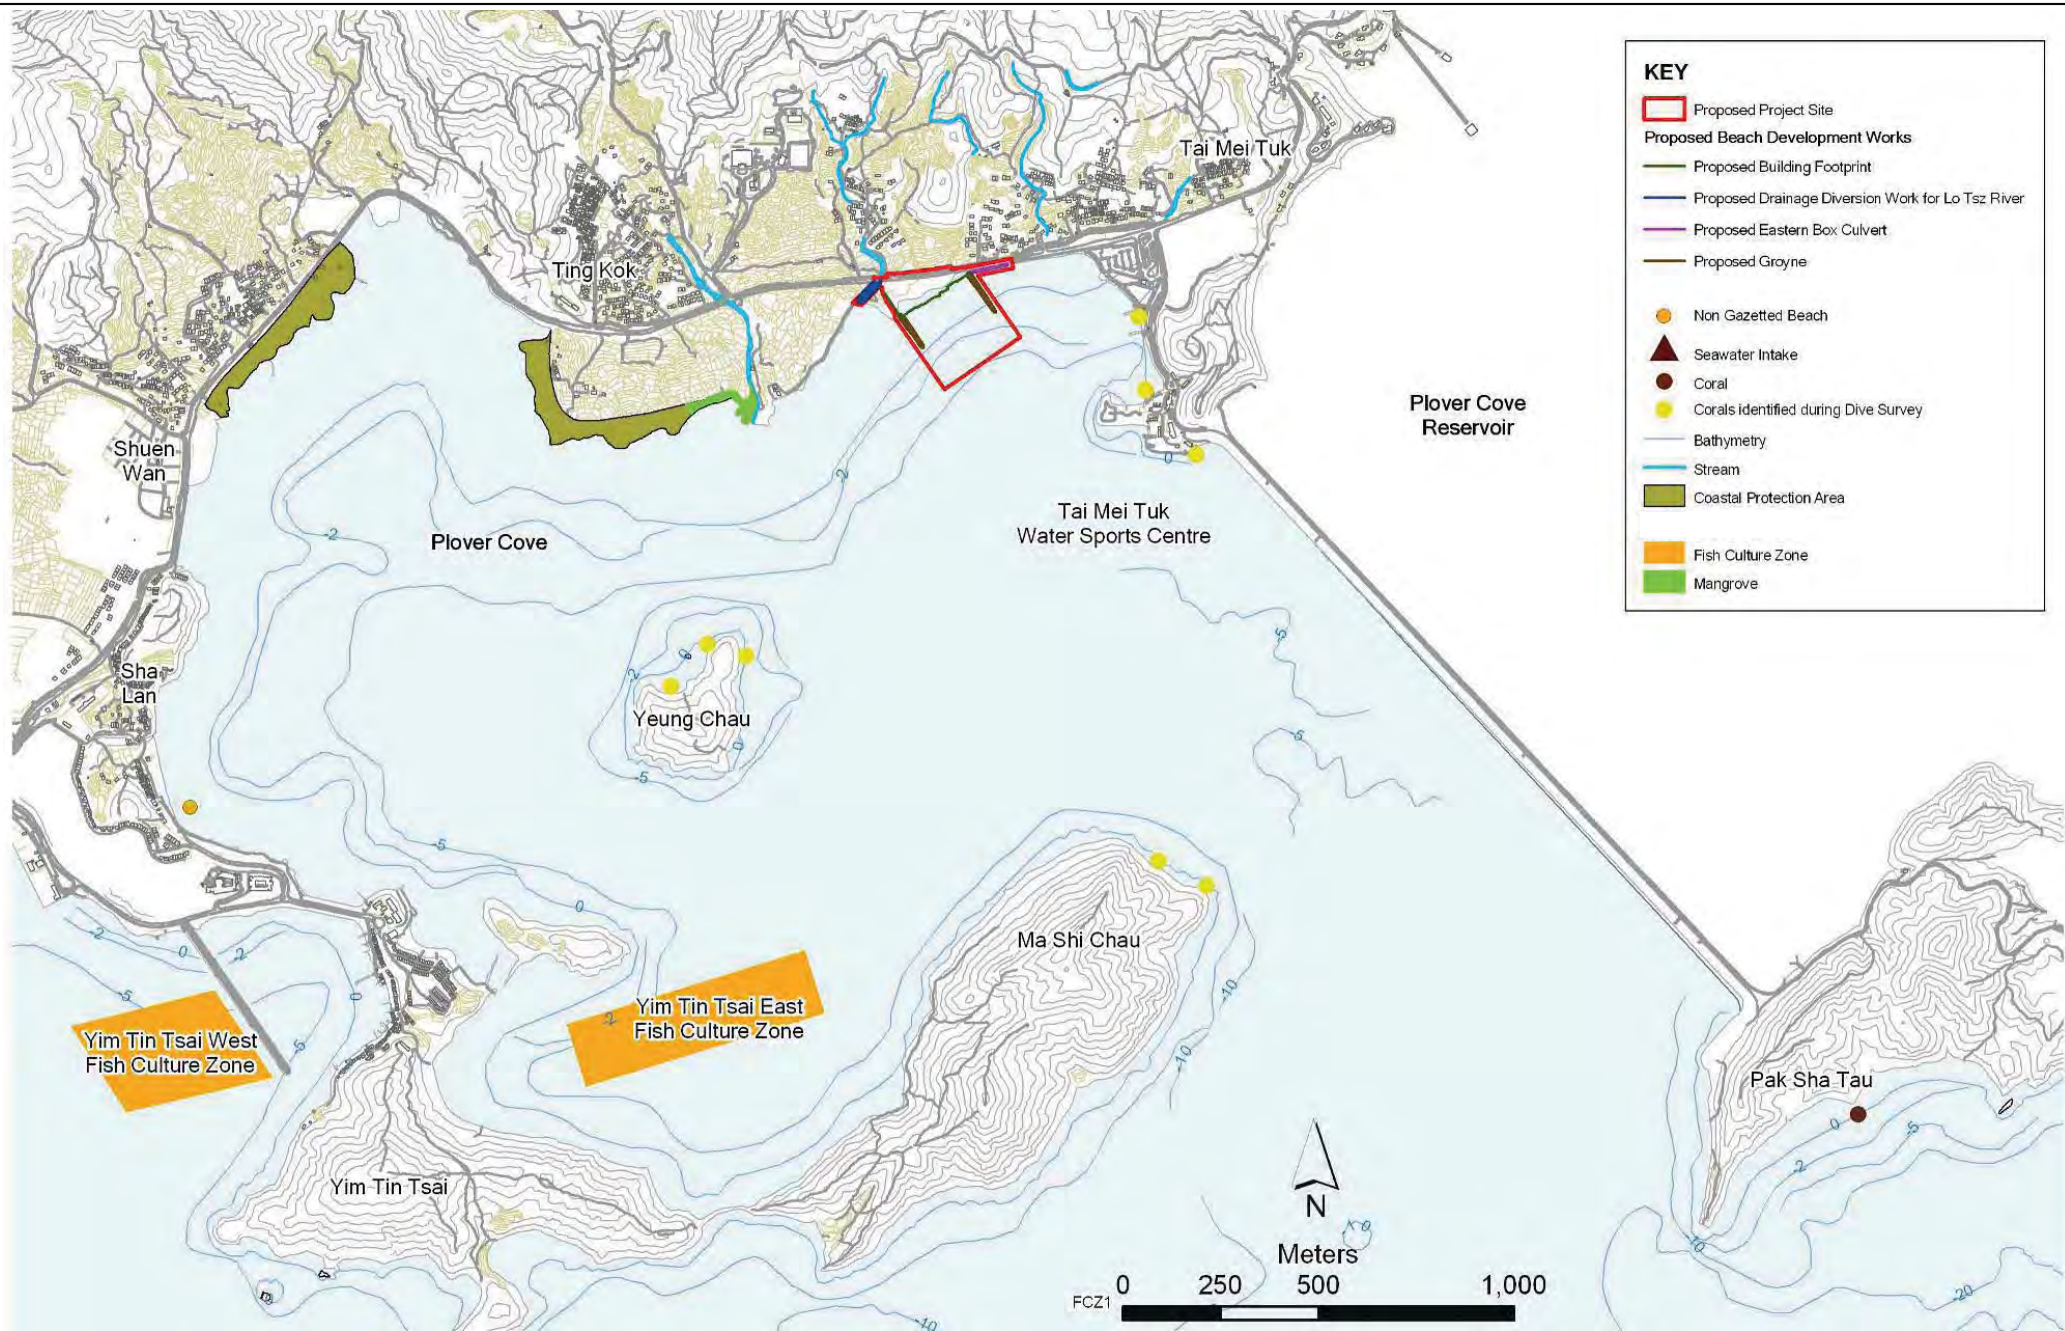
Layout plan of the Project

- Proposed Project Site
- Proposed Beach Development Works
- Proposed Building Footprint
- Proposed Drainage Diversion Work for Lo Tsz River
- Proposed Eastern Box Culvert
- Proposed Groyne
- Non Gazetted Beach
- ▲ Seawater Intake
- Coral
- Corals identified during Dive Survey
- Bathymetry
- Stream
- Coastal Protection Area
- Fish Culture Zone
- Mangrove

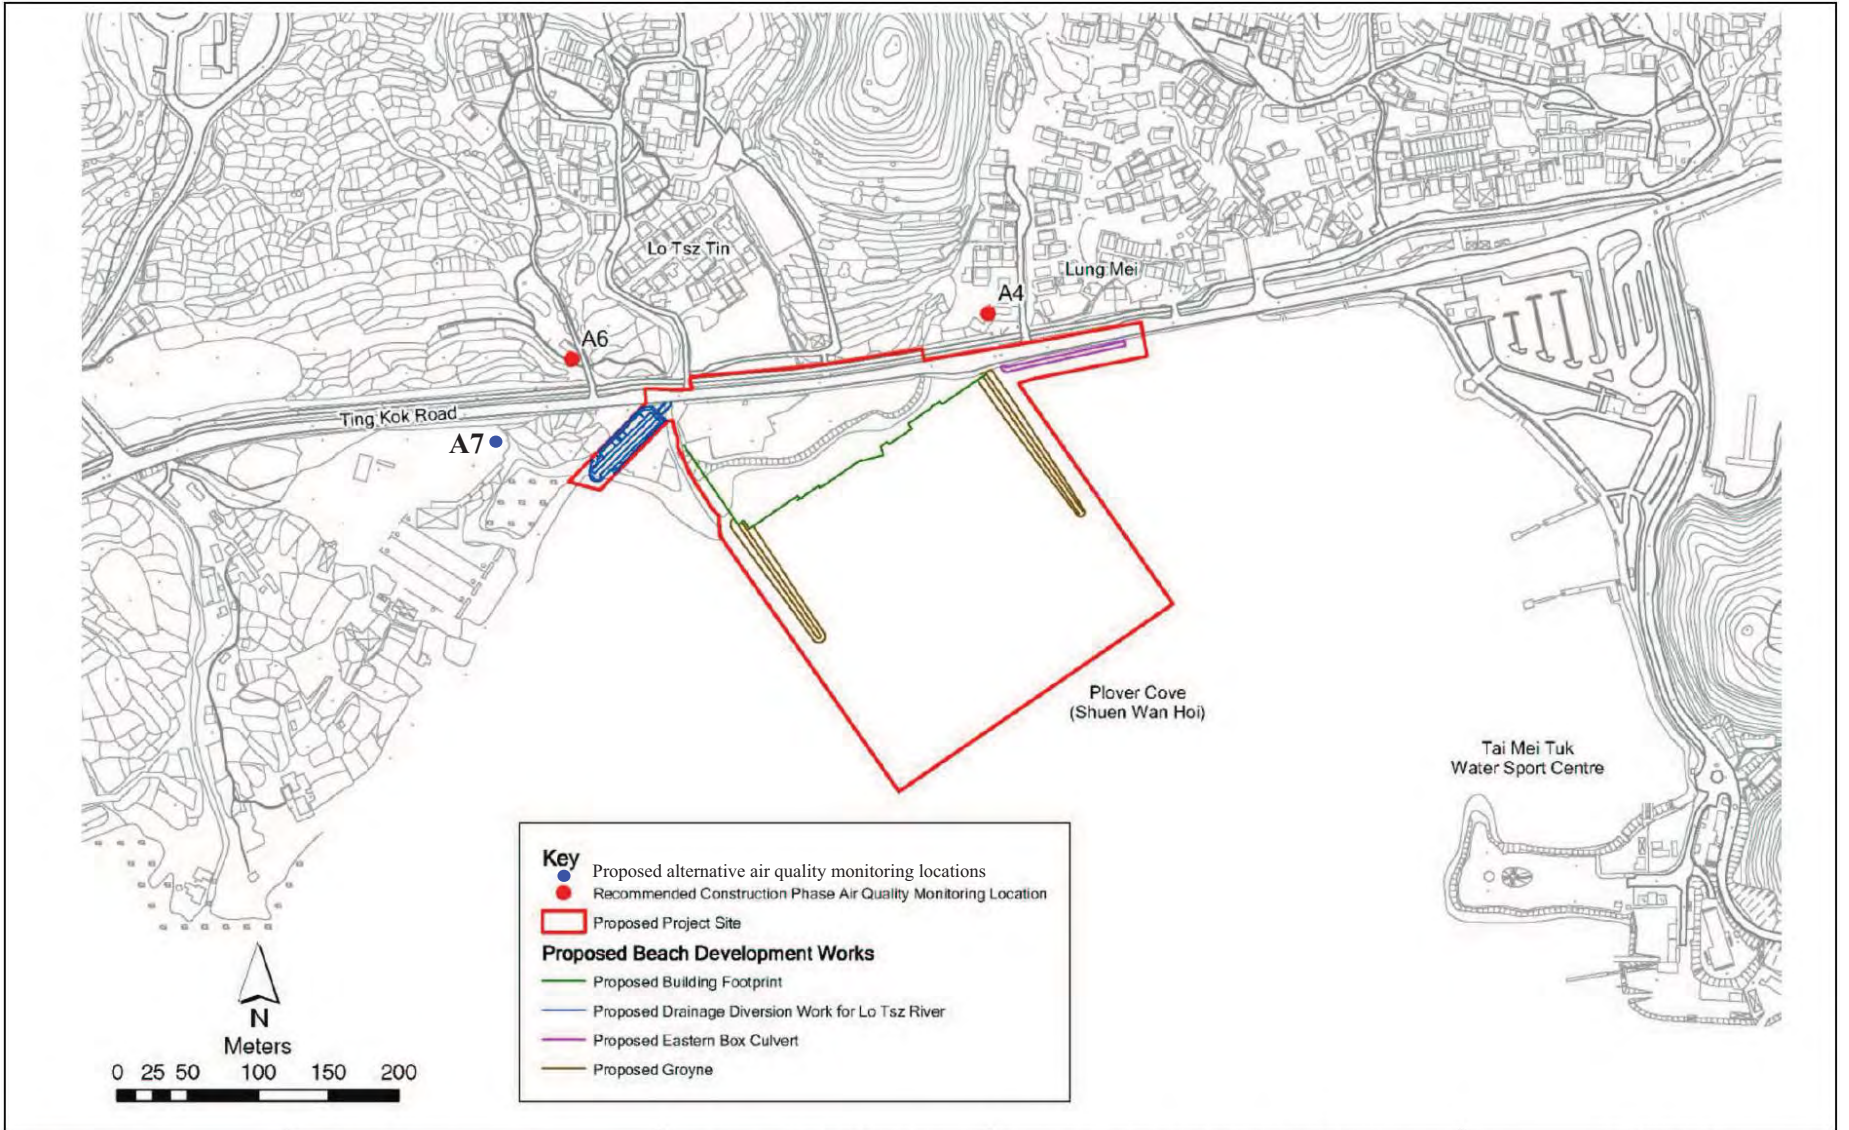
| Client CIVIL ENGINEERING AND DEVELOPMENT DEPARTMENT | Main Contractor 偉全建築有限公司 Welcome Construction Co., Ltd. | Agreement No.: CE 59/2005(EP) | ENVIRONMENTAL MONITORING AND AUDIT MANUAL | FIGURE 3.1 | | |

| | | Project Title: DEVELOPMENT OF A BATHING BEACH AT LUNG MEI, TAI PO | Figure Title: CONSTRUCTION PHASE AIR QUALITY MONITORING LOCATIONS | Checked: TF | Scale: AS SHOWN | Rev.: 2 |

3.3.1 There are air quality monitoring locations (A4 and A6) recommended in Section 3.1 of the EM&A Manual. During liaison with the landlord of A6, he refused to provide access and location for installation of High Volume Air Sampler (HVAS). Therefore, alternative location (A7) was proposed by ET in accordance with Section 3.4 of the EM&A Manual. The proposed alternative locations are considered capable of effectively representing the baseline conditions at the impact monitoring locations. The proposal (*ref no.: TCS00874/16/300/L0016b*) for alternative monitoring locations was verified by IEC and it has been submitted to EPD for approval on 8 May 2017. The air quality monitoring locations are in *Table 3-2* and illustrated in *Appendix C*.

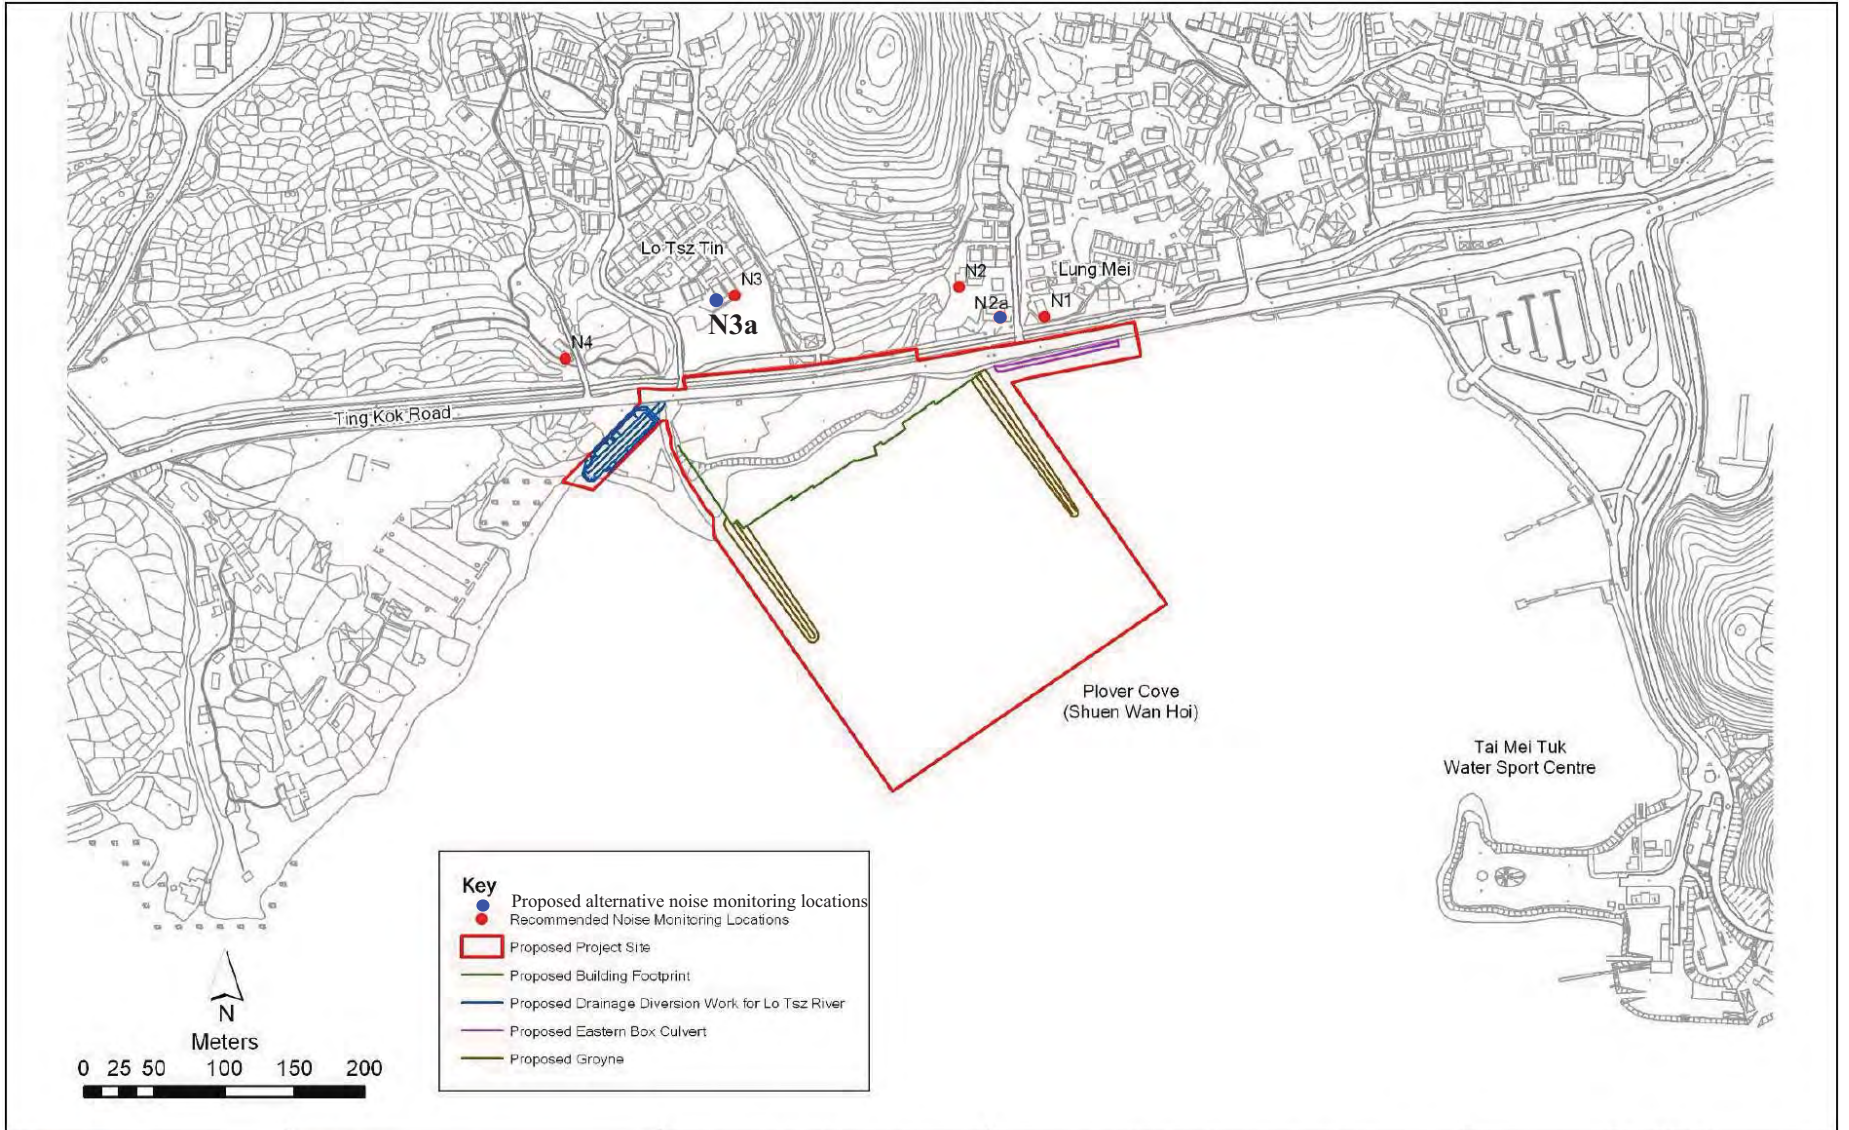
| Client CIVIL ENGINEERING AND DEVELOPMENT DEPARTMENT | 偉全建築有限公司 Welcome Construction Co., Ltd. | Agreement No.: CE 59/2005(EP) | ENVIRONMENTAL MONITORING AND AUDIT MANUAL | FIGURE 4.1 | | |

| | | Project Title: DEVELOPMENT OF A BATHING BEACH AT LUNG MEI, TAI PO | Figure Title: CONSTRUCTION PHASE NOISE MONITORING LOCATIONS | Checked: TF | Scale: AS SHOWN | Rev.: 2 |

3.3.2 According to Section 4.1 of the EM&A Manual, four designated noise sensitive receivers (N1, N2, N3 and N4) were recommended and they are listed in **Table 3-3**.

3.3.3 As confirmed on the first day of baseline monitoring, N2a (House no. 101 Lung Mei) has been changed to residential use. Therefore, the noise monitoring is conducted at N2a and to replace N2. Moreover, due to the lack of accessibility of noise monitoring at NSR N3 (Village house – No. 70 Lo Tsz Tin), alternative location was proposed to replace N3 to carry out the noise monitoring. Having reviewed the surrounding condition, NSR N3a (Village house – No. 66C Lo Tsz Tin) was proposed with the rationales summarized in below.

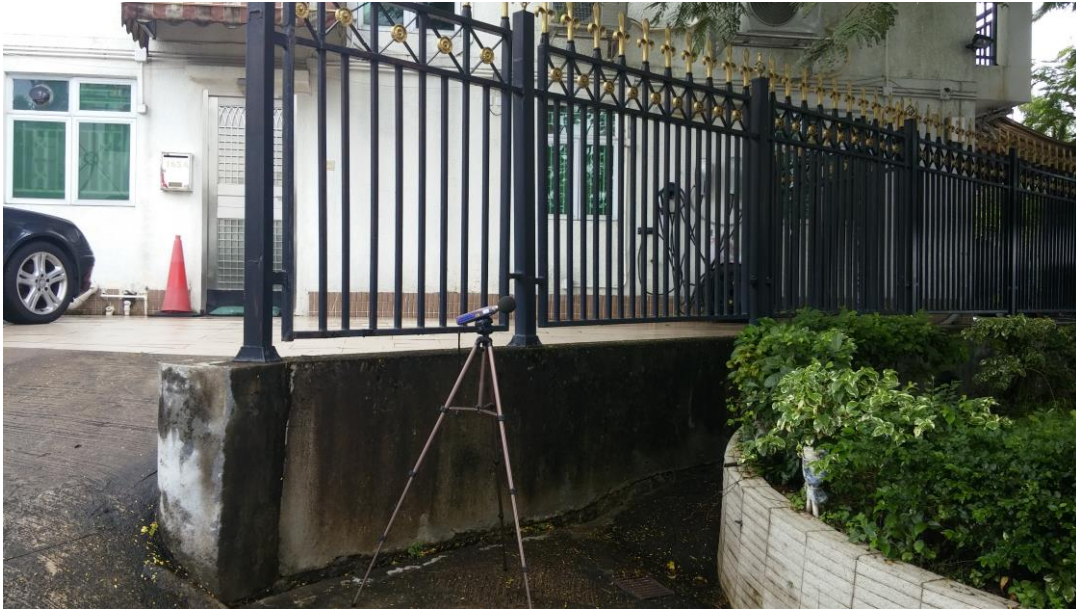
N1

Noise Monitoring

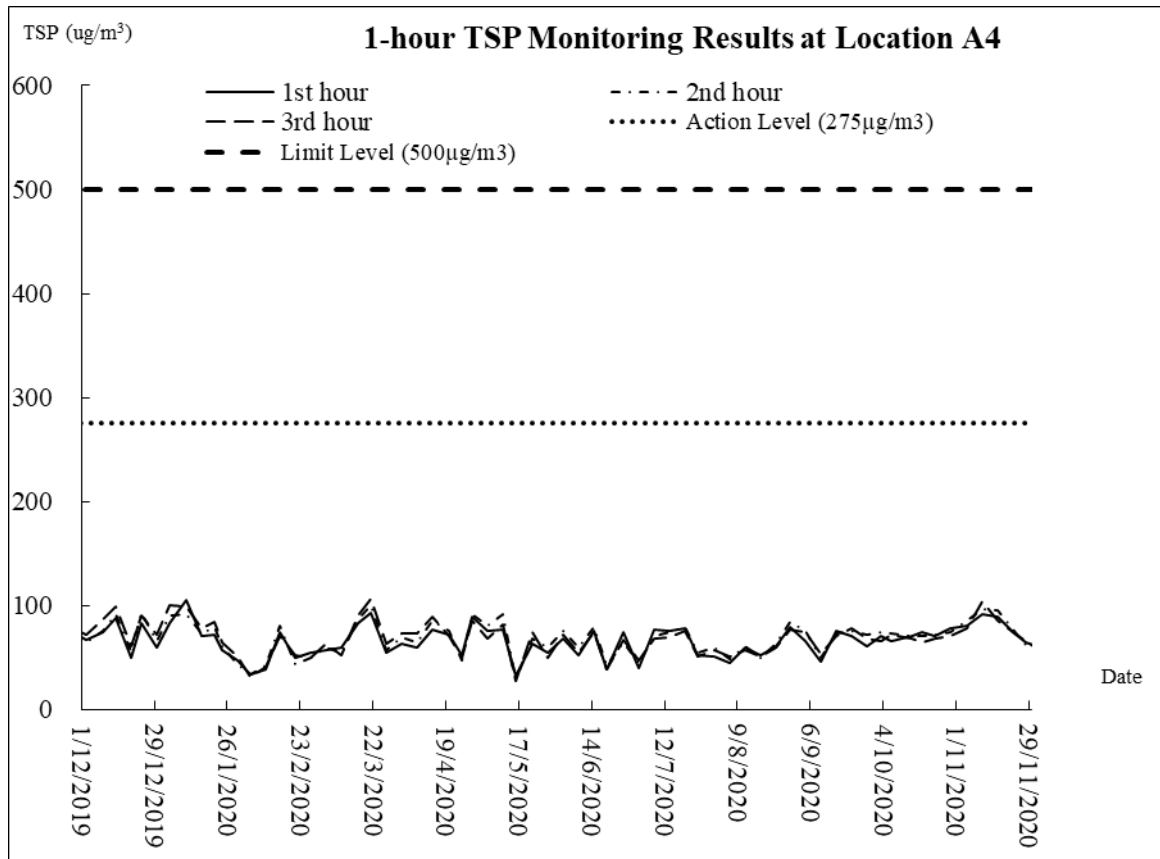
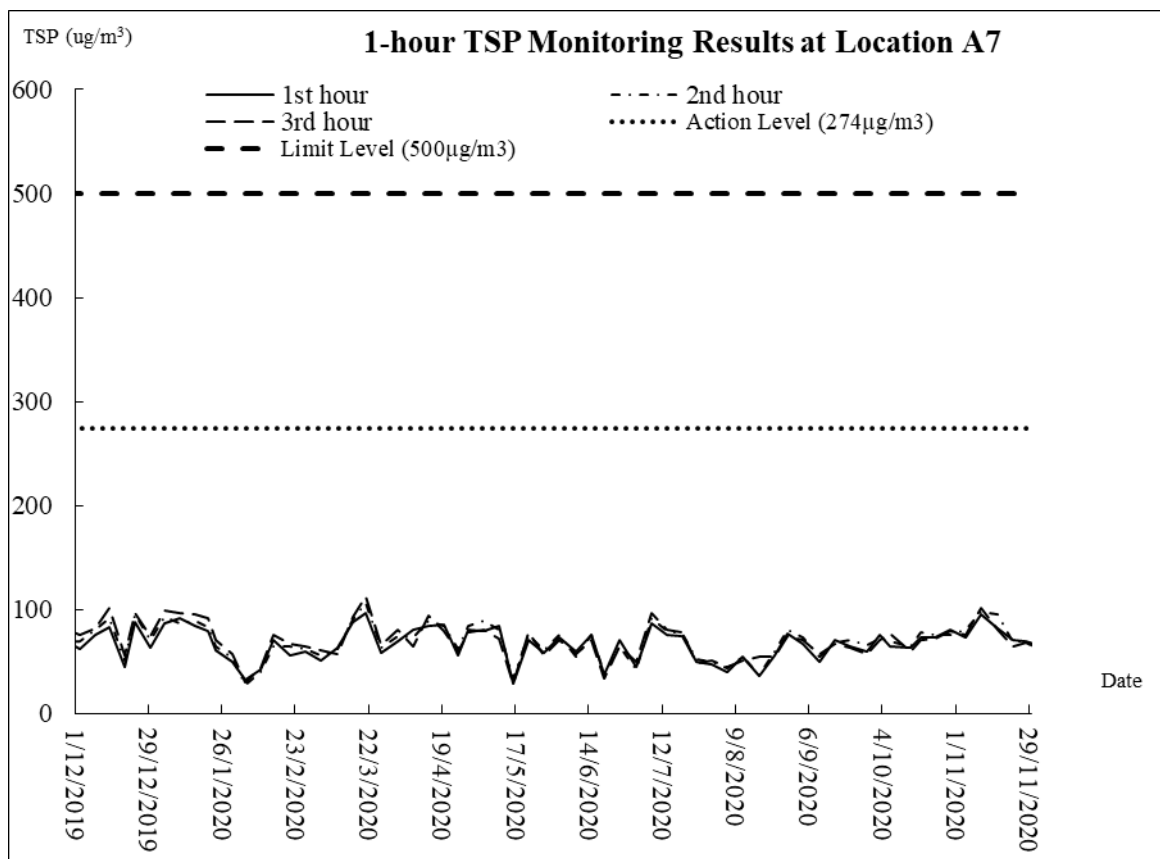
Air Quality – 1-hour TSP

- 4.2.5 In this Reporting Period, all the 1-hour TSP and 24-hour TSP monitoring results were below the Action/Limit Levels. No Notification of Exceedance (NOE) was therefore issued. The baseline air quality monitoring was conducted in June 2017 during typical rainy season. The data collected therefore may not reflect the air quality condition of dry seasons in Hong Kong which normally significantly different. However, with implementation of construction dust suppression measures and good site practices provided by the Contractor, the impact monitoring results recorded zero exceedance of the environmental quality criteria of the parameter.

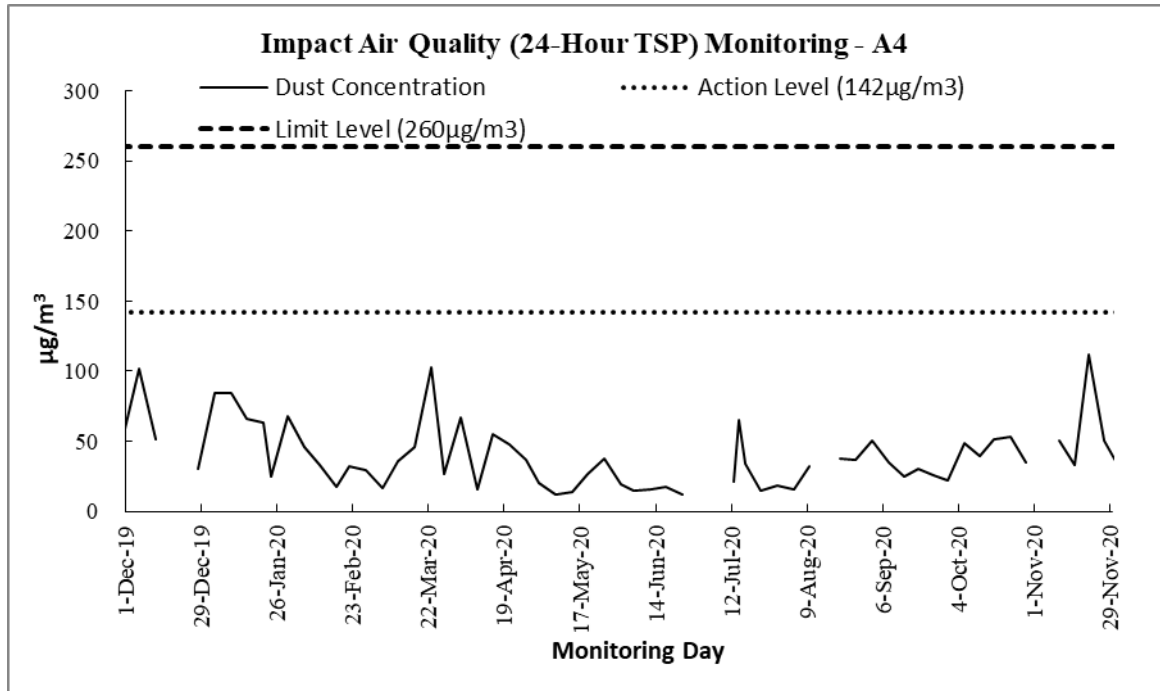
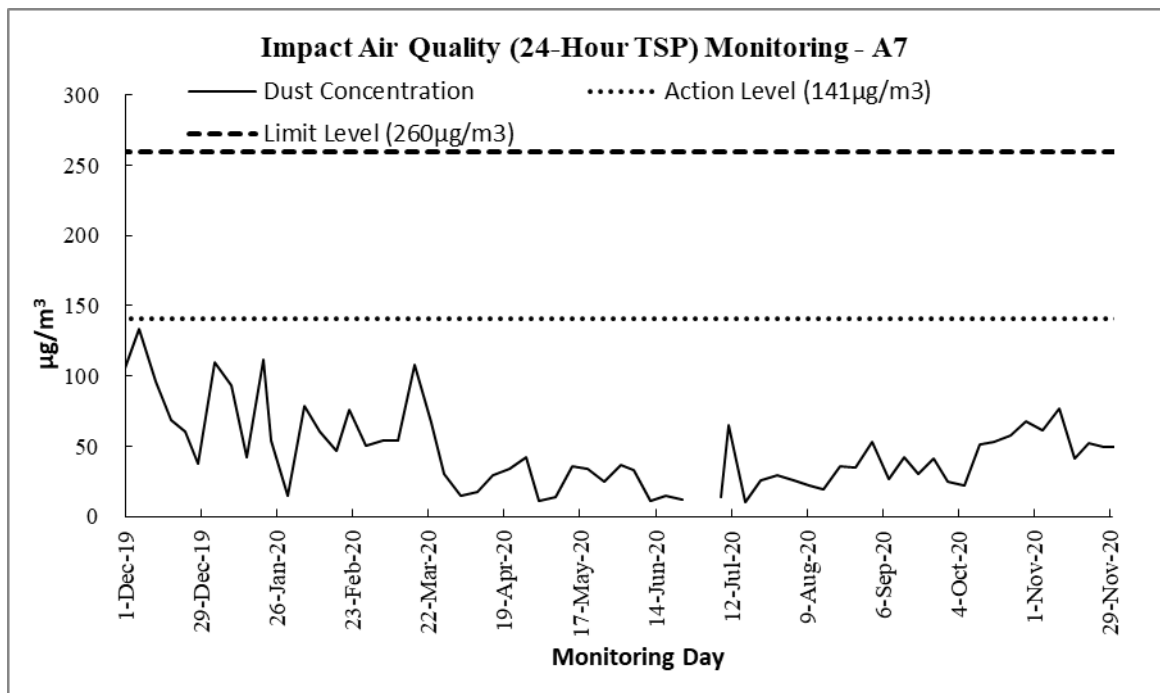
Air Quality – 24-hour TSP

4.2.2 In the Reporting Period, a total of 62 sessions of 24-hour TSP were carried out. however, 24-hour TSP at A4 on 18-27 December 2019, 30 June 2021, 15 August 2021 and 4 November 2021 were cancelled and 24-hour TSP at A7 on 30 June 2021 was cancelled due to power supply failure. Graphical plots of 24-hour TSP monitoring results in *Appendix E* show the 24-hour TSP at monitoring stations A4 and A7 were well below the environmental quality criteria. No remedial actions associated with the exceedances were therefore taken during the Reporting Period. Summary of 24-hour TSP monitoring results during the Reporting Period are tabulated in *Table 4-2*.

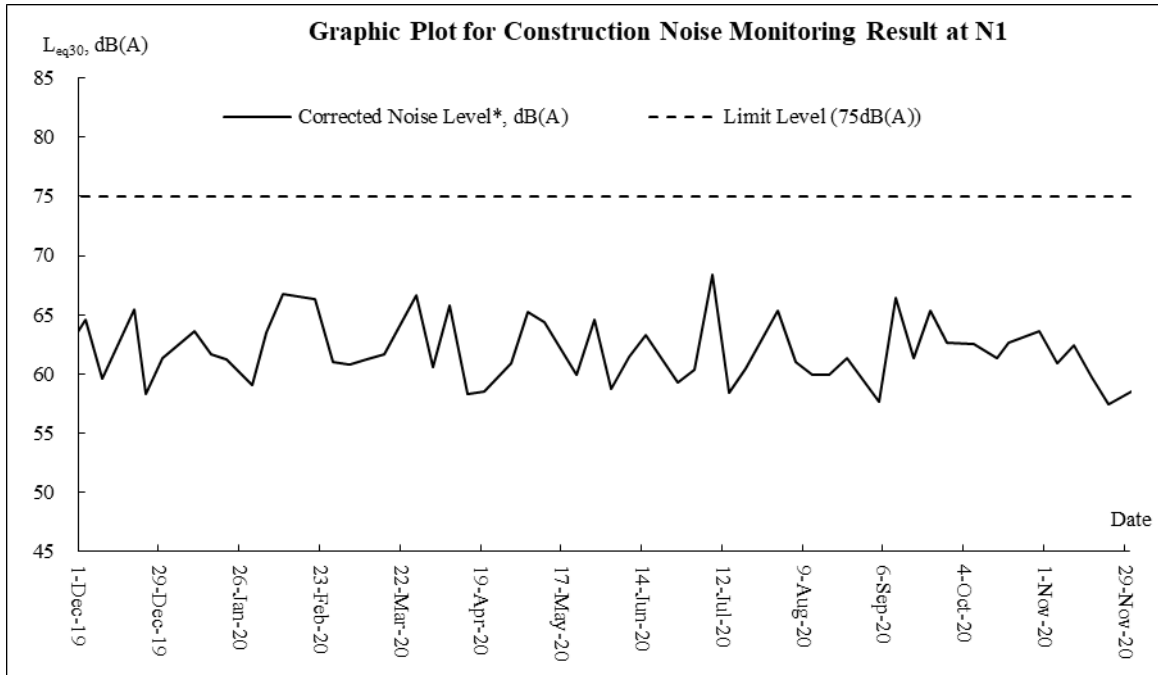
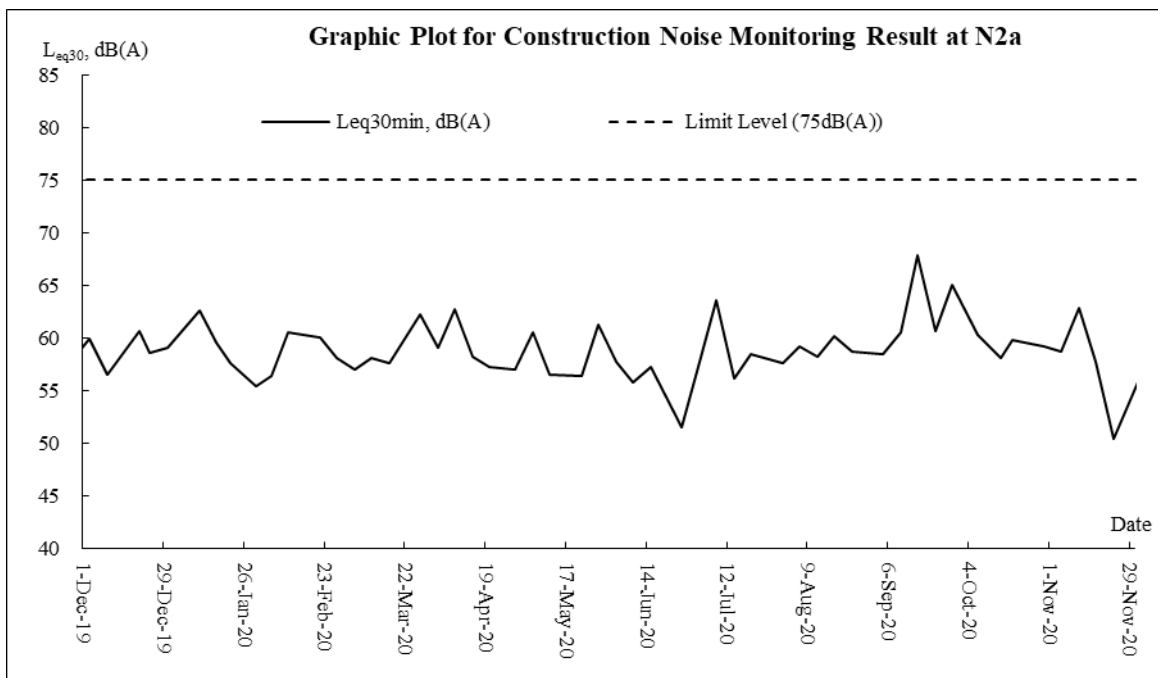
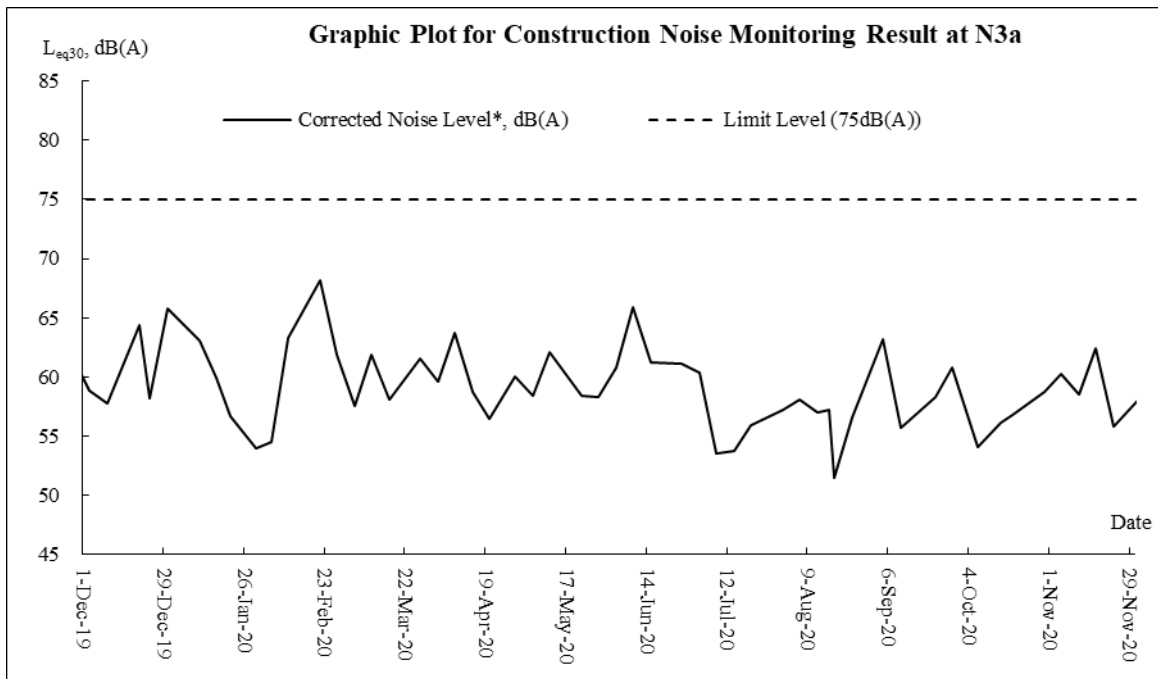
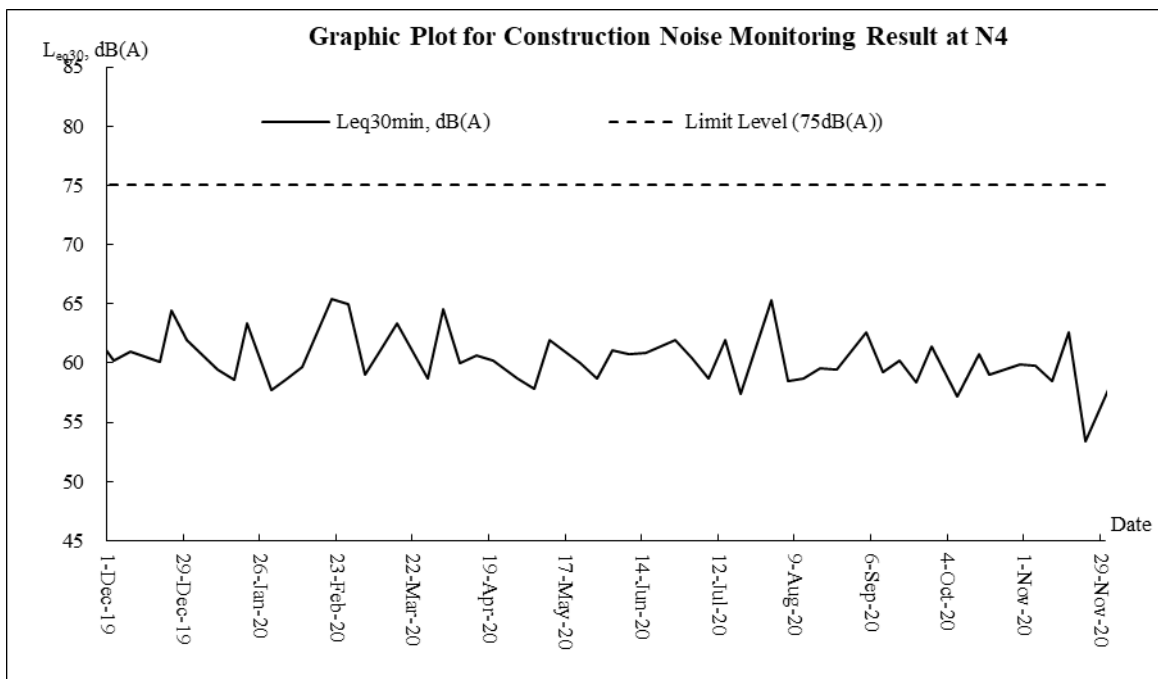
Construction Noise

quality criteria throughout the Reporting Period, indicating that the prediction of Final EIA prediction on the adverse noise nuisance to be generated from the construction of the Project is in general acceptable and the recommended environmental mitigation measures as stipulated in ISEMM is also adequate.

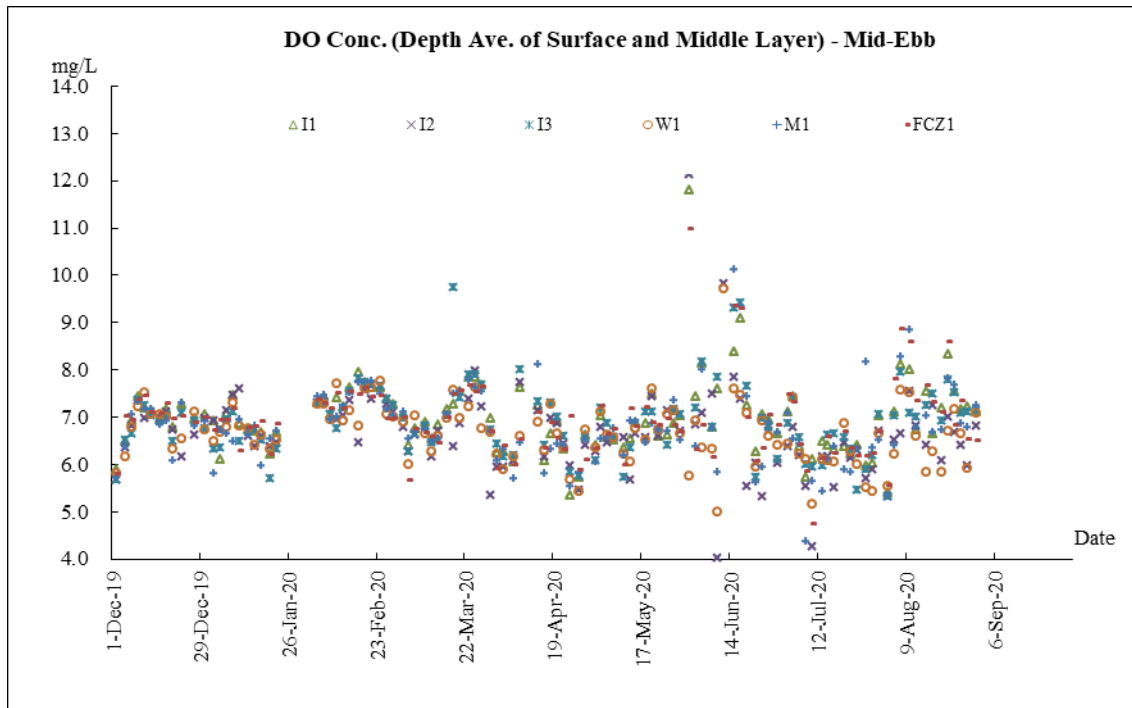
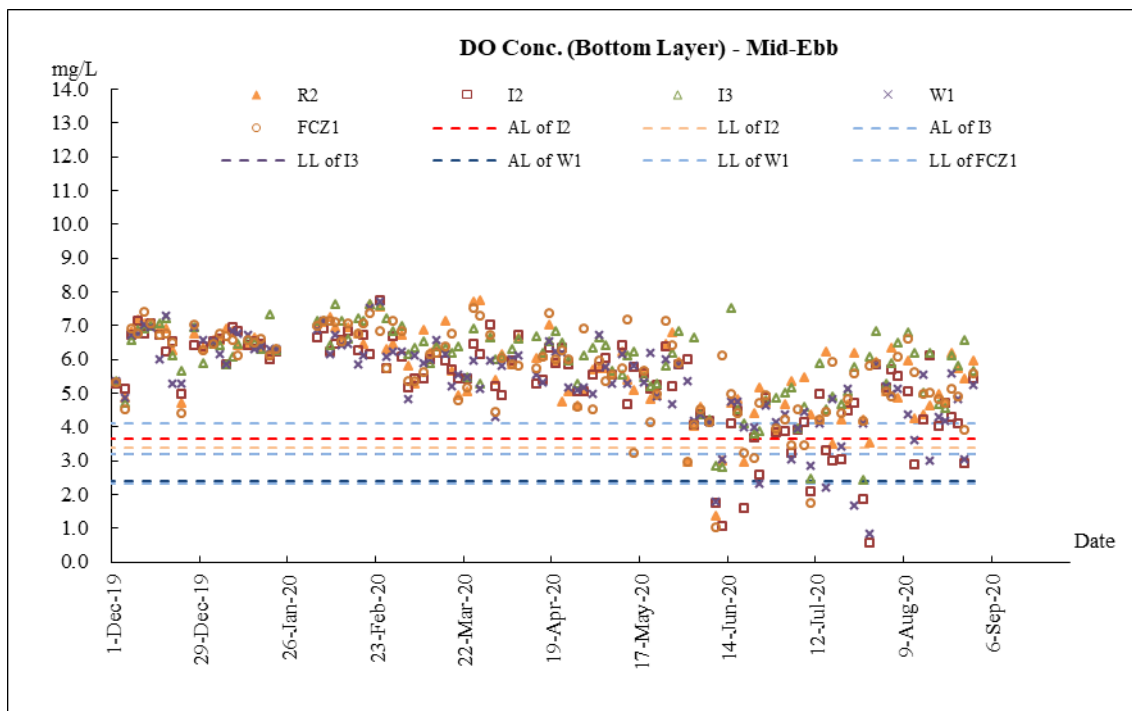
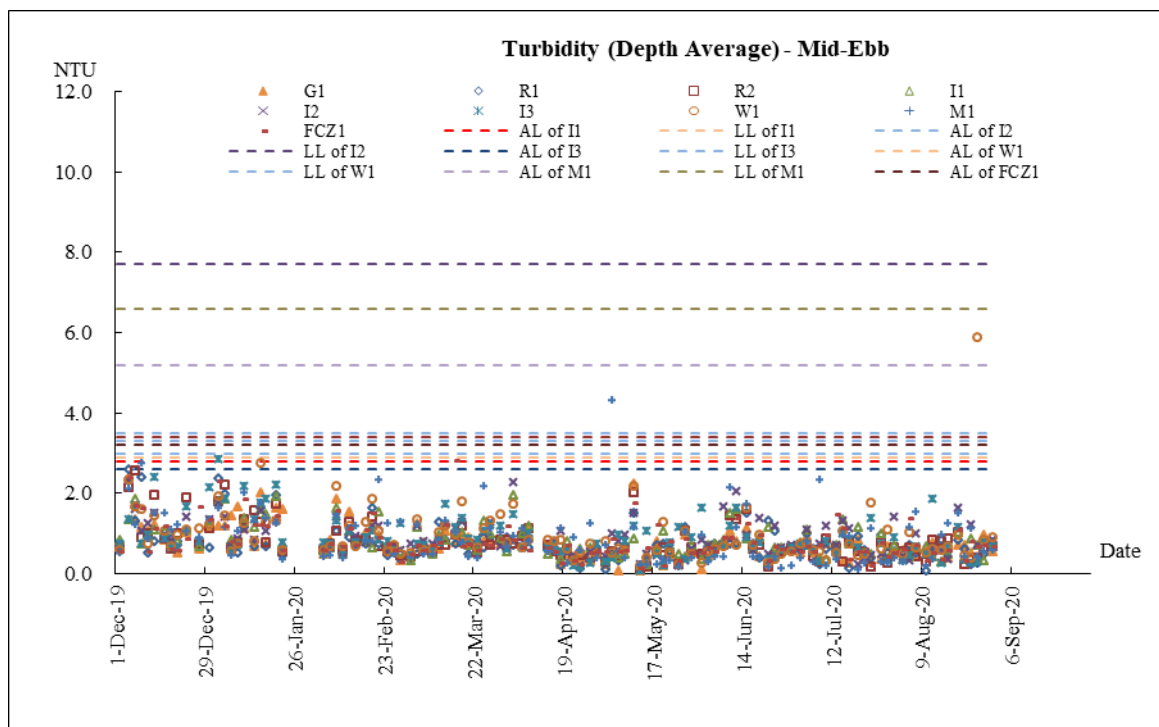
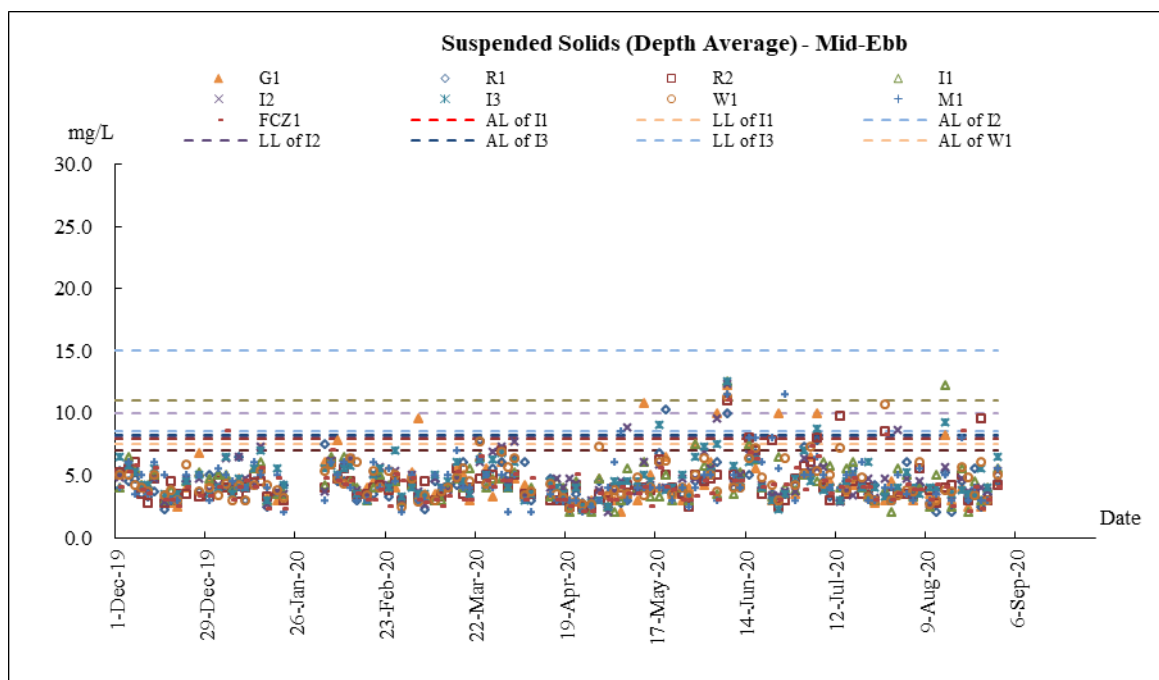
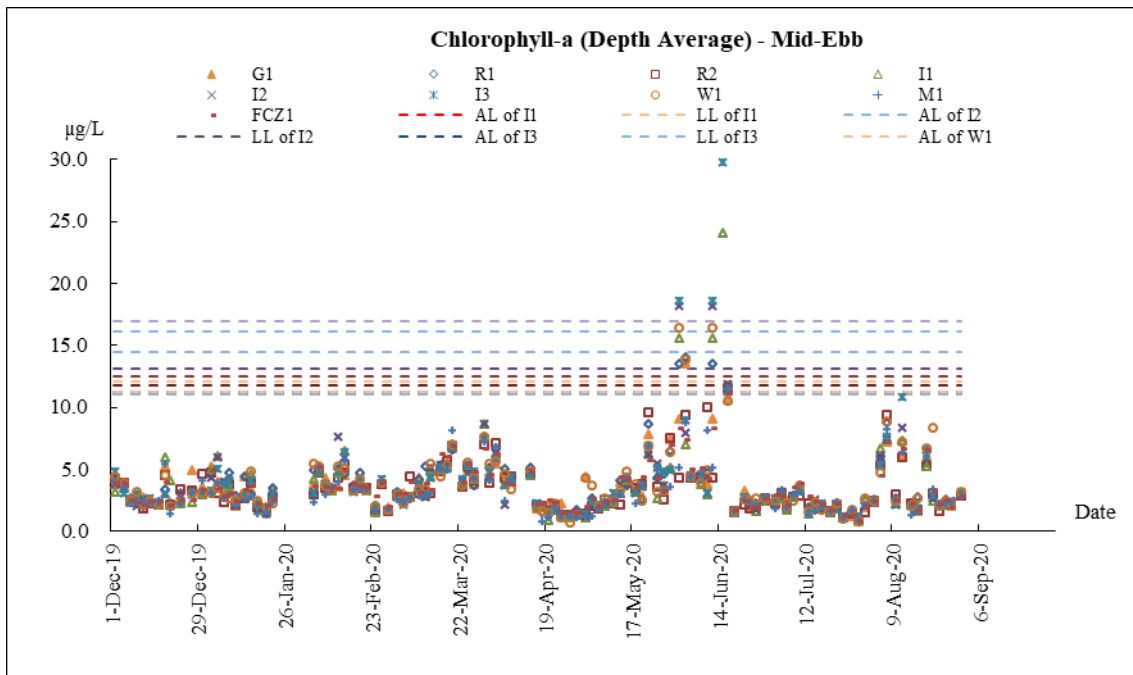
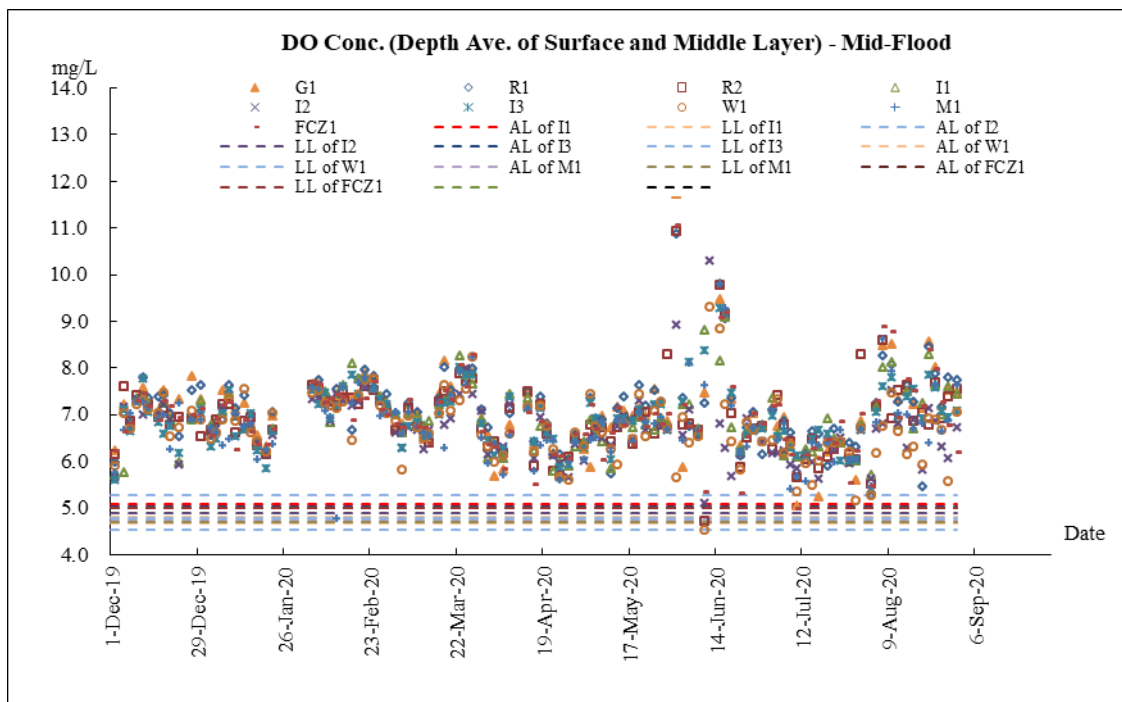
Water Quality

6.2.5 Baseline monitoring was carried out during the period between 23 September 2017 and 21 October 2017. It is important to point out that the baseline SS and turbidity conditions at the monitoring locations may differ significantly during raining, in particular under high tide flow conditions. The monitoring results in the Reporting Period are generally comparable with the baseline. With implementation of water quality mitigation measures and good site practices provided by the Contractor, except for two SS exceedances recorded on 15 January 2020, all the exceedances were likely related to natural variation and not caused by the works under the Project.

6.2.6 Nevertheless, the Contractor was reminded to strictly implement the water quality mitigation measure as recommended implementation schedule for environmental mitigation measures in the EM&A Manual and EP's condition.
