**CEDD CONTRACT NO. CV/2012/05
DEVELOPMENT OF A BATHING BEACH AT LUNG MEI,
TAI PO**

**3RD ANNUAL ENVIRONMENTAL MONITORING AND AUDIT
REVIEW REPORT (DECEMBER 2019 – NOVEMBER 2020)**

**PREPARED FOR
WELCOME CONSTRUCTION CO., LTD**

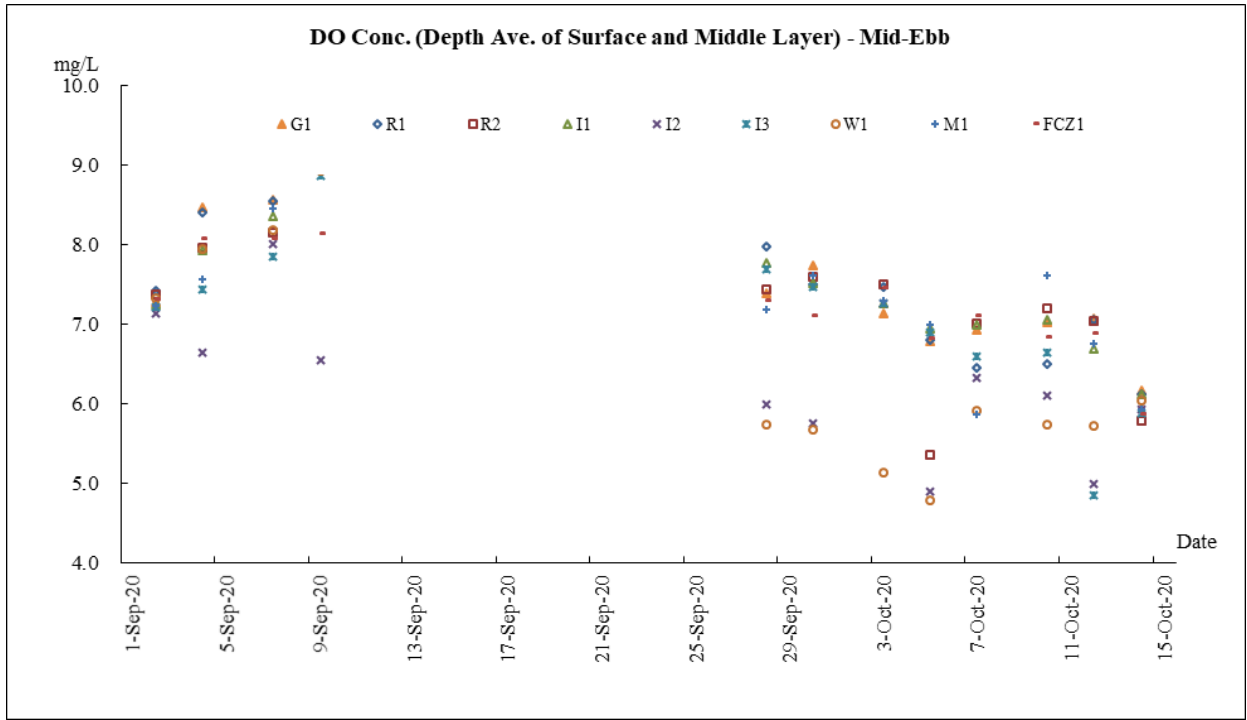
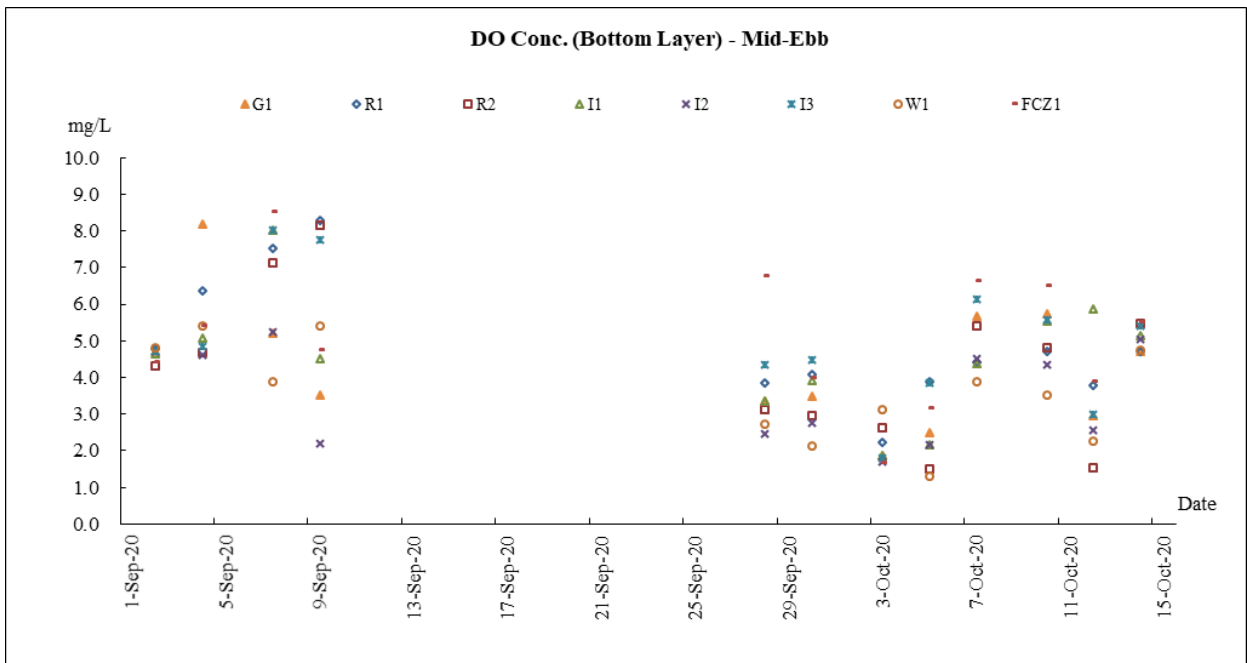
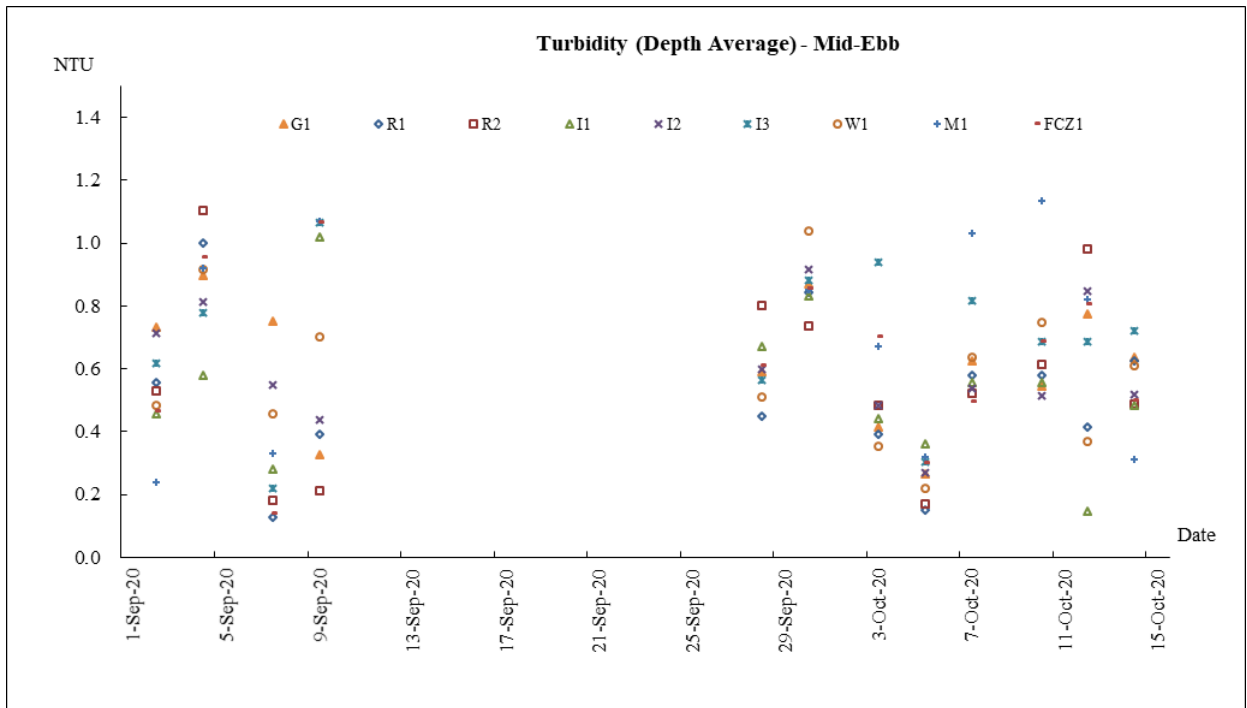
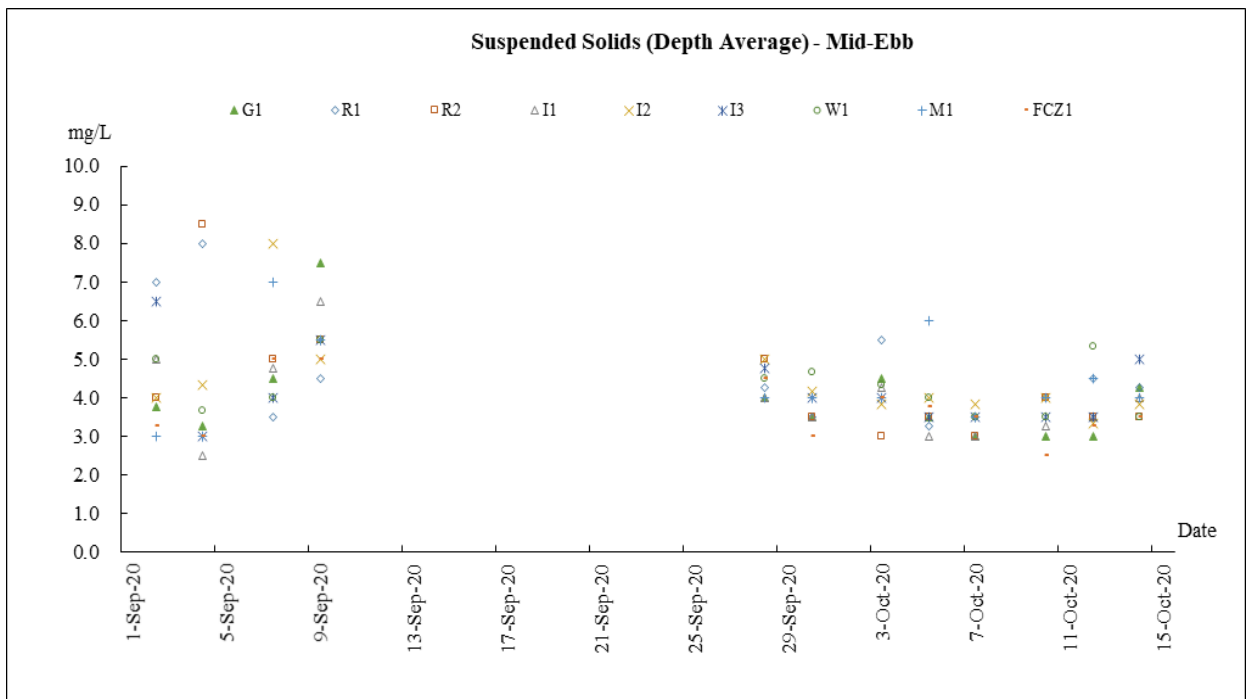
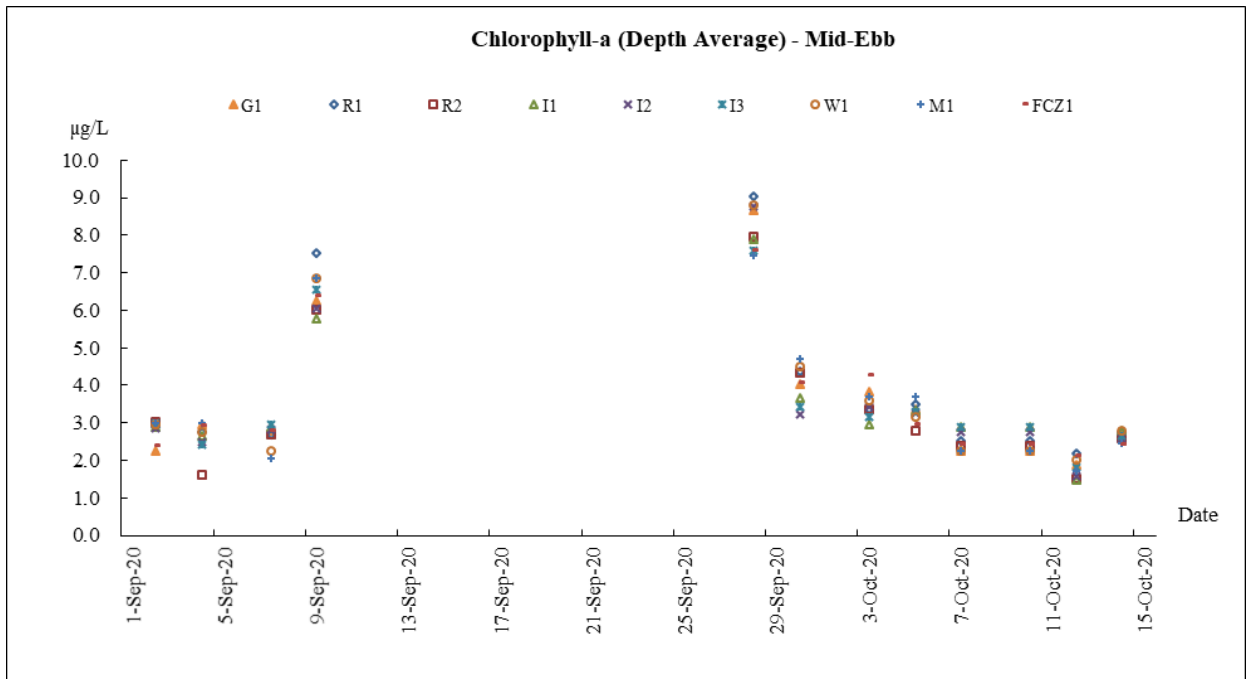
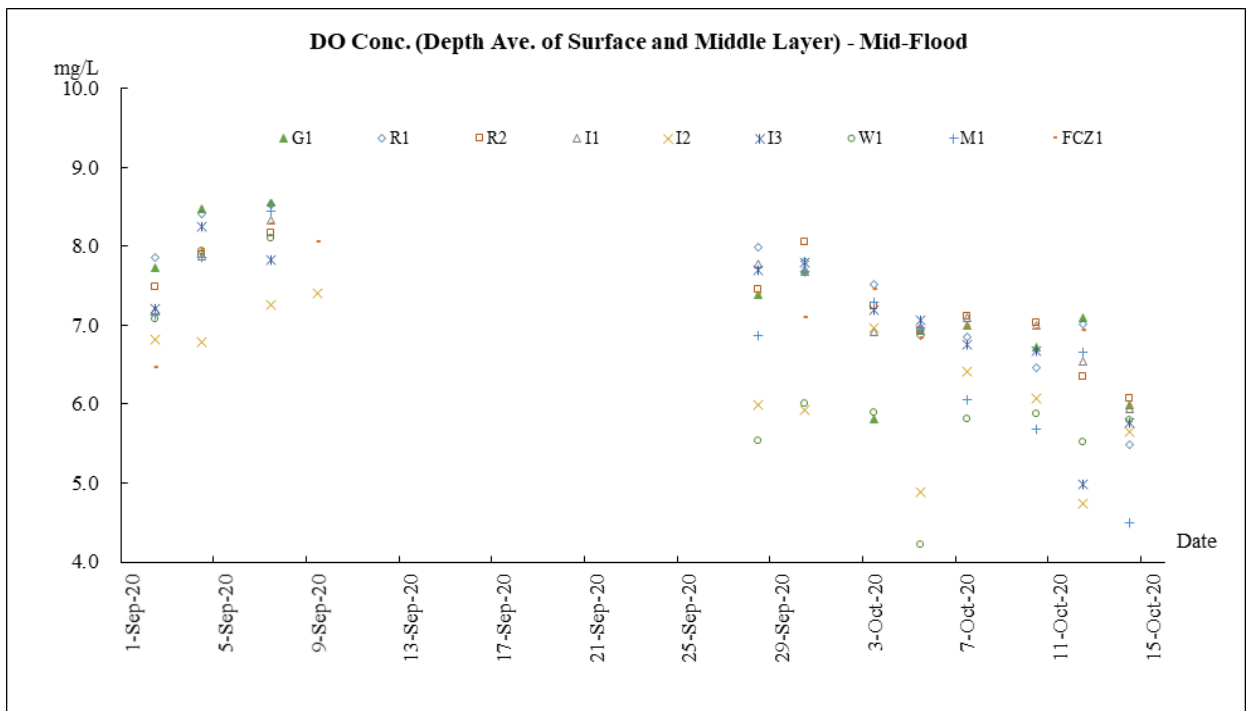
Post-project Water Quality Monitoring

6.2.4 Overall, most of the monitoring result obtained during post project marine water monitoring are fall within and similar to the baseline data. It is considered that no adverse impact was caused to the marine water quality after completion of the marine based construction works.
