**CEDD CONTRACT NO. CV/2012/05  
DEVELOPMENT OF A BATHING BEACH AT LUNG MEI,  
TAI PO**

**MONTHLY ENVIRONMENTAL MONITORING AND AUDIT  
REPORT (FEBRUARY 2018)**

**PREPARED FOR  
WELCOME CONSTRUCTION CO., LTD**

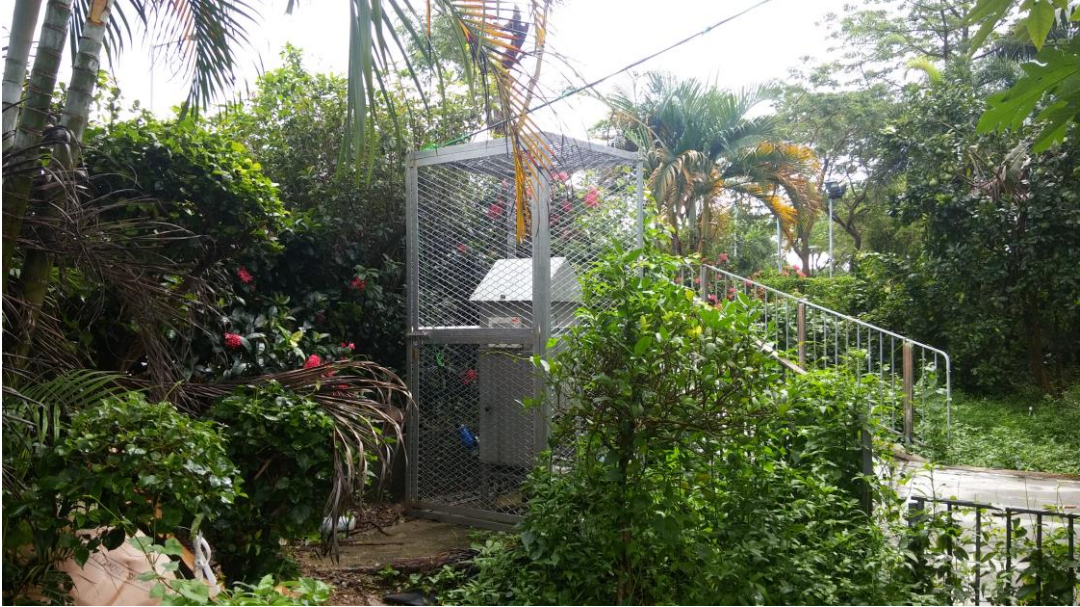
**A4**

**Air Quality Monitoring (24-Hour TSP & 1-Hour TSP)**

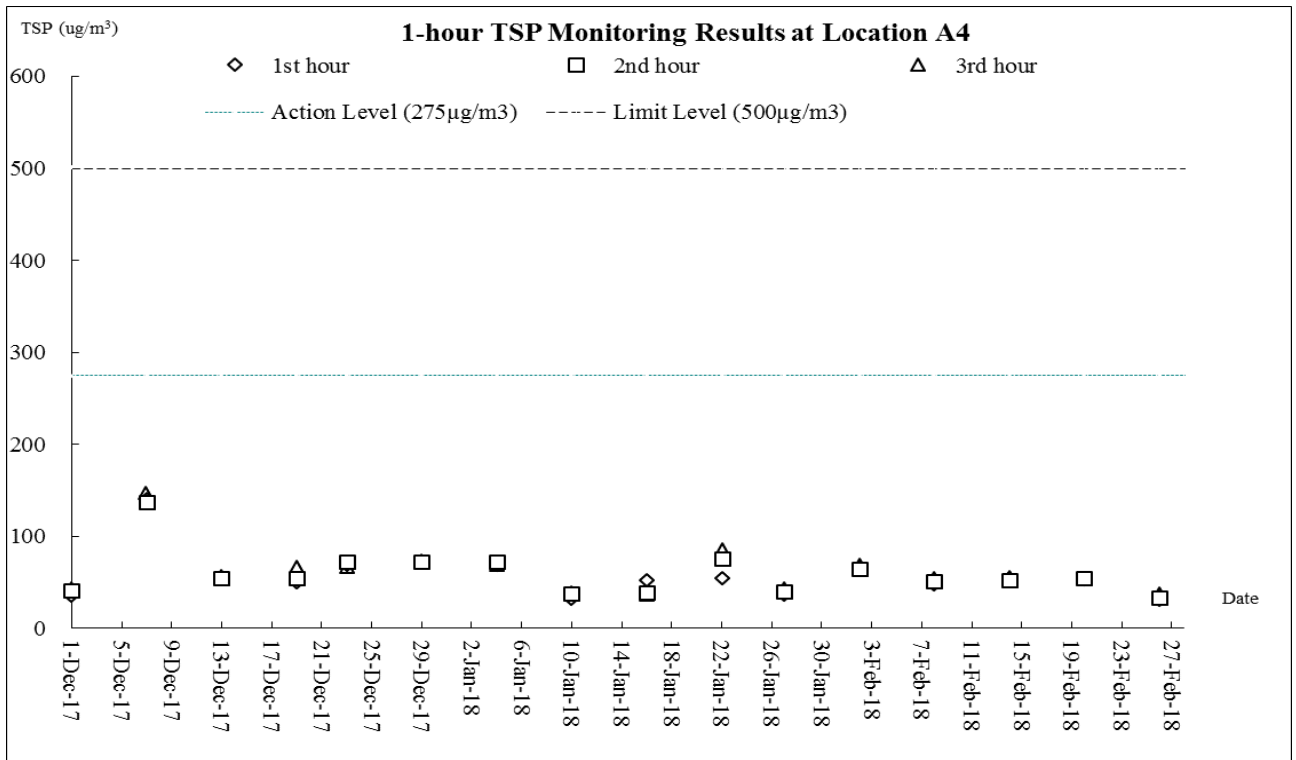
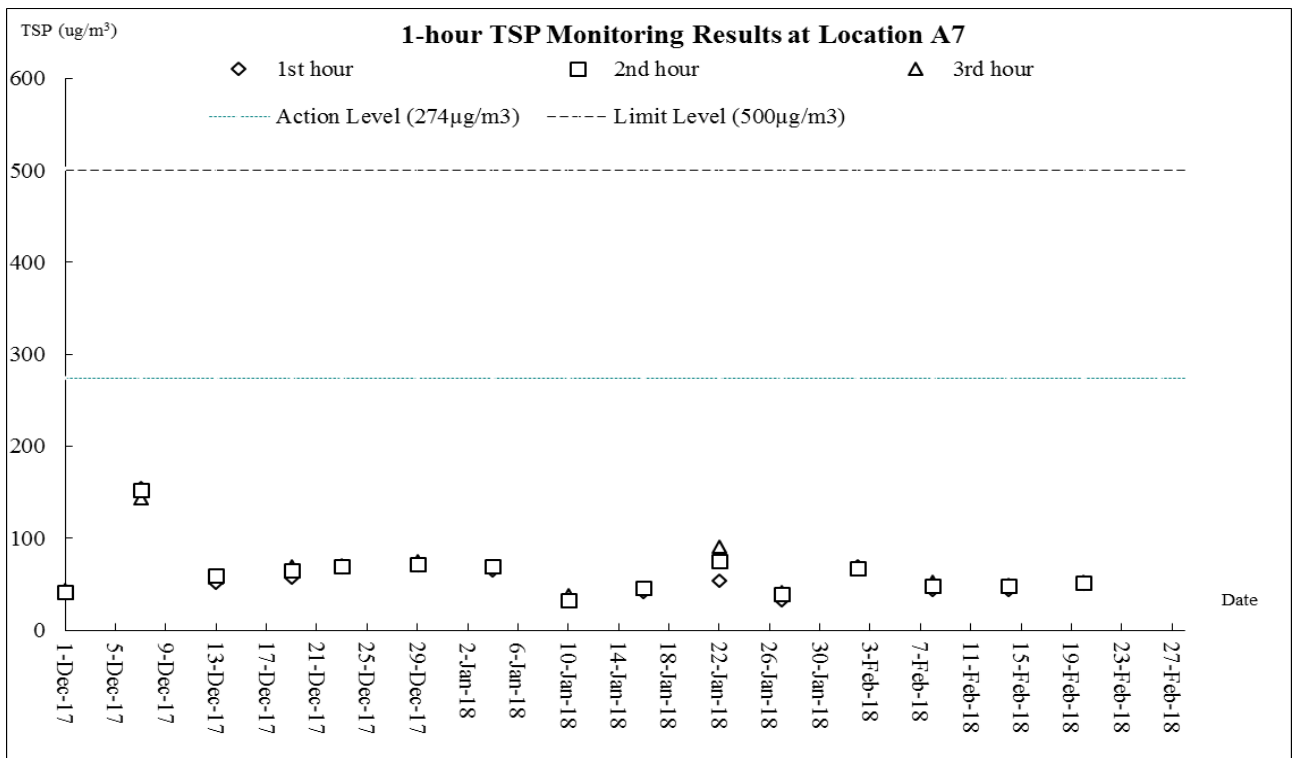
**Air Quality – 1-hour TSP**

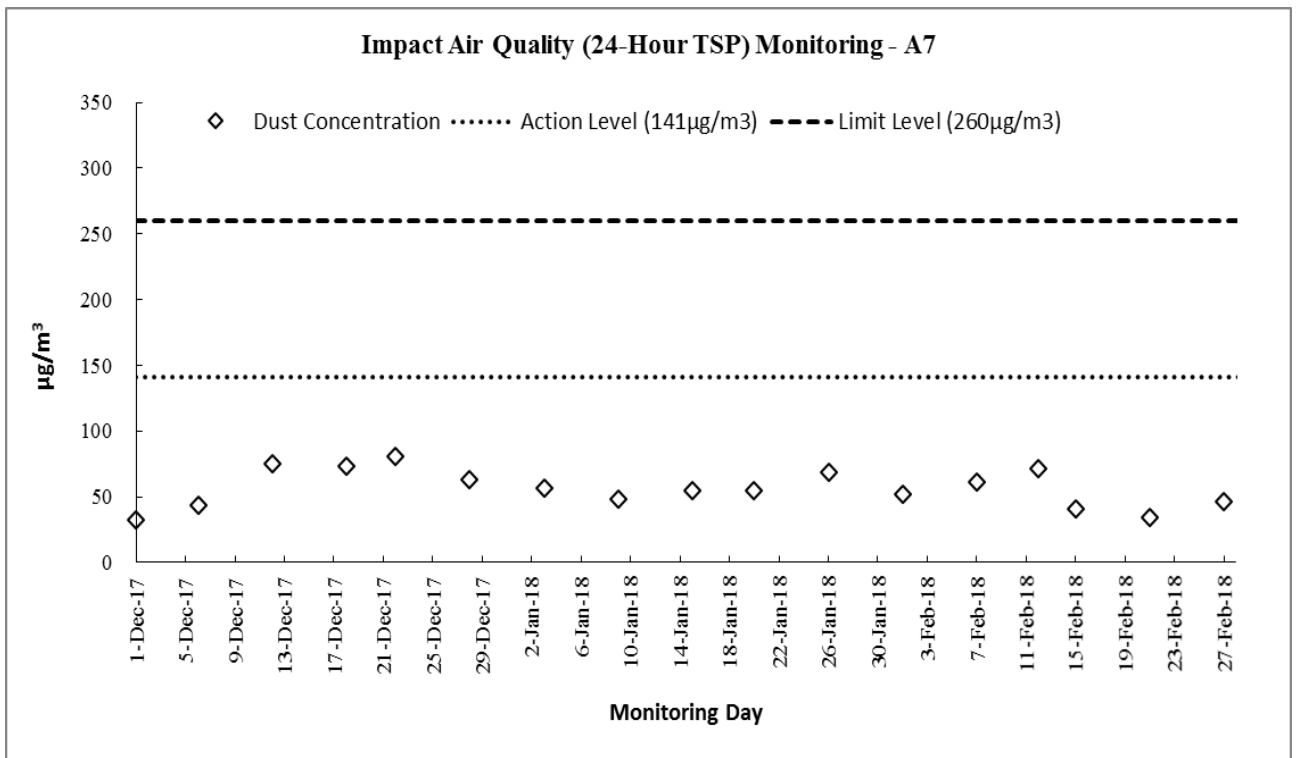
**Air Quality – 24-hour TSP**

*Remark: (\*) Power failure was occurred at A4 during 24-hour TSP monitoring on 7-Feb-18; remedial monitoring for the lost sample was taken on 8-Feb-18.*

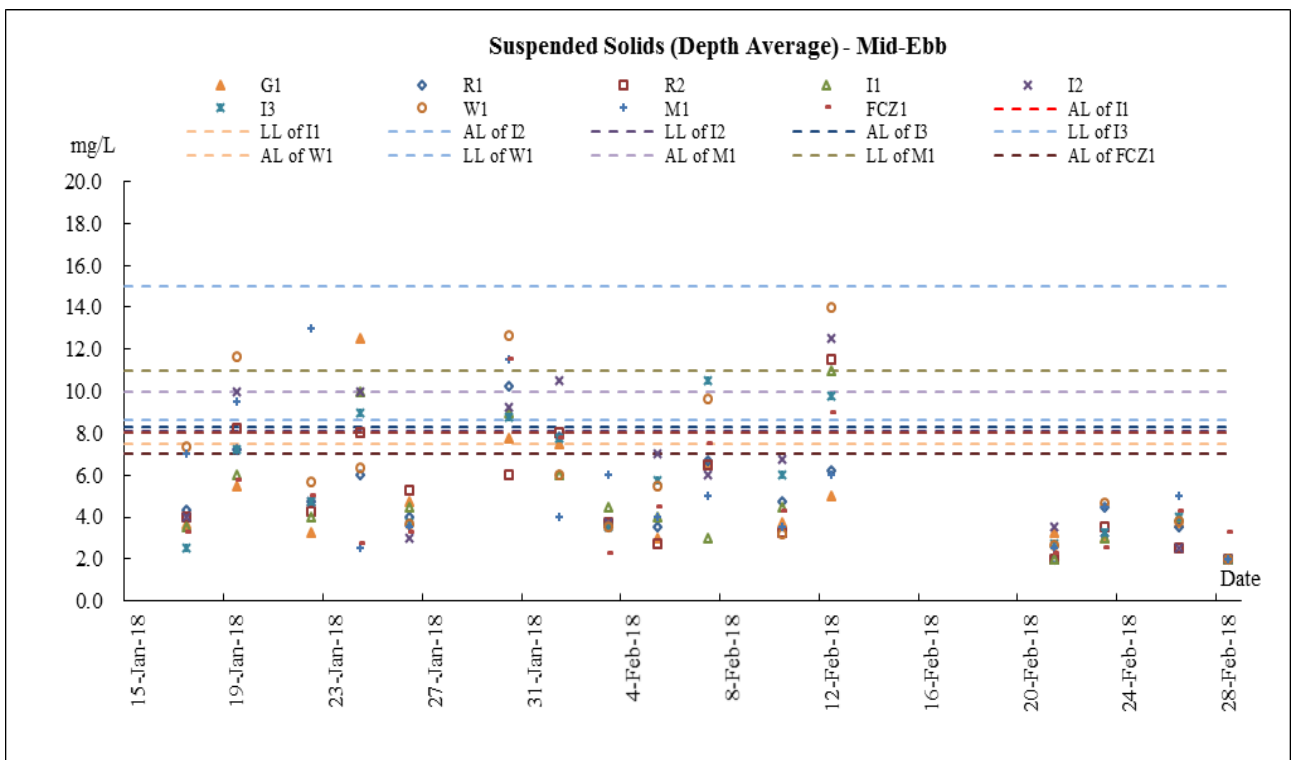
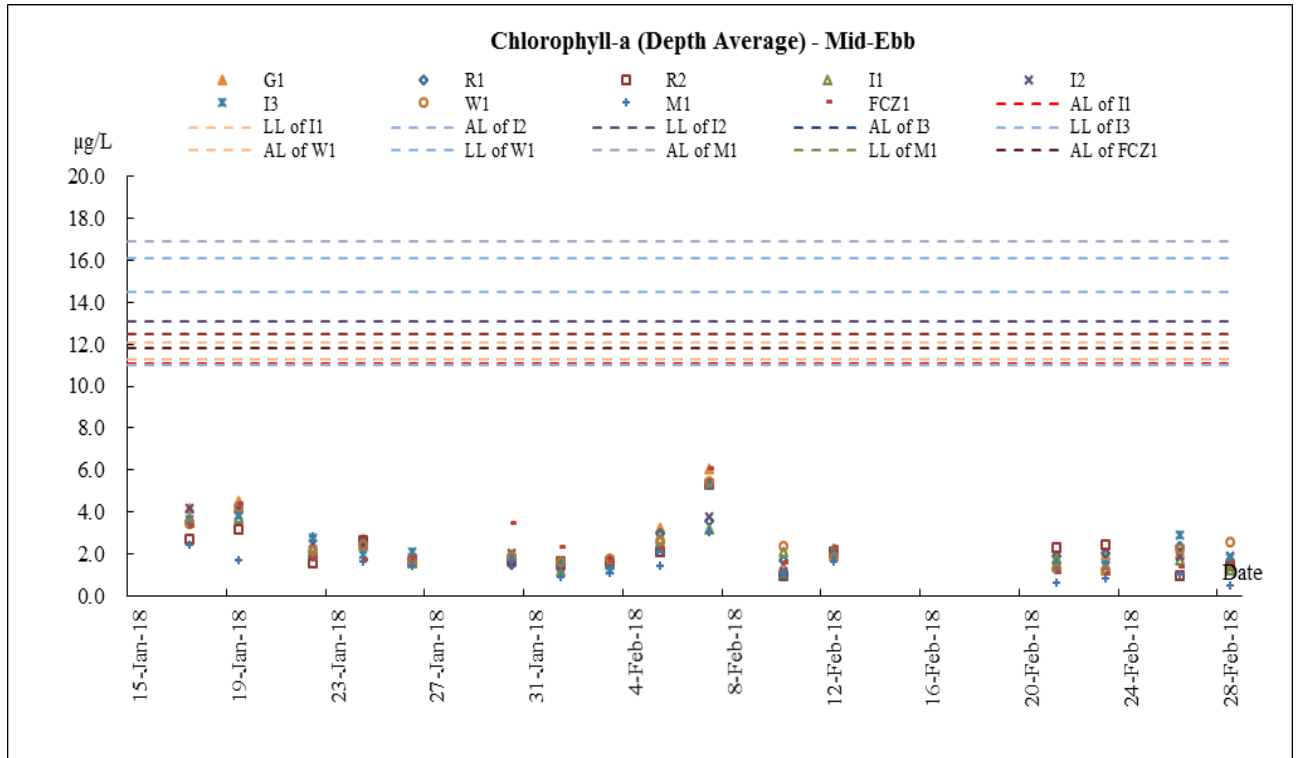
**Water Quality**

- 6.2.5 In this Reporting Period, twelve (12) Action Level (AL) exceedance and fifty-seven (57) Limit Level (LL) exceedances of Suspended Solids were recorded for the Project which involved 10 monitoring days. NOEs were issued to relevant parties upon confirmation of the monitoring result. Investigation for the cause of exceedance was carried out by ET subsequently.

- 6.2.6 In our investigation, there were no marine works carried out on 5, 12, 21, 23 and 28 February 2018, it is considered that exceedances in these monitoring days were unlikely caused by Project. There were marine construction activities carried out on 1, 3, 7, 10 and 26 February 2018 and exceedances of SS were recorded on these days. Water quality mitigation measures such as silt curtains were properly implemented and maintained at locations in accordance with EP's condition. During the joint site inspection by CEDD, Welcome and ET on 2 and 23 February 2018, the overall environmental performance was satisfactory and no adverse water quality impact was observed and recorded. Having reviewed environmental performance of the construction site and the monitoring results of both reference and impact stations, it is considered that the elevated SS levels were comparable to the measured reference results and the fluctuation of SS level were likely due to natural variation and not caused by the works under the project.
