JOB No.: TCS00874/16

CEDD CONTRACT NO. CV/2012/05
DEVELOPMENT OF A BATHING BEACH AT LUNG MEI,
TAI PO

MONTHLY ENVIRONMENTAL MONITORING AND AUDIT
REPORT (APRIL 2018)

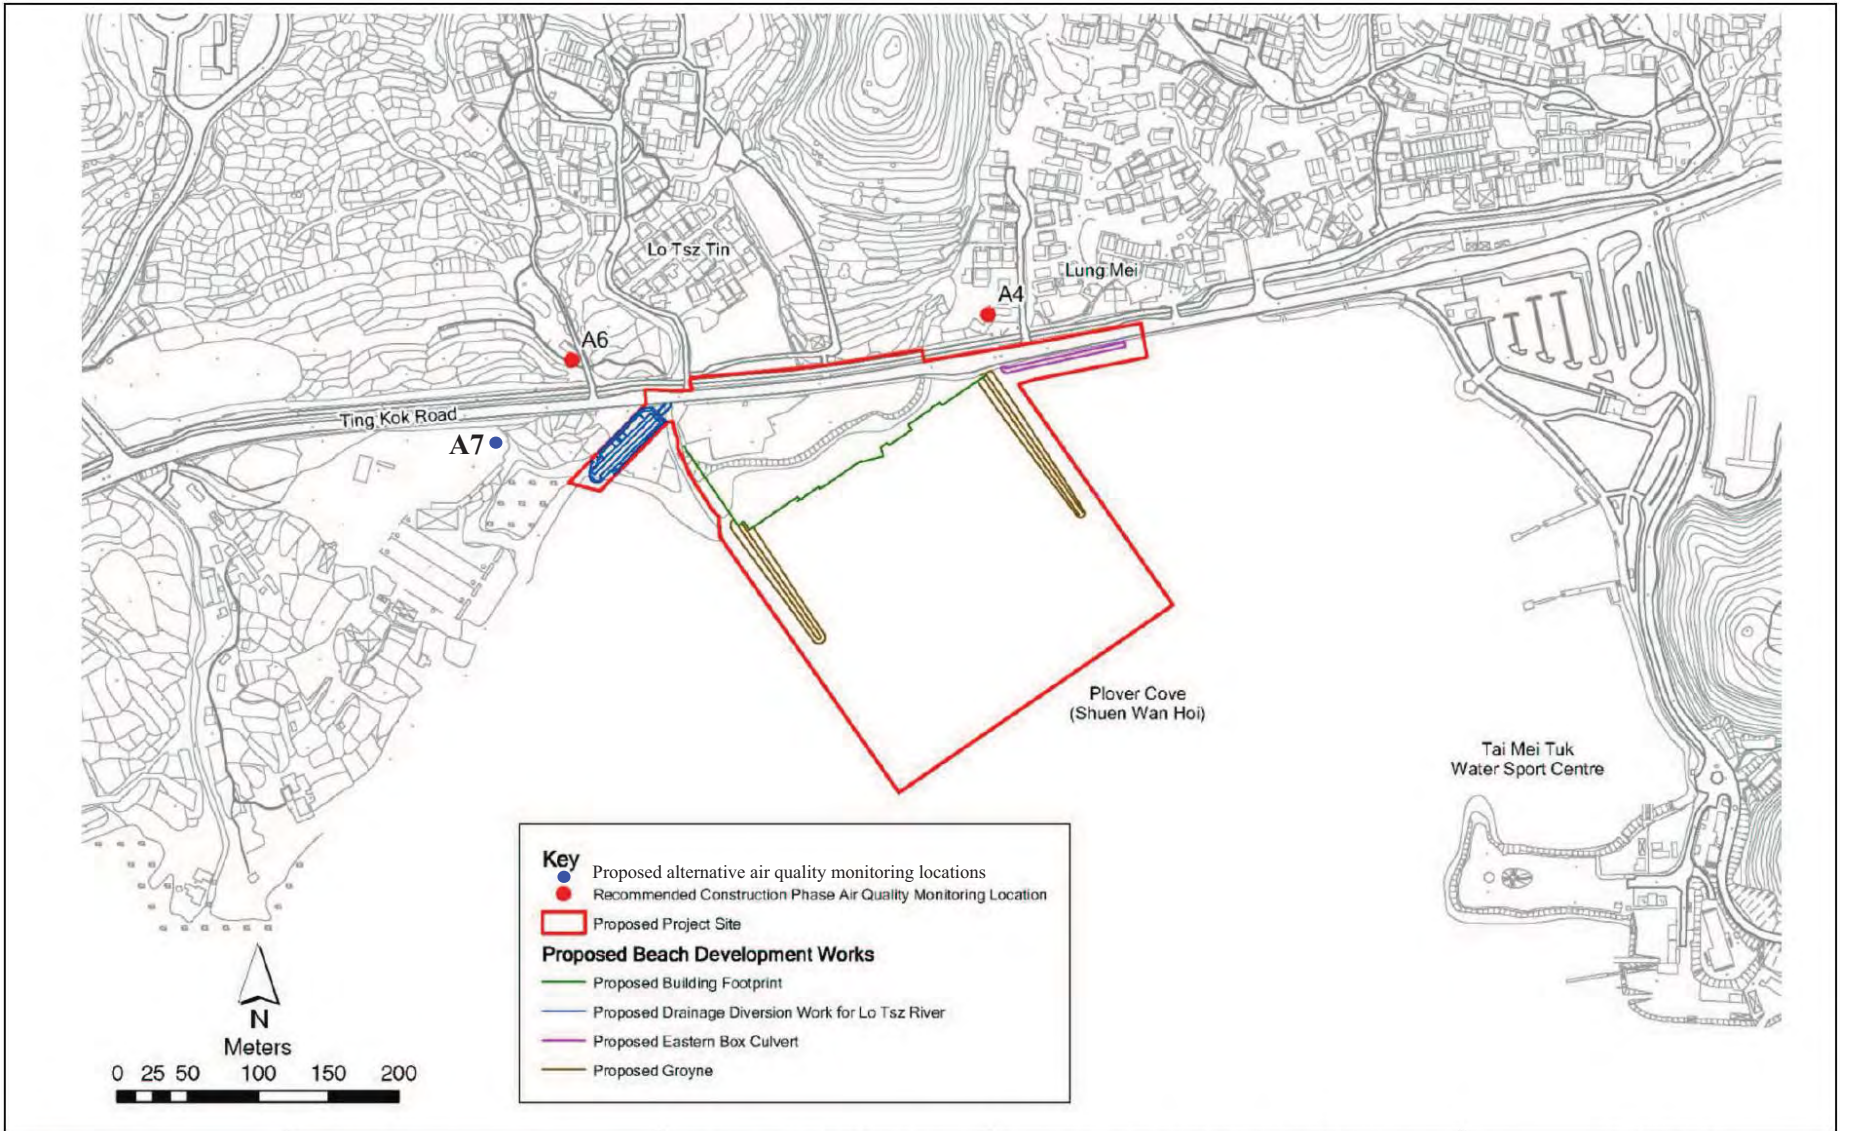
3.3.1 There are air quality monitoring locations (A4 and A6) recommended in Section 3.1 of the EM&A Manual. During liaison with the landlord of A6, he refused to provide access and location for installation of High Volume Air Sampler (HVAS). Therefore, alternative location (A7) was proposed by ET in accordance with Section 3.4 of the EM&A Manual. The proposed alternative locations are considered capable of effectively representing the baseline conditions at the impact monitoring locations. The proposal (*ref no.: TCS00874/16/300/L0016b*) for alternative monitoring locations was verified by IEC and it has been submitted to EPD for approval on 8 May 2017. The air quality monitoring locations are in *Table 3-2* and illustrated in *Appendix D*.

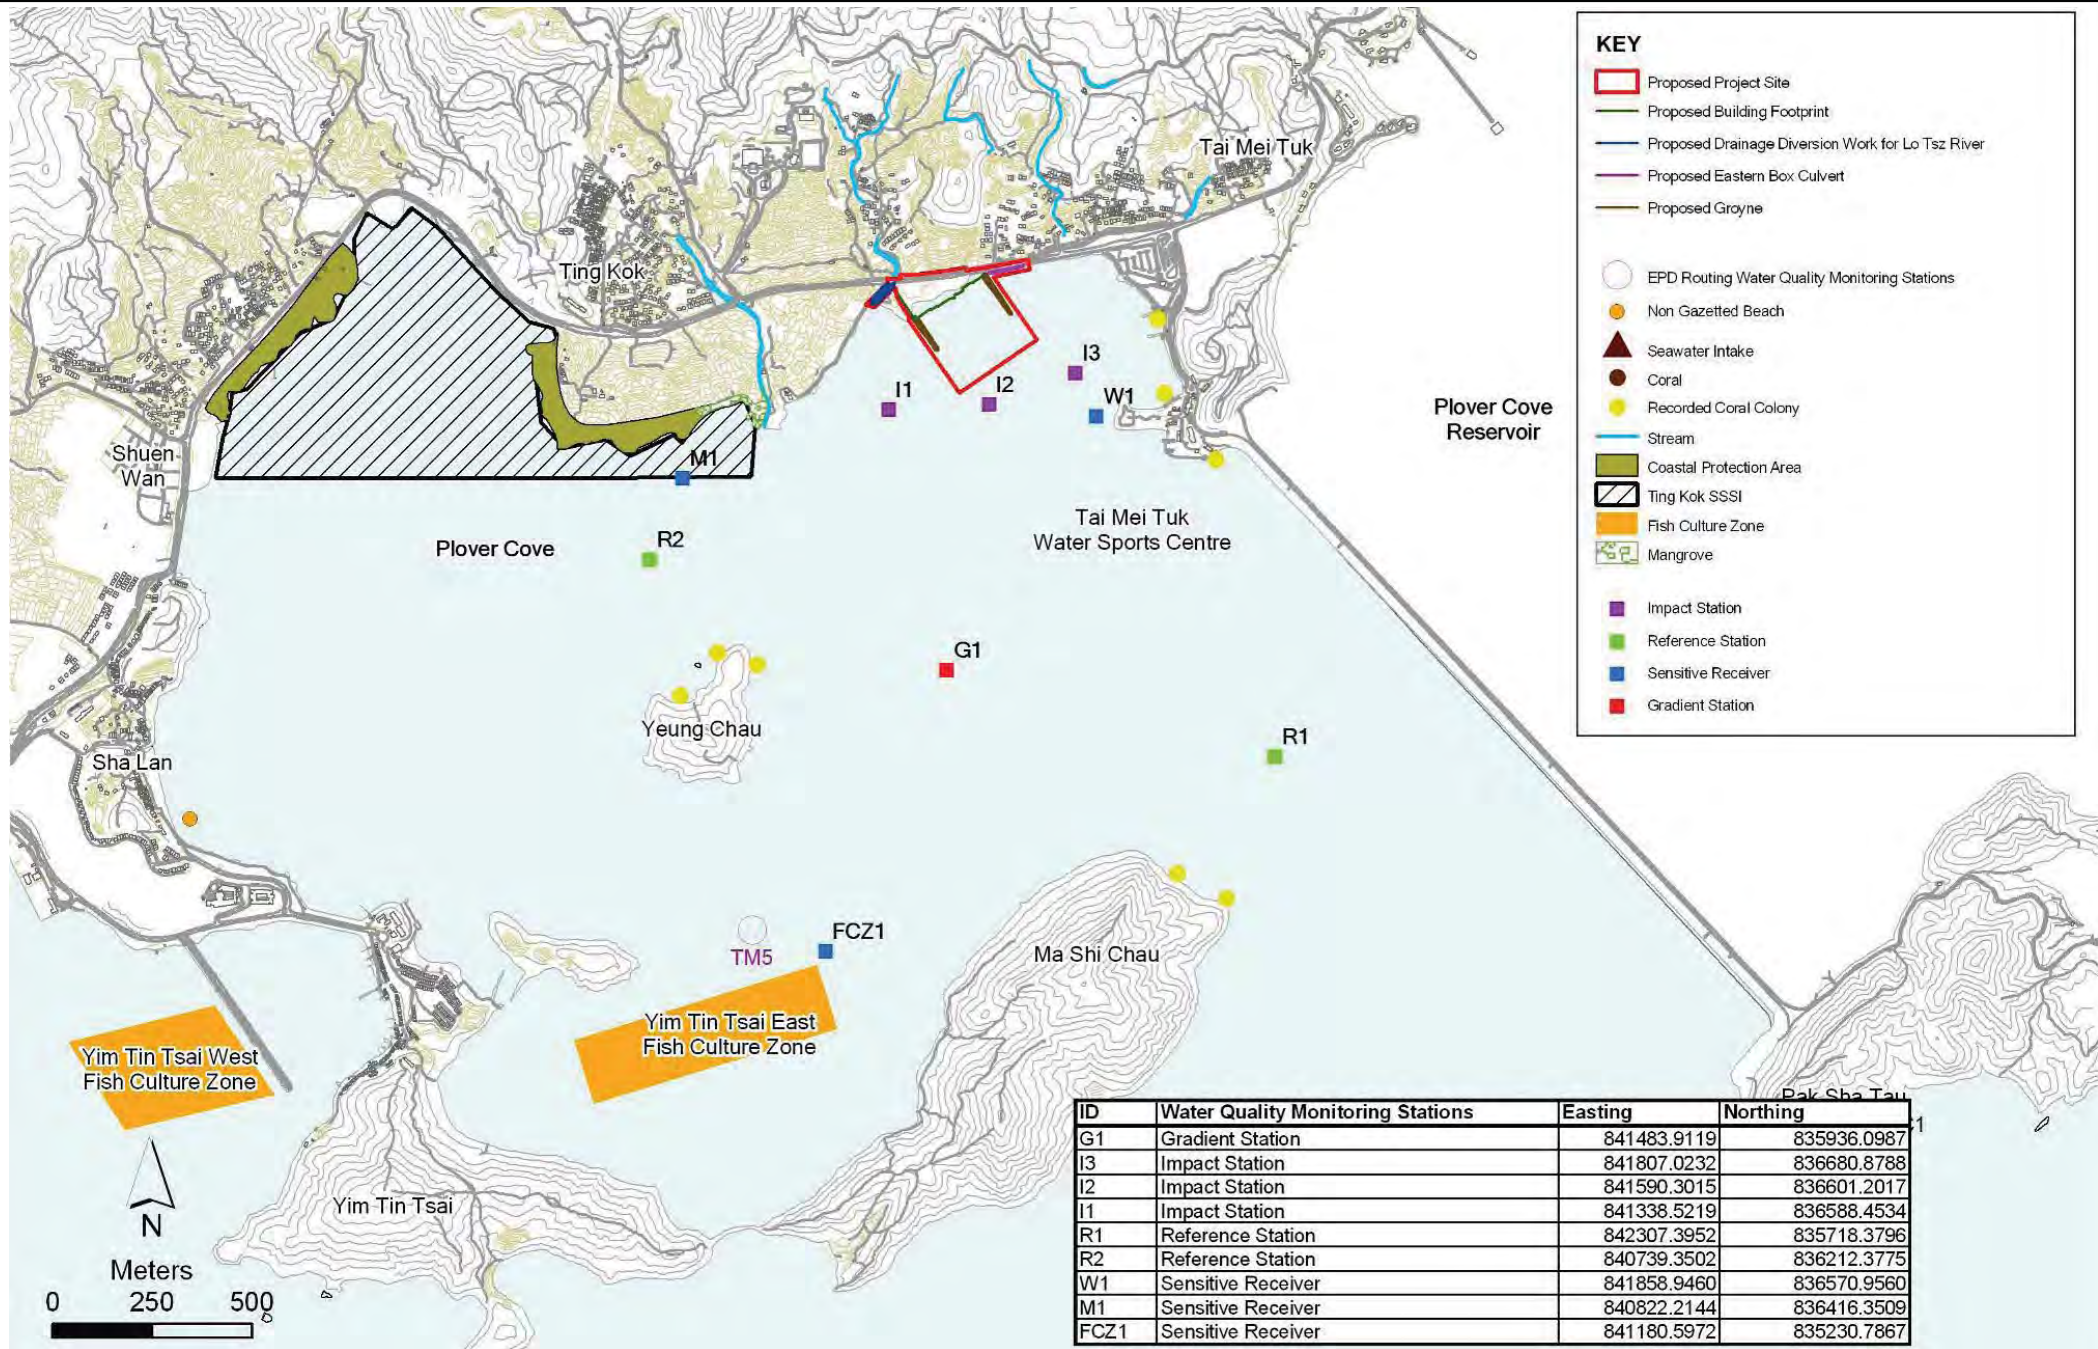
ID	Water Quality Monitoring Stations	Easting	Northing
G1	Gradient Station	841483.9119	835936.0987
I3	Impact Station	841807.0232	836680.8788
I2	Impact Station	841590.3015	836601.2017
I1	Impact Station	841338.5219	836588.4534
R1	Reference Station	842307.3952	835718.3796
R2	Reference Station	840739.3502	836212.3775
W1	Sensitive Receiver	841858.9460	836570.9560
M1	Sensitive Receiver	840822.2144	836416.3509
FCZ1	Sensitive Receiver	841180.5972	835230.7867

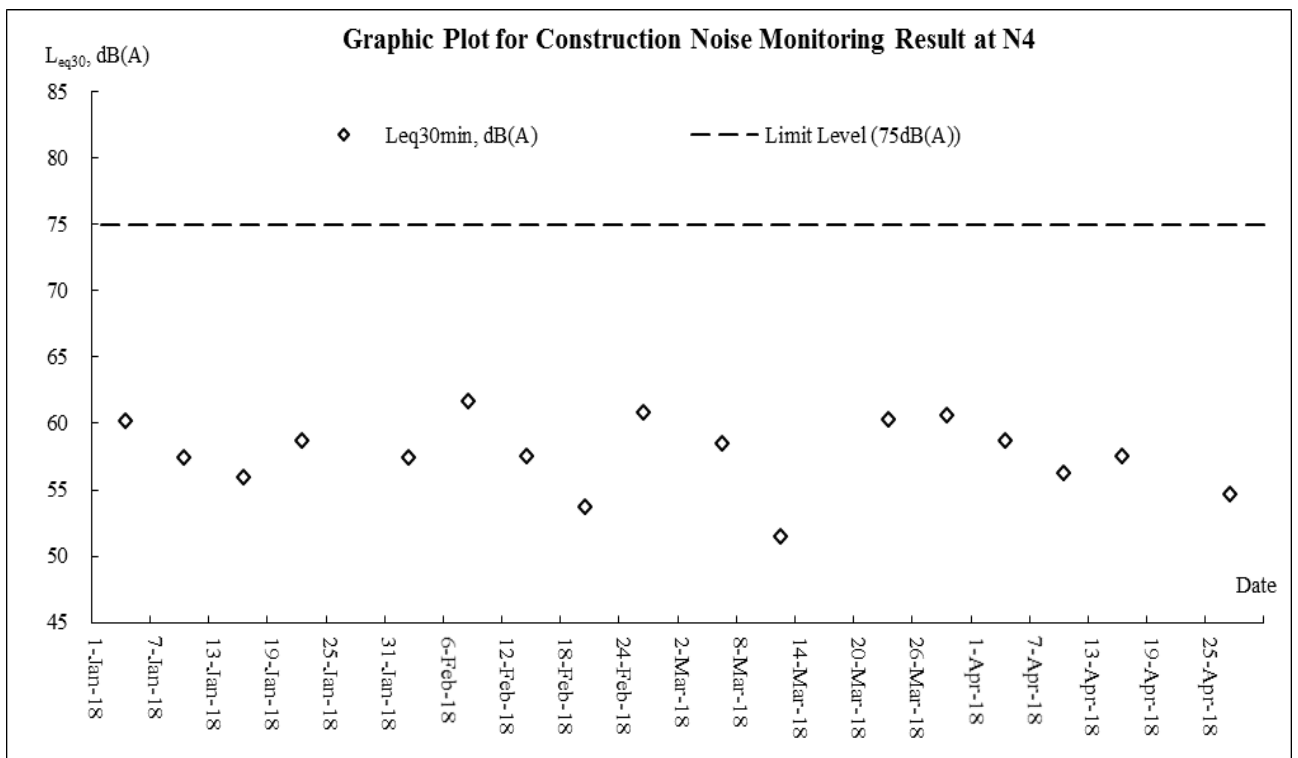
Construction Noise

5.2.2 As shown in [Table 5-1 to Table 5-4](#), all the designated locations measured results were below 75dB(A) of the acceptance criteria. Furthermore, no complaint on construction noise was registered, indicating no exceedance of Action Level. No non-compliance was therefore found during the Reporting Period.

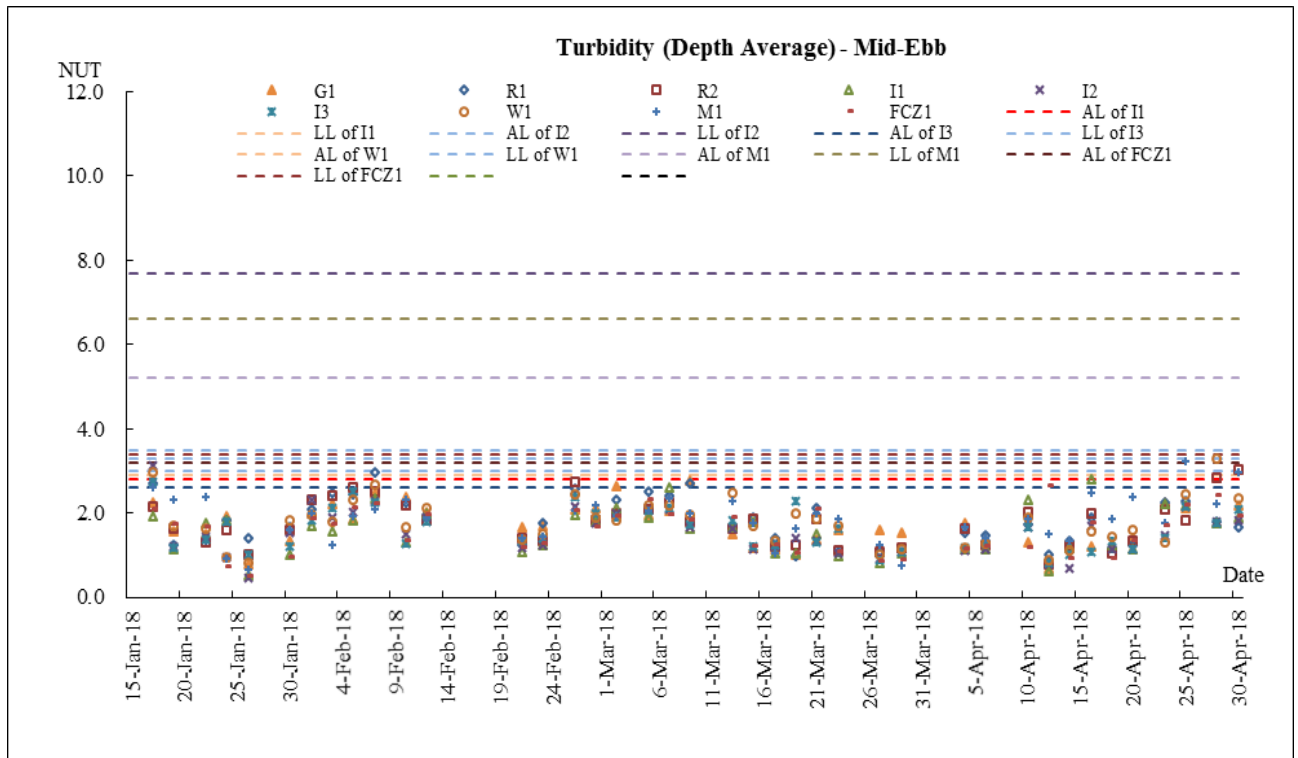
Water Quality

- 12.1.4 For marine water quality monitoring, a total of 139 Action/ Limit Level exceedances of Turbidity, Suspended Solids and Chlorophyll-*a* were recorded which involved 11 monitoring days. NOEs were issued to relevant parties upon confirmation of the monitoring result. In our investigation, there were no marine works carried out during the monitoring days on 6, 10, 12, 14, 16, 18, 20, 23, 25, 28 & 30 April 2018, it is considered that exceedances of turbidity, SS and chlorophyll-*a* in these monitoring days were unlikely caused by Project. In our conclusion, the elevated turbidity, SS levels and chlorophyll-*a* were likely due to natural variation and not caused by the works under the project.
