CEDD CONTRACT NO. CV/2012/05
DEVELOPMENT OF A BATHING BEACH AT LUNG MEI,
TAI PO

MONTHLY ENVIRONMENTAL MONITORING AND AUDIT
REPORT (MAY 2018)

PREPARED FOR
WELCOME CONSTRUCTION CO., LTD

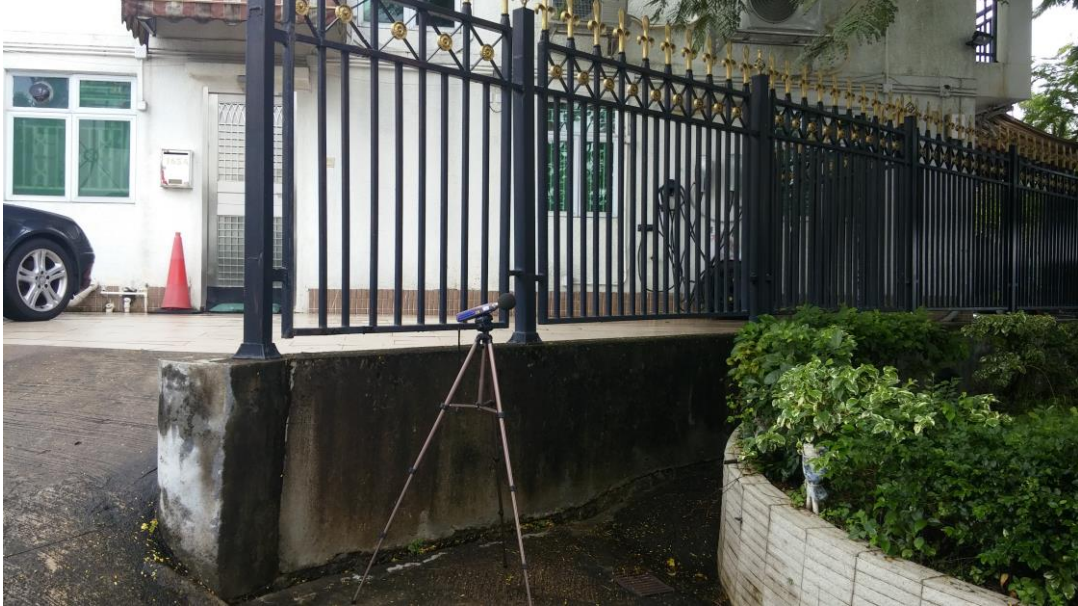
N1

Noise Monitoring

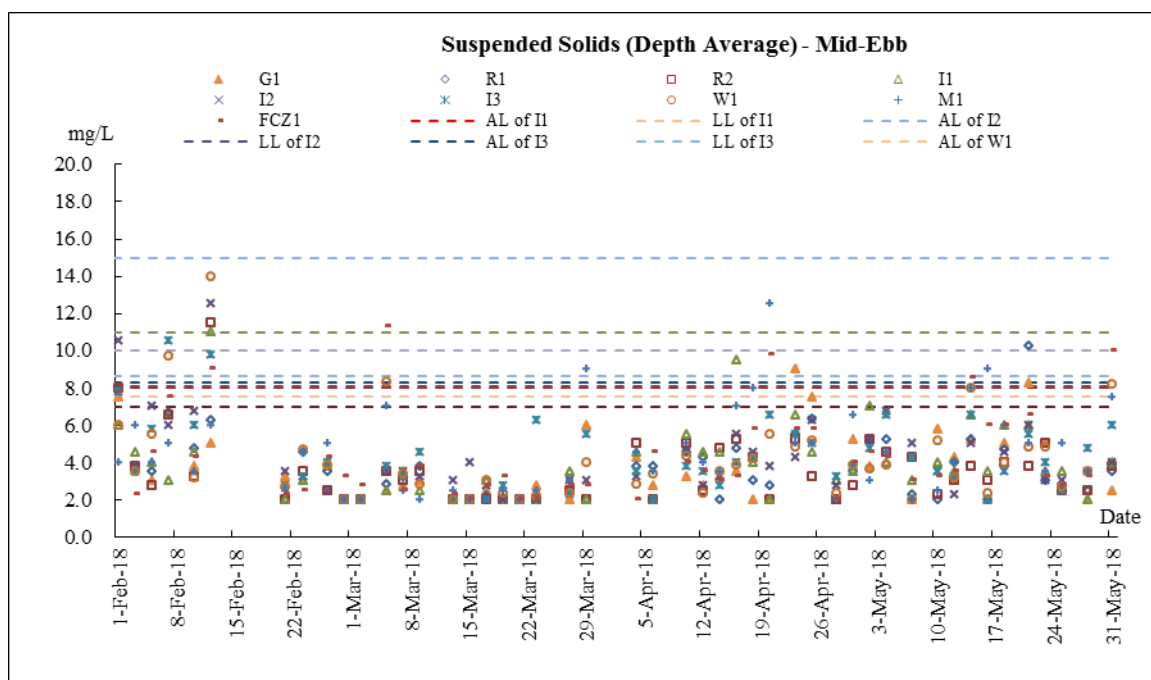
Water Quality

6.2.9 As advised by the Contractor and confirmed by Site Resident Engineers (SRE), there were no marine works undertaken during the monitoring days on 2 to 21 May 2018, it is considered that all exceedances, including turbidity, SS and Chlorophyll-*a*, recorded in this period were unlikely caused by the Project. During 23 to 31 May 2018, rock filling work at west groyne was undertaken as marine activities. As water quality mitigation measures, silt curtains were properly implemented and maintained at locations in accordance with EP's condition. Joint site inspection by CEDD / Welcome / ET was carried out to assess the implementation of water quality mitigation measures and environmental performance of the construction site and there were no adverse water quality impact was observed and recorded. Nevertheless, the Contractor was reminded to check the implementation of silt curtain regularly to ensure no seepage of muddy water into the marine water body.

6.2.10 Having reviewed environmental performance of the Project site and the monitoring results of the reference stations, impact stations as well as the sensitive receiver stations, it is considered that the turbidity, SS and chlorophyll-*a* exceedances were likely due to natural variation and not caused by the works under the project.
