**CEDD CONTRACT NO. CV/2012/05
DEVELOPMENT OF A BATHING BEACH AT LUNG MEI,
TAI PO**

**MONTHLY ENVIRONMENTAL MONITORING AND AUDIT
REPORT (JUNE 2018)**

**PREPARED FOR
WELCOME CONSTRUCTION CO., LTD**

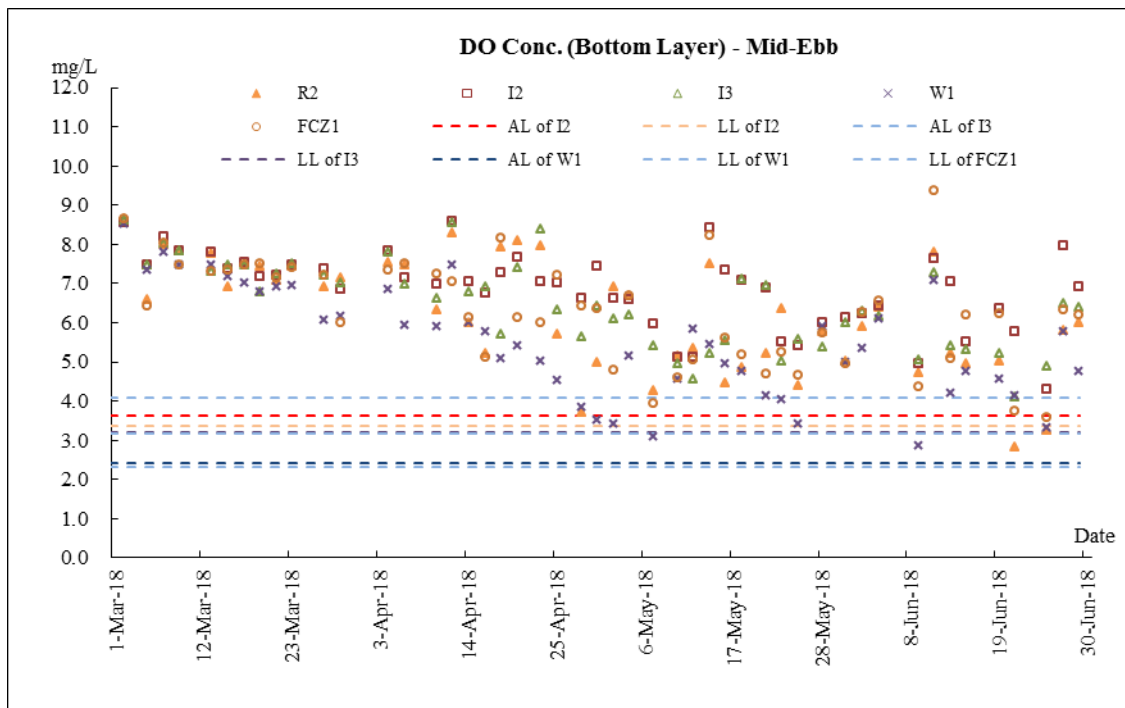
Water Quality

- ES.06 No exceedance of air quality and construction noise monitoring were recorded in this Reporting Period. For water quality monitoring, a total of 69 Action/Limit Level exceedances were recorded for parameters of Turbidity, Suspended Solids and Chlorophyll-a. NOEs were issued to relevant parties upon confirmation of the monitoring result and investigation for the causes of exceedances were carried out by ET subsequently. The statistics of environmental exceedance, NOE issued and investigation of exceedance are summarized in the following table.
