CEDD CONTRACT NO. CV/2012/05
DEVELOPMENT OF A BATHING BEACH AT LUNG MEI,
TAI PO

3RD QUARTERLY ENVIRONMENTAL MONITORING AND
AUDIT SUMMARY REPORT (JUNE 2018 – AUGUST 2018)

PREPARED FOR
WELCOME CONSTRUCTION CO., LTD

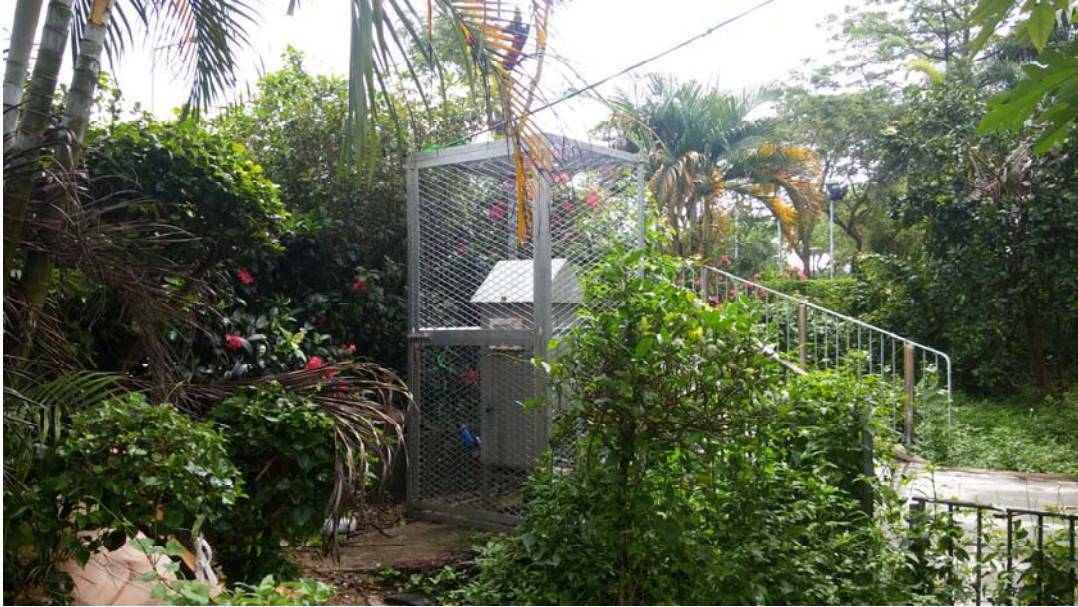
A4

Air Quality Monitoring (24-Hour TSP & 1-Hour TSP)

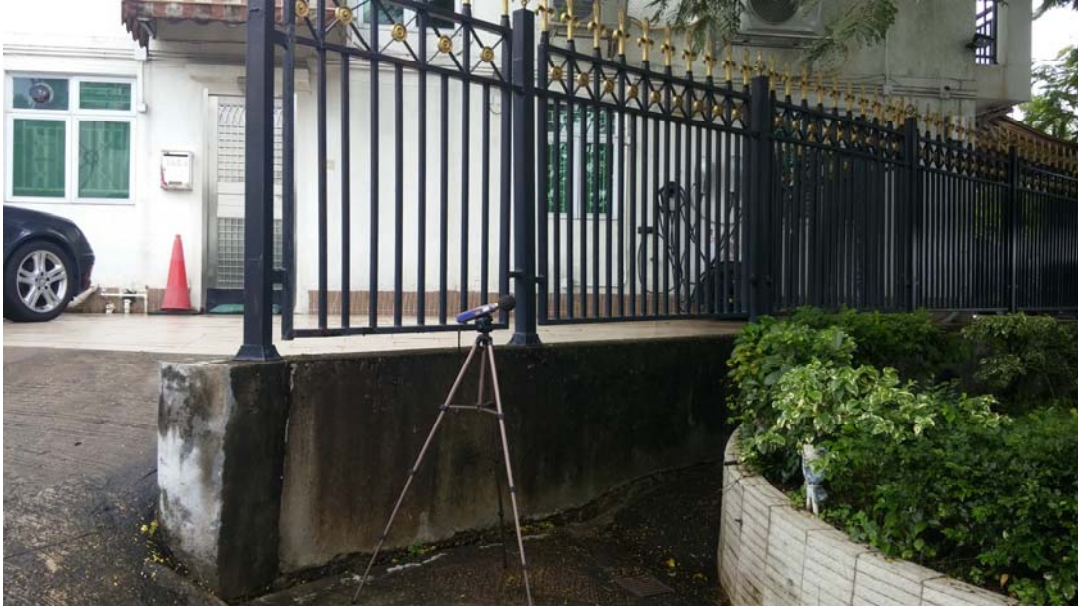
N1

Noise Monitoring

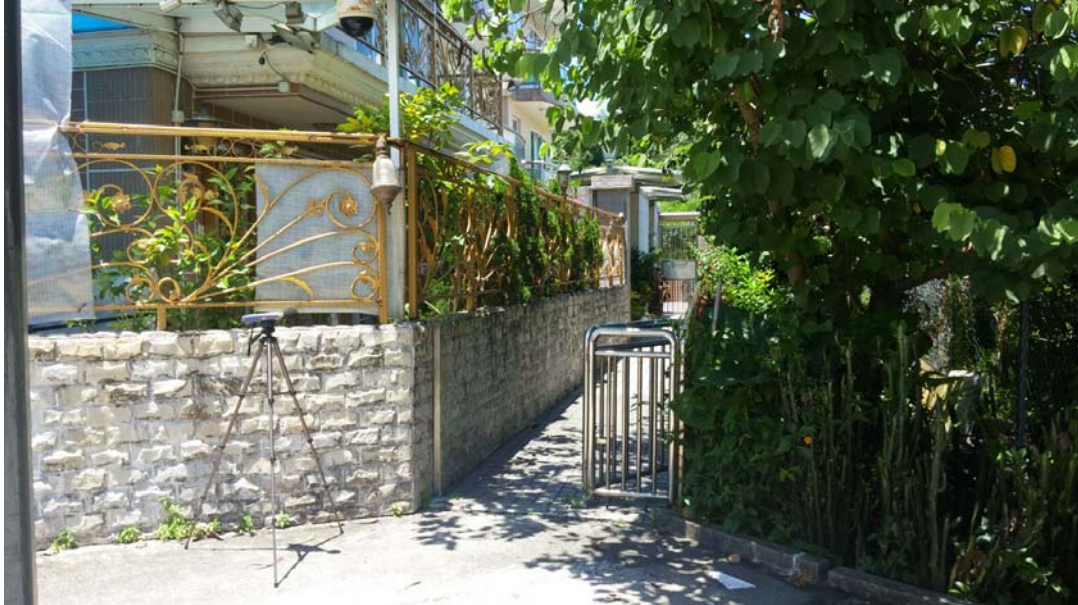
Noise Monitoring

- 1) The distance between N3 and N3a is about 18 meter apart and N3a locates at close proximity of the project site and major site activities which are likely to have noise impacts;
- 2) N3a is a village type residential house and it is a noise sensitive receiver (NSR);
- 3) Accessibility for noise monitoring work at N3a is available; and
- 4) Minimal disturbance would be only caused to the proposed monitoring location N3a.
