JOB No.: TCS00874/16

CEDD CONTRACT NO. CV/2012/05  
DEVELOPMENT OF A BATHING BEACH AT LUNG MEI,  
TAI PO

MONTHLY ENVIRONMENTAL MONITORING AND AUDIT  
REPORT (OCTOBER 2018)

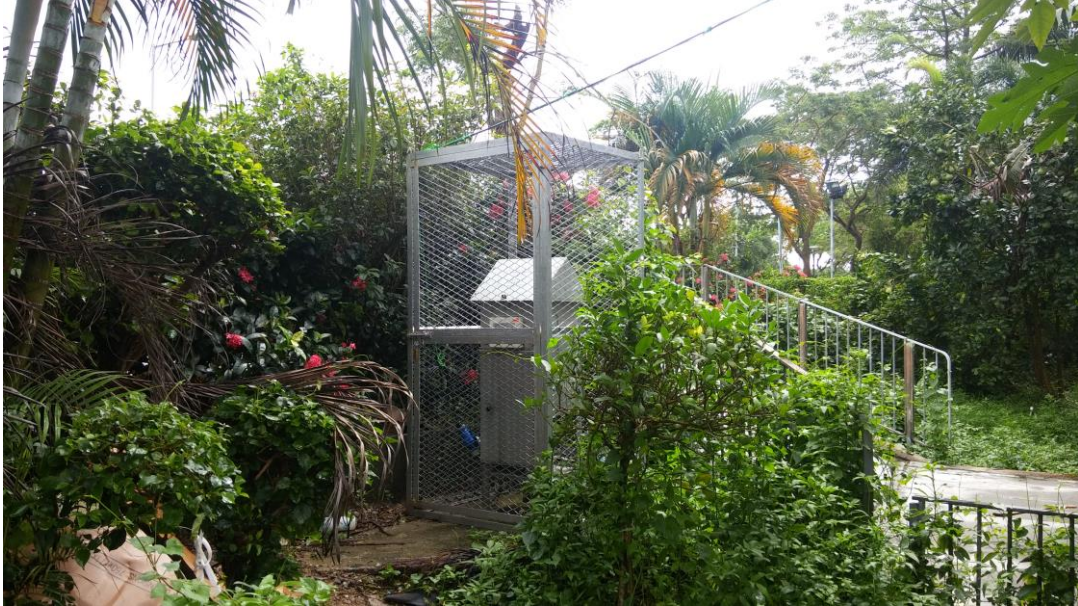
**A4**

**Air Quality Monitoring (24-Hour TSP & 1-Hour TSP)**

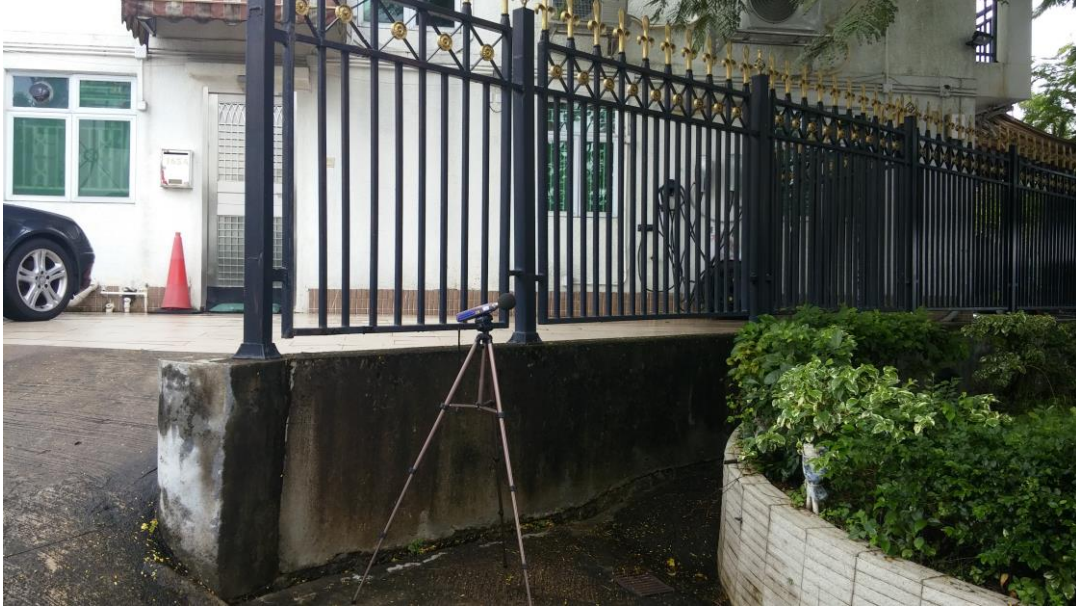
**N1**

**Noise Monitoring**

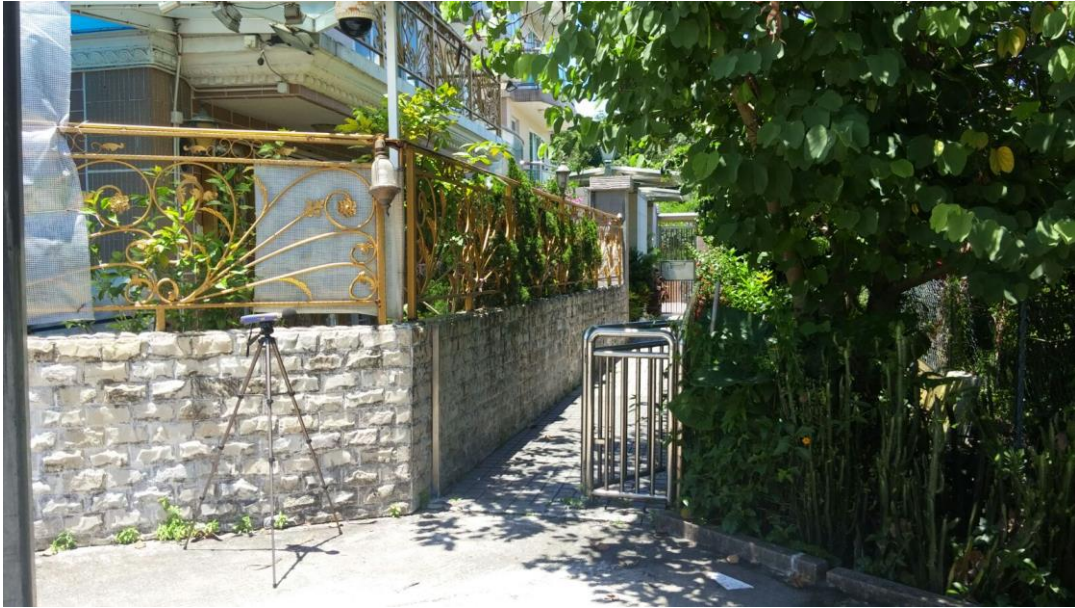
## Noise Monitoring

3.3.3 As confirmed on the first day of baseline monitoring, N2a (House no. 101 Lung Mei) has been changed to residential use. Therefore, the noise monitoring is conducted at N2a and to replace N2. Moreover, due to the lack of accessibility of noise monitoring at N3 (Village house – No. 70 Lo Tsz Tin), alternative location was proposed to replace N3 to carry out the noise monitoring. Having reviewed the surrounding condition, N3a (Village house – No. 66C Lo Tsz Tin) was proposed with the rationales summarized in below.

- 1) The distance between N3 and N3a is about 18 meter apart and N3a locates at close proximity of the project site and major site activities which are likely to have noise impacts;
- 2) N3a is a village type residential house and it is a noise sensitive receiver (NSR);
- 3) Accessibility for noise monitoring work at N3a is available; and
- 4) Minimal disturbance would be only caused to the proposed monitoring location N3a.
