JOB No.: TCS00874/16

CEDD CONTRACT NO. CV/2012/05
DEVELOPMENT OF A BATHING BEACH AT LUNG MEI,
TAI PO

MONTHLY ENVIRONMENTAL MONITORING AND AUDIT
REPORT (FEBRUARY 2019)

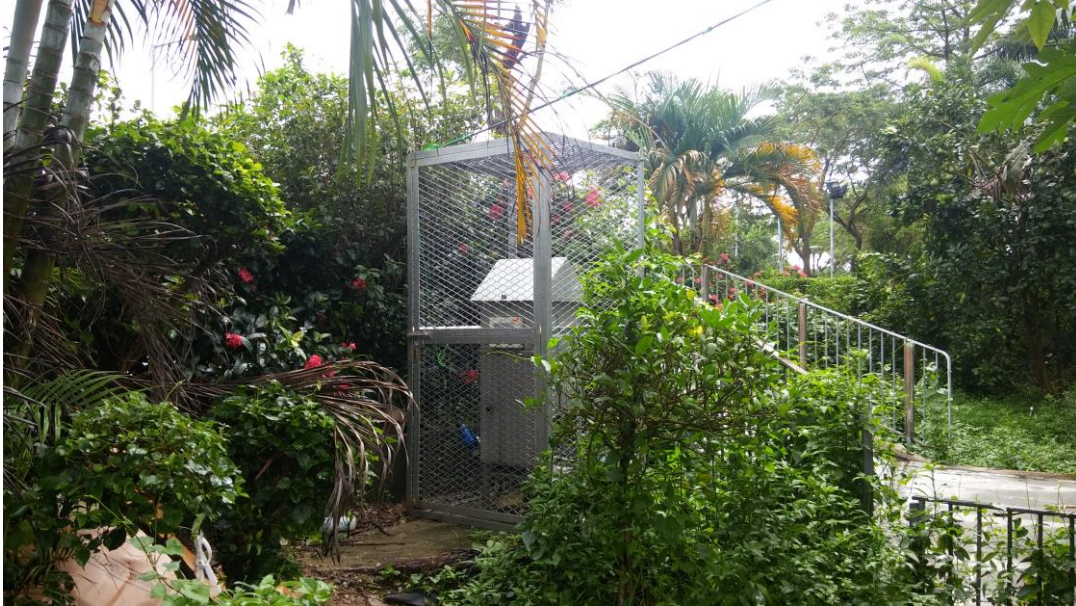
A4

Air Quality Monitoring (24-Hour TSP & 1-Hour TSP)

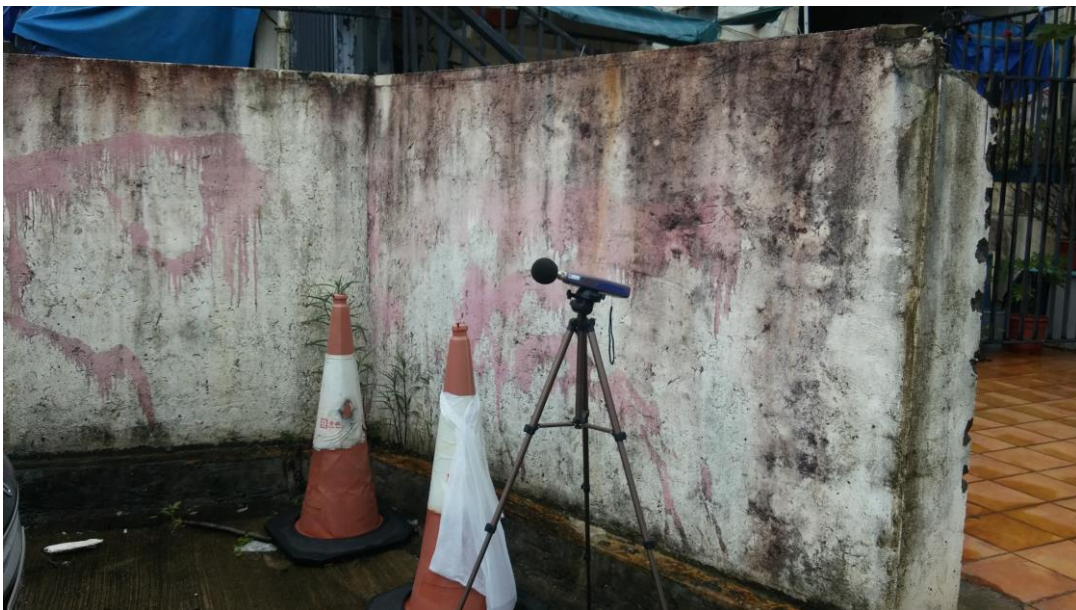
3.3.3 As confirmed on the first day of baseline monitoring, N2a (House no. 101 Lung Mei) has been changed to residential use. Therefore, the noise monitoring is conducted at N2a and to replace N2. Moreover, due to the lack of accessibility of noise monitoring at N3 (Village house – No. 70 Lo Tsz Tin), alternative location was proposed to replace N3 to carry out the noise monitoring. Having reviewed the surrounding condition, N3a (Village house – No. 66C Lo Tsz Tin) was proposed with the rationales summarized in below.

Noise Monitoring

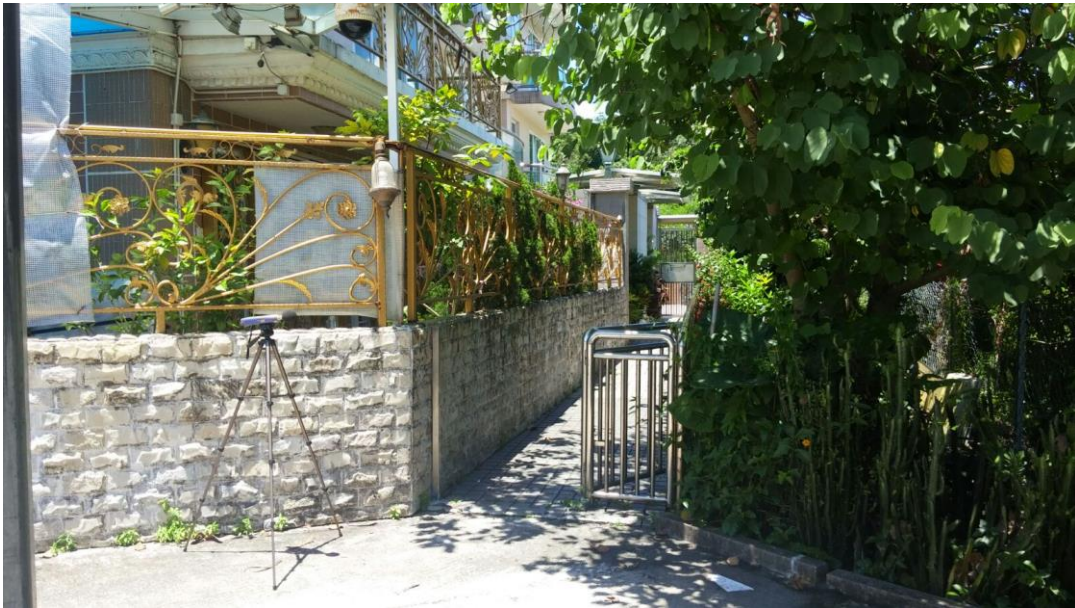
- 1) The distance between N3 and N3a is about 18 meter apart and N3a locates at close proximity of the project site and major site activities which are likely to have noise impacts;
- 2) N3a is a village type residential house and it is a noise sensitive receiver (NSR);
- 3) Accessibility for noise monitoring work at N3a is available; and
- 4) Minimal disturbance would be only caused to the proposed monitoring location N3a.

Noise Monitoring
