CEDD CONTRACT NO. CV/2012/05  
DEVELOPMENT OF A BATHING BEACH AT LUNG MEI,  
TAI PO

MONTHLY ENVIRONMENTAL MONITORING AND AUDIT  
REPORT (MARCH 2019)

PREPARED FOR  
WELCOME CONSTRUCTION CO., LTD

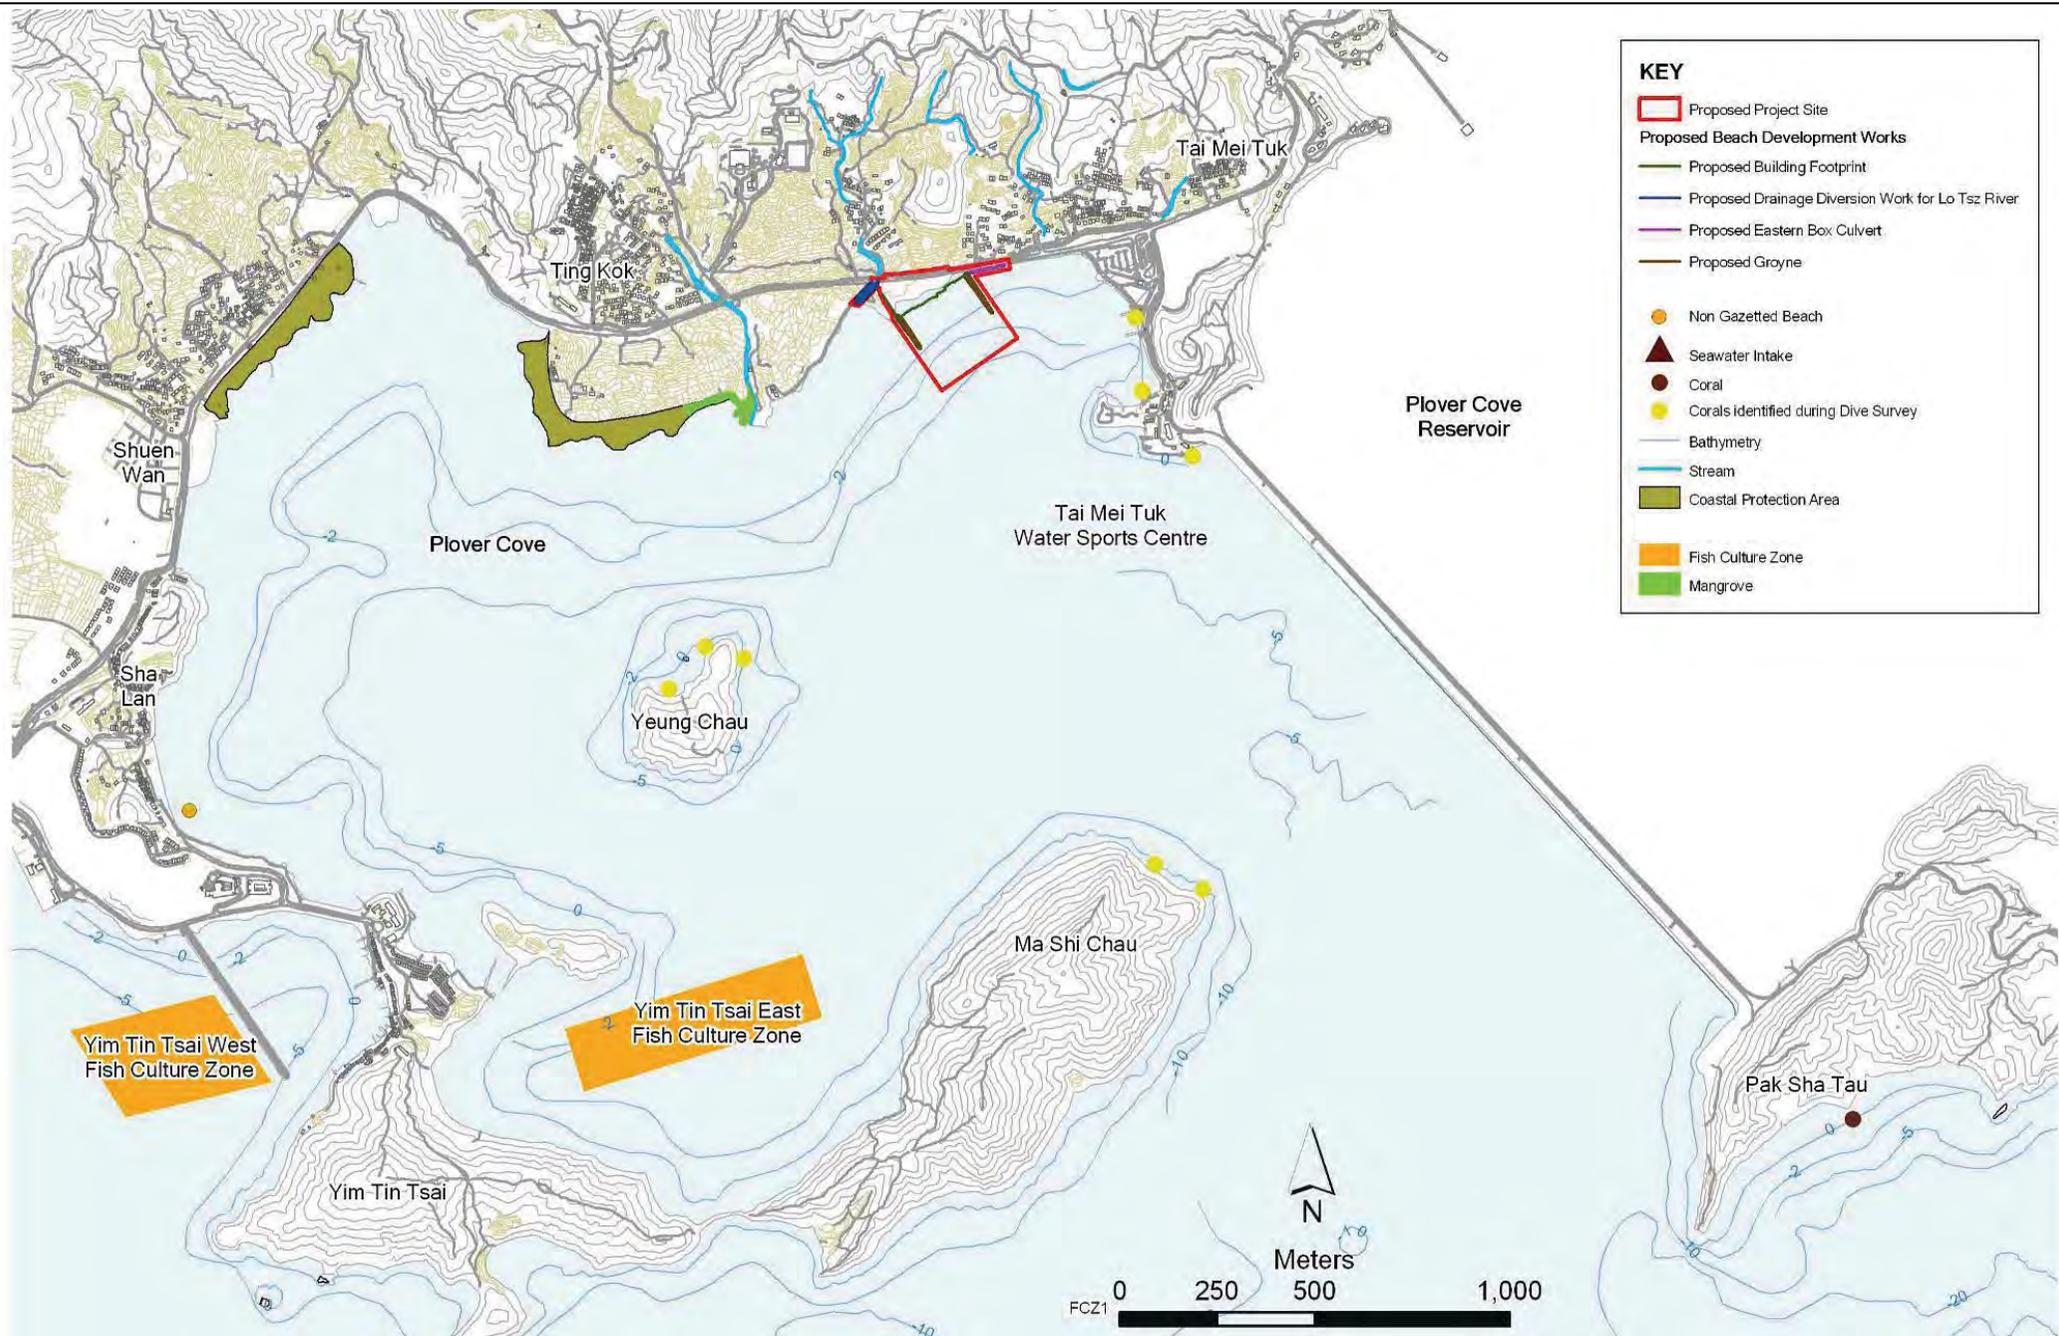
### **Layout plan of the Project**

- Proposed Project Site
- Proposed Beach Development Works
- Proposed Building Footprint
- Proposed Drainage Diversion Work for Lo Tsz River
- Proposed Eastern Box Culvert
- Proposed Groyne
- Non Gazetted Beach
- ▲ Seawater Intake
- Coral
- Corals identified during Dive Survey
- Bathymetry
- Stream
- Coastal Protection Area
- Fish Culture Zone
- Mangrove

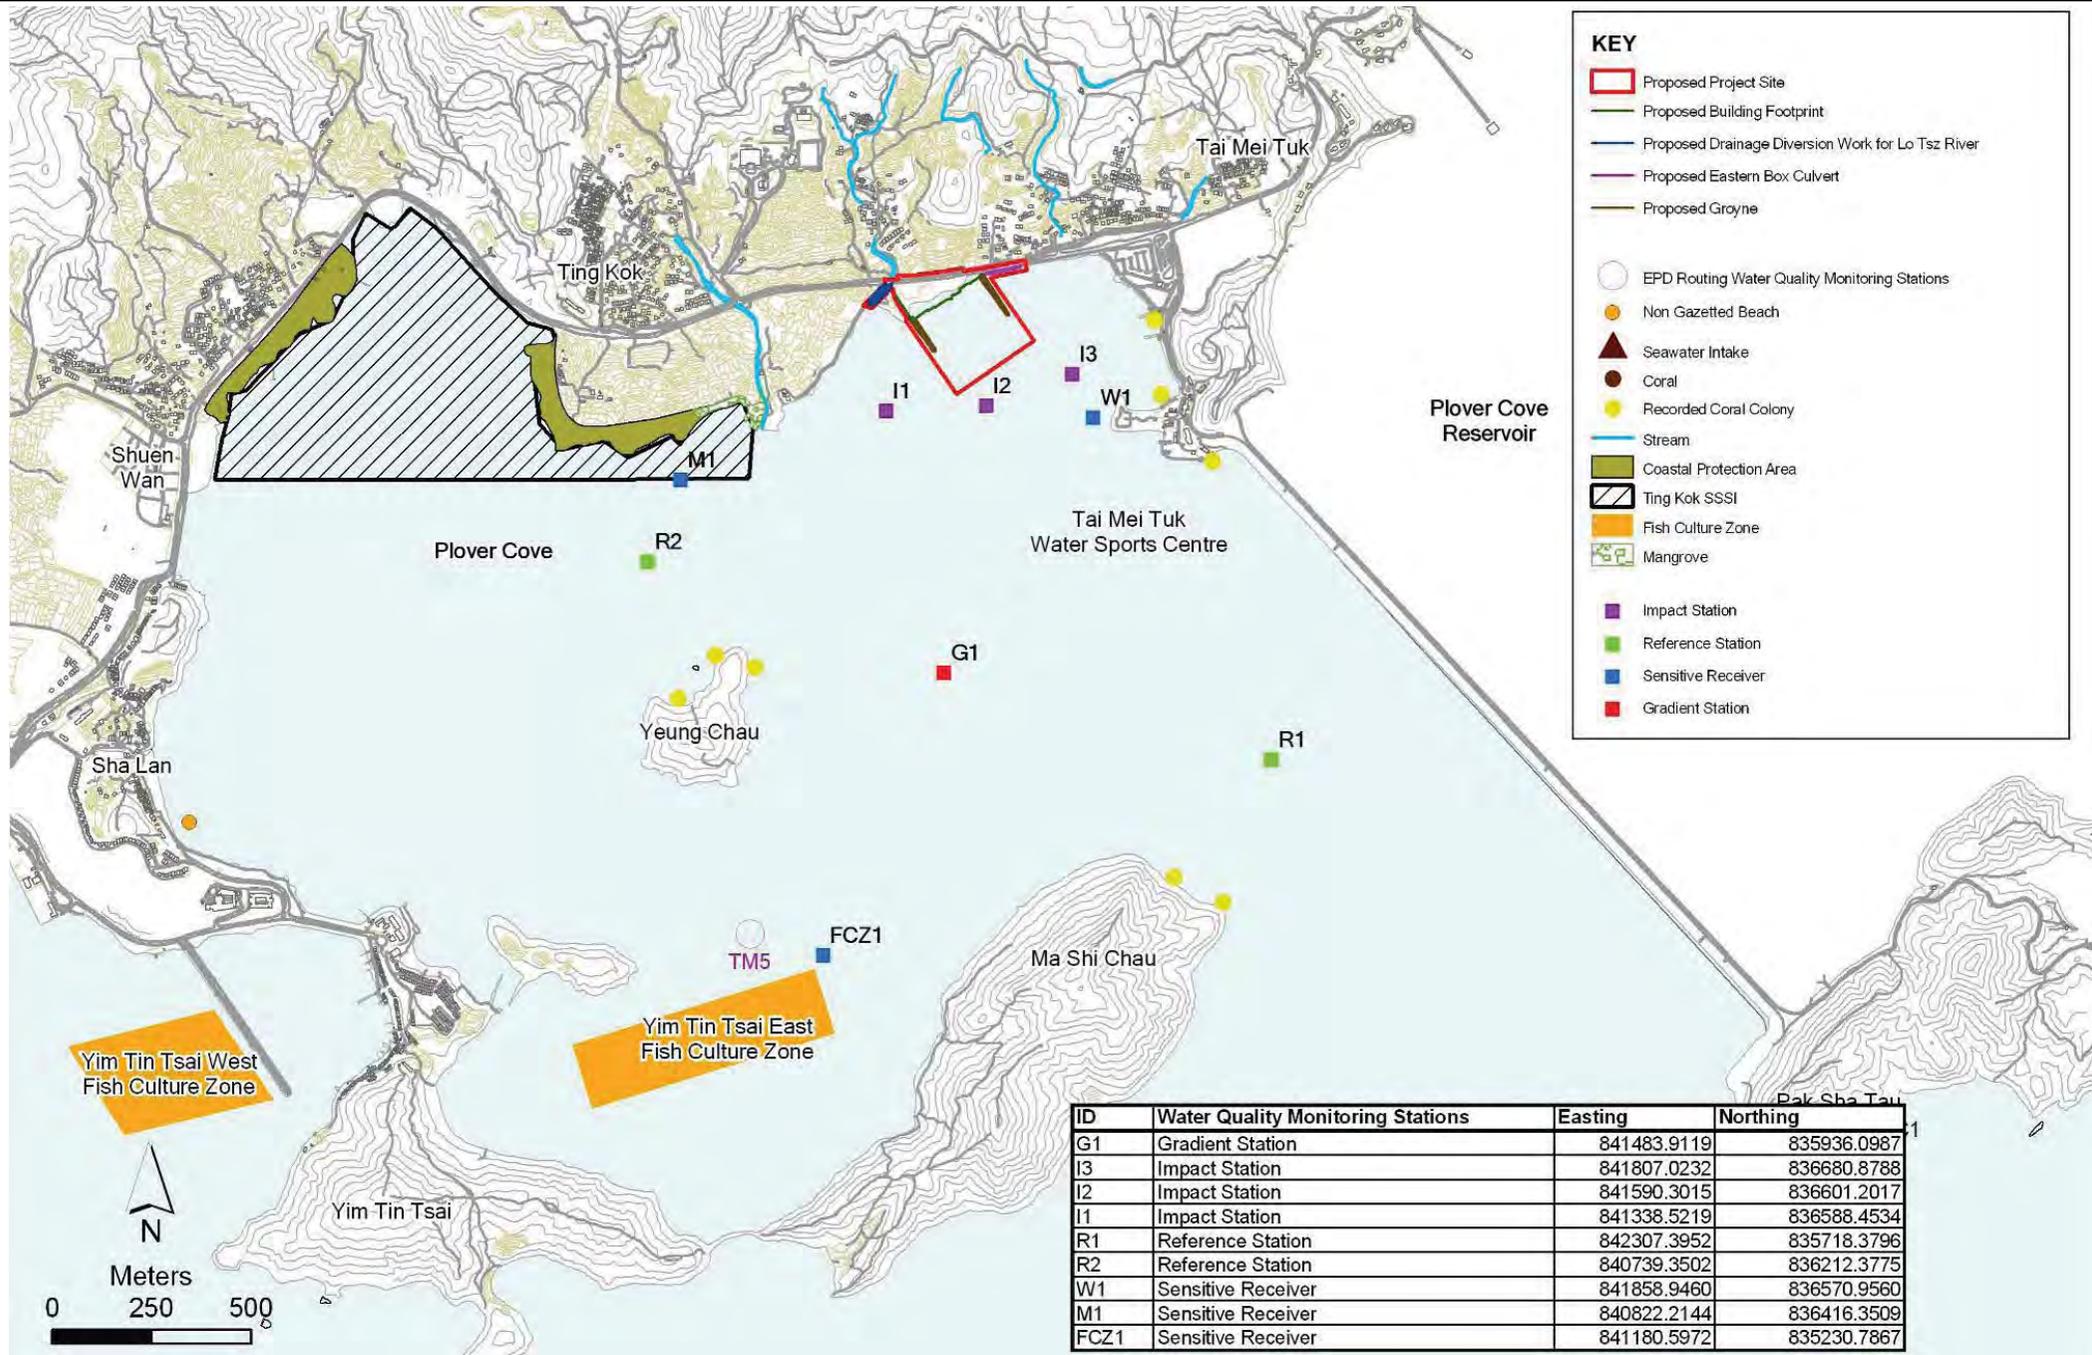
KEY	
	Proposed Project Site
	Proposed Building Footprint
	Proposed Drainage Diversion Work for Lo Tsz River
	Proposed Eastern Box Culvert
	Proposed Groyne
	EPD Routing Water Quality Monitoring Stations
	Non Gazetted Beach
	Seawater Intake
	Coral
	Recorded Coral Colony
	Stream
	Coastal Protection Area
	Ting Kok SSSI
	Fish Culture Zone
	Mangrove
	Impact Station
	Reference Station
	Sensitive Receiver
	Gradient Station

ID	Water Quality Monitoring Stations	Easting	Northing
G1	Gradient Station	841483.9119	835936.0987
I3	Impact Station	841807.0232	836680.8788
I2	Impact Station	841590.3015	836601.2017
I1	Impact Station	841338.5219	836588.4534
R1	Reference Station	842307.3952	835718.3796
R2	Reference Station	840739.3502	836212.3775
W1	Sensitive Receiver	841858.9460	836570.9560
M1	Sensitive Receiver	840822.2144	836416.3509
FCZ1	Sensitive Receiver	841180.5972	835230.7867

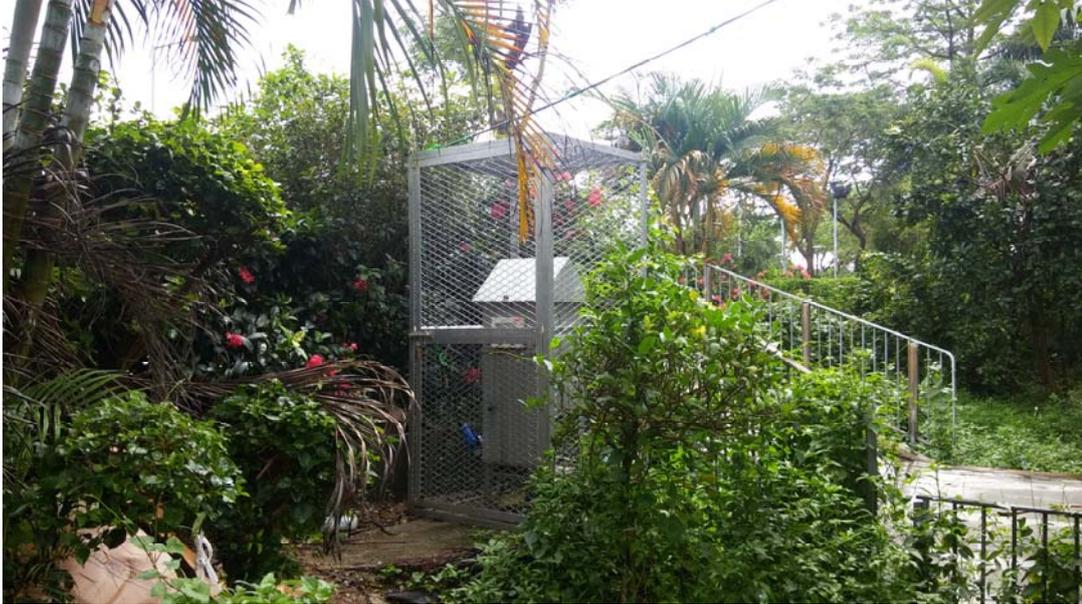
A4

**Air Quality Monitoring (24-Hour TSP & 1-Hour TSP)**

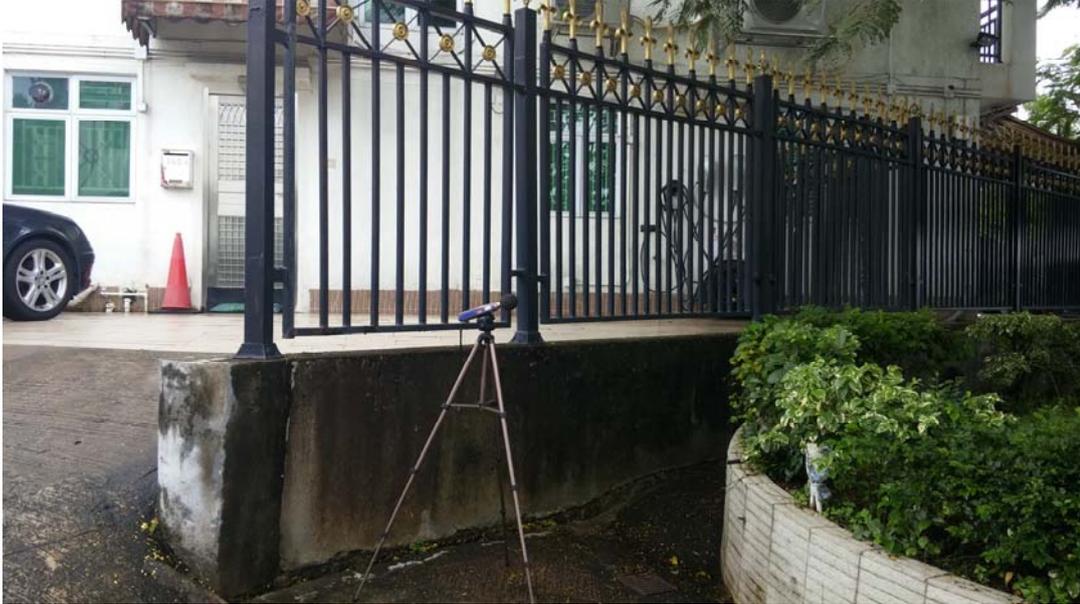
N1

Noise Monitoring

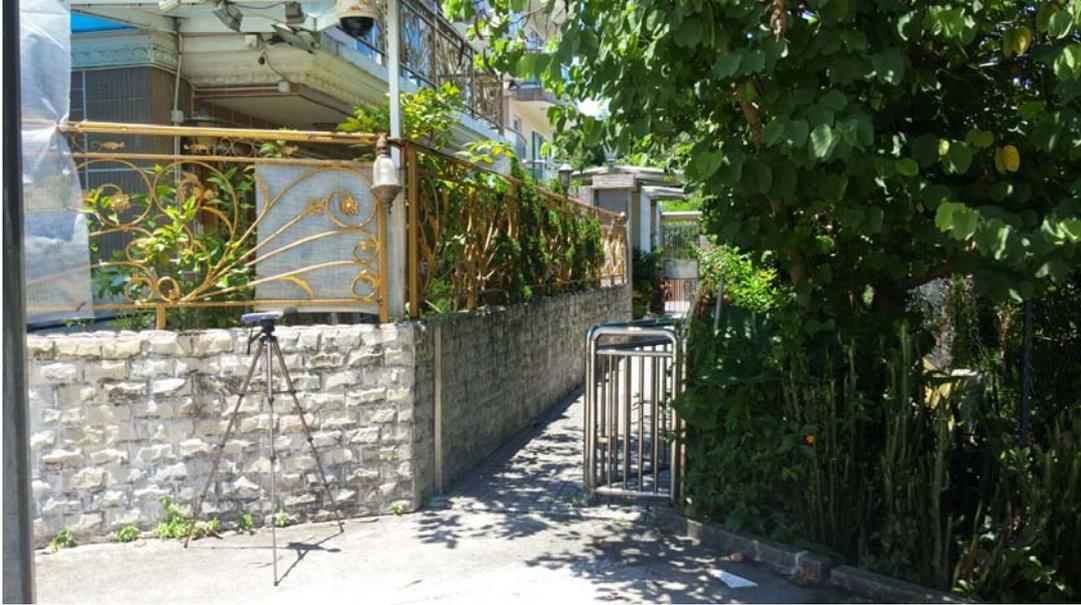
N3a

## Noise Monitoring

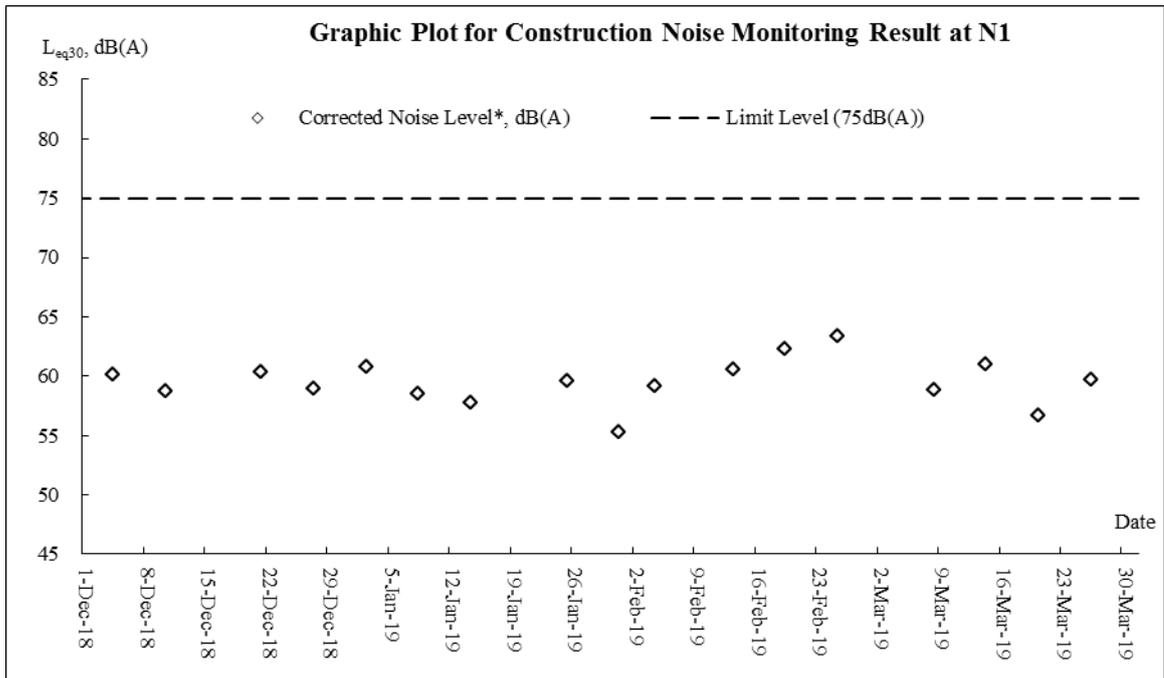
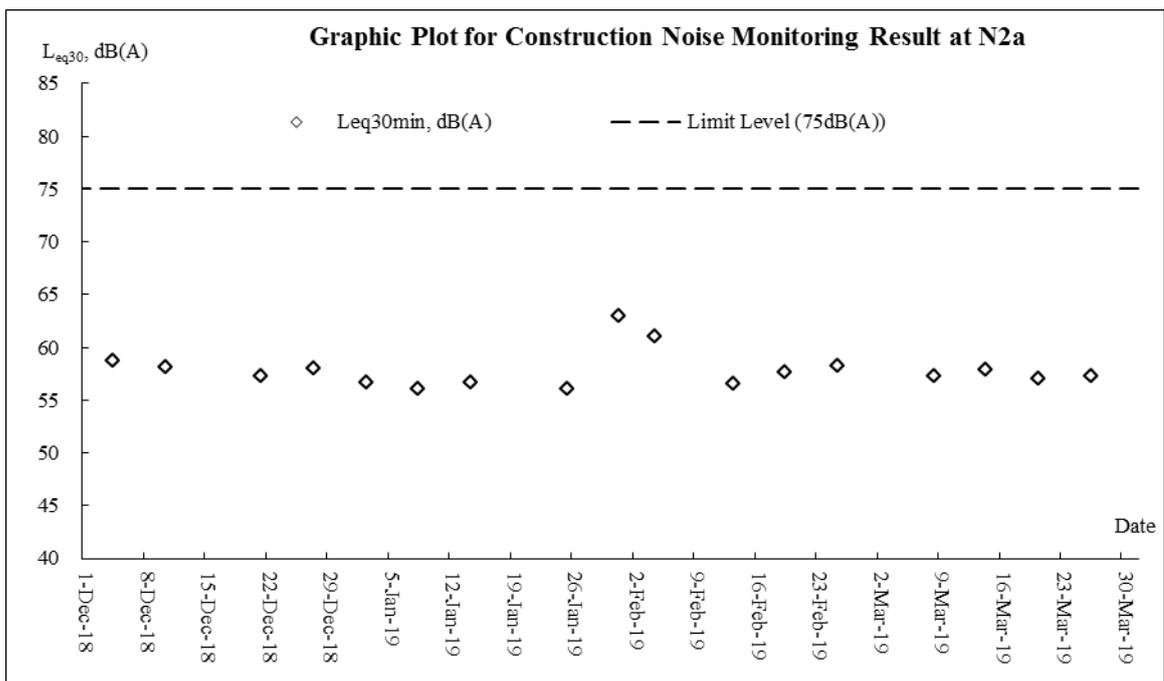
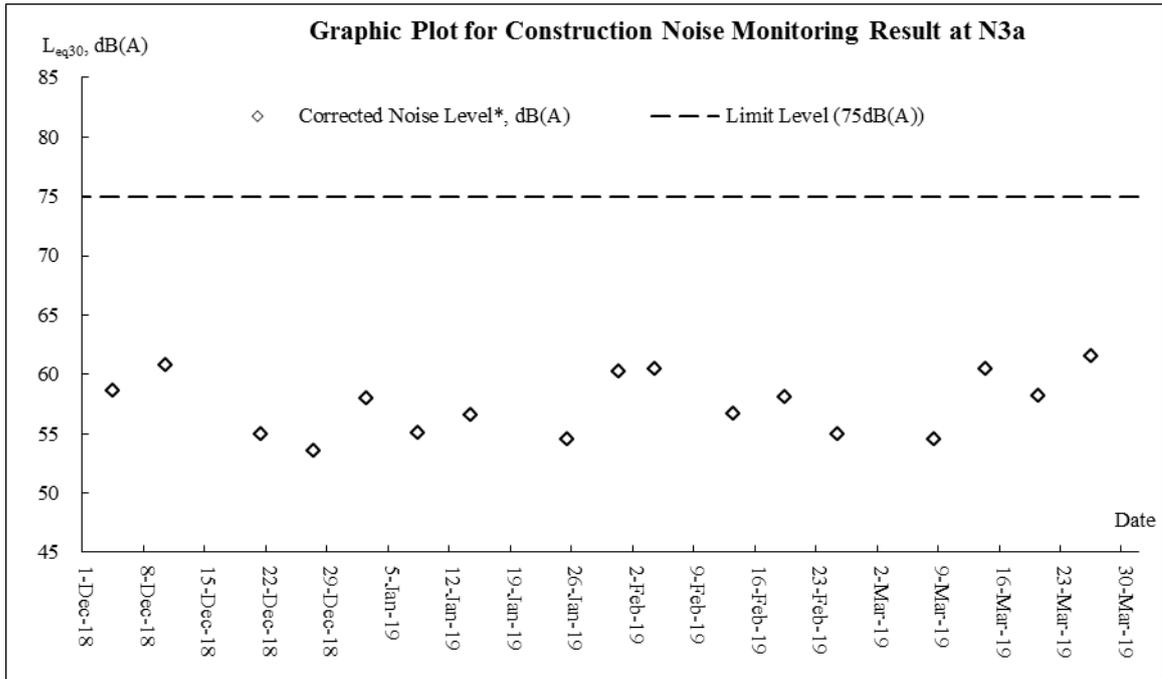
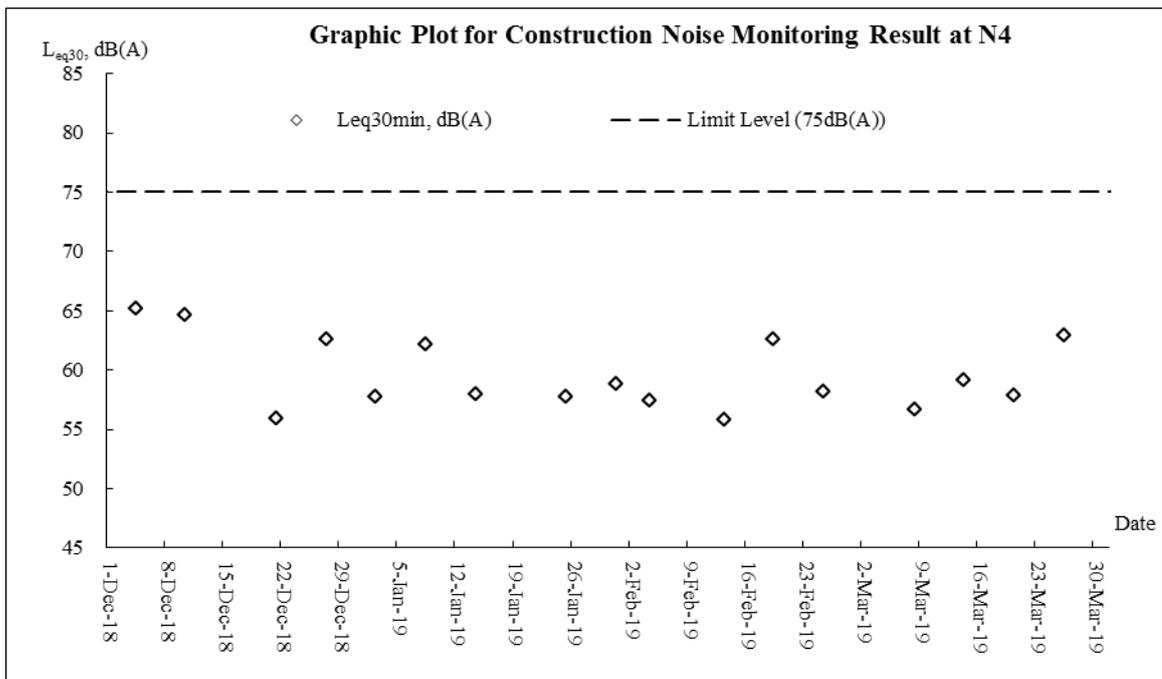
**Construction Noise**

5.2.2 As shown in [Table 5-1 to Table 5-4](#), all the designated locations measured results were below 75dB(A) of the acceptance criteria. Furthermore, no complaint on construction noise was registered, indicating no exceedance of Action Level. No non-compliance was therefore found during the Reporting Period.

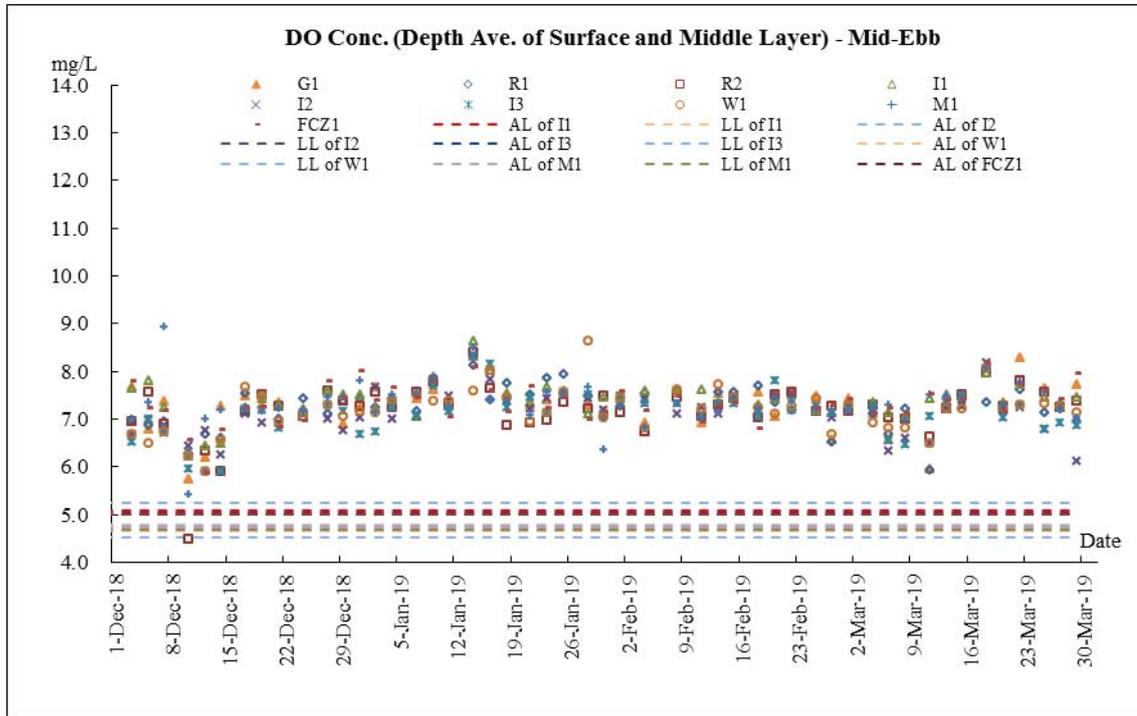
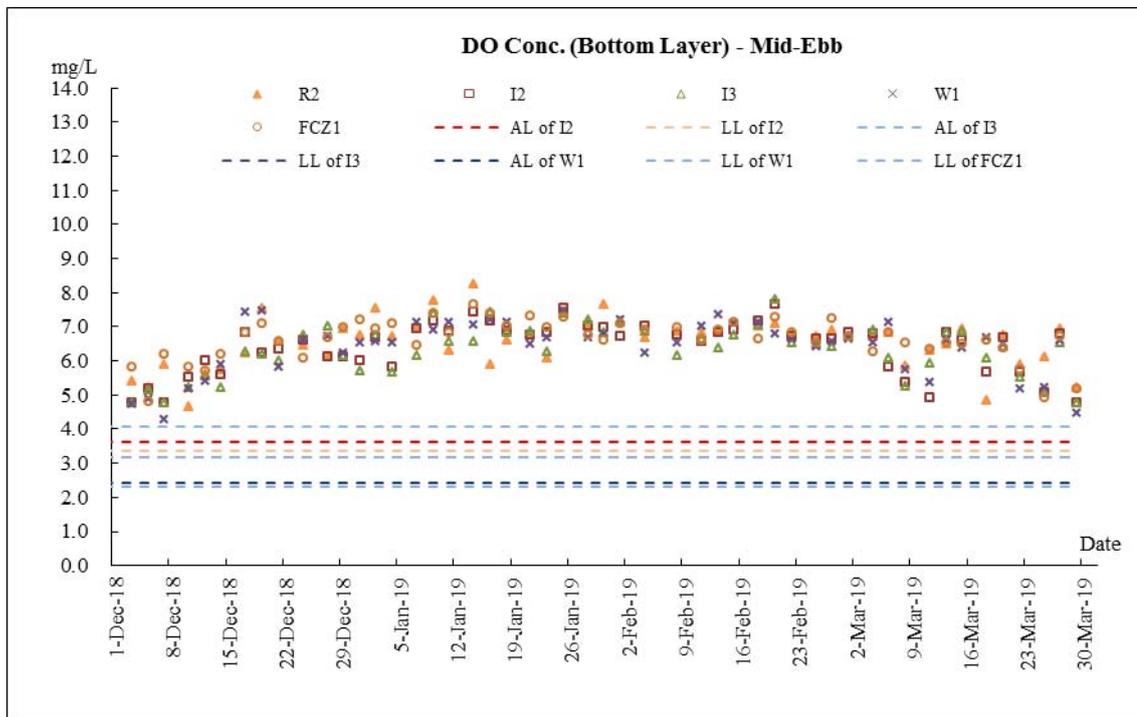
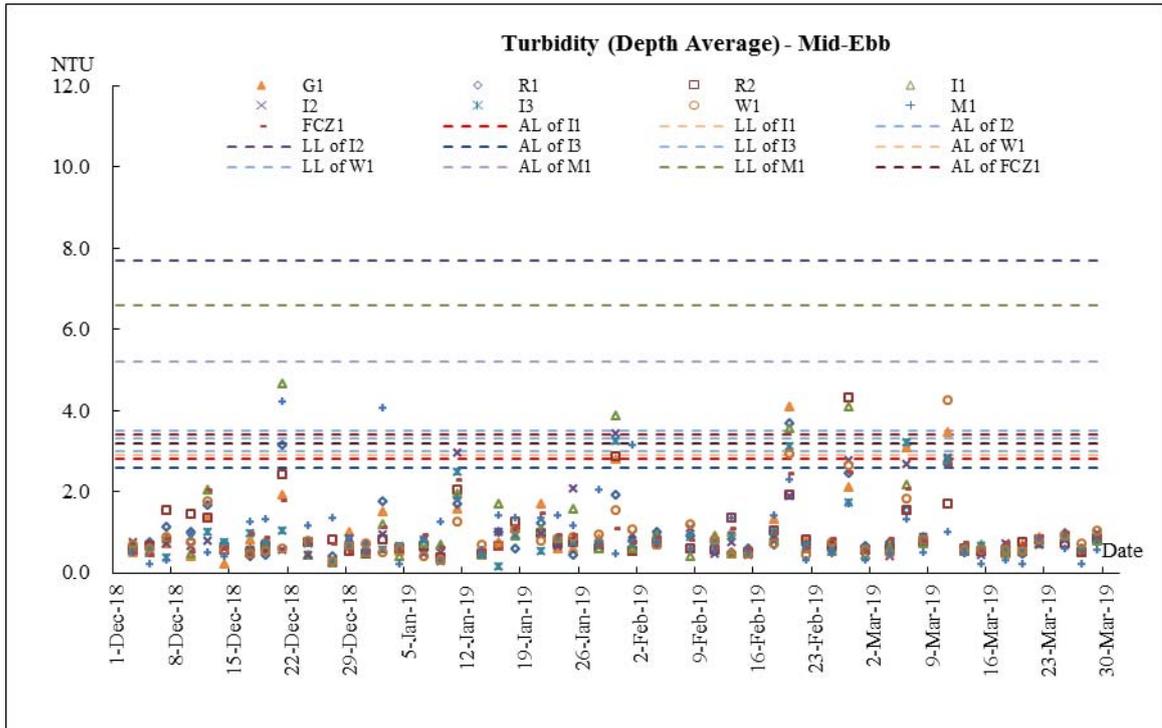
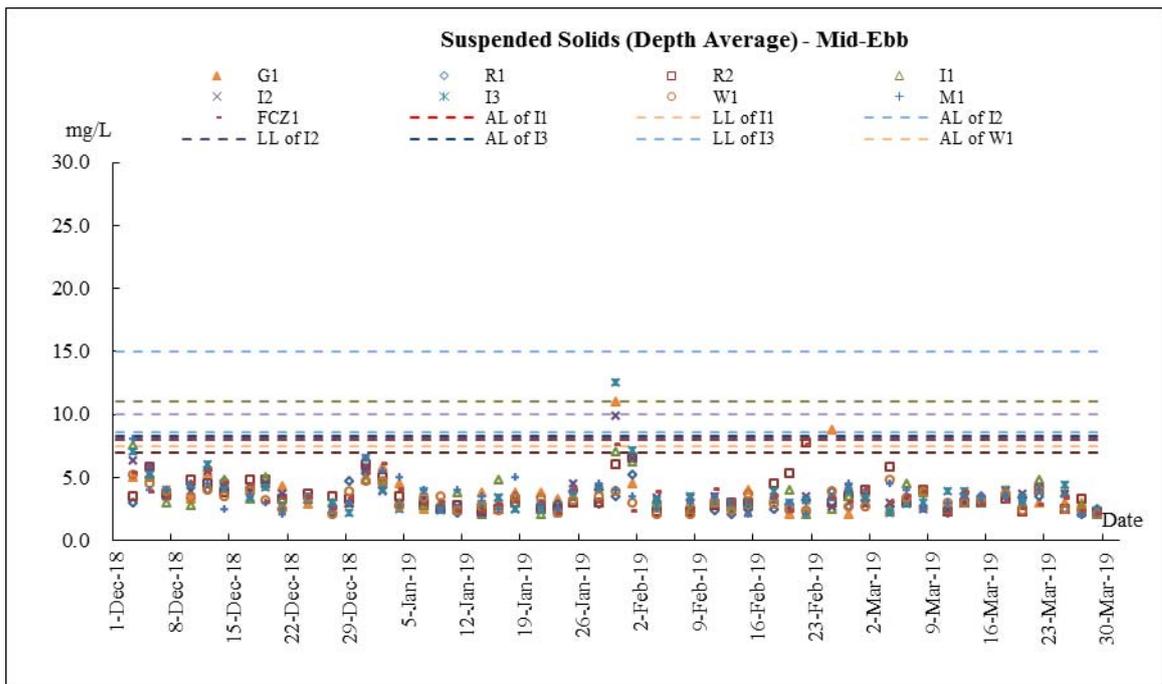
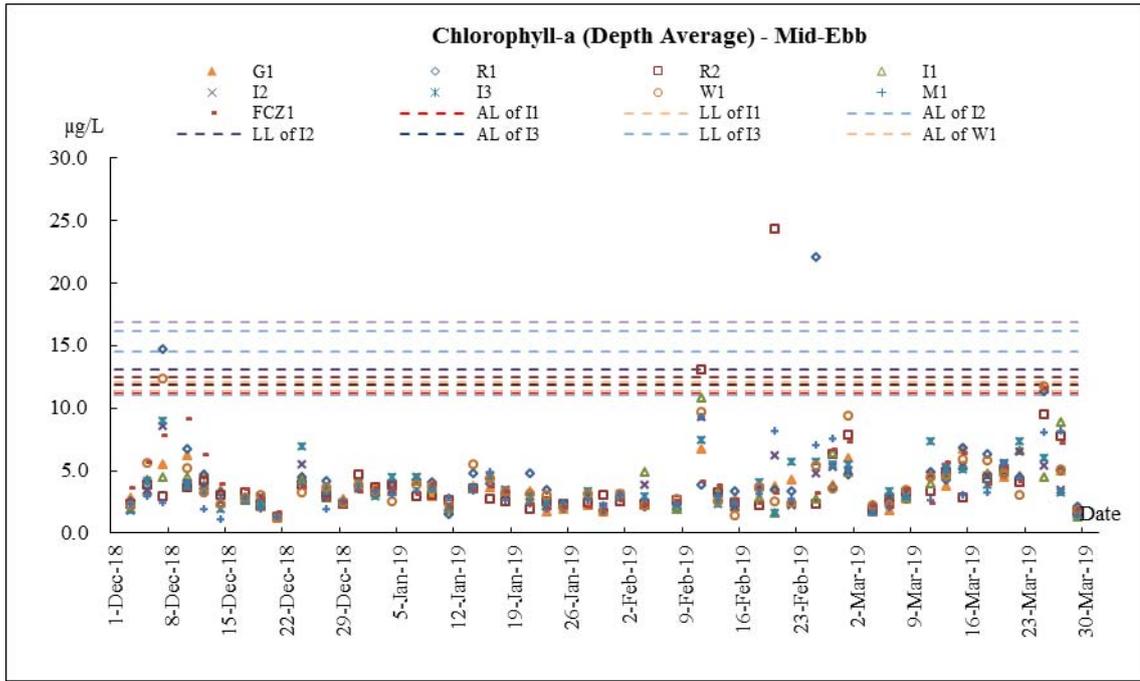
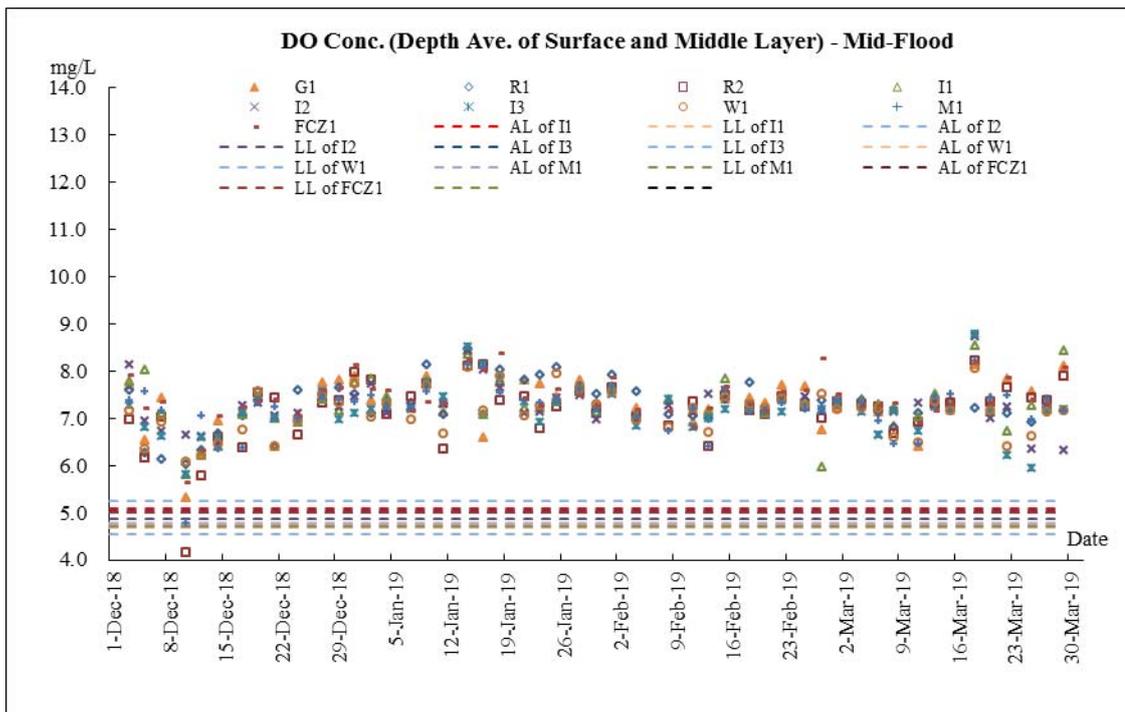
**Water Quality**

- ES.06 No exceedance of air quality and construction noise monitoring were recorded in this Reporting Period. For water quality monitoring and a total of **86** Action/Limit Level exceedances were recorded for parameters of Turbidity, Suspended Solids and Chlorophyll-*a* as shown in below table. NOEs were issued to relevant parties upon confirmation of the monitoring result and investigation for the causes of exceedances were carried out by ET subsequently. The statistics of environmental exceedance, NOE issued and investigation of exceedance are summarized in the following table.
