CEDD CONTRACT NO. CV/2012/05
DEVELOPMENT OF A BATHING BEACH AT LUNG MEI,
TAI PO

7TH QUARTERLY ENVIRONMENTAL MONITORING AND
AUDIT SUMMARY REPORT (JUNE – AUGUST 2019)

PREPARED FOR
WELCOME CONSTRUCTION CO., LTD

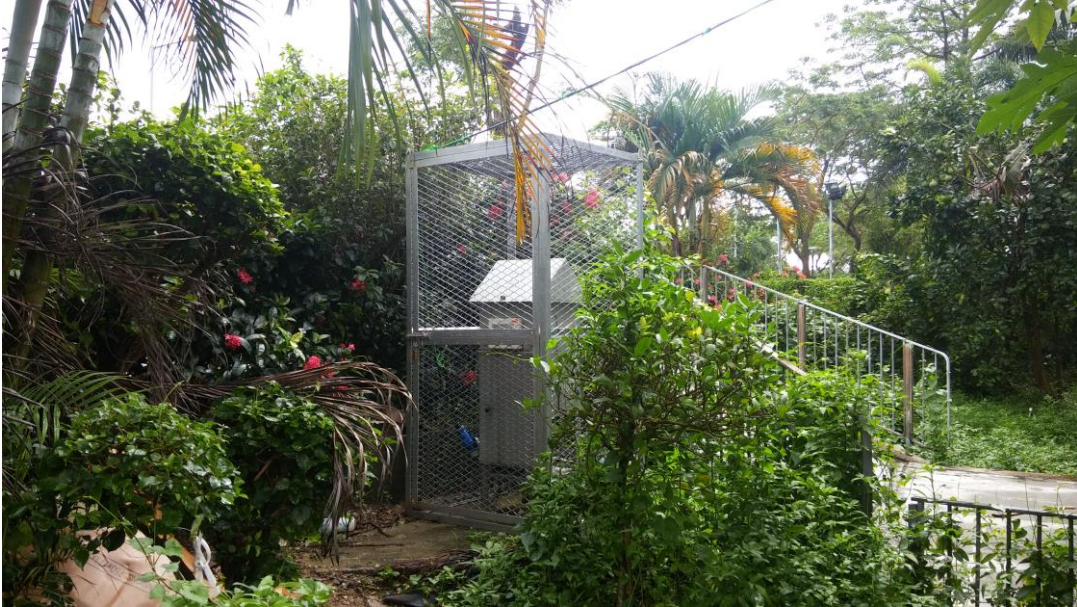
A4

Air Quality Monitoring (24-Hour TSP & 1-Hour TSP)
