CEDD CONTRACT NO. CV/2012/05
DEVELOPMENT OF A BATHING BEACH AT LUNG MEI,
TAI PO

MONTHLY ENVIRONMENTAL MONITORING AND AUDIT
REPORT (JULY 2019)

PREPARED FOR
WELCOME CONSTRUCTION CO., LTD

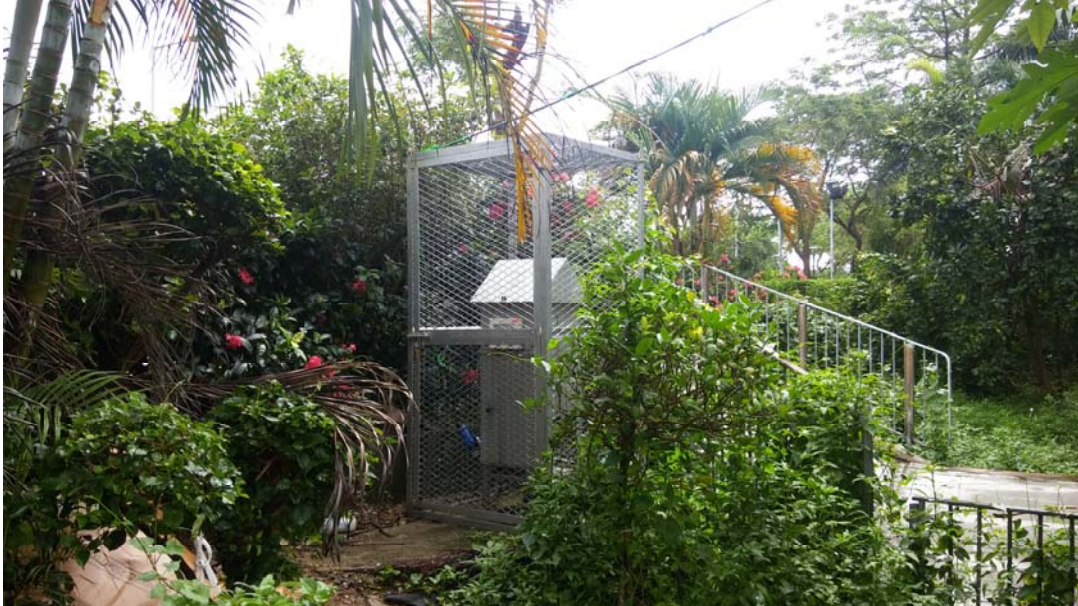
A4

Air Quality Monitoring (24-Hour TSP & 1-Hour TSP)

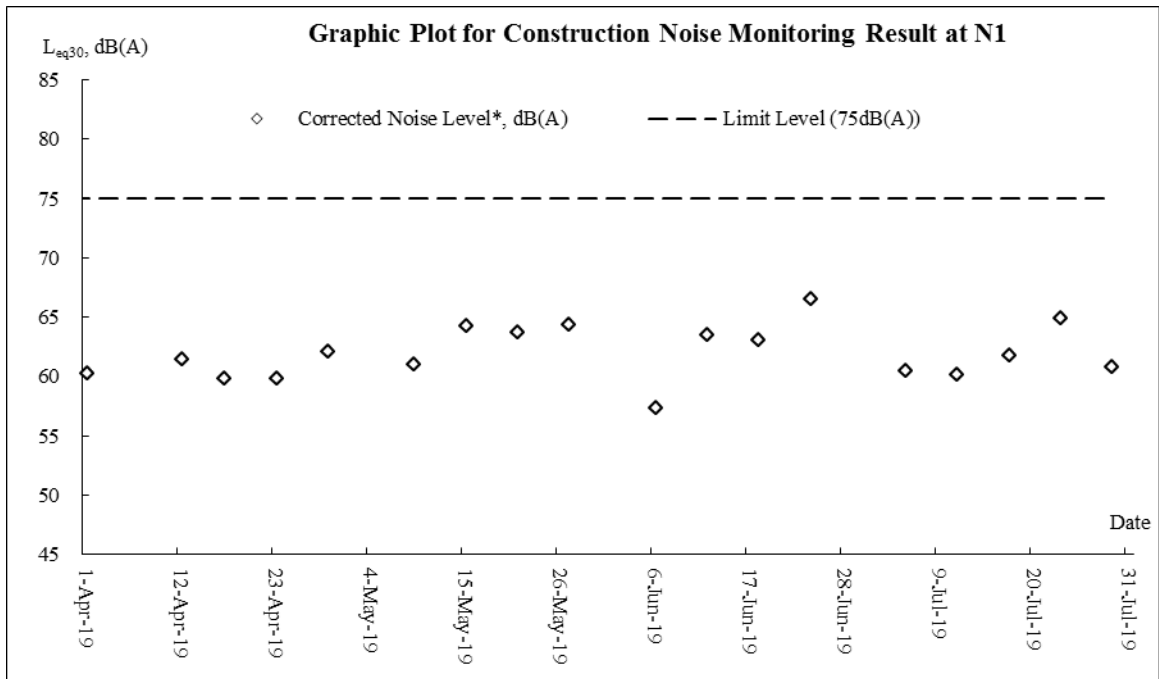
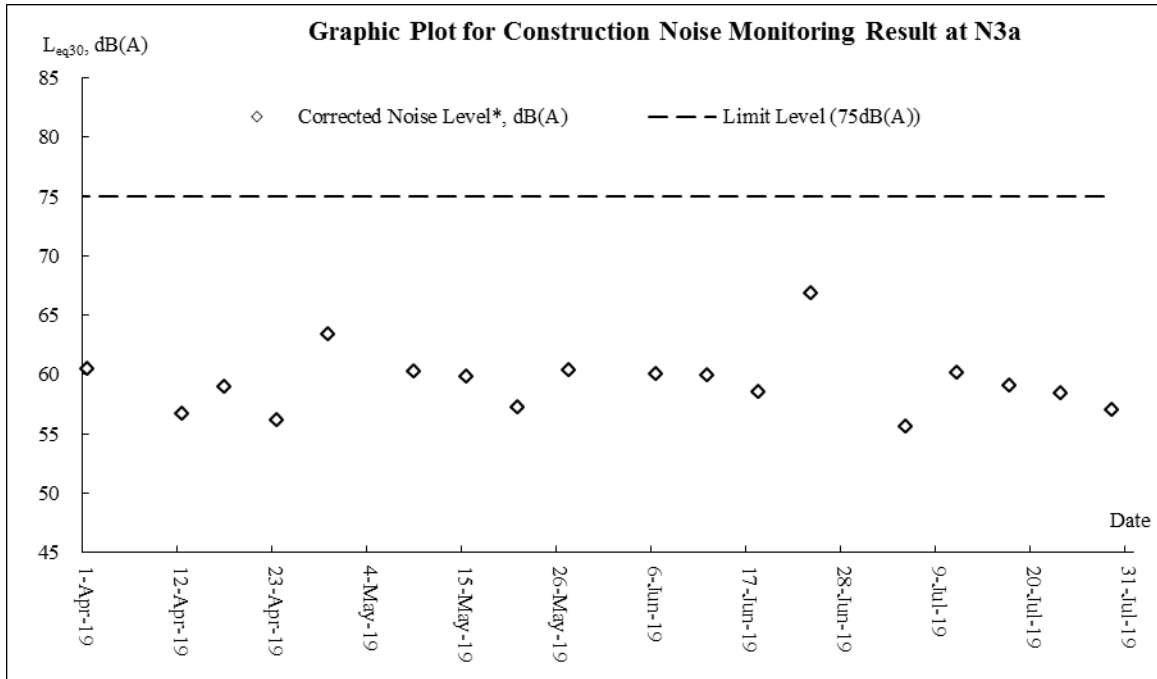
Construction Noise

5.2.2 As shown in [Table 5-1 to Table 5-4](#), all the designated locations measured results were below 75dB(A) of the acceptance criteria. Furthermore, no complaint on construction noise was registered, indicating no exceedance of Action Level. No non-compliance was therefore found during the Reporting Period.

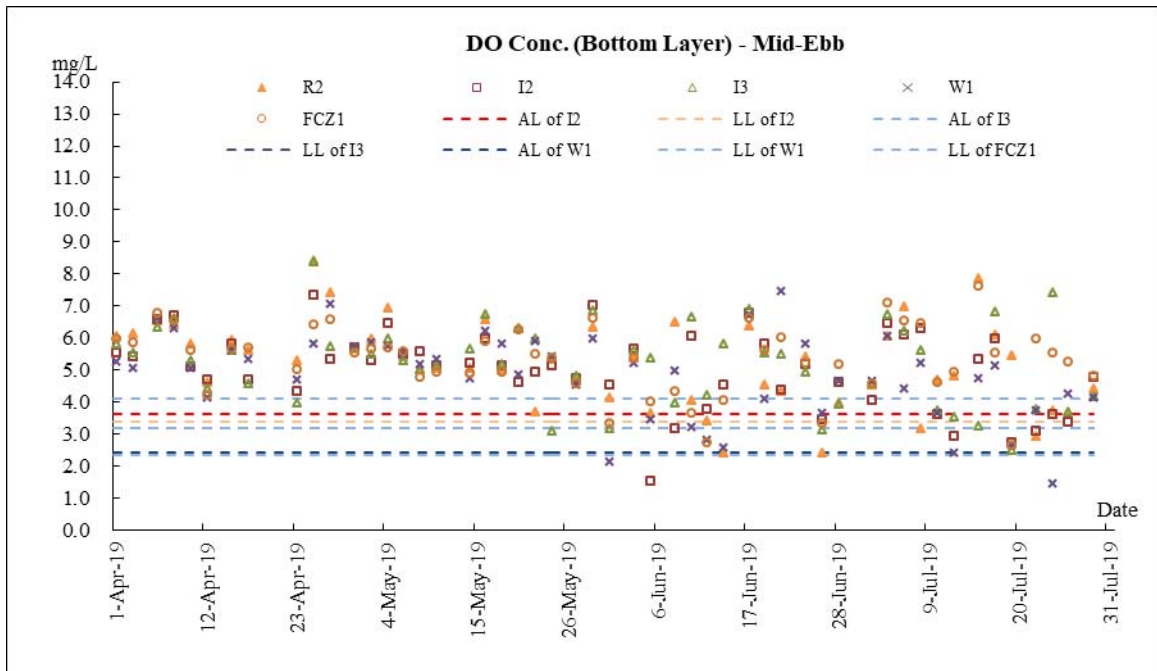
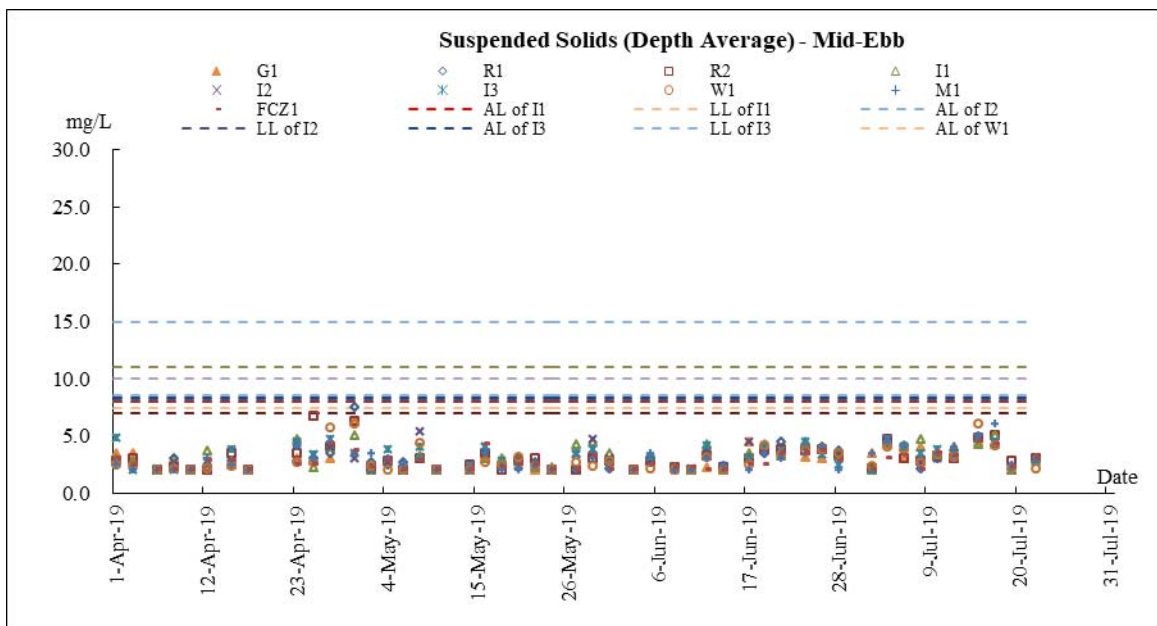
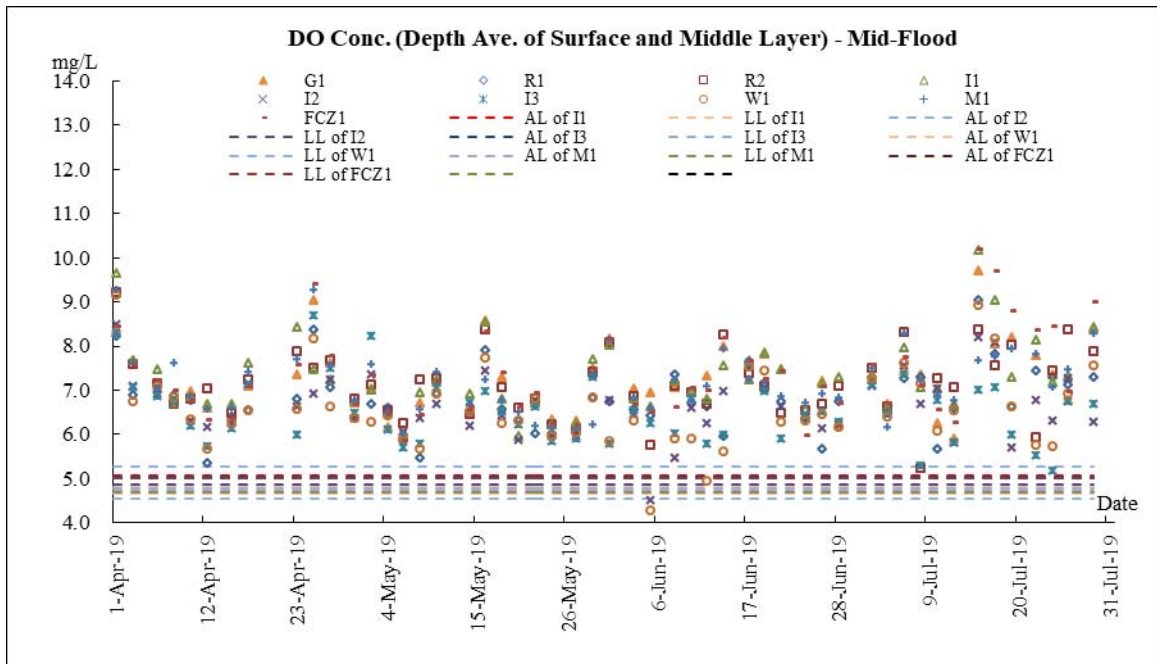
Water Quality

- 6.3.3 As reported by the sampling team, no abnormal and turbid discharge was observed made from the construction site during the course of marine water quality monitoring. Having reviewed the monitoring result, it is noted that the exceeded values of turbidity and SS were generally lower than the AL derived from the baseline. Moreover, all the measured turbidity and SS levels were within respective range of baseline. For the DO exceedances, since the baseline was obtained

during dry season, it is considered that the DO exceedances were related to the seasonal change. With the implementation of silt curtain, no abnormal / elevated reading of turbidity and SS were recorded, it is considered that the exceedances were unlikely caused by the works under the project.
