CEDD CONTRACT NO. CV/2012/05
DEVELOPMENT OF A BATHING BEACH AT LUNG MEI,
TAI PO

8TH QUARTERLY ENVIRONMENTAL MONITORING AND
AUDIT SUMMARY REPORT (SEPTEMBER –
NOVEMBER 2019)

PREPARED FOR
WELCOME CONSTRUCTION CO., LTD

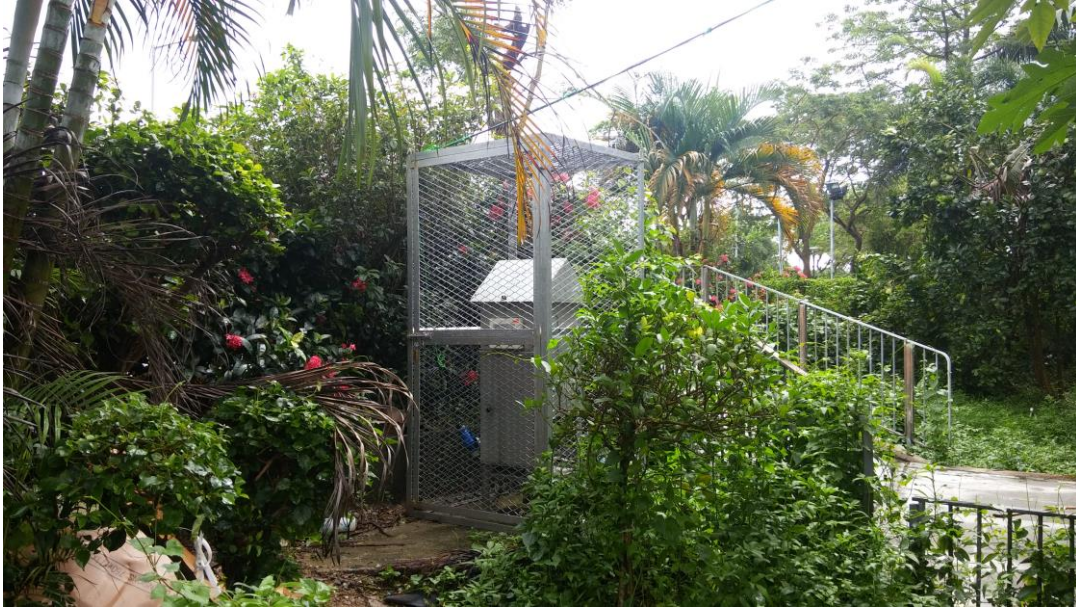
A4

Air Quality Monitoring (24-Hour TSP & 1-Hour TSP)

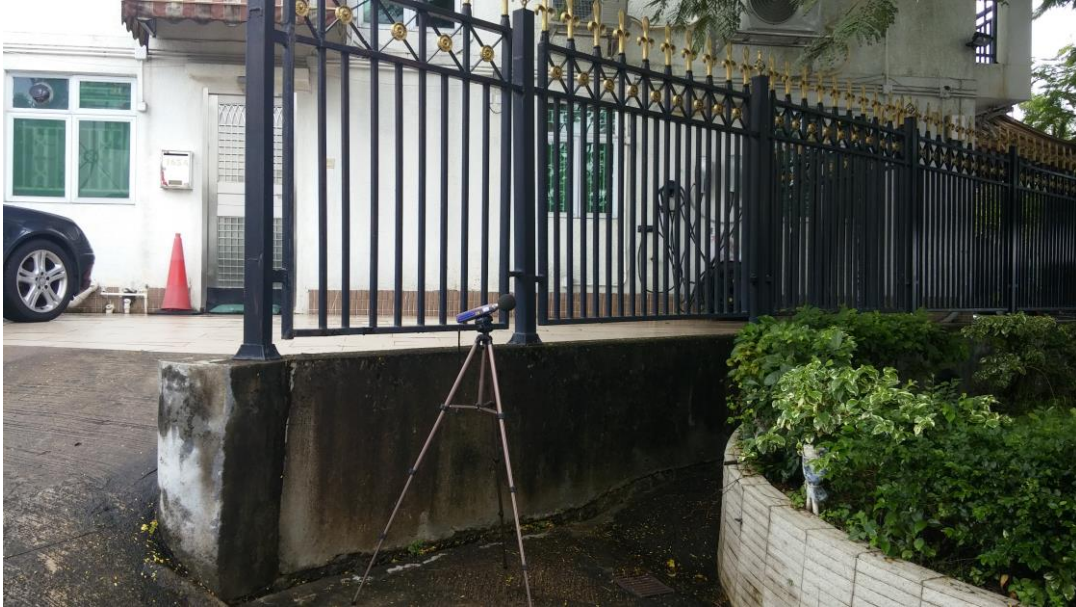
N1

Noise Monitoring

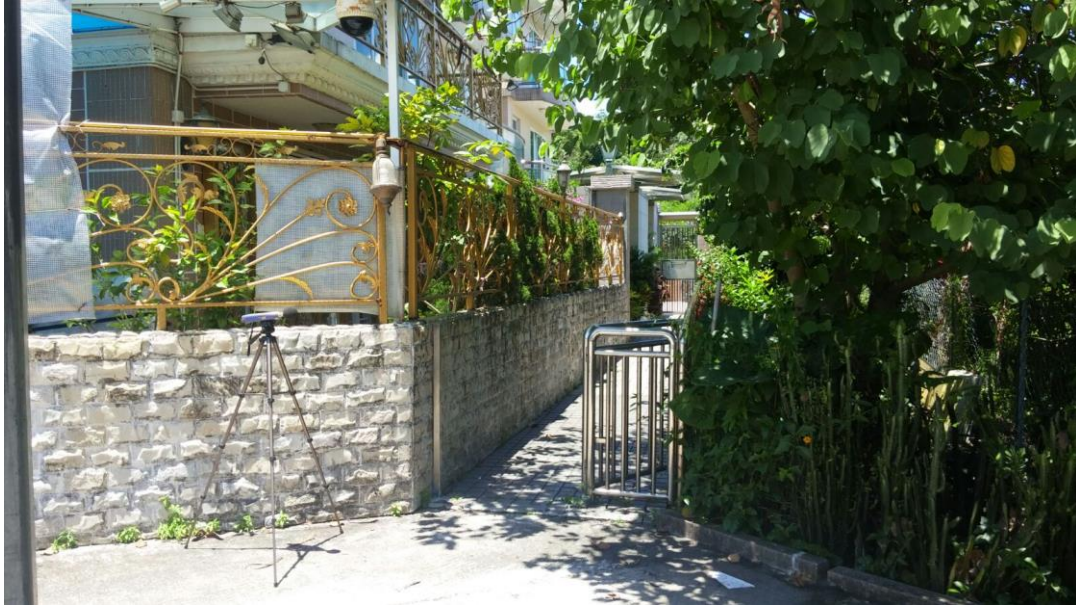
N3a

Noise Monitoring

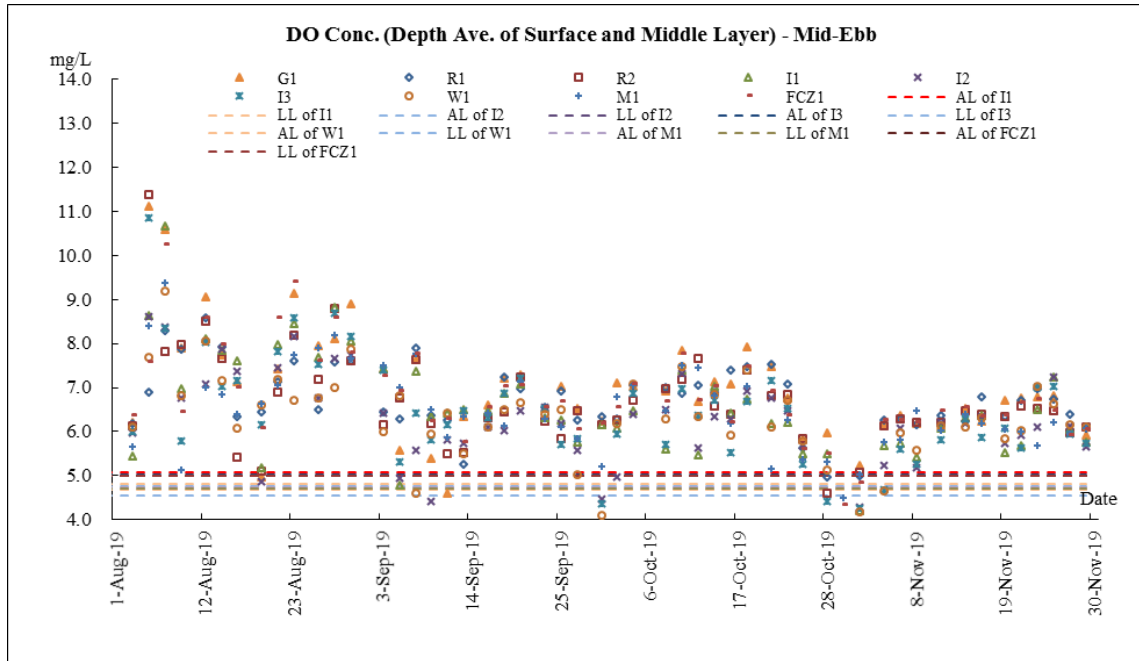
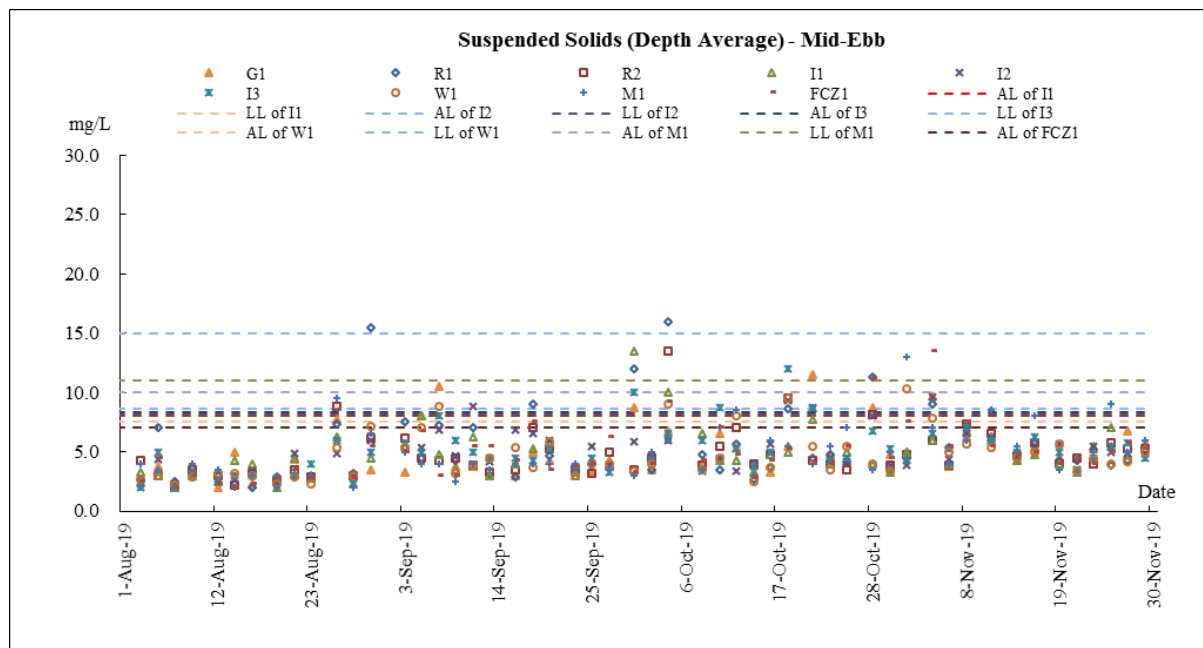
Water Quality

6.3.1 According to Section 11.7 of the EM&A Manual, an assessment of the construction impacts on SS by a comparison of the difference between the quarterly mean and the 1.3 times the ambient mean value (defined as a 30% increase of the baseline data) was conducted. The analytical result presented in *Table 6-7* demonstrated that “quantity mean is significantly higher than the 1.3 ambient mean values” was observed at Impact Station I1 and I2.
