JOB No.: TCS00874/16

CEDD CONTRACT NO. CV/2012/05
DEVELOPMENT OF A BATHING BEACH AT LUNG MEI,
TAI PO

MONTHLY ENVIRONMENTAL MONITORING AND AUDIT
REPORT (OCTOBER 2019)

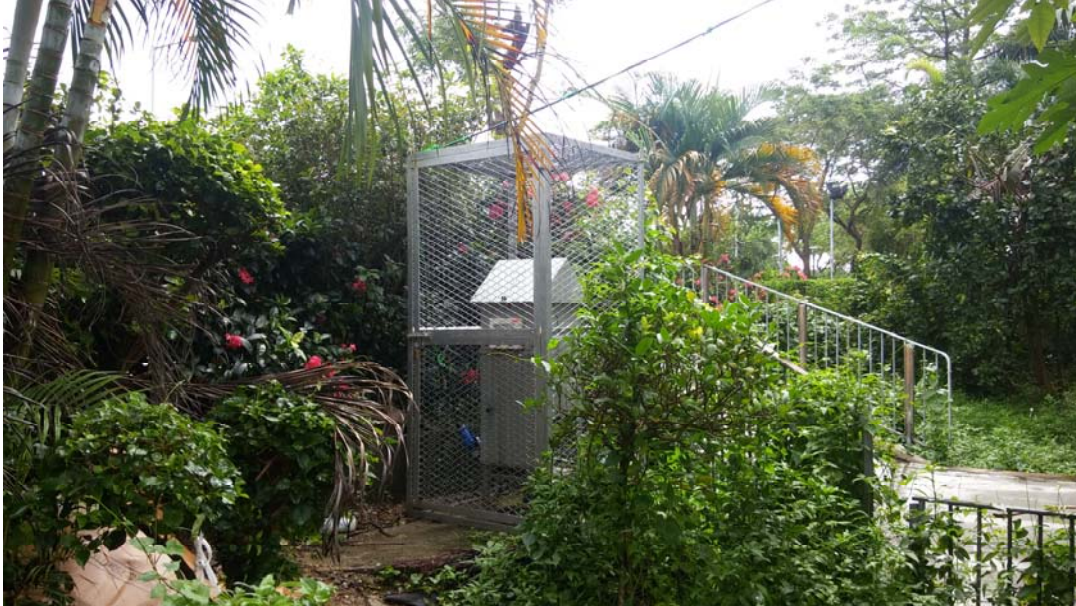
A4

Air Quality Monitoring (24-Hour TSP & 1-Hour TSP)

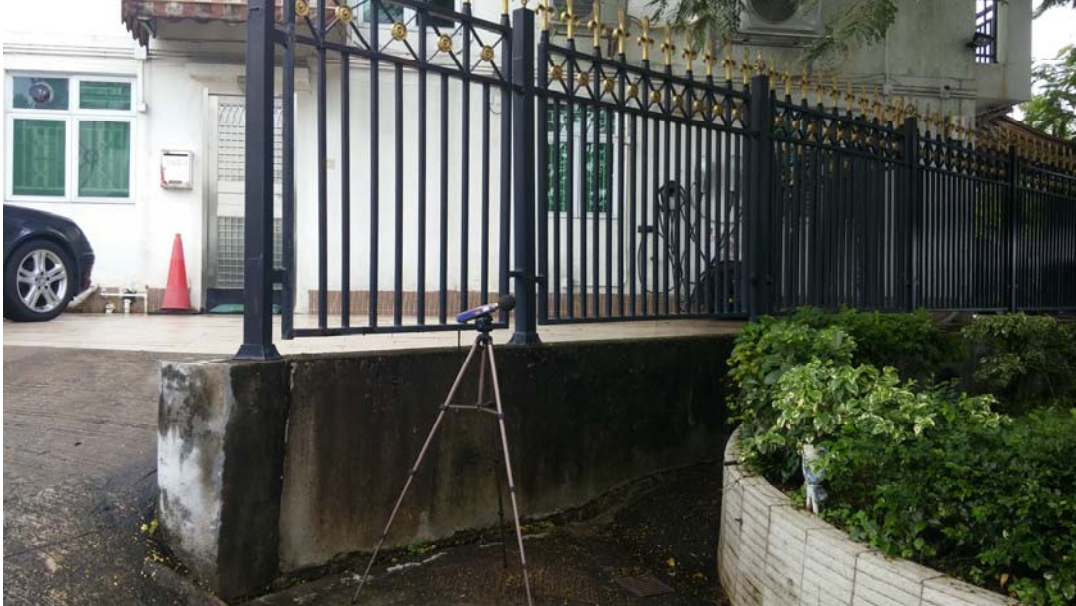
N1

Noise Monitoring

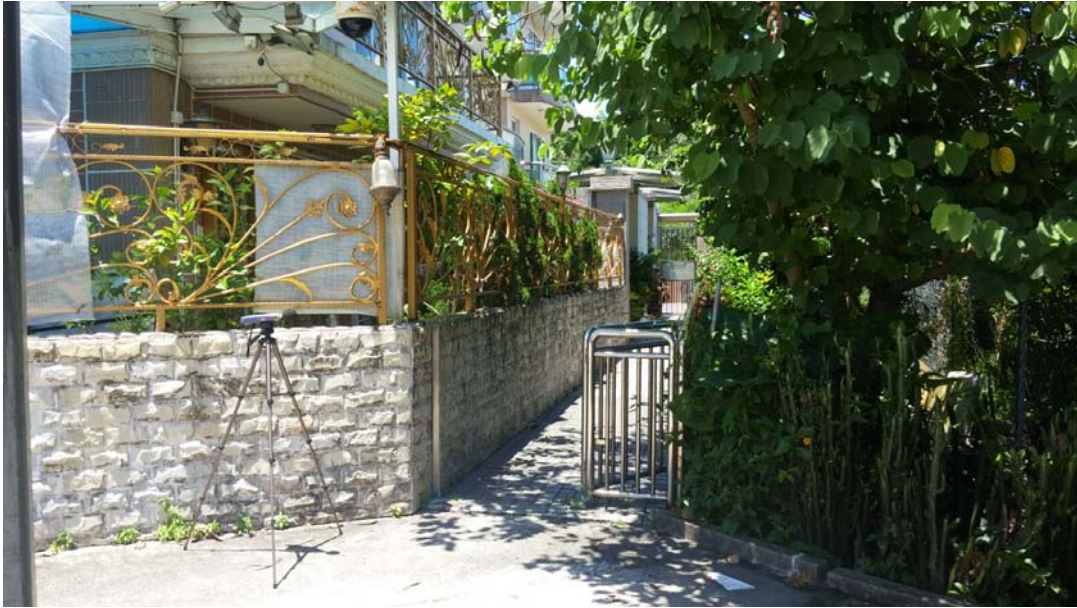
N3a

Noise Monitoring

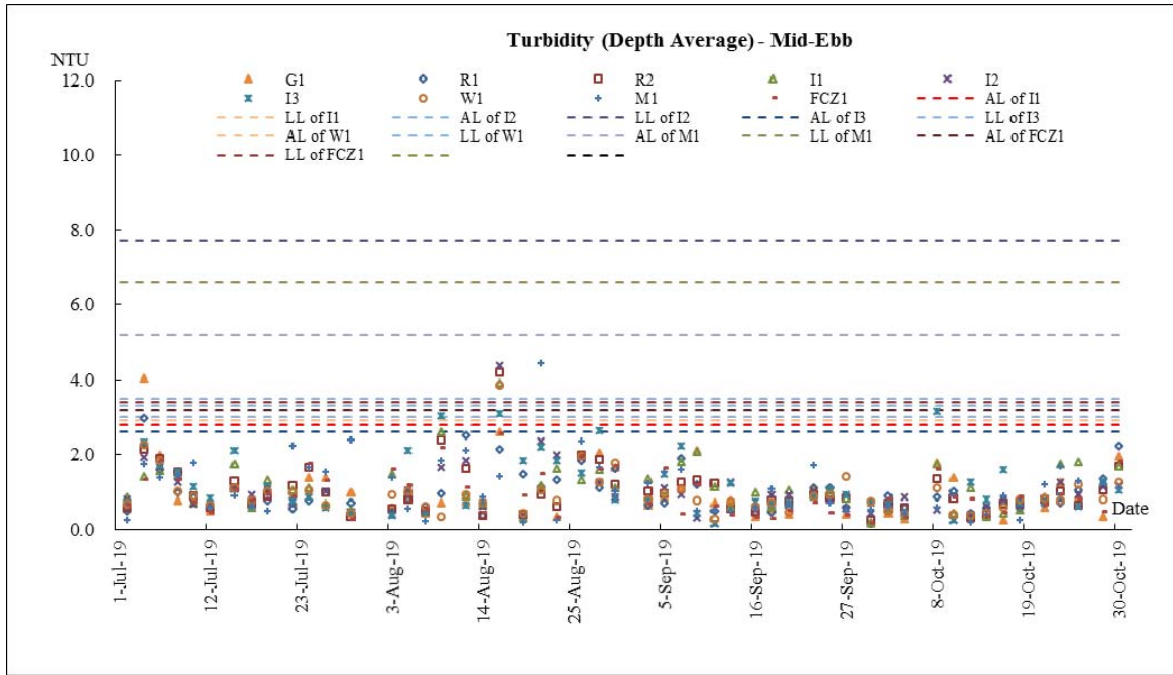
Water Quality

- 12.1.4 In this Reporting Period, there were total of 202 exceedances recorded, included 53 AL/LL exceedance of Dissolved Oxygen, 79 AL/LL exceedances of Turbidity and 70 AL/LL exceedances of Suspended Solids. As water quality mitigation measures, silt curtains were properly in place at locations in accordance with EP. During the course of marine water quality monitoring, no abnormal and turbid discharge made from the construction site was observed. With the implementation of silt curtain, no abnormal / elevated reading of suspended solids and turbidity were recorded, it is considered that the exceedances were unlikely caused by the works under the project. For the DO exceedances, since the baseline was obtained during dry season, it is consideration that the DO exceedances were related to the seasonal change.
