CEDD CONTRACT NO. CV/2012/05
DEVELOPMENT OF A BATHING BEACH AT LUNG MEI,
TAI PO

MONTHLY ENVIRONMENTAL MONITORING AND AUDIT
REPORT (NOVEMBER 2019)

PREPARED FOR
WELCOME CONSTRUCTION CO., LTD

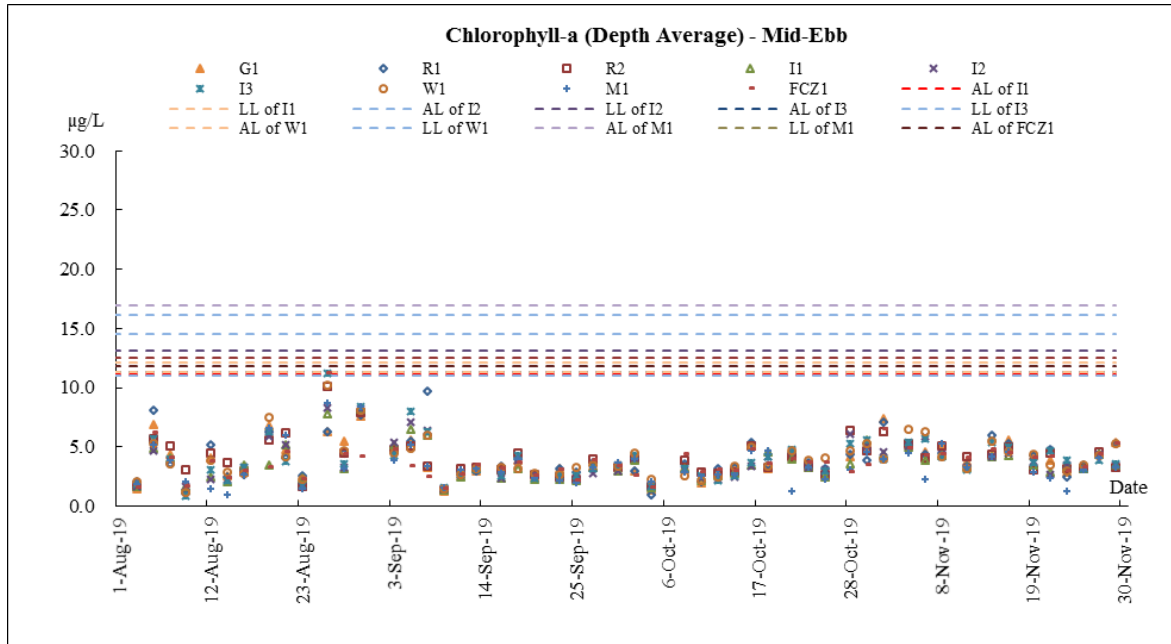
Water Quality

- 12.1.4 In this Reporting Period, there were total of 142 exceedances recorded, included 20 AL/LL exceedance of Dissolved Oxygen, 73 AL/LL exceedances of Turbidity and 49 AL/LL exceedances of Suspended Solids. As water quality mitigation measures, silt curtains were properly in place at locations in accordance with EP. During the course of marine water quality monitoring, no abnormal and turbid discharge made from the construction site was observed. With the implementation of silt curtain, no abnormal / elevated reading of suspended solids and turbidity were recorded, it is considered that the exceedances were unlikely caused by the works under the project. For the DO exceedances, since the baseline was obtained during dry season, it is consideration that the DO exceedances were related to the seasonal change.
