CEDD CONTRACT NO. CV/2012/05
DEVELOPMENT OF A BATHING BEACH AT LUNG MEI,
TAI PO

MONTHLY ENVIRONMENTAL MONITORING AND AUDIT
REPORT (JANUARY 2020)

PREPARED FOR
WELCOME CONSTRUCTION CO., LTD

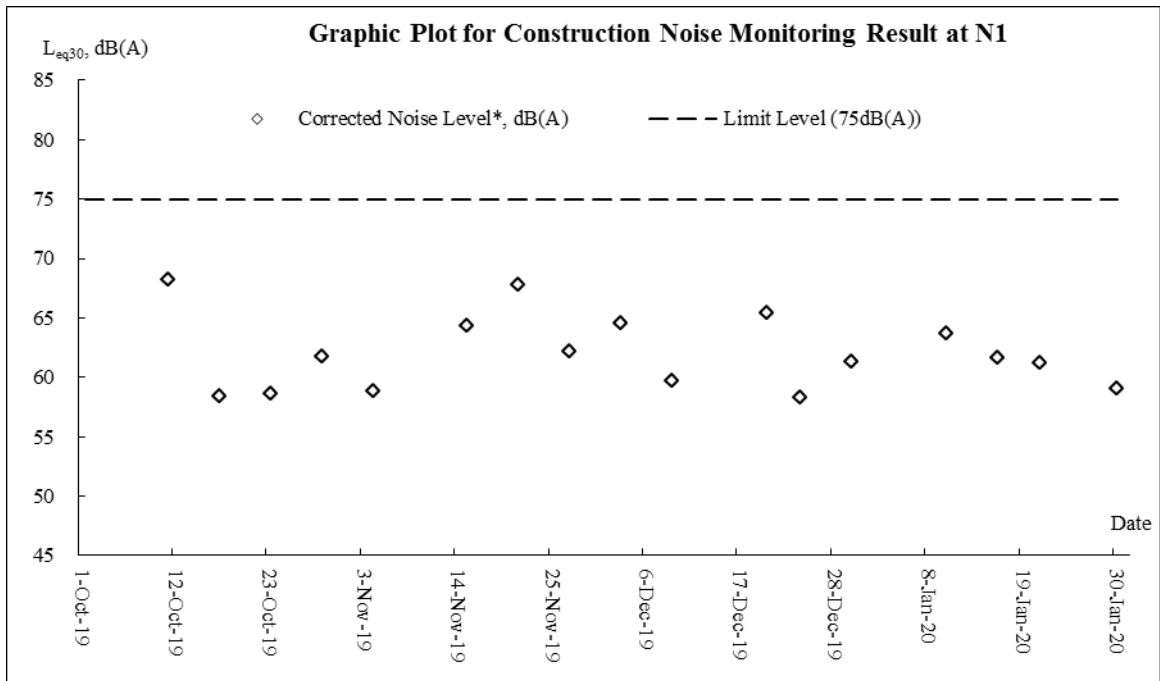
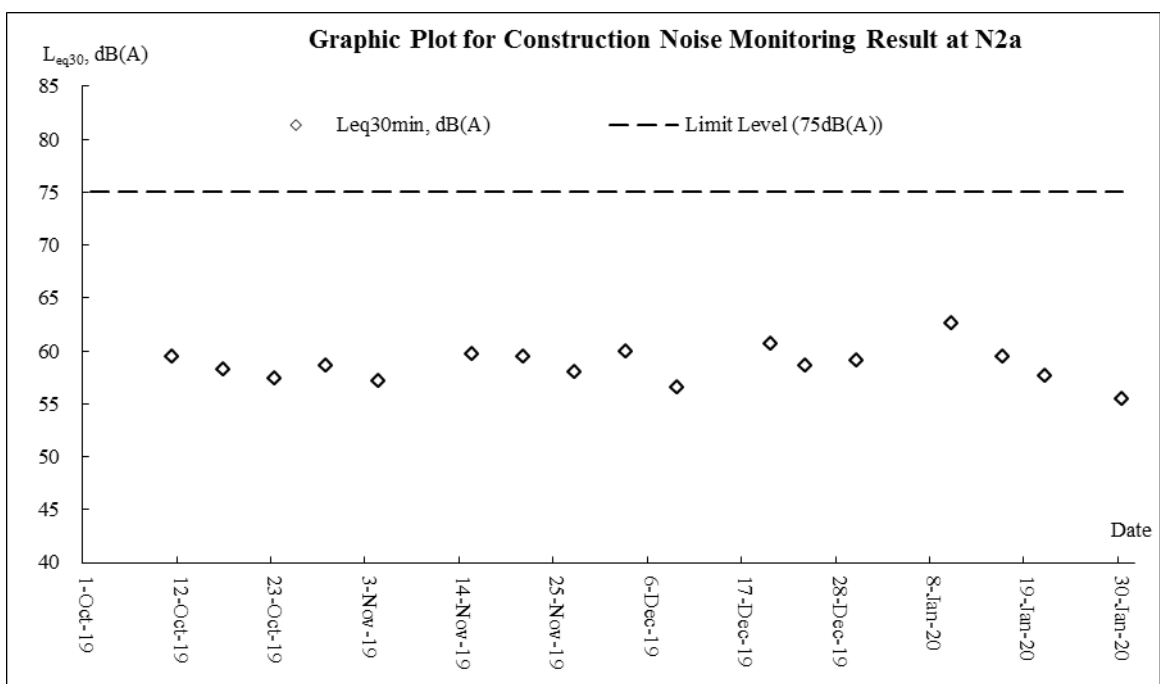
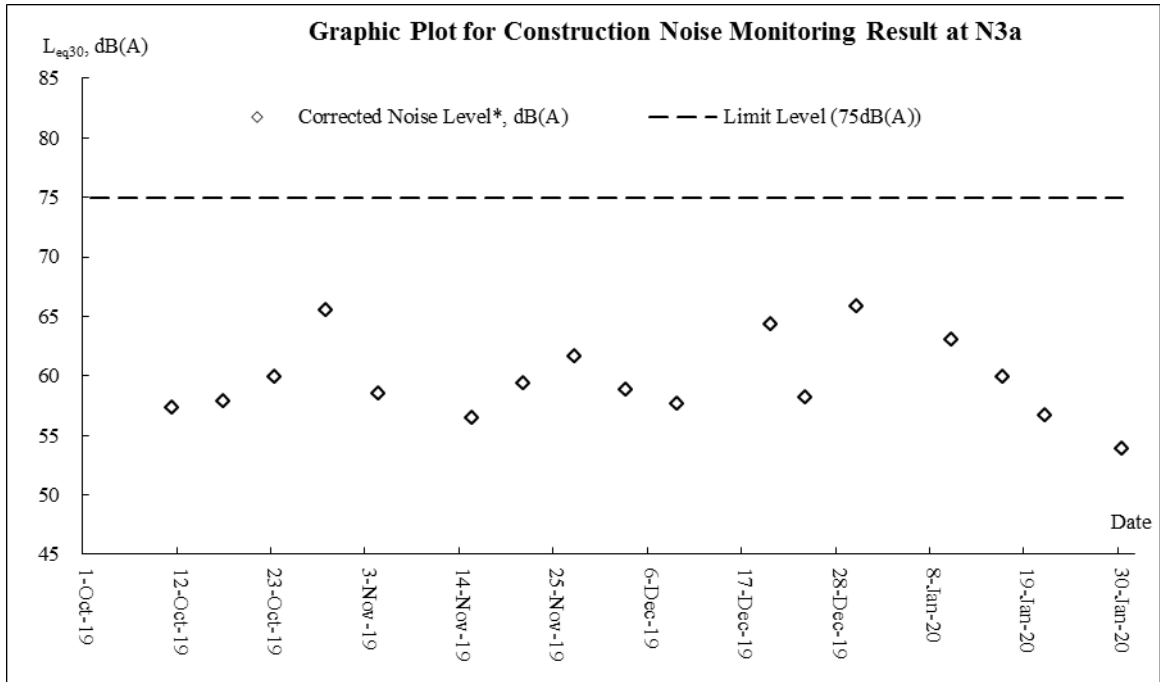
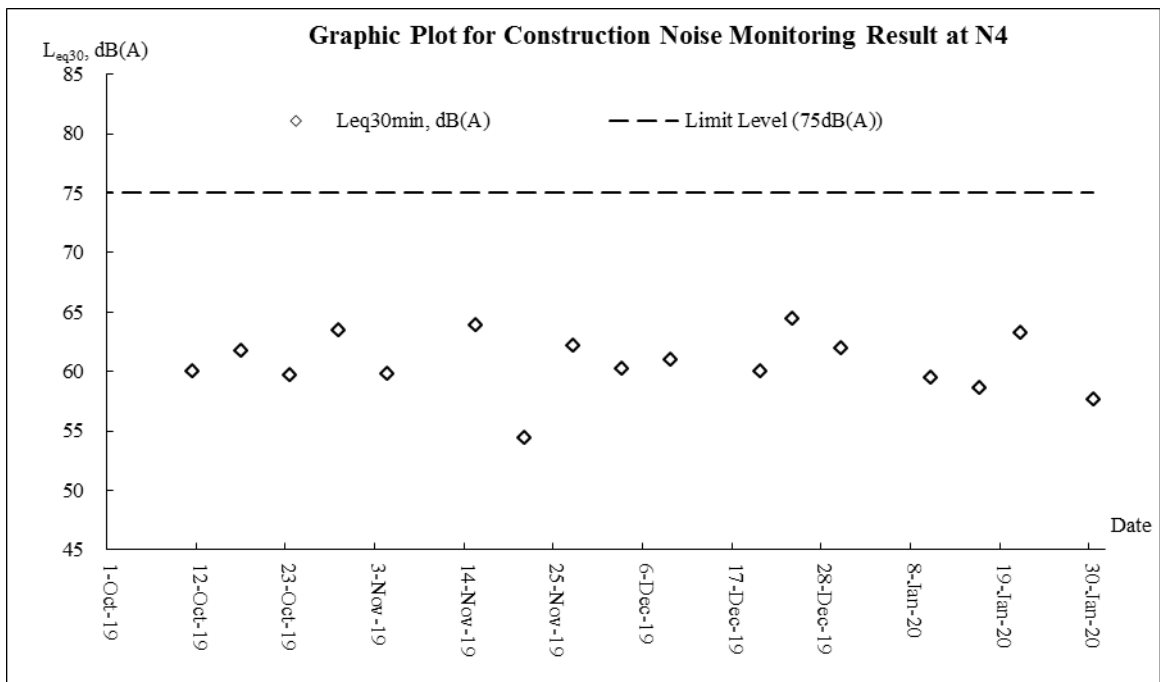
Construction Noise

5.2.2 As shown in [Table 5-1 to Table 5-4](#), all the designated locations measured results were below 75dB(A) of the acceptance criteria. Furthermore, no complaint on construction noise was registered, indicating no exceedance of Action Level. No non-compliance was therefore found during the Reporting Period.

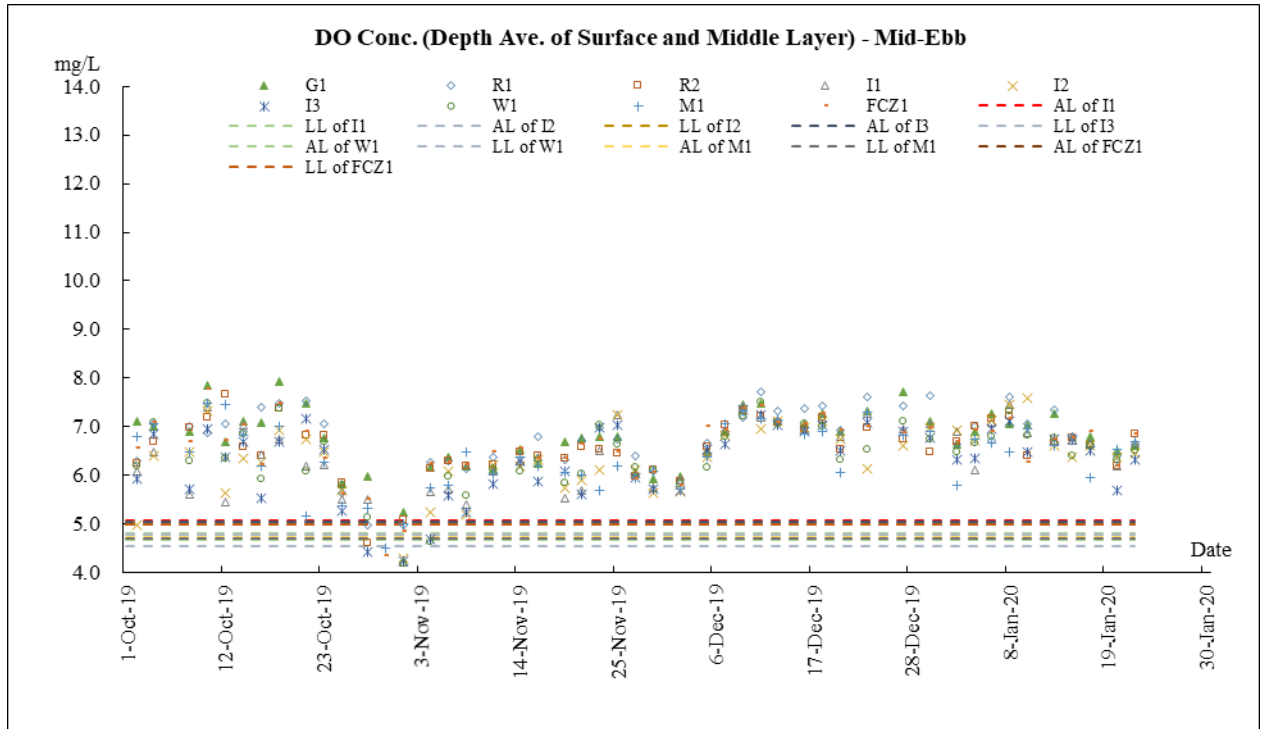
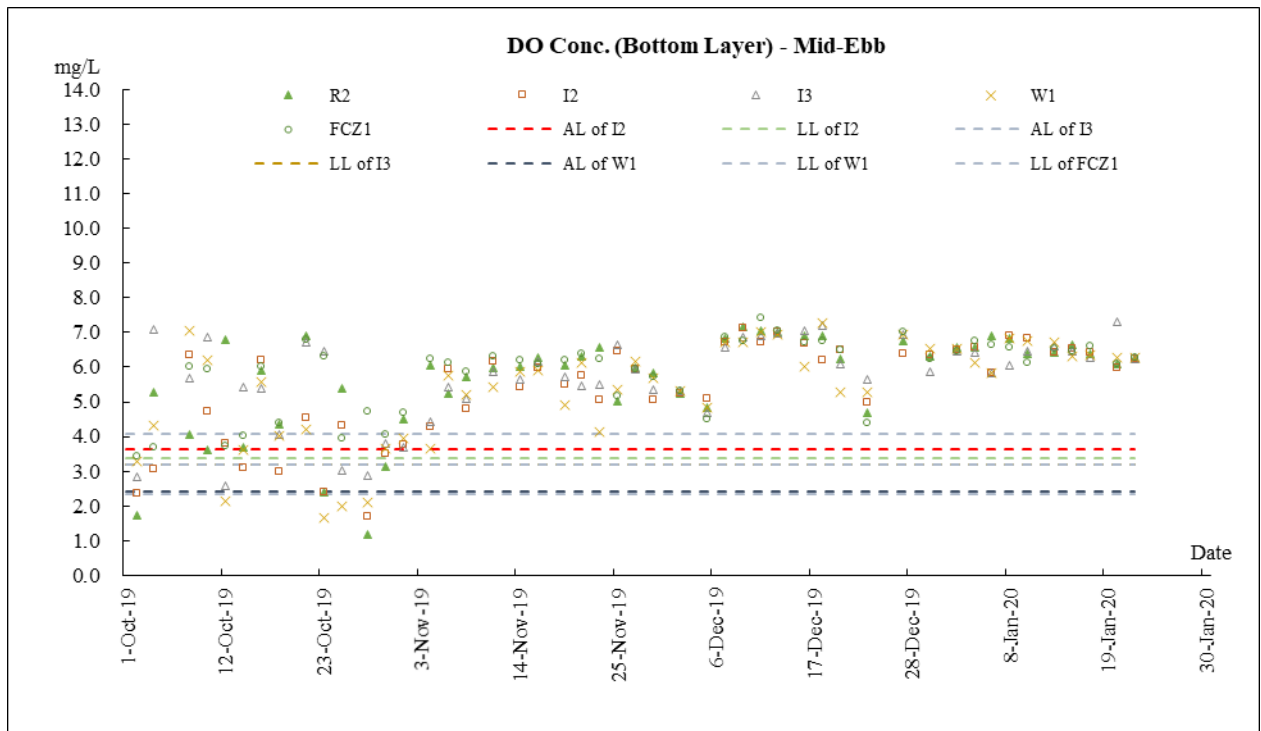
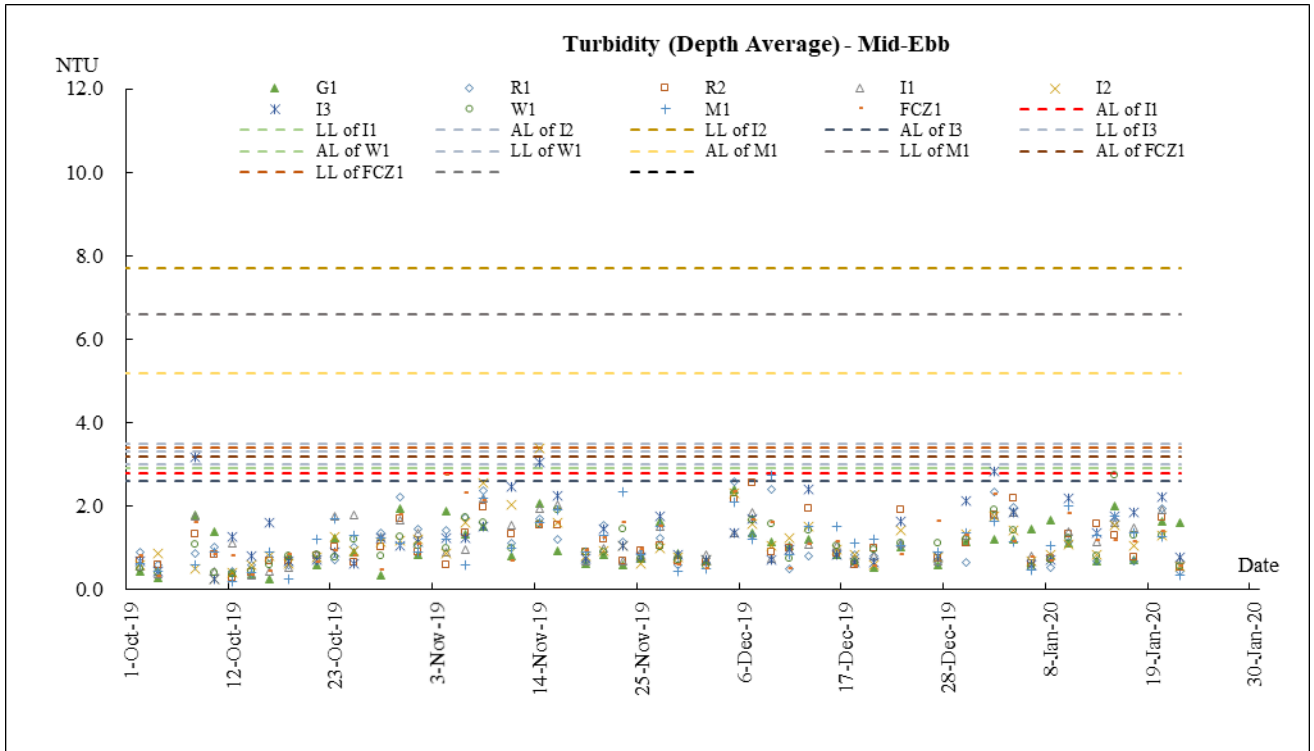
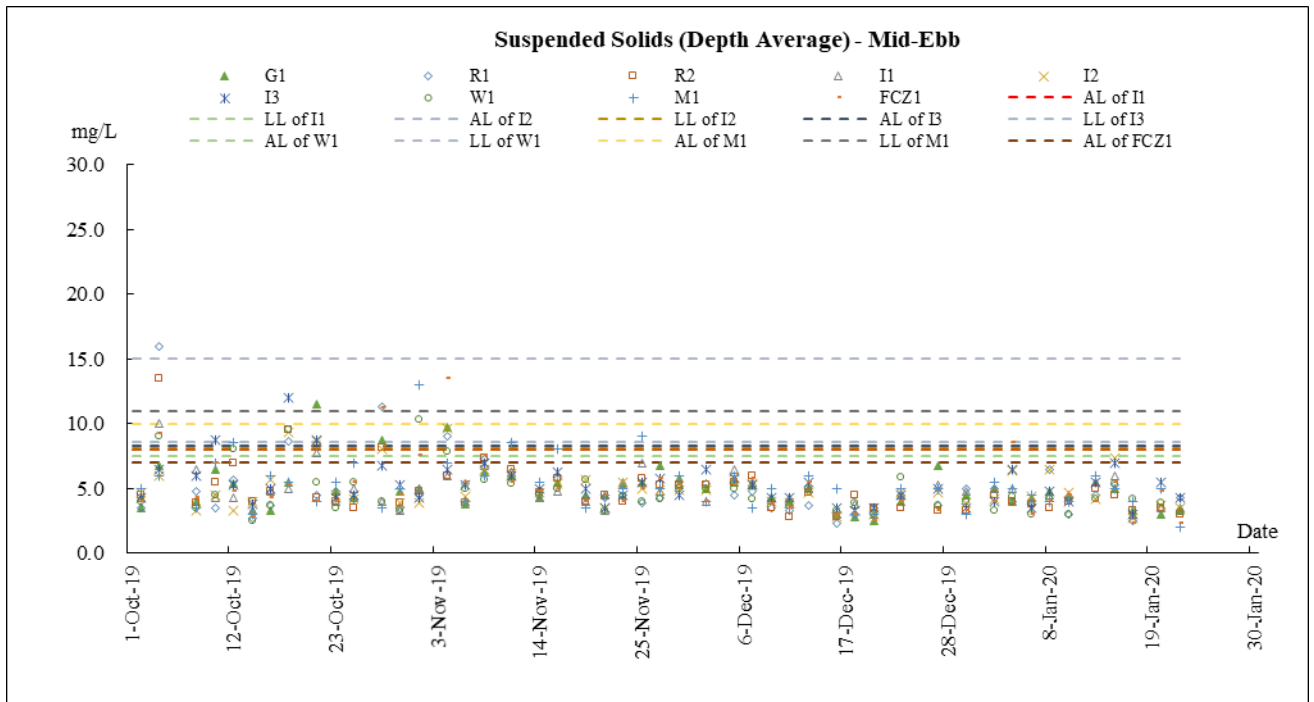
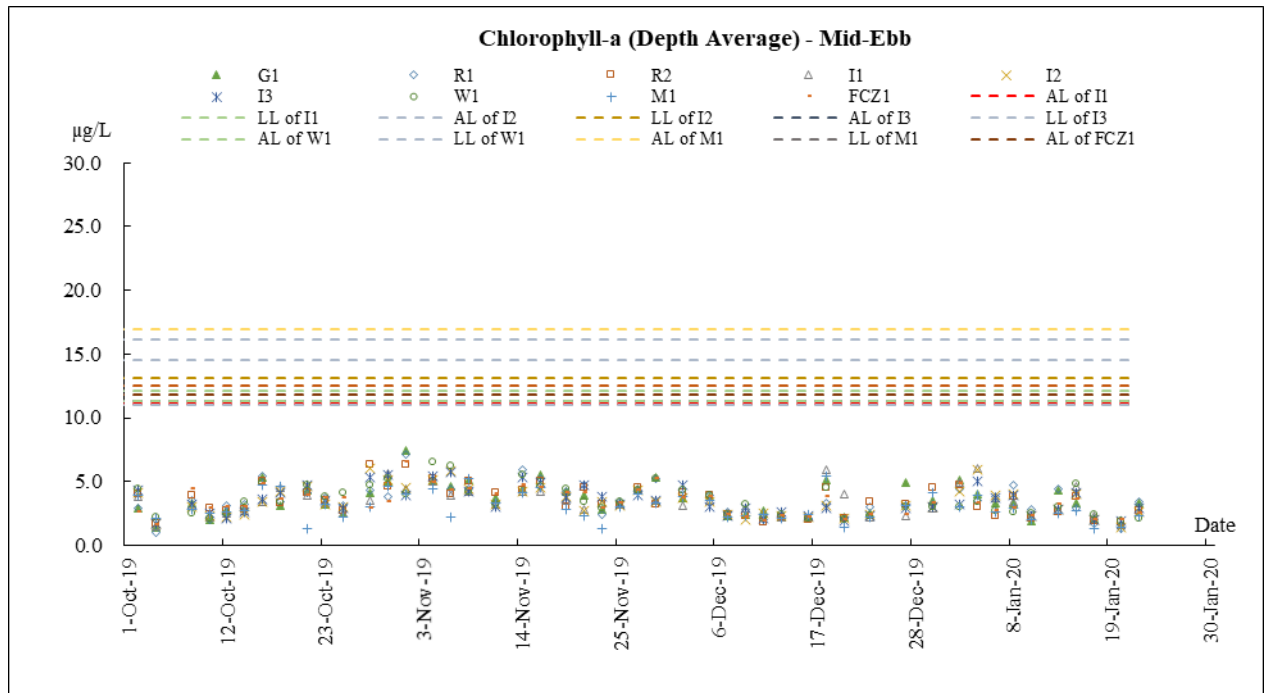
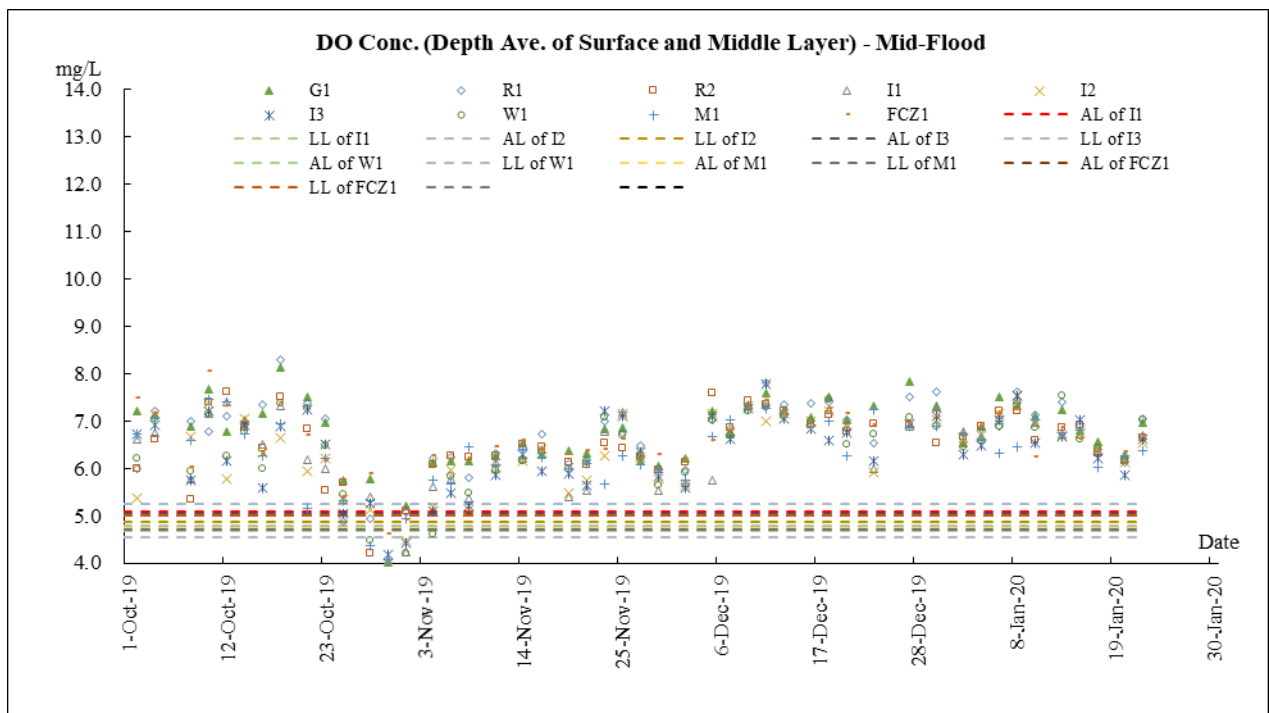
Water Quality

- 6.3.3 Having assessed the monitoring results, it is noted that the elevated suspended solids and turbidity results which exceeded the environmental performance criteria were generally within the respective range of baseline, except for the results of SS at IS1 and IS2 on 15 January 2020 which slightly over the baseline. In view of the site activities and status of water quality mitigation measures, it is considered that the two (2) exceedances of SS recorded during mid-flood on 15 January 2020 were likely related to the works under the project. For the rest of exceedances recorded in the Reporting Period, they are comparable to the baseline and previous months and considered as non-project related. As additional measures for sand stockpiling, the Contractor immediately repaired and set up the silt curtain properly according to the EP. In view of the upcoming sand filling activities, the Contractor was strongly reminded to follow the water quality mitigation measures as stipulated in the EP.
