CEDD CONTRACT NO. CV/2012/05
DEVELOPMENT OF A BATHING BEACH AT LUNG MEI,
TAI PO

MONTHLY ENVIRONMENTAL MONITORING AND AUDIT
REPORT (FEBRUARY 2020)

Environmental Permit No. EP-388/2010

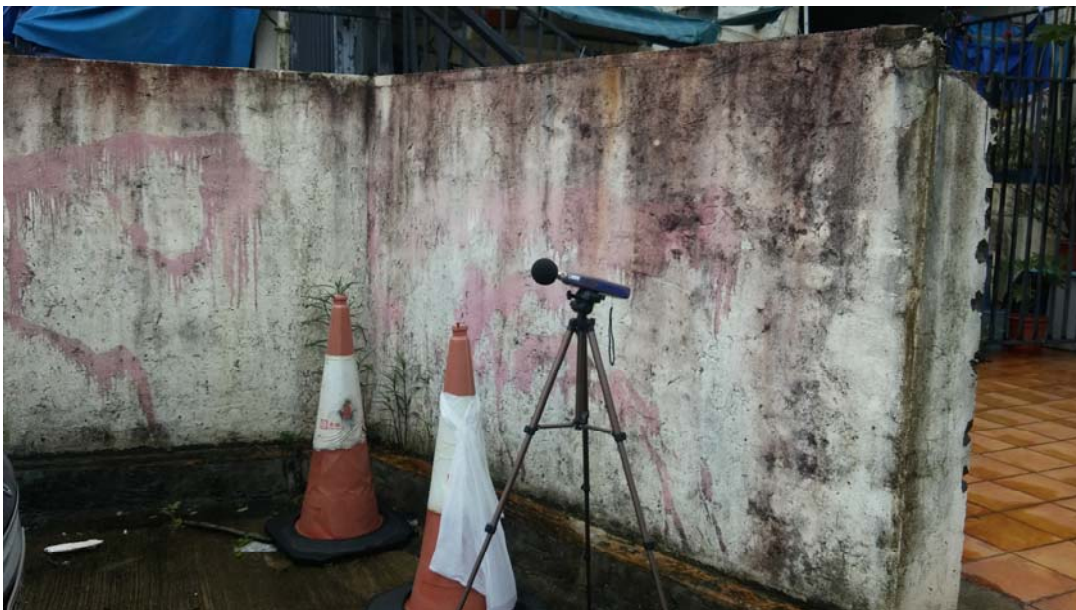
3.3.3 As confirmed on the first day of baseline monitoring, N2a (House no. 101 Lung Mei) has been changed to residential use. Therefore, the noise monitoring is conducted at N2a and to replace N2. Moreover, due to the lack of accessibility of noise monitoring at N3 (Village house – No. 70 Lo Tsz Tin), alternative location was proposed to replace N3 to carry out the noise monitoring. Having reviewed the surrounding condition, N3a (Village house – No. 66C Lo Tsz Tin) was proposed with the rationales summarized in below.

Noise Monitoring

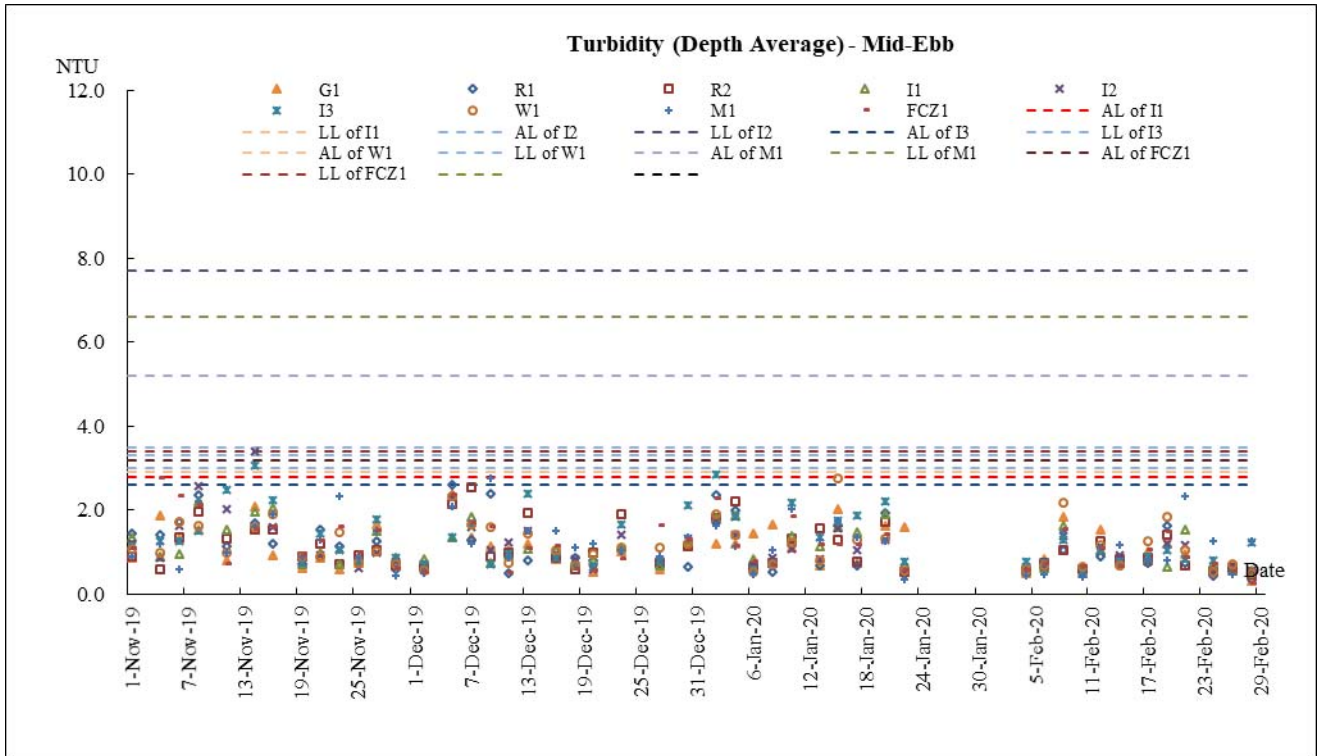
Water Quality

- 12.1.4 In this Reporting Period, there were total of 106 exceedances recorded, included 58 AL/LL exceedances of Turbidity and 48 AL/LL exceedances of Suspended Solids. The Contractor advised that there were no marine works (dredging and sand filling) carried out during the Reporting Period and only rock filling above sea level at East Groyne was conducted. As water quality mitigation measures, silt curtain at Eastern Box Culvert was properly installed whereas the broken silt curtain between East Groyne and West Groyne has been reinstated in late February 2020. Having assessed the monitoring results, it is noted that the apart from a SS result recorded at sensitive receiver station W1, all elevated suspended solids and turbidity results which exceeded the environmental performance criteria were generally within the respective range of baseline, it is considered that the exceedances were unlikely caused by the works under the project.
