CEDD CONTRACT NO. CV/2012/05  
DEVELOPMENT OF A BATHING BEACH AT LUNG MEI,  
TAI PO

MONTHLY ENVIRONMENTAL MONITORING AND AUDIT  
REPORT (JUNE 2020)

PREPARED FOR  
WELCOME CONSTRUCTION CO., LTD

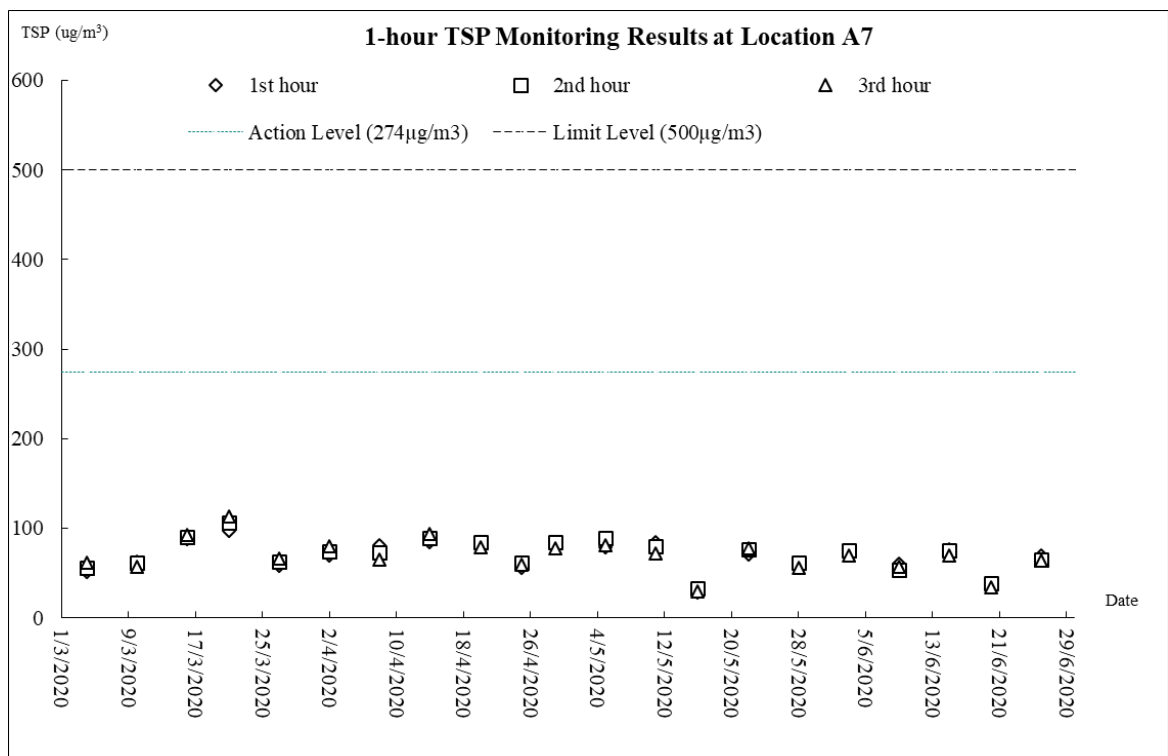
**Air Quality – 1-hour TSP**

4.2.1 In the Reporting Period, **5** sessions of 1-hour TSP and **5** sessions 24-hour TSP were performed at Stations A4 and A7. Due to damage to power cables for HVS at A4 and A7, monitoring was unable to carry out. Make up for lost sample will be conducted once power issue resolve. The monitoring results for air quality monitoring are summarized in [Tables 4-1 to 4-2](#). The detailed 24-hour TSP and 1-hour TSP monitoring data are presented in [Appendix H](#) and the relevant graphical plots are shown in [Appendix I](#). The meteorological data during the impact monitoring period are summarized in [Appendix J](#).

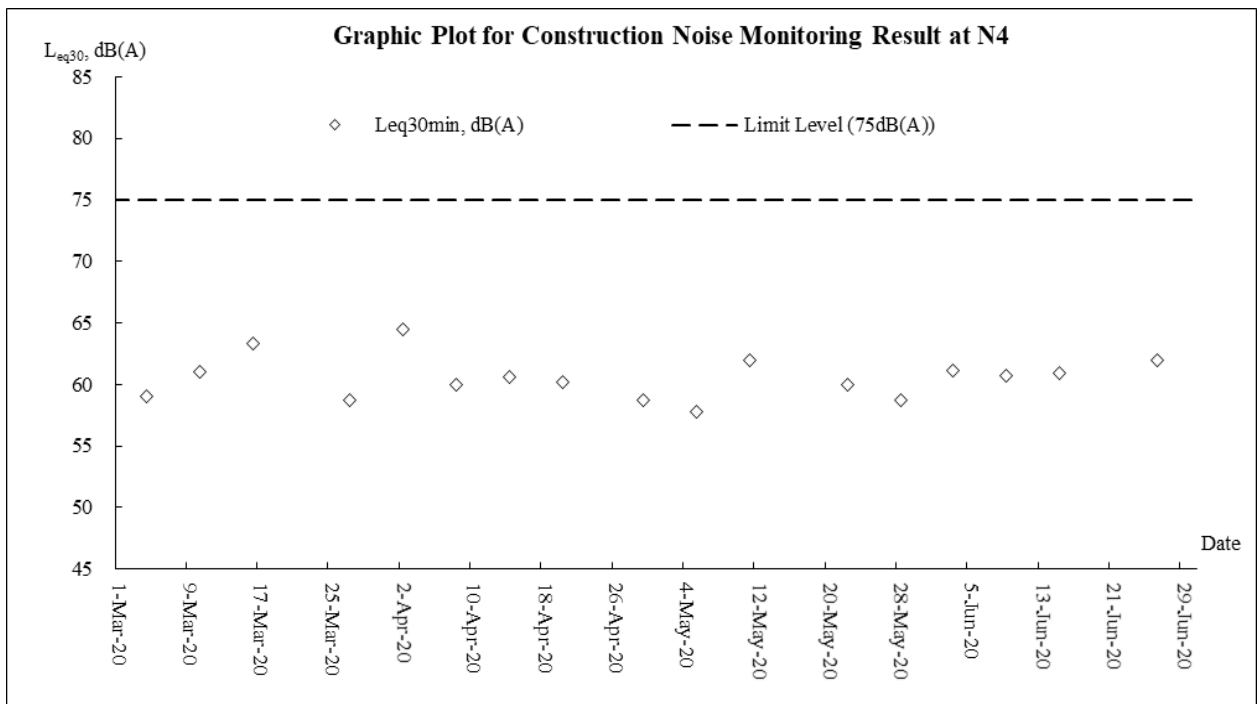
### Construction Noise

5.2.2 As shown in [Table 5-1 to Table 5-4](#), all the designated locations measured results were below 75dB(A) of the acceptance criteria. Furthermore, no complaint on construction noise was registered, indicating no exceedance of Action Level. No non-compliance was therefore found during the Reporting Period.

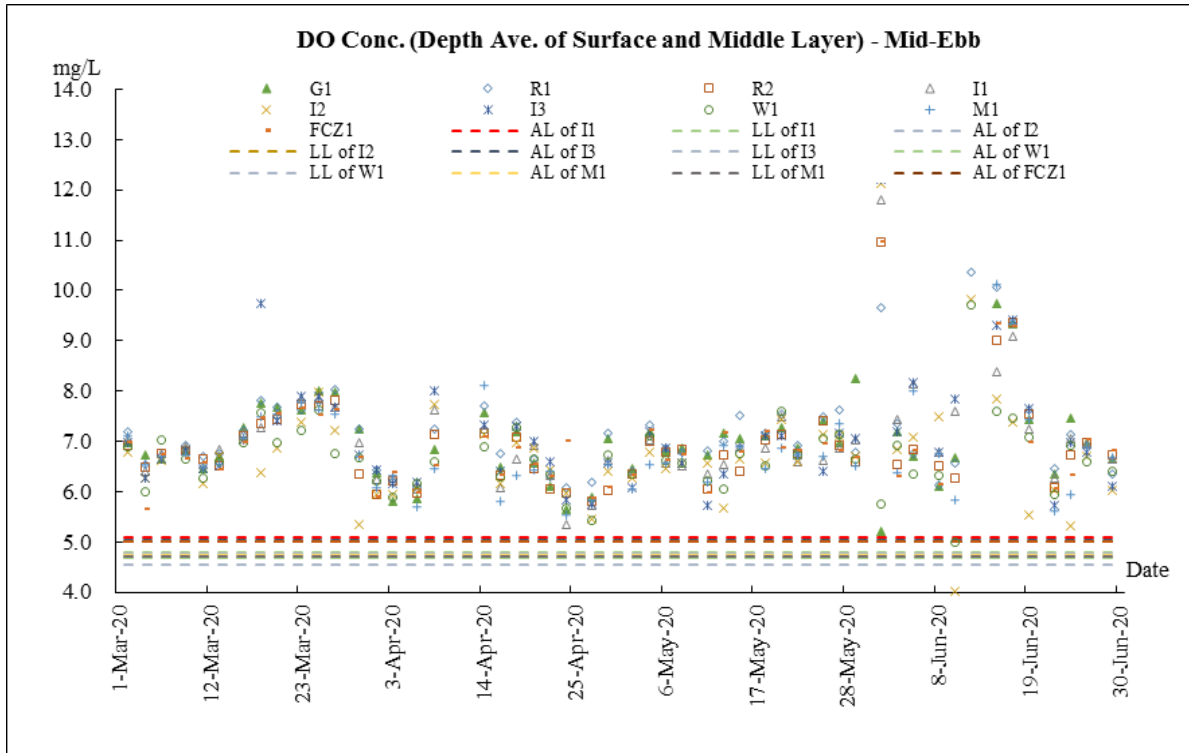
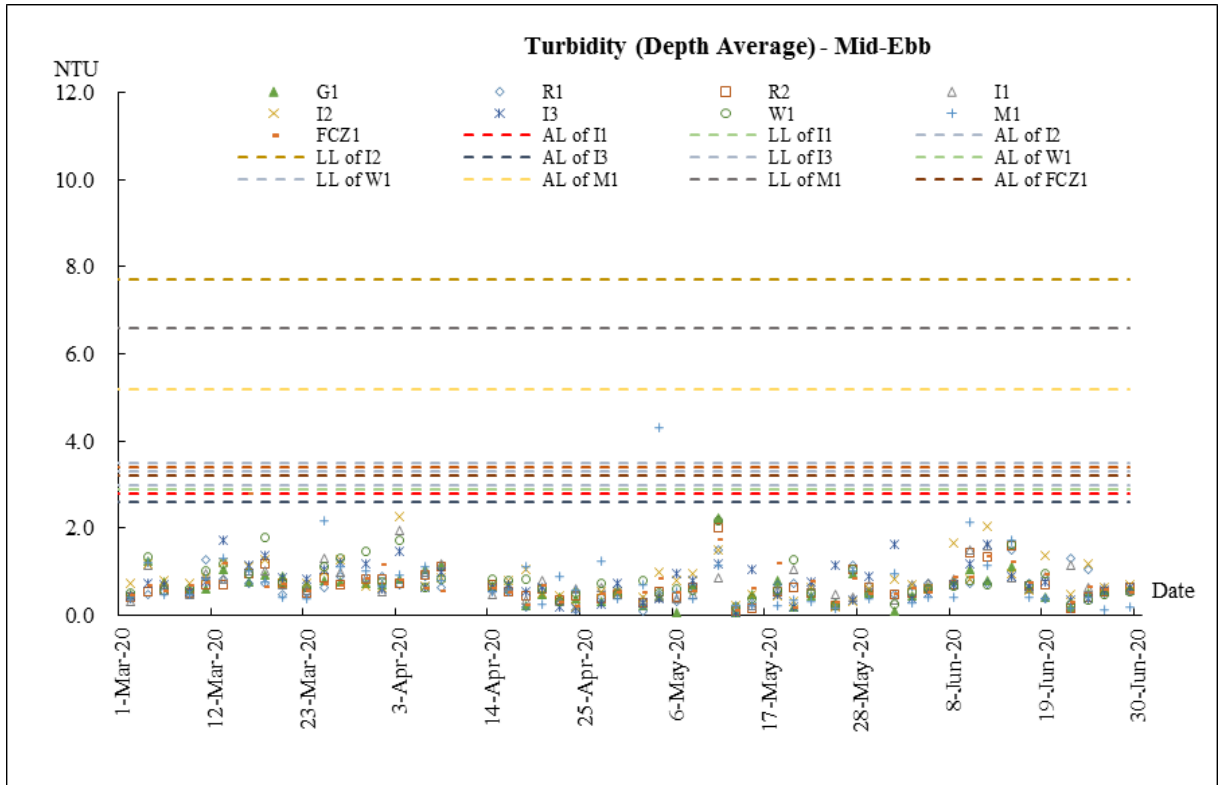
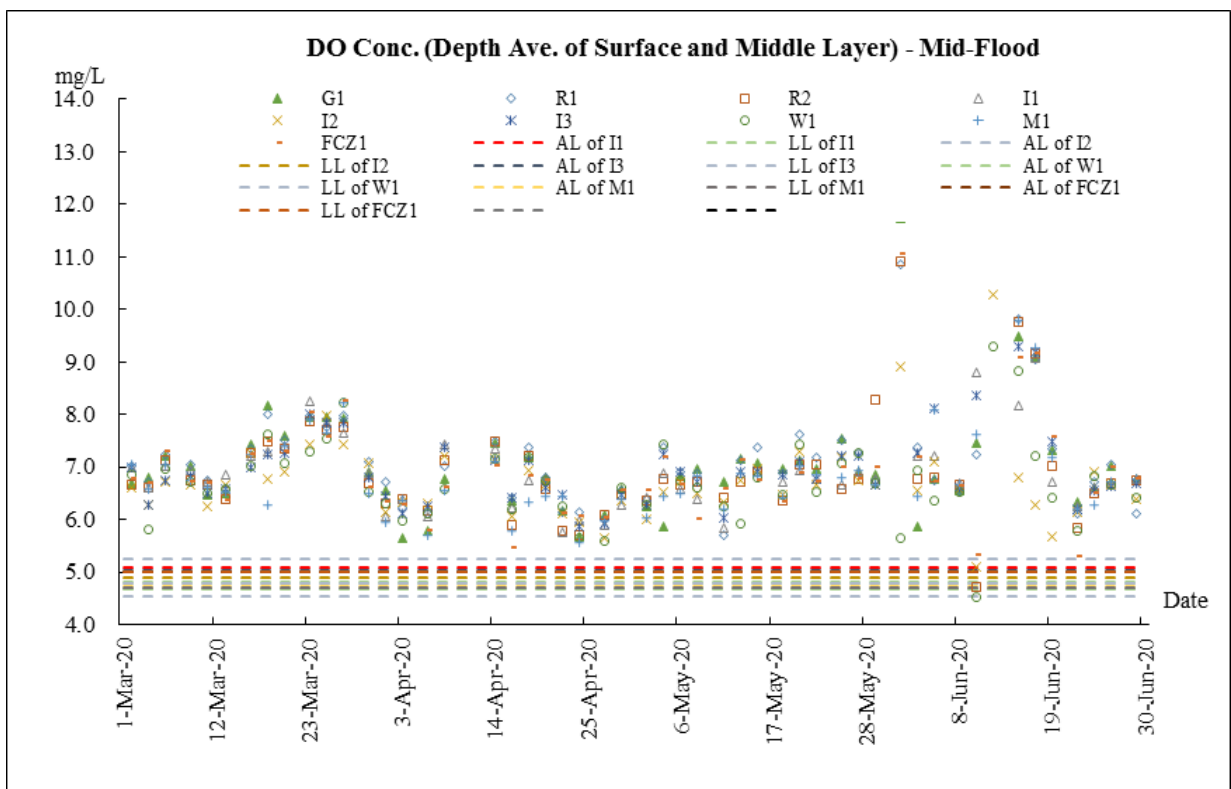
### Water Quality

- 6.3.3 Having assessed the monitoring results, special attention was paid on the elevated suspended solids levels observed on 8 June and it was likely related to the heavy rainstorm during the monitoring. Besides, it was noted that all the turbidity and SS results at Impact Stations were comparable to the baseline. For Chlorophyll-*a* exceedances, there were no marine dredging conducted and elevated Chlorophyll-*a* levels were also observed at Reference Stations, the Chlorophyll-*a* exceedances were likely related to natural variation. Besides, according to the past monitoring data, low levels of DO were recorded during summer period and it was considered that the exceedances of DO were caused by seasonal fluctuation.

- 6.3.4 In view of the weather condition and site activities in the Reporting Period, it is considered that the exceedances were likely related to the rainstorm and natural variation and not caused by the works under the project.
