JOB No.: TCS00874/16

CEDD CONTRACT NO. CV/2012/05  
DEVELOPMENT OF A BATHING BEACH AT LUNG MEI,  
TAI PO

MONTHLY ENVIRONMENTAL MONITORING AND AUDIT  
REPORT (MARCH 2021)

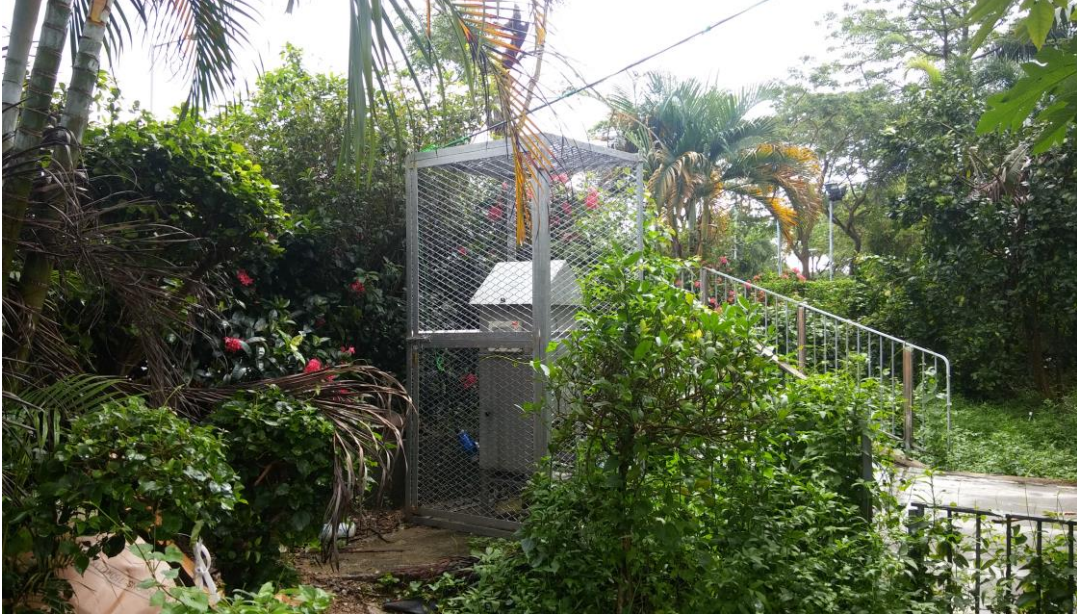
**A4**

**Air Quality Monitoring (24-Hour TSP & 1-Hour TSP)**

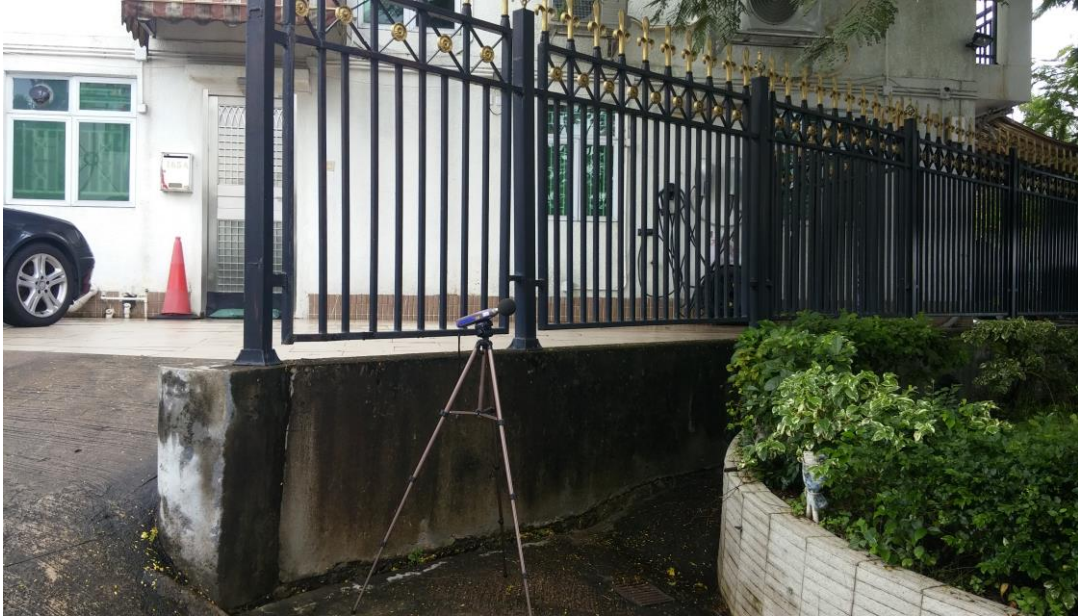
**N1**

**Noise Monitoring**

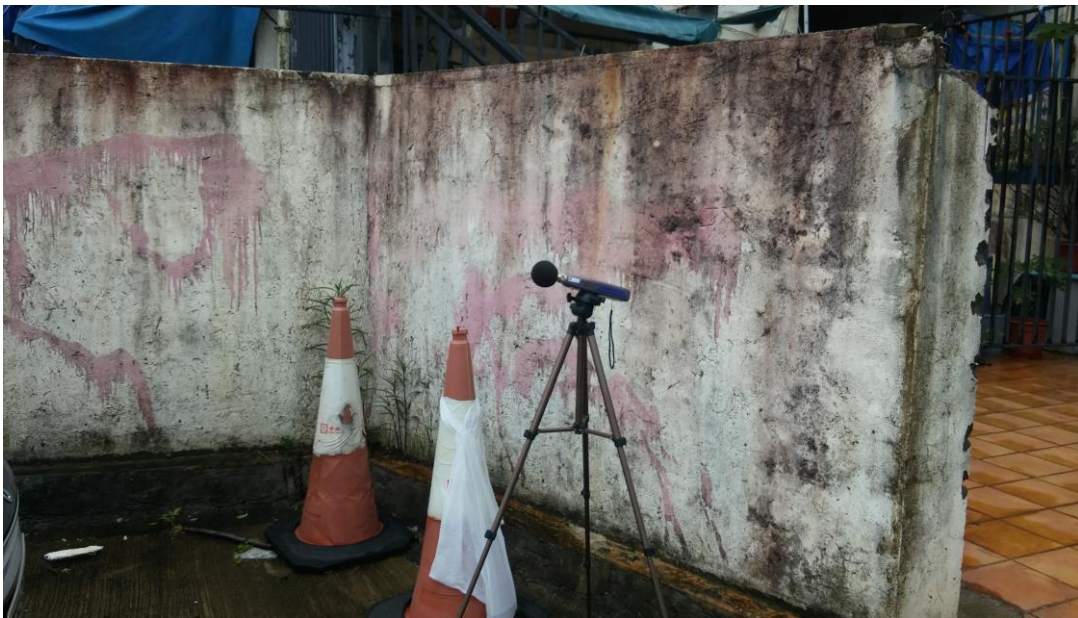
**N2a**

3.3.3 As confirmed on the first day of baseline monitoring, N2a (House no. 101 Lung Mei) has been changed to residential use. Therefore, the noise monitoring is conducted at N2a and to replace

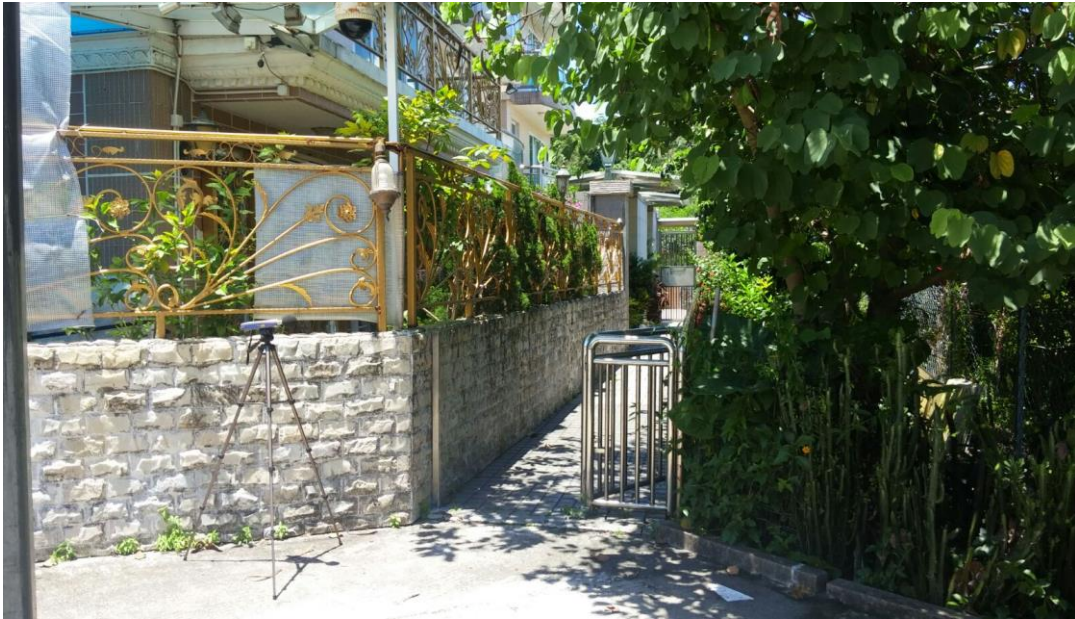
N2. Moreover, due to the lack of accessibility of noise monitoring at N3 (Village house – No. 70 Lo Tsz Tin), alternative location was proposed to replace N3 to carry out the noise monitoring. Having reviewed the surrounding condition, N3a (Village house – No. 66C Lo Tsz Tin) was proposed with the rationales summarized in below.

- 1) The distance between N3 and N3a is about 18 meter apart and N3a locates at close proximity of the project site and major site activities which are likely to have noise impacts;
- 2) N3a is a village type residential house and it is a noise sensitive receiver (NSR);
- 3) Accessibility for noise monitoring work at N3a is available; and
- 4) Minimal disturbance would be only caused to the proposed monitoring location N3a.
