**Installation of Submarine Gas  
Pipelines and Associated Facilities  
from To Kwa Wan to North Point for  
Former Kai Tak Airport Development**

*Tenth Coral Impact Report*

19 November 2012

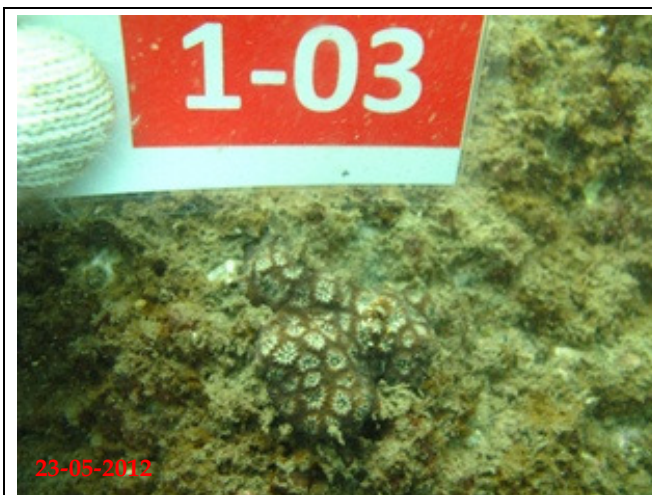
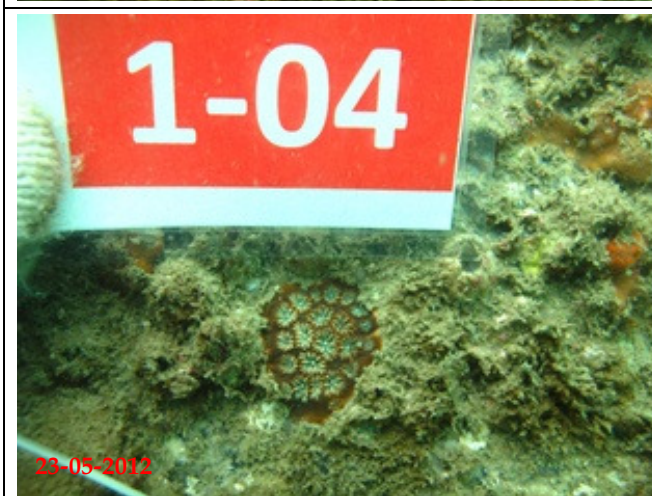
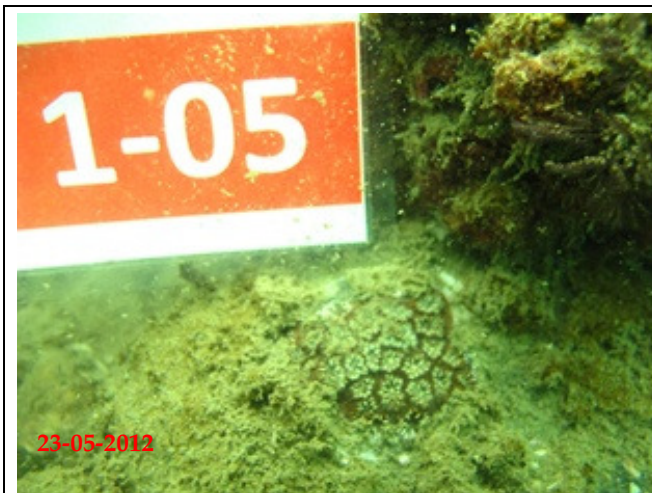
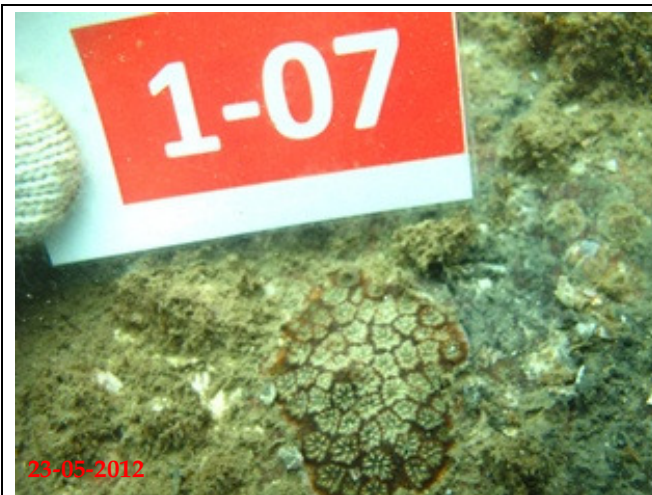
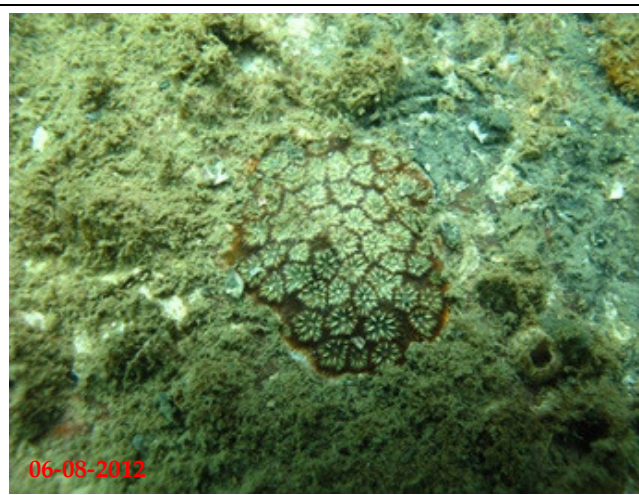
*Annex A1 Photographic Records of Tagged Coral Colonies at Impact Monitoring Site (Area 1) during the Baseline and Impact Monitoring Surveys*

The species, size, growth form, partial mortality, sediment cover (thickness, type and colour) and general health of the tagged corals recorded during the Baseline (ie including the Baseline and Update Baseline Surveys) and the 10<sup>th</sup> Impact Coral Monitoring Surveys were summarized in *Tables 2.2 to 2.5*. Photographic records of the tagged coral colonies are shown in *Annex A*.

Findings of the 10<sup>th</sup> Impact Coral Monitoring Surveys indicated that the Action Levels or Limit Levels for coral monitoring were not exceeded (*Tables 2.2-2.5*). There did not appear to be any deterioration in the general health

and condition of the tagged coral colonies as a result of the dredging activities within 250 m from the To Kwa Wan breakwaters.

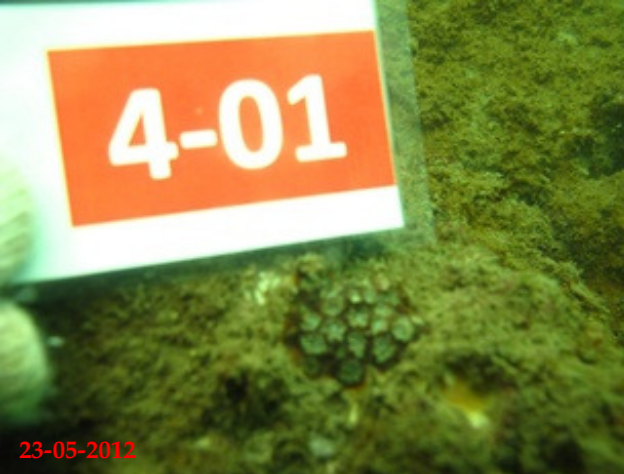
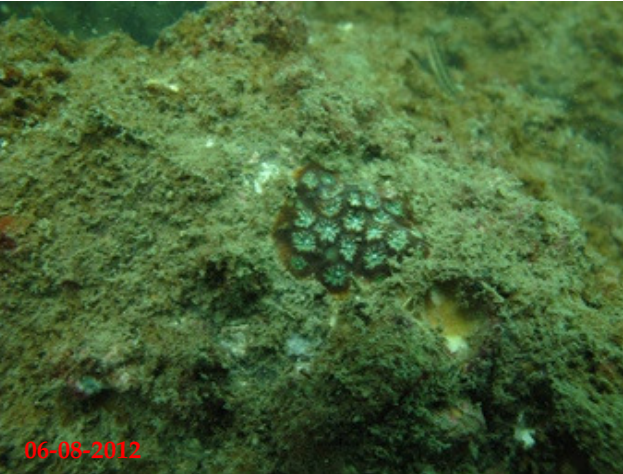
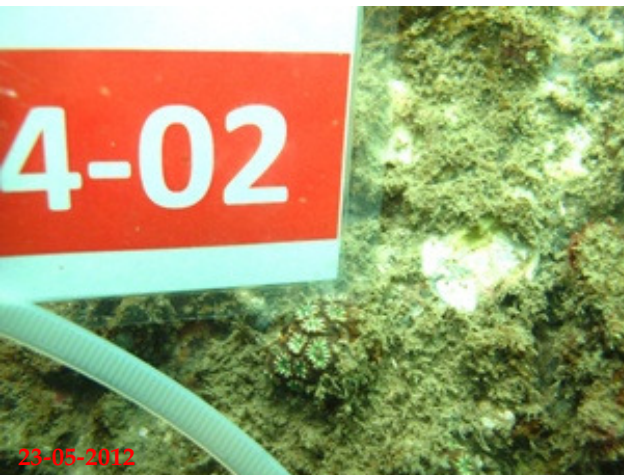
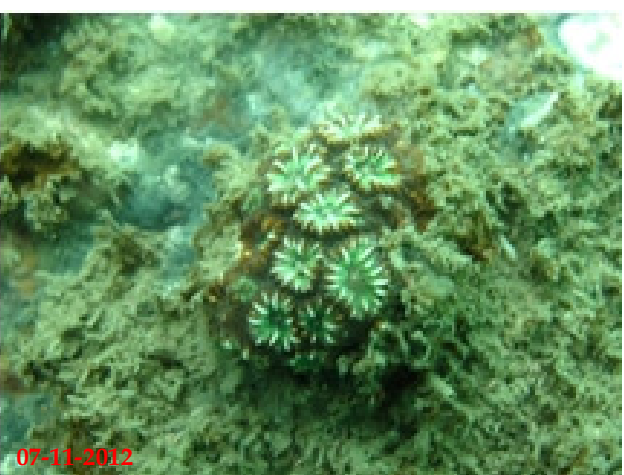
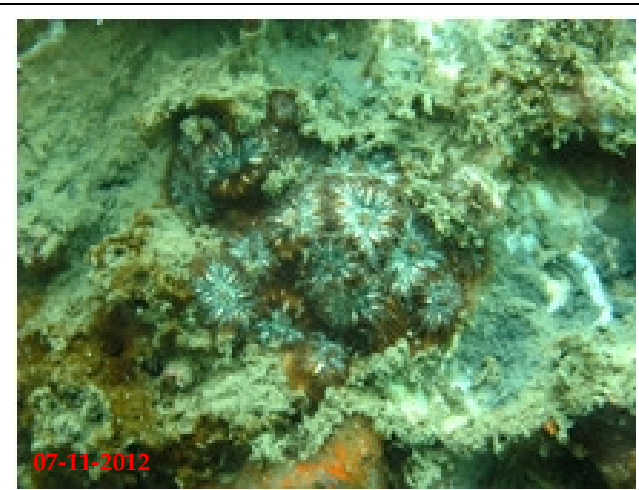
*Annex A4 Photographic Records of Tagged Coral Colonies at Control Site (Area 4) during Baseline and Impact Monitoring Surveys*

Baseline 23 May 2012	Updated Baseline 6 August 2012	Impact 7 November 2012
