**Installation of Submarine Gas  
Pipelines and Associated Facilities  
from To Kwa Wan to North Point for  
Former Kai Tak Airport Development**

*Eighth Coral Impact Report*

17 October 2012

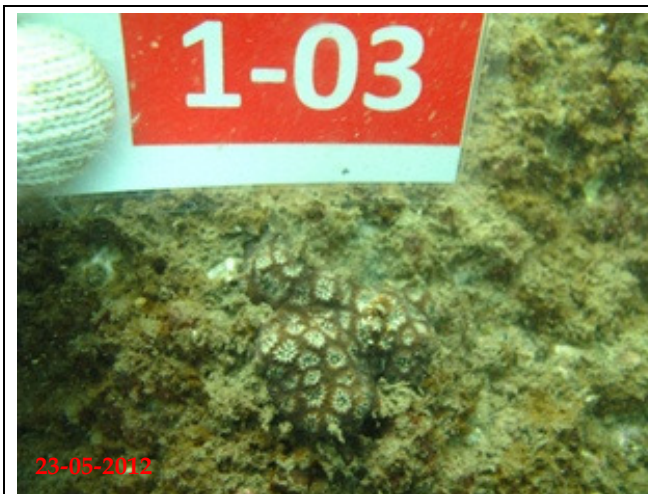
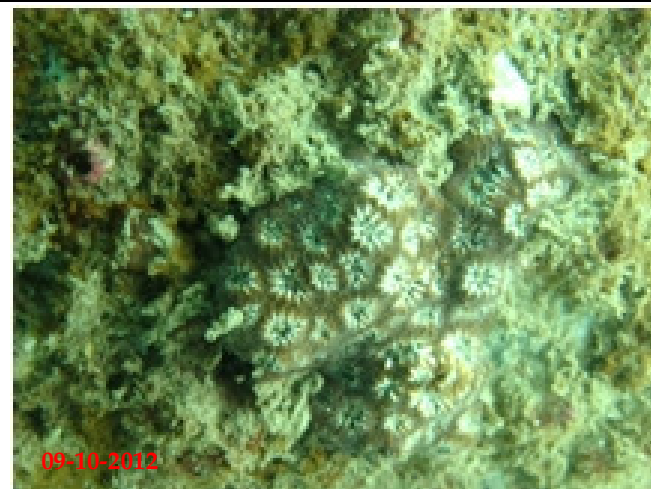
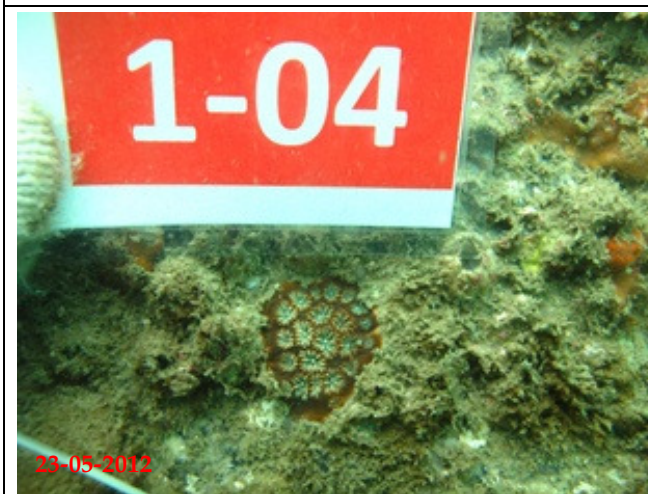
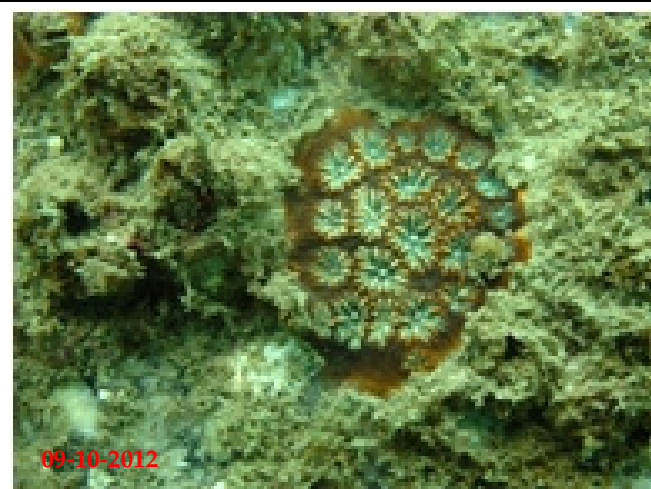
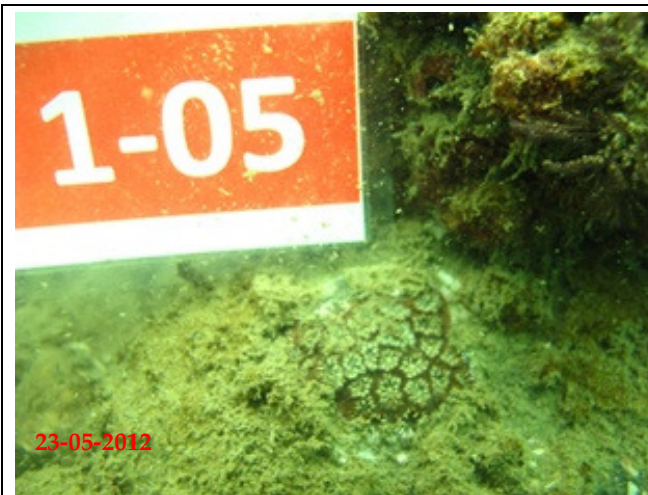
*Annex A1 Photographic Records of Tagged Coral Colonies at Impact Monitoring Site (Area 1) during the Baseline and Impact Monitoring Surveys*

Findings of the 8<sup>th</sup> Impact Coral Monitoring Surveys indicated that the Action Levels or Limit Levels for coral monitoring were not exceeded (*Tables 2.2-2.5*). There did not appear to be any deterioration in the general health and

condition of the tagged coral colonies as a result of the dredging activities within 250 m from the To Kwa Wan breakwaters.

Baseline 23 May 2012	Updated Baseline 6 August 2012	Impact 9 October 2012

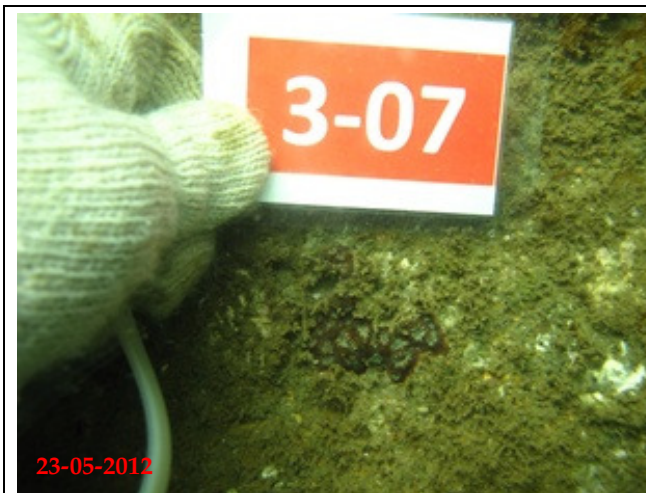
*Annex A3 Photographic Records of Tagged Coral Colonies at Impact Monitoring Site (Area 3) during Baseline and Impact Monitoring Surveys*

Baseline 23 May 2012	Updated Baseline 6 August 2012	Impact 9 October 2012

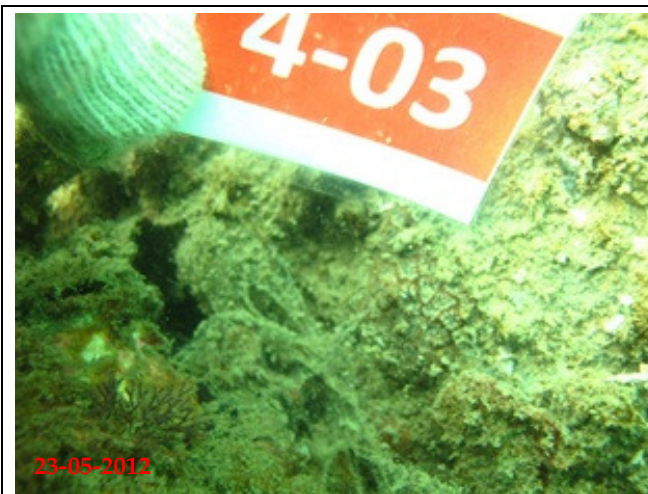
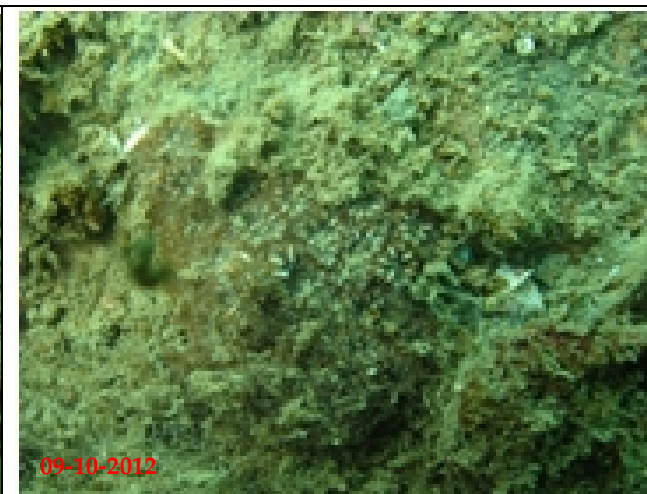
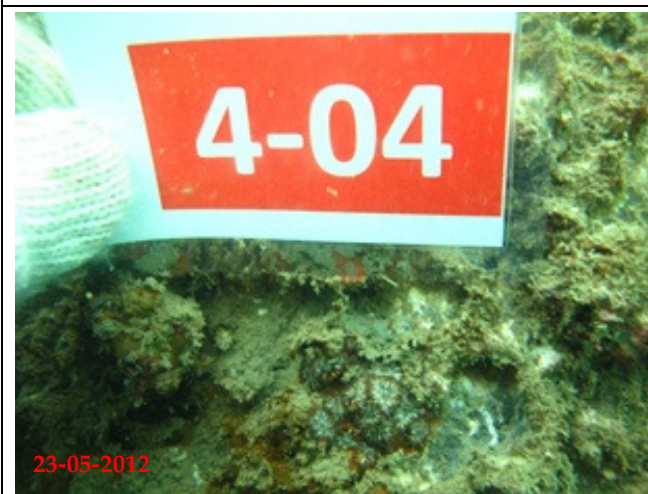
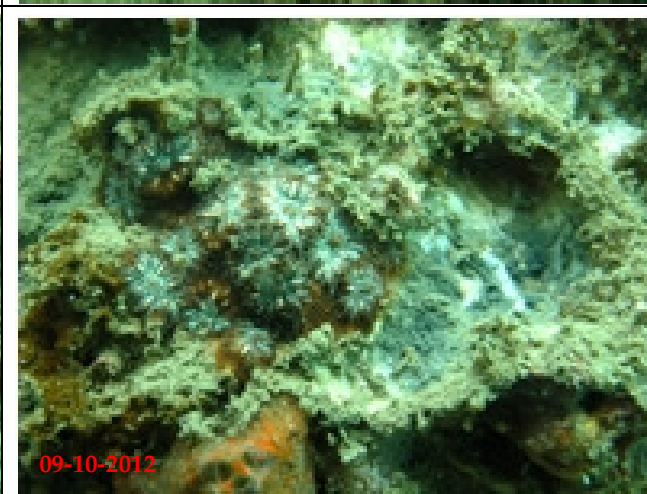
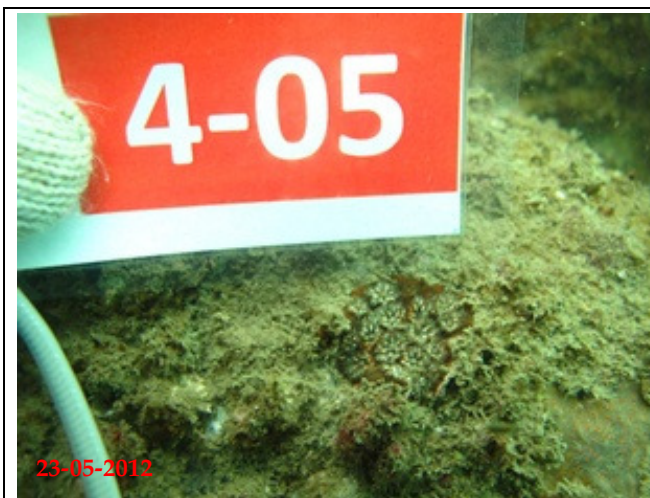
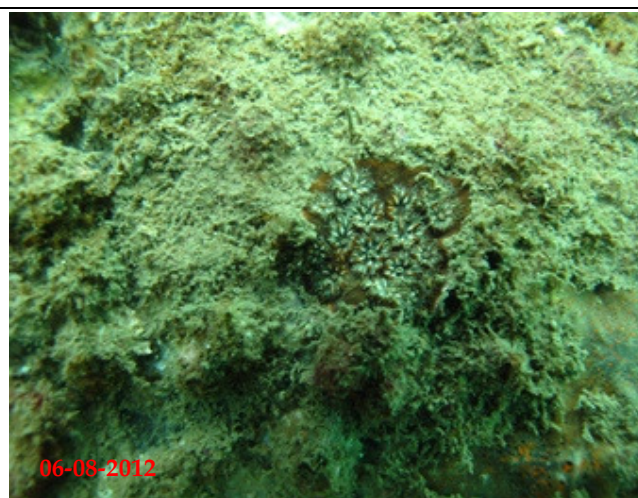
*Annex A4 Photographic Records of Tagged Coral Colonies at Control Site (Area 4) during Baseline and Impact Monitoring Surveys*

Action and Limit Levels for the partial mortality of tagged corals were established based on the baseline coral data (*Table 3.1*). No exceedances of the Action and Limit Levels were identified during the 8<sup>th</sup> Impact Coral Monitoring Survey on 9 October 2012. There thus did not appear to be any deterioration in the general health and condition of the tagged coral colonies as a result of the dredging activities within 250 m from the To Kwa Wan breakwaters.

Baseline 23 May 2012	Updated Baseline 6 August 2012	Impact 9 October 2012
