Proposed Road Improvement Works in West Kowloon Reclamation Development – Phase 1

Environmental Monitoring & Audit Report

01/07/2016 – 31/07/2016

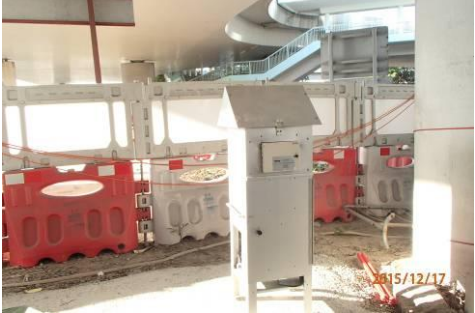
Monitoring Location	Photo Record
<p>AM1 Marine Department New Yau Ma Tei Public Cargo Working Area Administrative Building</p>	  <p>A photograph showing a grey air quality monitoring station on a tiled rooftop terrace. The station is positioned next to a white door with ventilation slats. A date stamp in the bottom right corner reads '2015/11/07'.</p>
<p>AM2 Garden Building</p>	  <p>A photograph of an air quality monitoring station outdoors. The station is grey and has a sign on top that reads '空氣質素監測站' and 'Air Quality Monitoring Station'. A yellow warning sign with a lightning bolt symbol is visible on the front. The station is located near a building entrance and a set of stairs. A date stamp in the bottom right corner reads '2015/05/18'.</p>
<p>AM3-A International Commerce Centre (Contractor Work Area 4)</p>

<p>A photograph of an air quality monitoring station in a construction area. The station is grey and is surrounded by red and white safety barriers. The area appears to be a contractor work area. A date stamp in the bottom right corner reads '2015/12/17'.</p>

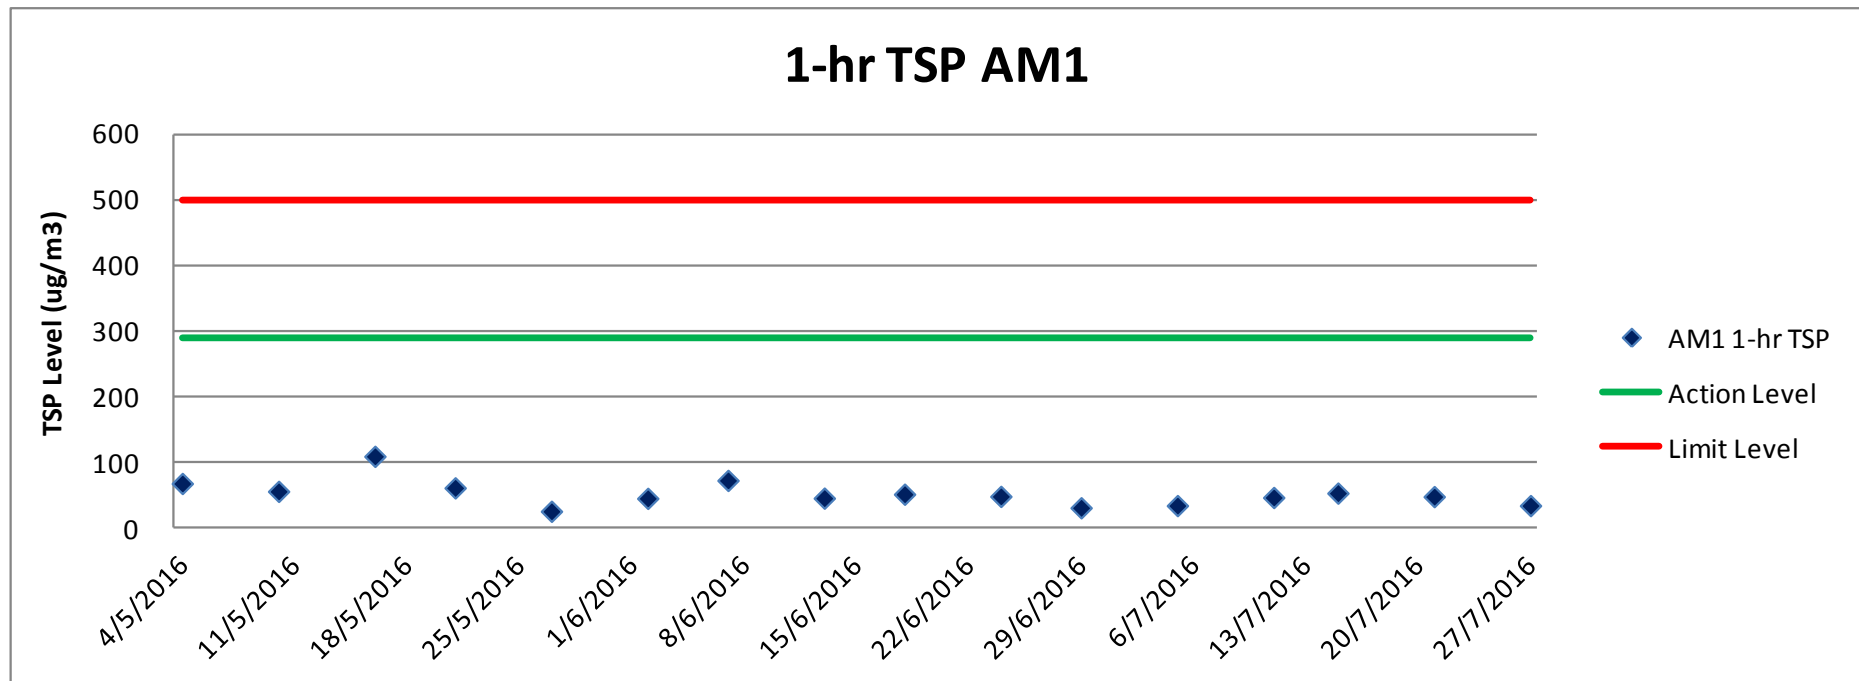
Date	Weather	Temperature (°C) *	Wind Direction *	Wind Speed (m/s) *	Sampling Time			Reading ($\mu\text{g}/\text{m}^3$)			
					1	2	3	1	2	3	Average
5/7/2016	Sunny	25.3 - 31.0	SE	0.0 - 5.8	14:14	15:15	16:16	33	32	39	35
11/7/2016	Cloudy	25.3 - 31.0	W	0.0 - 5.0	13:50	14:51	15:52	47	47	47	47
15/7/2016	Sunny	28.0 - 32.1	W	0.0 - 5.0	9:17	10:18	11:19	62	52	47	54
21/7/2016	Sunny	27.3 - 32.3	W	0.0 - 4.4	15:06	16:07	17:08	32	55	58	48
27/7/2016	Sunny	27.3 - 32.8	SW	0.0 - 4.2	13:06	14:07	15:08	27	33	44	35

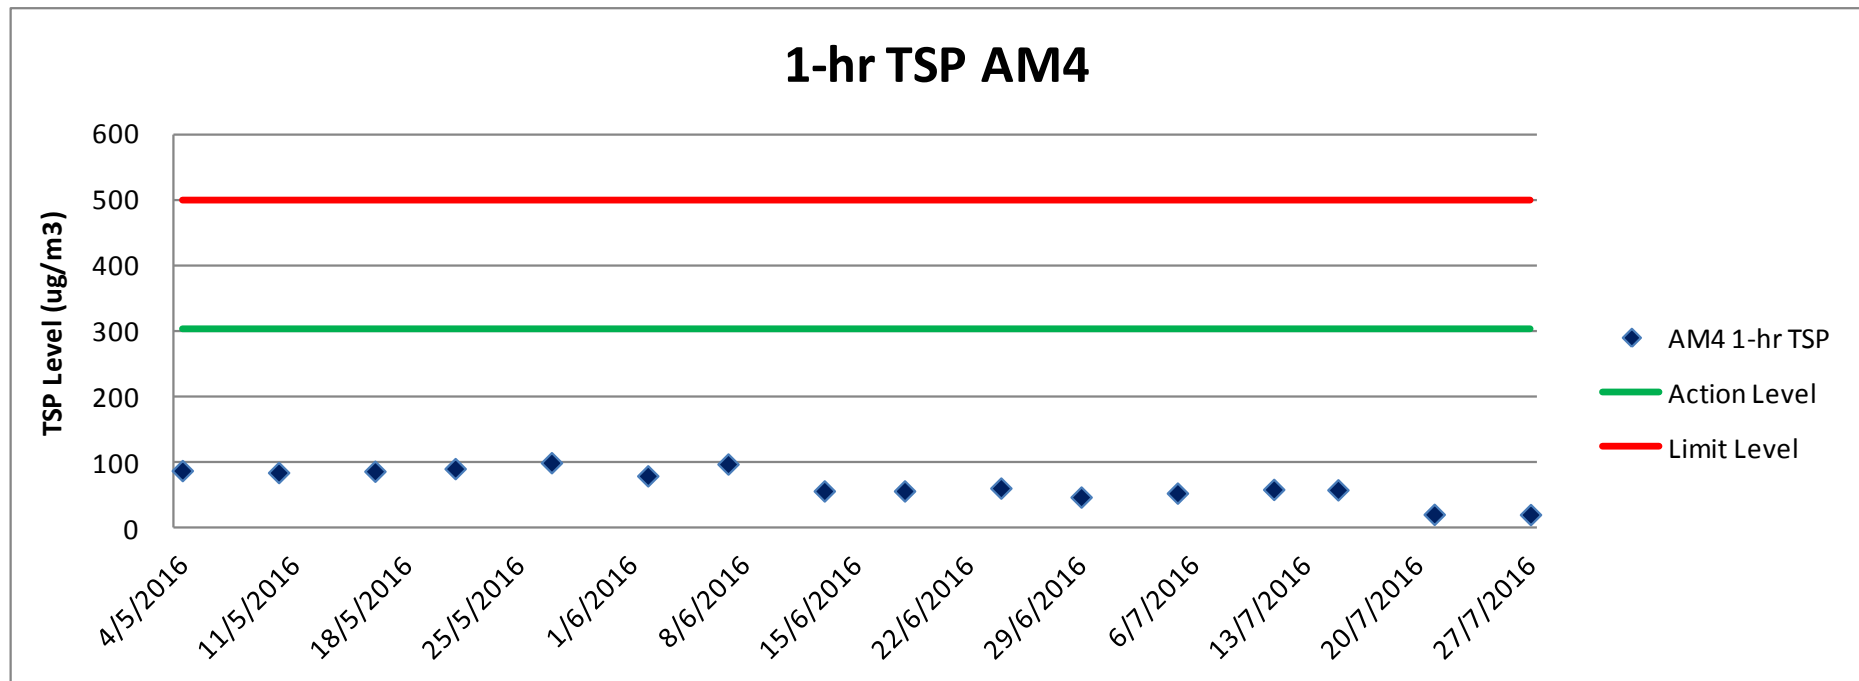
1-hr TSP Monitoring Result for AM4

Date	Weather	Temperature (°C) *	Wind Direction *	Wind Speed (m/s) *	Sampling Time			Reading ($\mu\text{g}/\text{m}^3$)			
					1	2	3	1	2	3	Average
5/7/2016	Sunny	25.3 - 31.0	SE	0.0 - 5.8	9:25	10:26	11:27	51	48	62	54
11/7/2016	Cloudy	25.3 - 31.0	W	0.0 - 5.0	13:57	14:58	15:59	58	67	53	59
15/7/2016	Sunny	28.0 - 32.1	W	0.0 - 5.0	14:01	15:02	16:03	60	59	57	59
21/7/2016	Sunny	27.3 - 32.3	W	0.0 - 4.4	13:53	14:54	15:55	22	25	17	21
27/7/2016	Sunny	27.3 - 32.8	SW	0.0 - 4.2	13:51	14:52	15:53	18	18	27	21
