CEDD CONTRACT AGREEMENT NO. EDO/04/2018 - ENVIRONMENTAL TEAM FOR CROSS BAY LINK, TSEUNG KWAN O

MONTHLY ENVIRONMENTAL MONITORING & AUDITING REPORT OF THE PROJECT – NOVEMBER 2022

PREPARED FOR
CIVIL ENGINEERING AND DEVELOPMENT DEPARTMENT
(CEDD)

14 December 2022 TCS00975/18/600/R0703v2

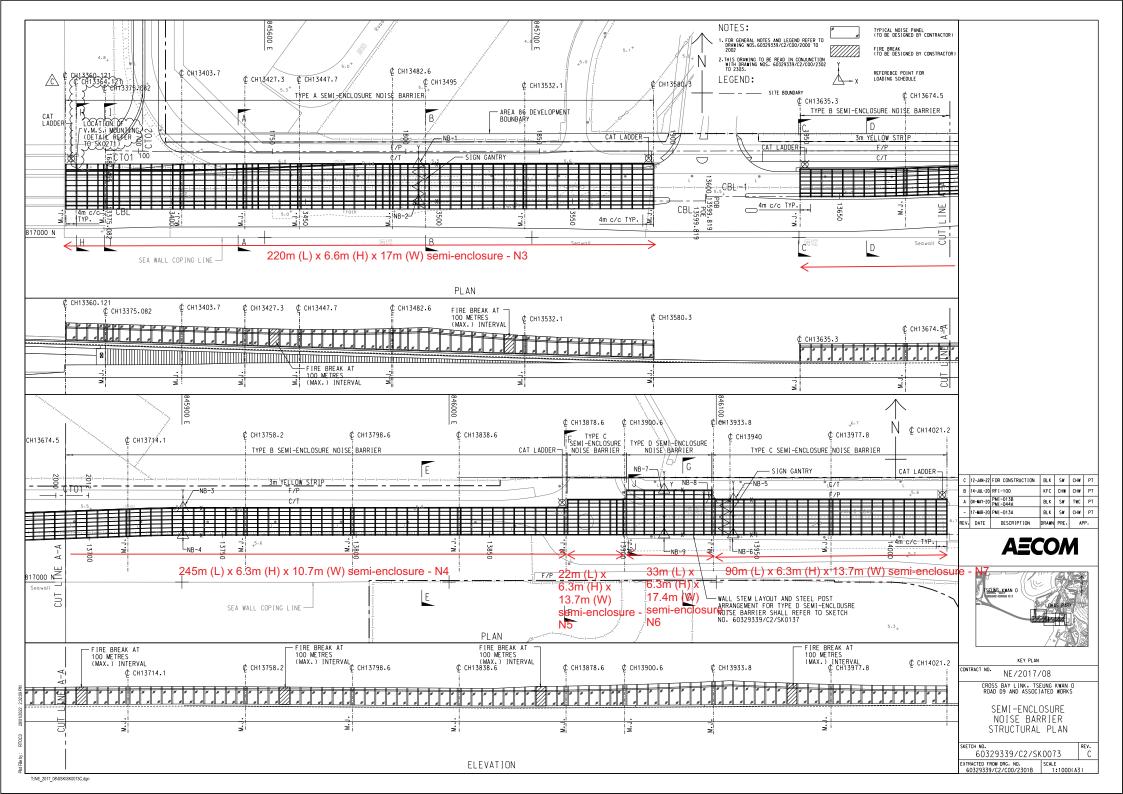
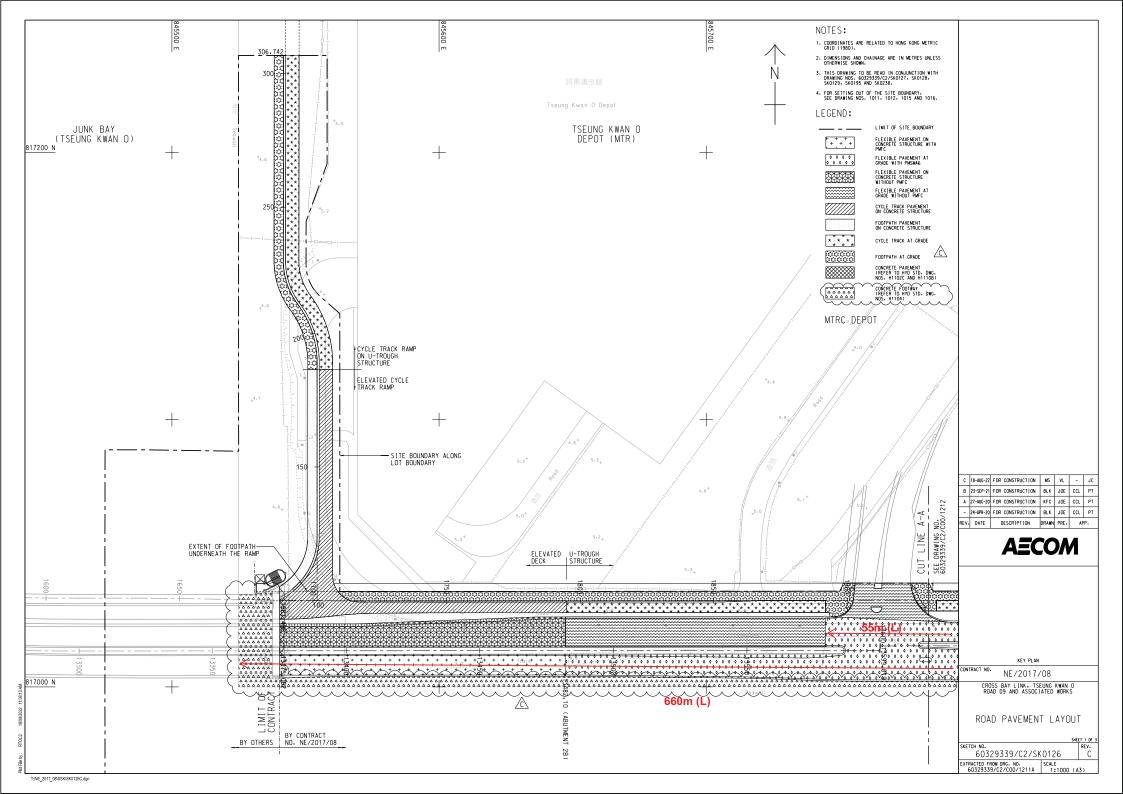
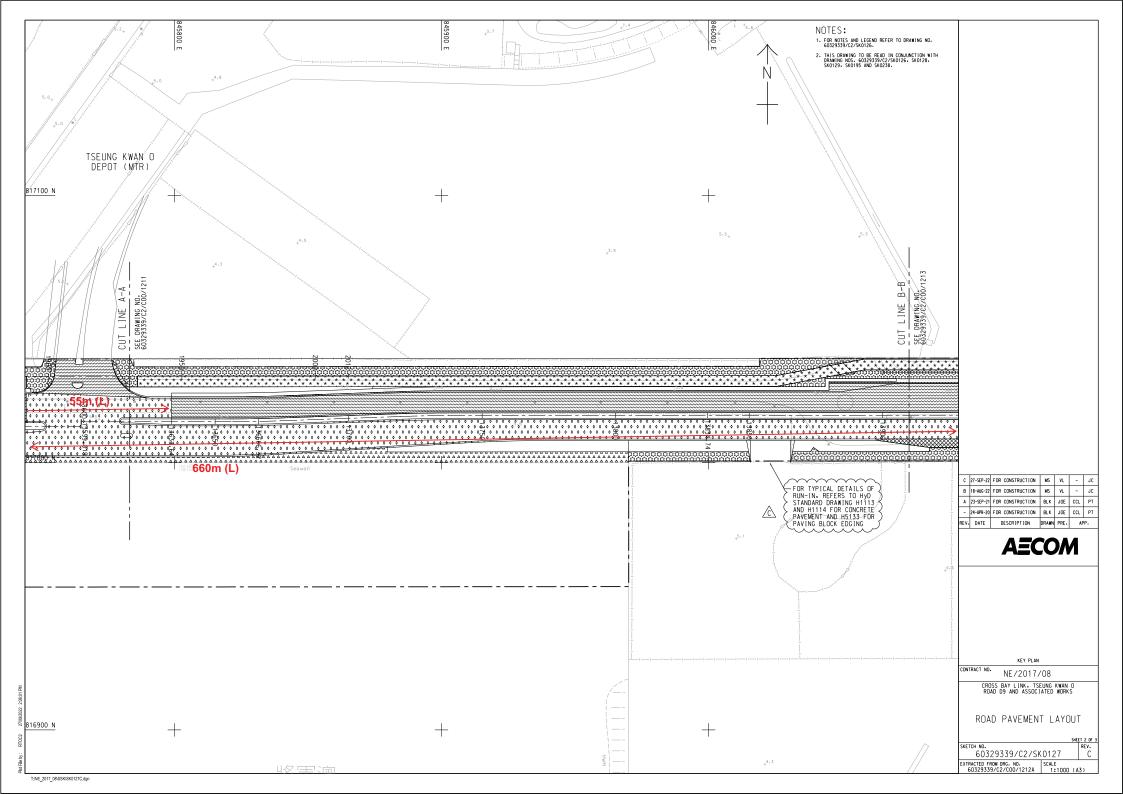
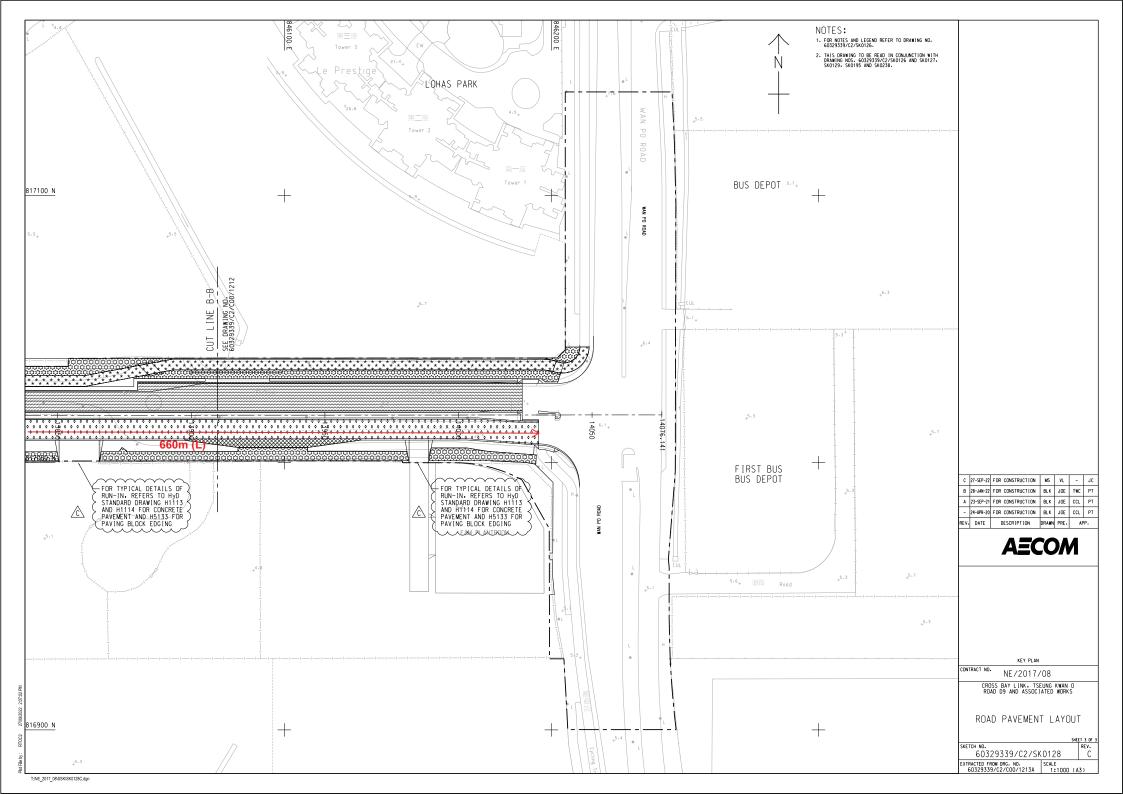
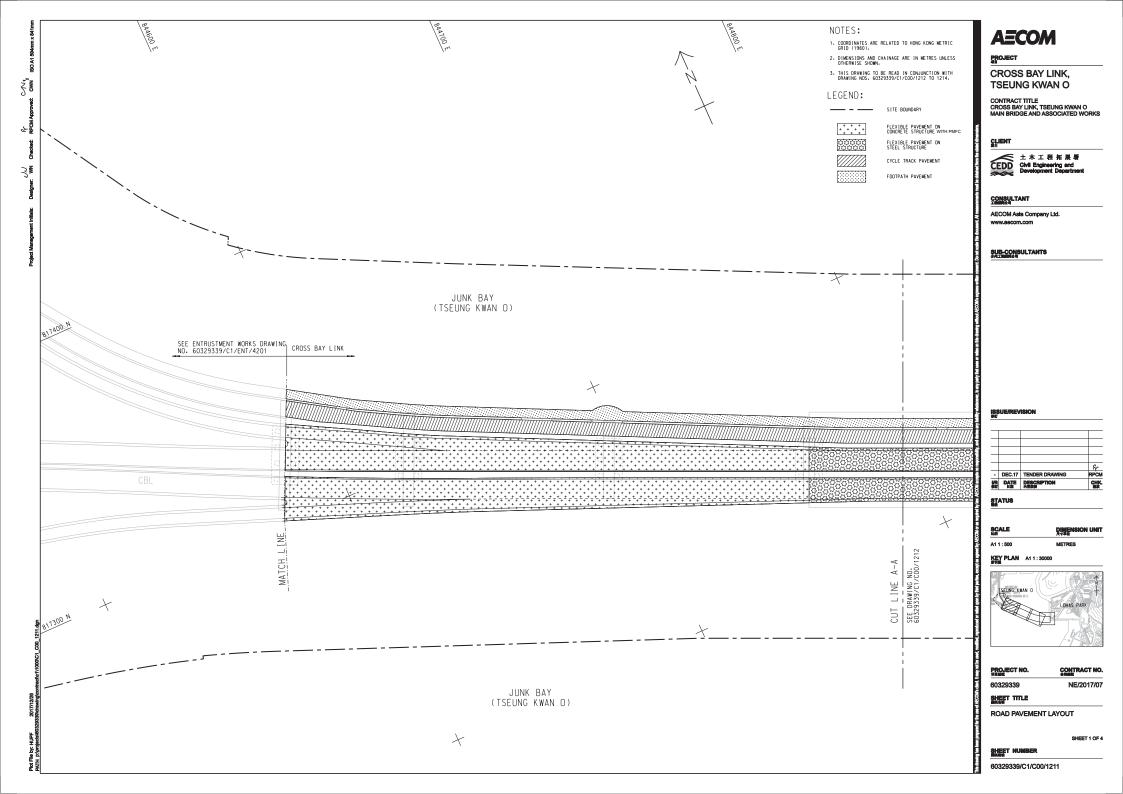
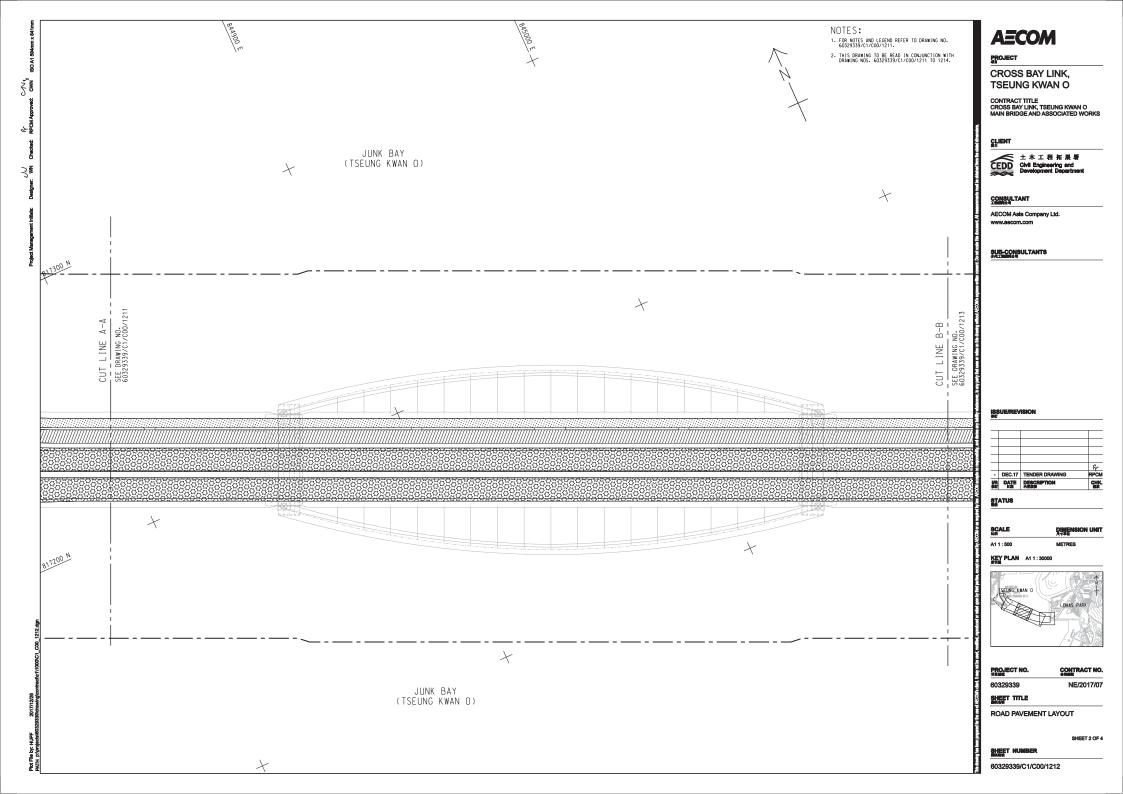
As-built Drawing of the Low Noise Surfacing and Semi-Enclosure Noise Barrier

11.2.1 According to Environmental Permit EP-459/2013 Condition 3.4, noise mitigation measures such as low noise surfacing and semi-enclosure noise barrier shall be implemented at CBL main bridge and Road D9 to mitigate traffic noise impact arising from the operation of Project. The details of the mitigation measures are shown in Table 11-2. An as-built drawing of the low noise surfacing and semi-enclosure noise barrier at CBL main bridge Road D9 was shown in **Appendix O**. All the locations and dimensions of the required mitigation measures are complied with Table 1 and Figure 2 of the EP.

- ES16 Opening of Cross Bay Link will be held on 10 December 2022. Operational noise mitigation measures required in Environmental Permit EP-459/2013 Condition 3.4 were implemented, and all the locations and dimensions of the required mitigation measures are complied with Table 1 and Figure 2 of the EP.
