# **Expansion of Hong Kong International Airport into a Three-Runway System**

Construction Phase Quarterly EM&A Report  
No.18 (1 April to 30 June 2020)

September 2020

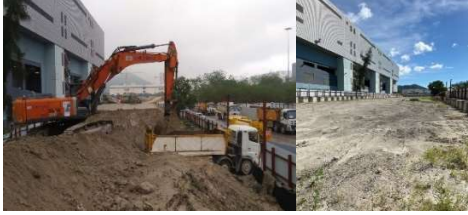
**Snapshots of Good Environmental Practices in the Reporting Period**

<p>Reuse of inert C&amp;D materials as filling materials for the marine reclamation</p>	<p>Reuse of rubble and asphalt generated from demolition for paving haul roads</p>	<p>Seawall blocks with eco-enhancement designs along the artificial vertical seawall</p>
