**MONTHLY ENVIRONMENTAL MONITORING AND AUDIT  
(EM&A) REPORT (NO. 4)**

**CONTRACT NO. 3/WSD/15  
IN-SITU REPROVISIONING OF SHA TIN  
WATER TREATMENT WORKS – SOUTH WORKS**

**MONTHLY ENVIRONMENTAL  
MONITORING AND AUDIT  
(EM&A) REPORT (NO. 4) -**

**CONTRACT NO. 3/WSD/15  
IN-SITU REPROVISIONING OF SHA TIN WATER  
TREATMENT WORKS – SOUTH WORKS**

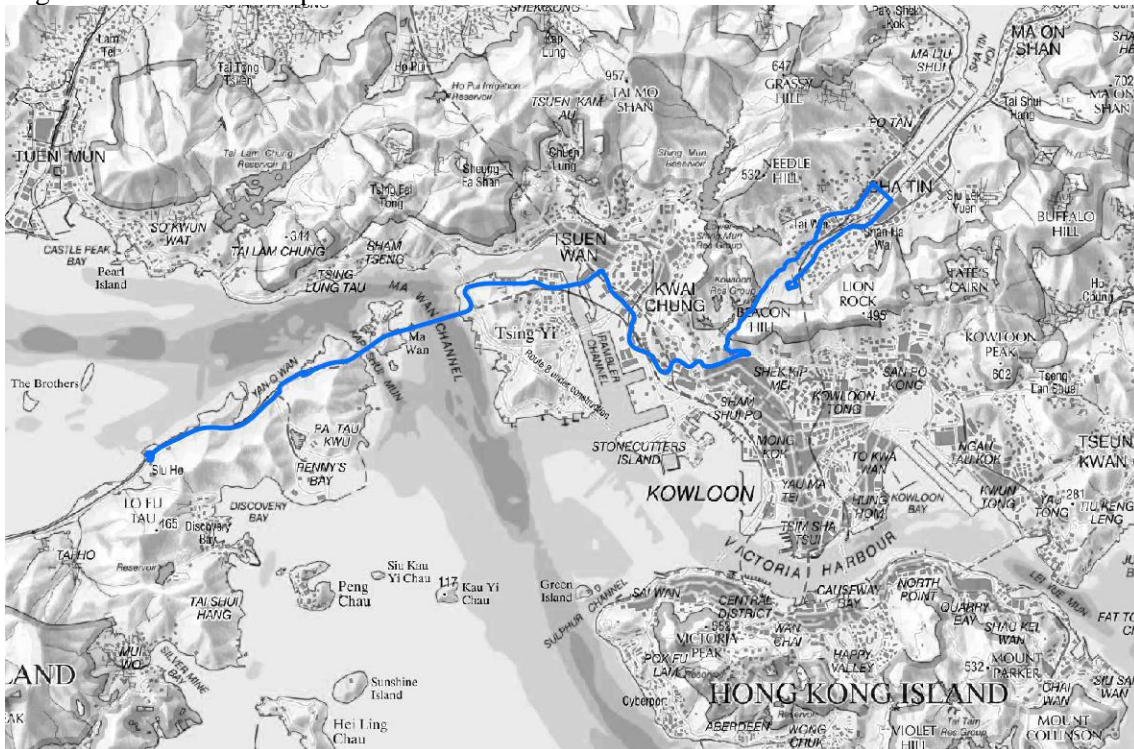
Figure 1: Chlorine Transport Route to Sha Tin Water Treatment Works

- 2.7.1 Chlorine is delivered to Sha Tin WTW in batches of up to 6×1-tonne drums. The transport route from Sham Shui Kok dock on North Lantau is shown in **Figure 1**. The route passes along the North Lantau Expressway, around the northern edge of Tsing Yi, through Tsuen Wan and along Tai Po Road (Piper’s Hill) to Sha Tin (Table 2-15)
