CONTRACT NO. 1/WSD/19 & 6/WSD/21

IN-SITU REPROVISIONING OF SHA TIN WATER TREATMENT WORKS (SOUTH WORKS) – WATER TREATMENT WORKS AND **ANCILLARY FACILITIES Environmental Permit EP-494/2015**

In-Situ Reprovisioning of Sha Tin Water Treatment Works (South Works) – Water Treatment Works and Ancillary Facilities
Environmental Permit EP-494/2015
Submission of 90th monthly EM&A Report

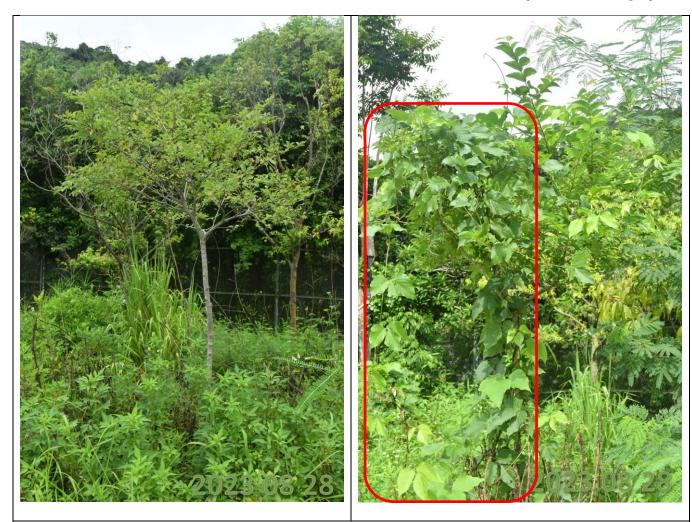
Photo 10. New sprouts keep emerging from the *Desmos chinensis* that reported dead previously. Construction materials nearby have been taken away.

Photo 11. *Schefflera heptaphylla* as compensatory planting of TA326.

- 2.5.4 New small sprouts keep emerging from the two *Desmos chinensis* that have been reported dead previously. Construction materials was also found too close to the planter. An eye-catching protective fence shall be set up as a protection zone. No construction materials shall be placed near/ within the protection zone.
